**Inspection Photos**  
**Operator: Hilcorp Energy**  
**Location/API #: 067-08147**  
**Date: 12-18-2019**

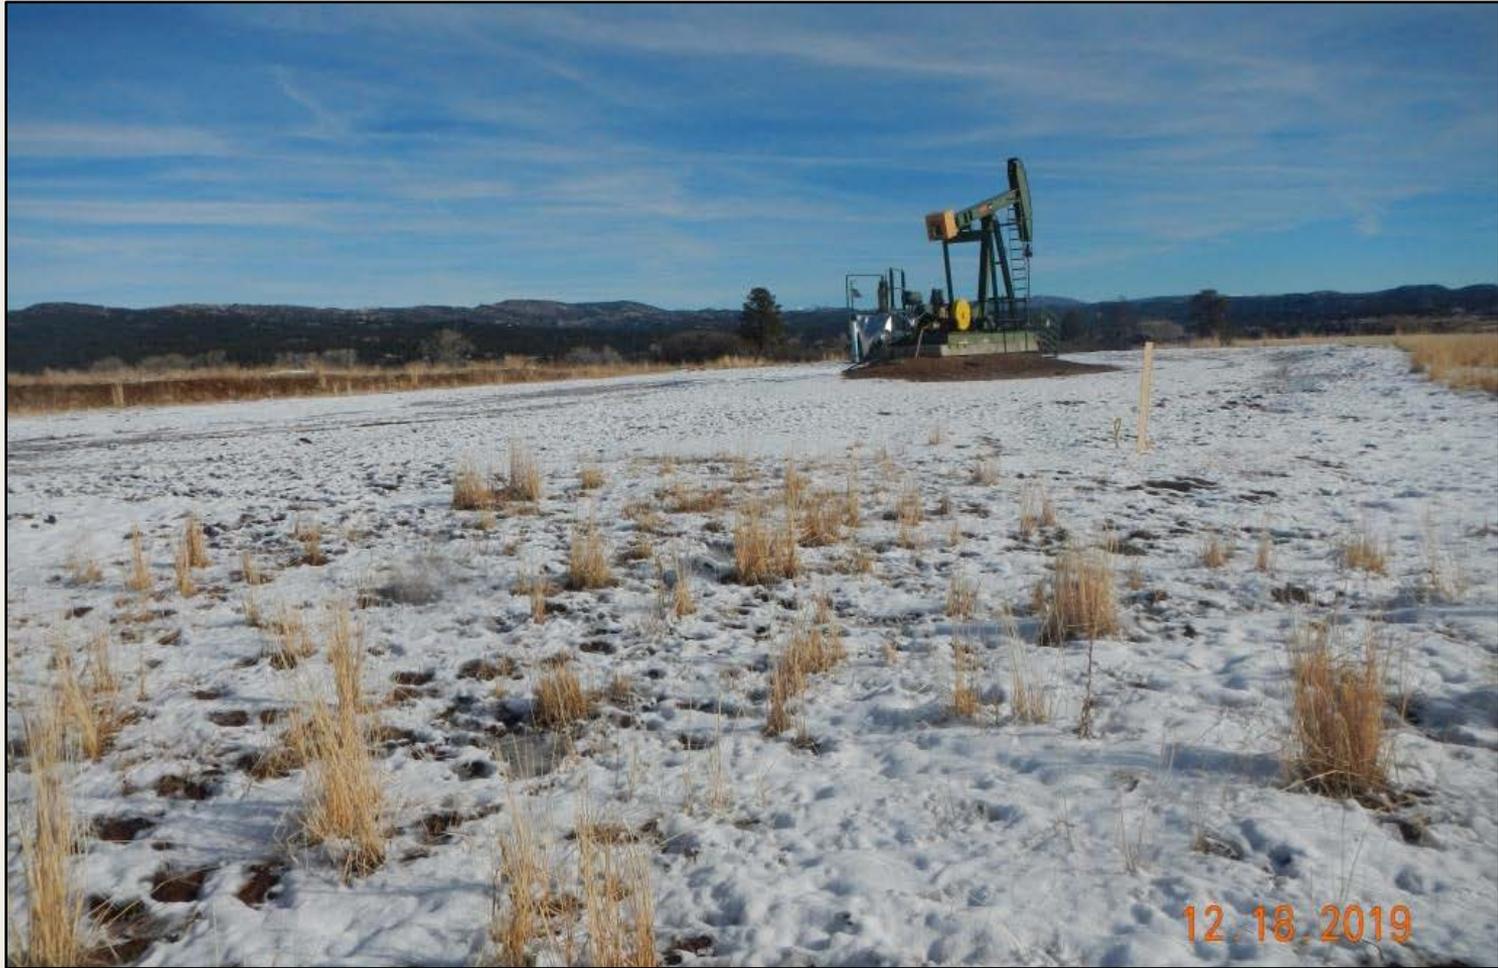
Photo 1. View of the project area from the southwestern edge facing center.

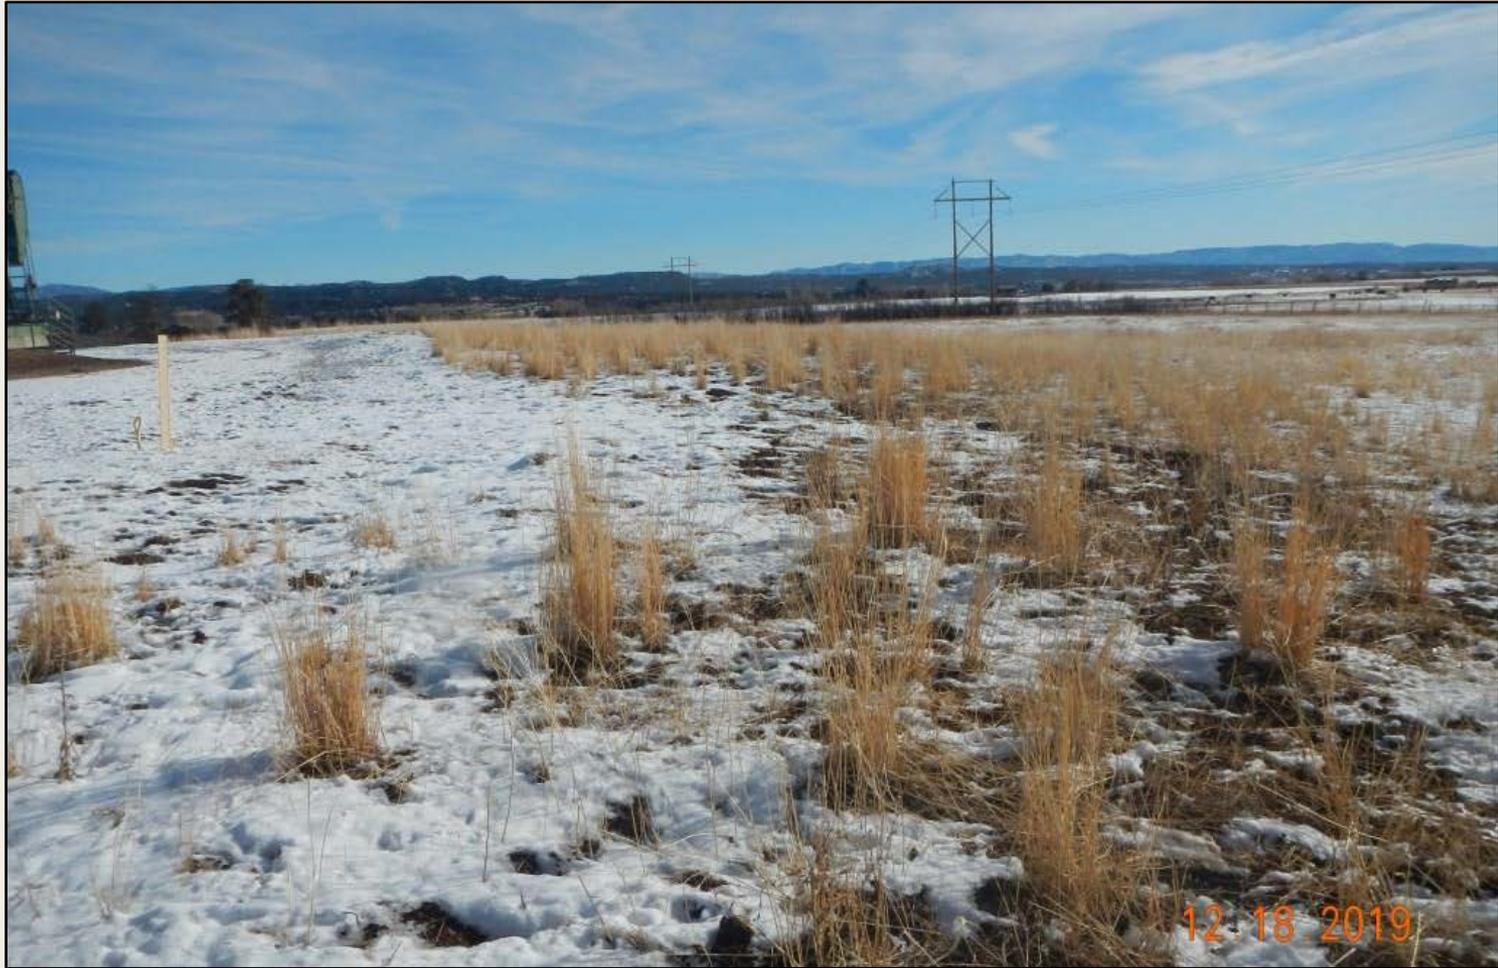
Photo 2. View of the southern fill slope from the southwestern corner facing eastward. Location is partially snow covered at this time. Revegetation is in a dormant vegetative condition, and largely comprised of intermediate wheatgrass.

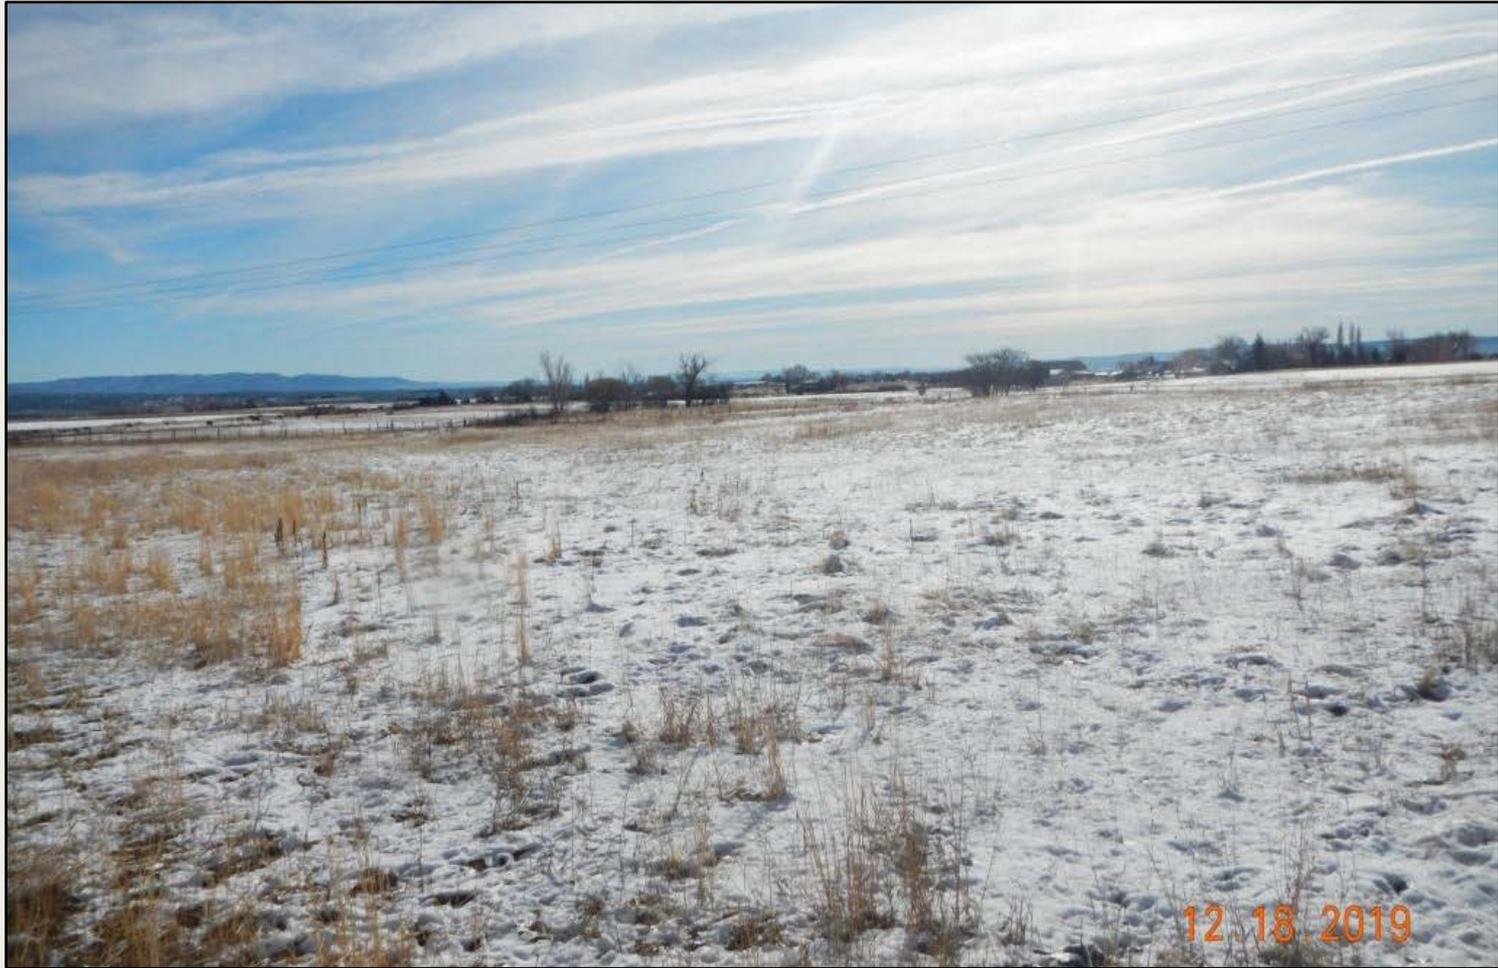
Photo 3. View of reference area, comprised of a grass field in dormant vegetative condition.
