Inspection Photos

Operator: Hilcorp Energy
Location/API #: 067-08202
Date: 12-18-2019

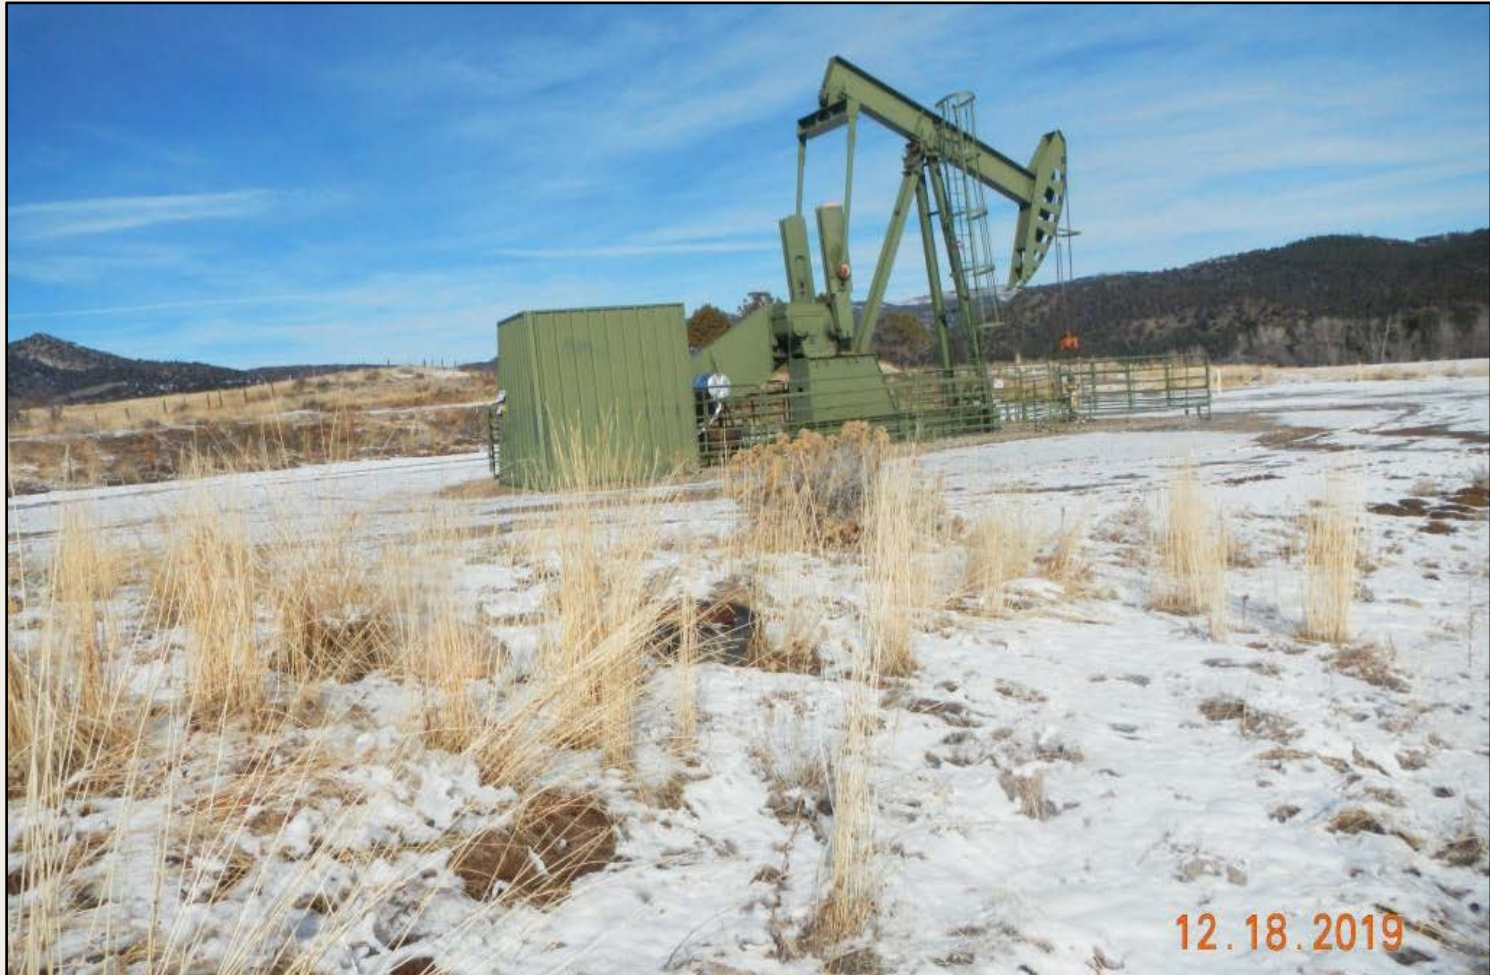
Photo 1. View of the project area from the southeastern corner facing center.

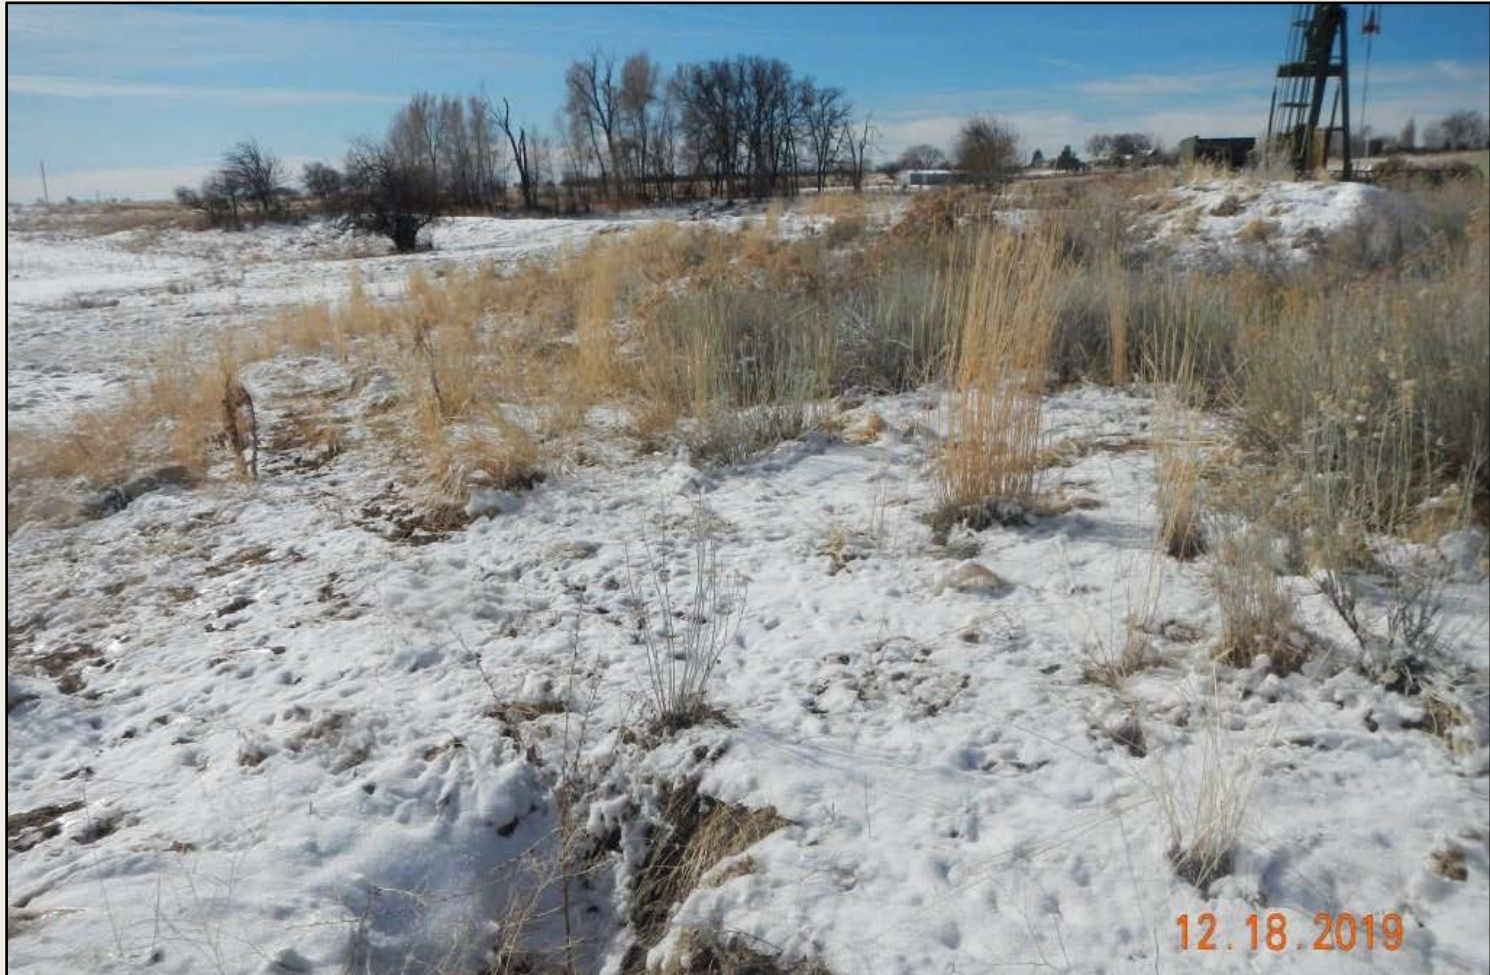
Photo 2. View of the eastern fill slope from the northeastern corner facing southward. Location is partially snow covered at this time. Revegetation is in a dormant vegetative condition, and largely comprised of smooth brome, rubber rabbitbrush, and sand dropseed.

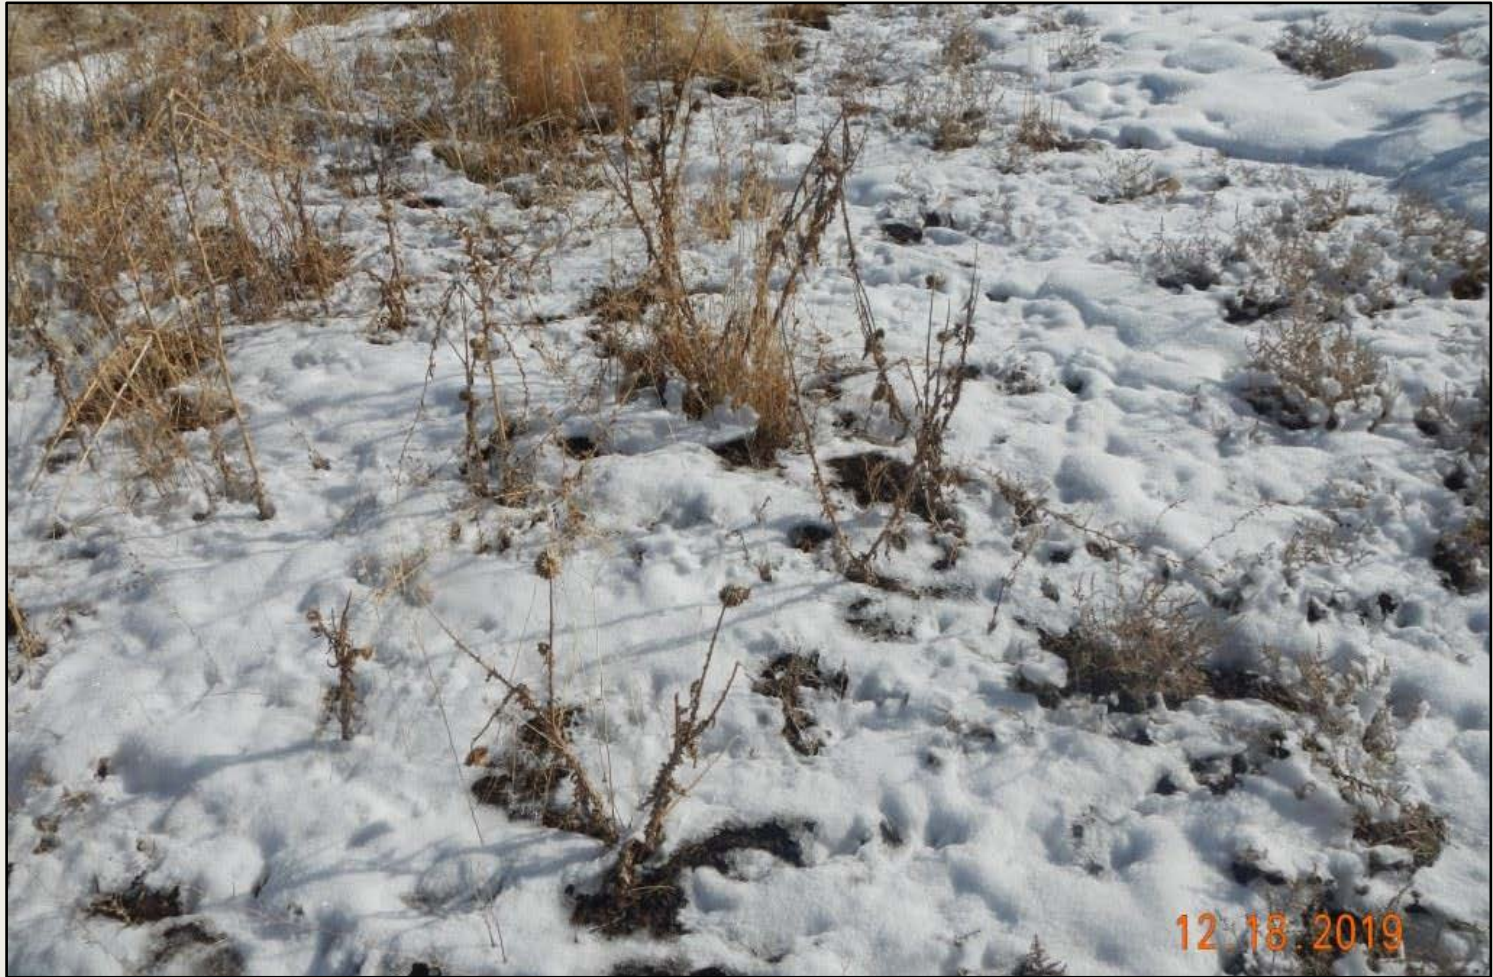
Photo 3. View of musk thistles in a post-flowering condition within the interim reclamation area.
