Inspection Photos
Operator: Hilcorp Energy
Location/API #: 067-07580
Date: 12-18-2019

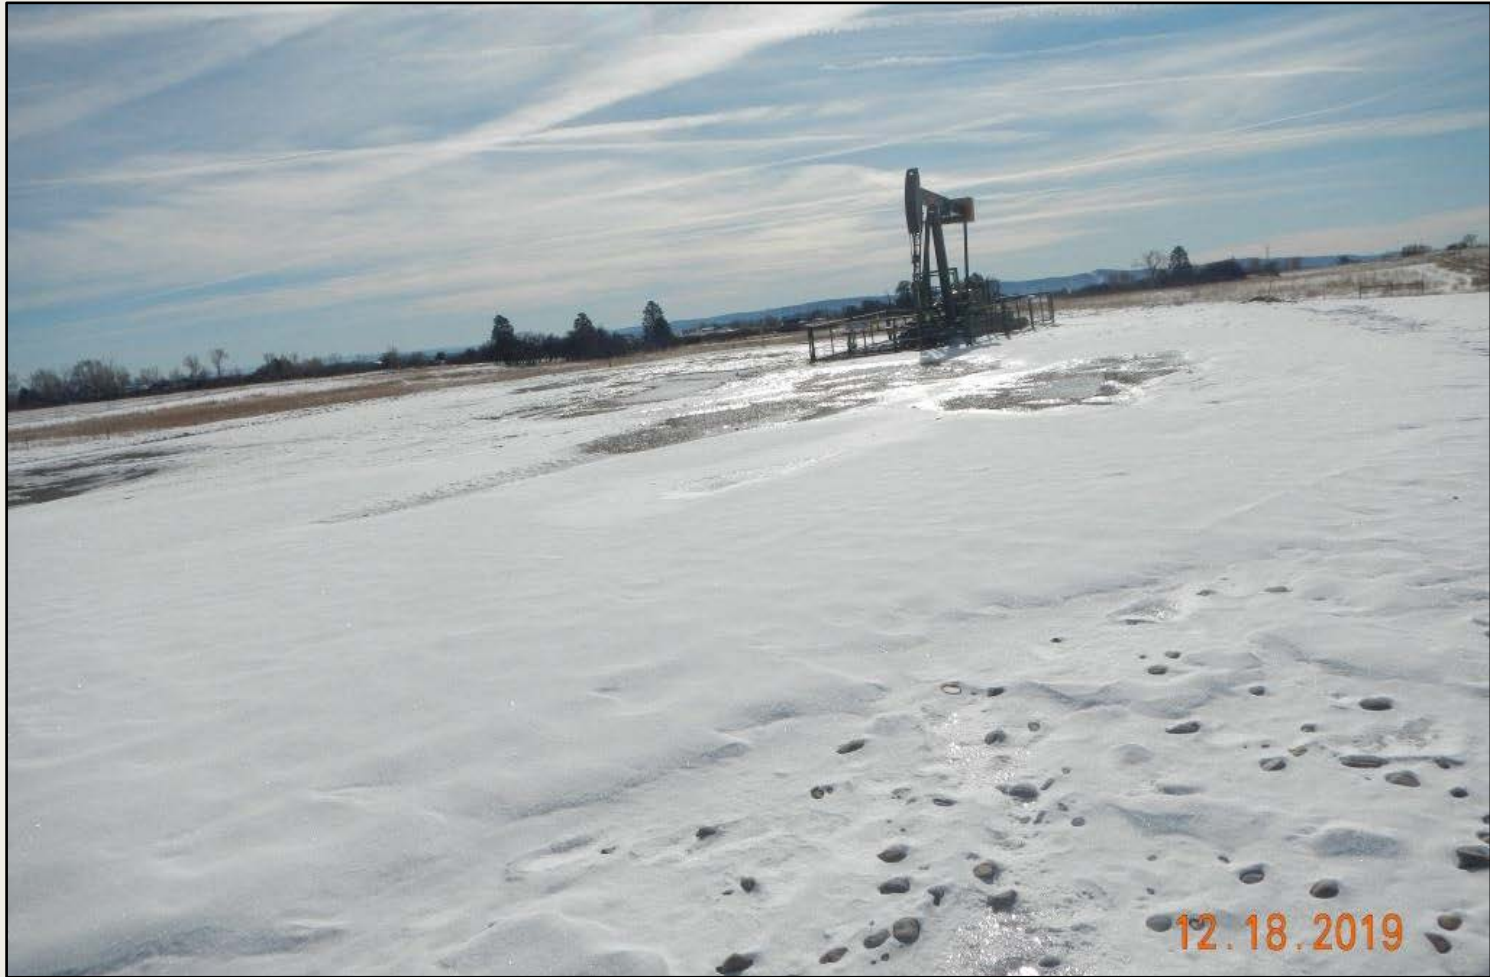
Photo 1. View of the project area from the northeastern corner facing center.

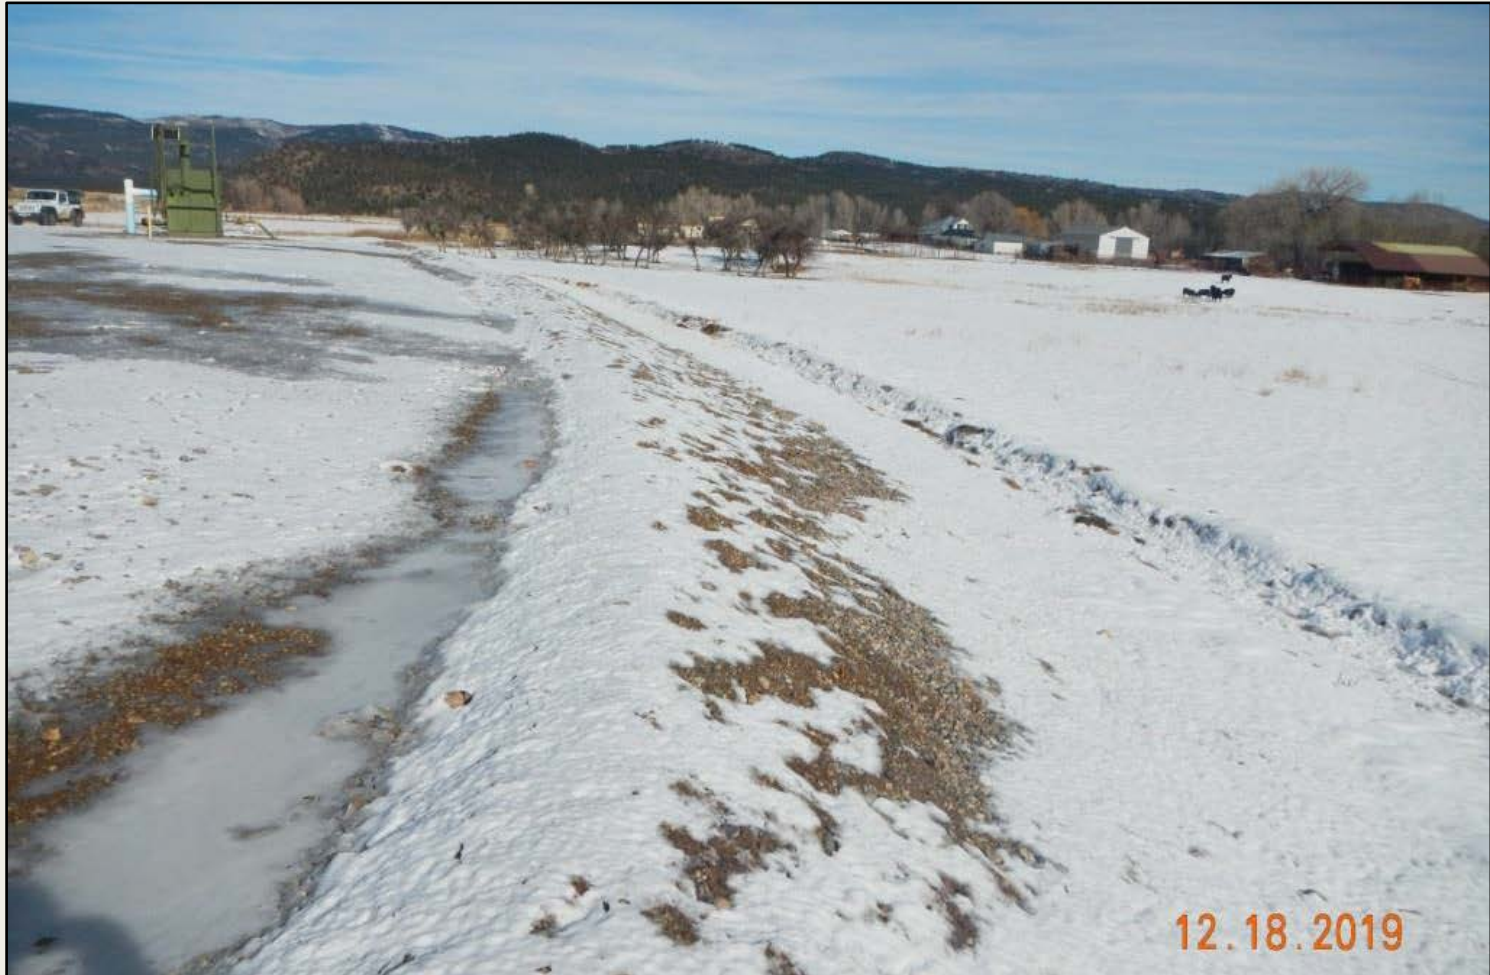
Photo 2. View of the eastern fill slope from the southeastern corner facing northward. Location is largely snow covered at this time. Revegetation is in a dormant vegetative condition, and largely comprised of smooth brome.

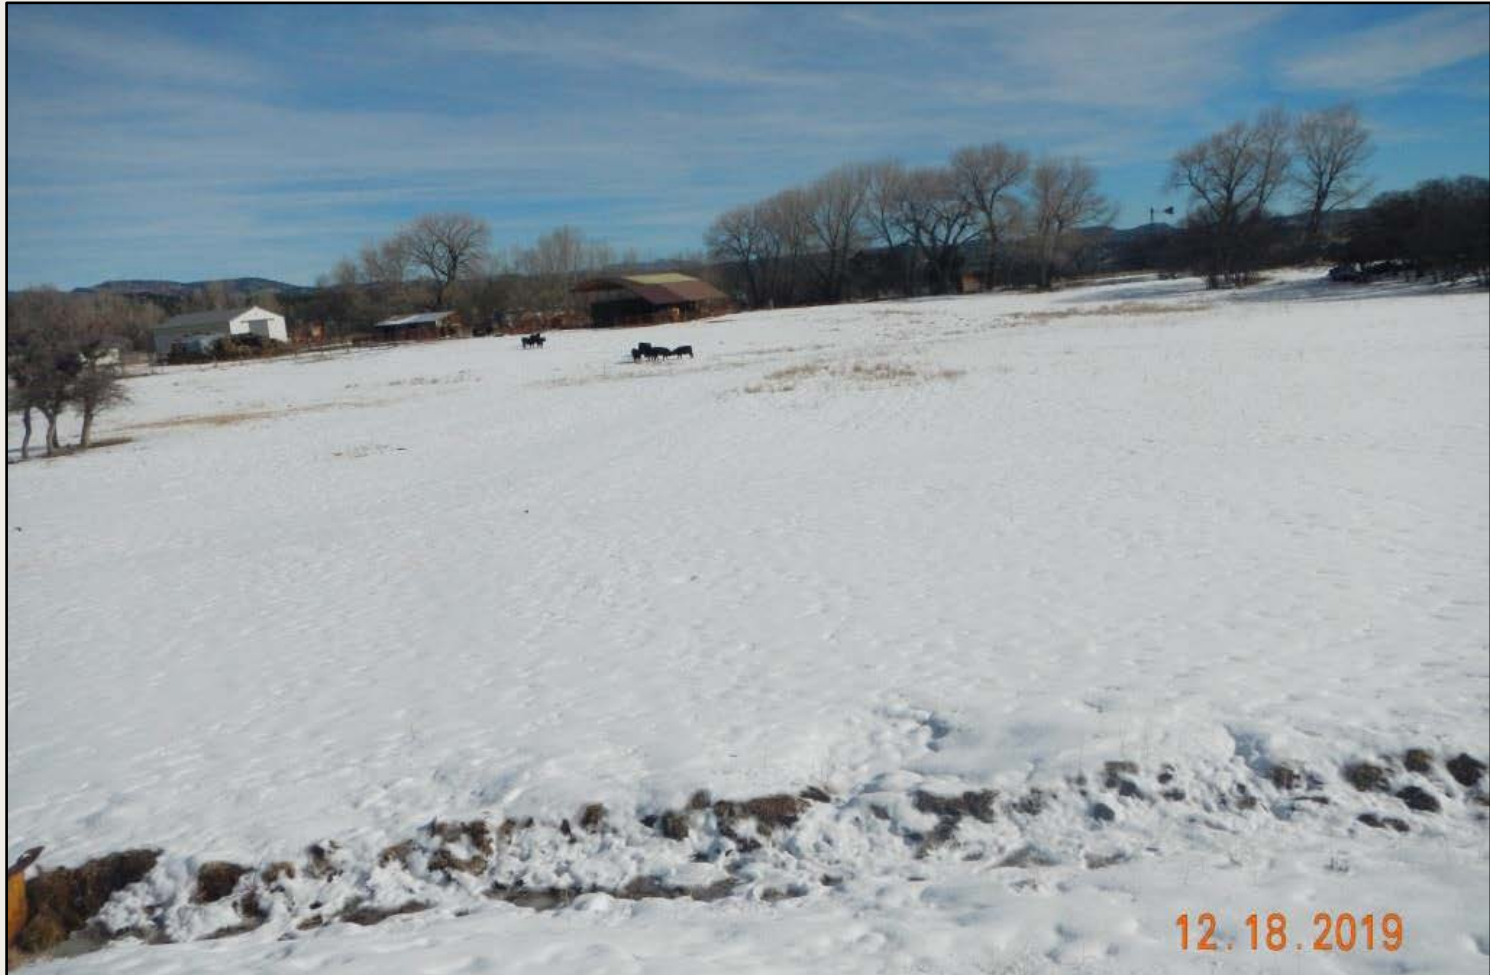
Photo 3. View of reference area, comprised of an irrigated grass field in dormant vegetative condition.
