Inspection Photos
Operator: Hilcorp Energy
Location/API #: 067-07787
Date: 12-18-2019

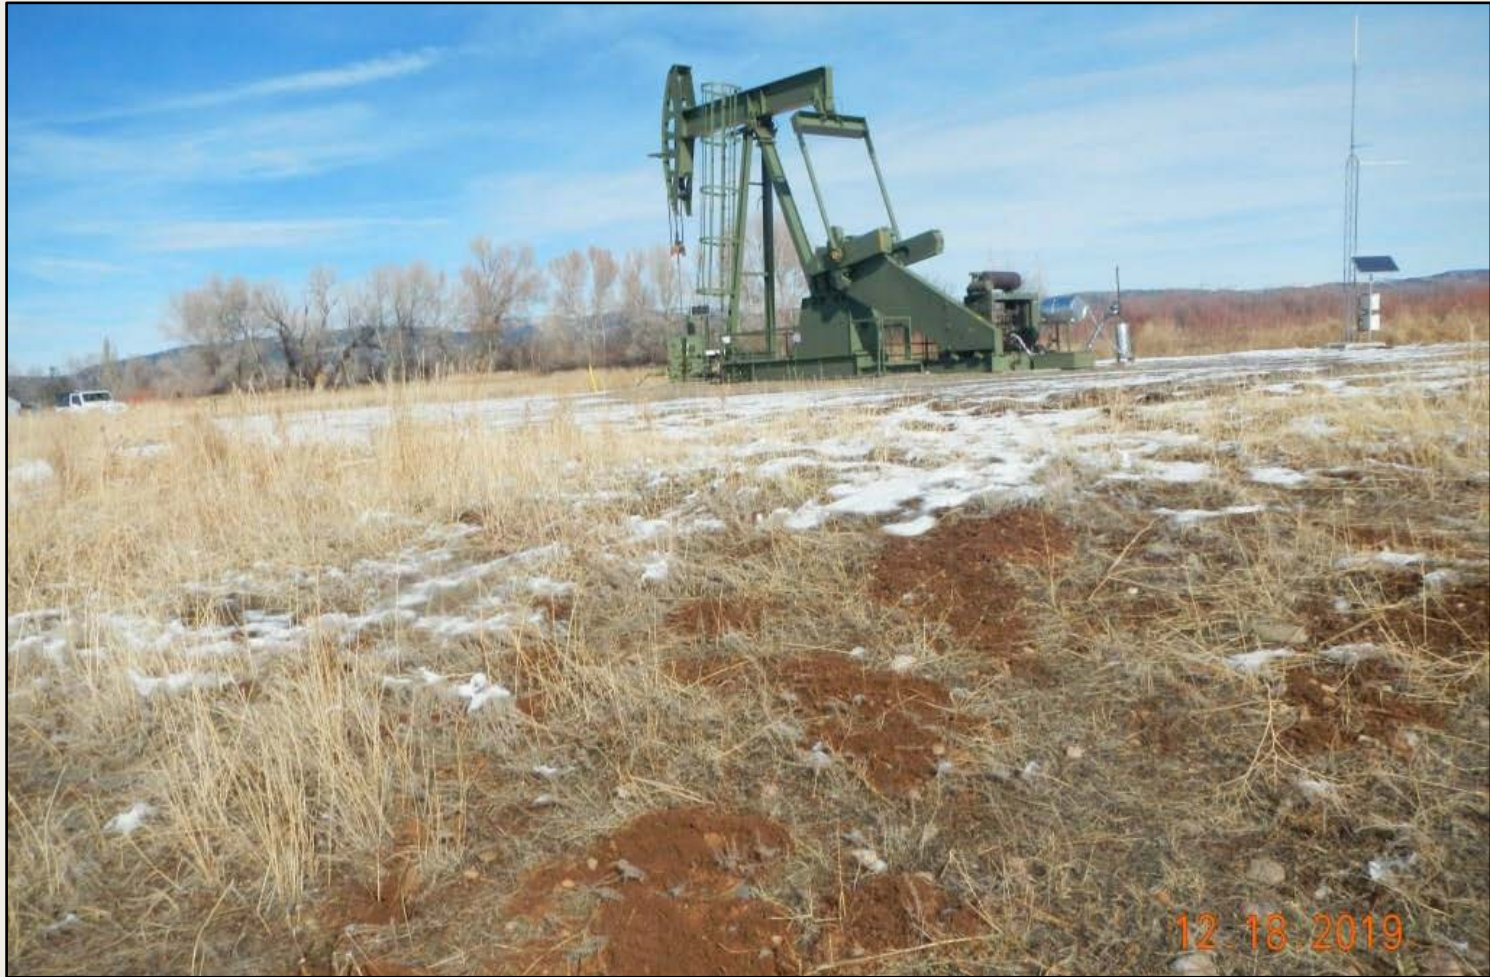
Photo 1. View of the project area from the southwestern corner facing center.

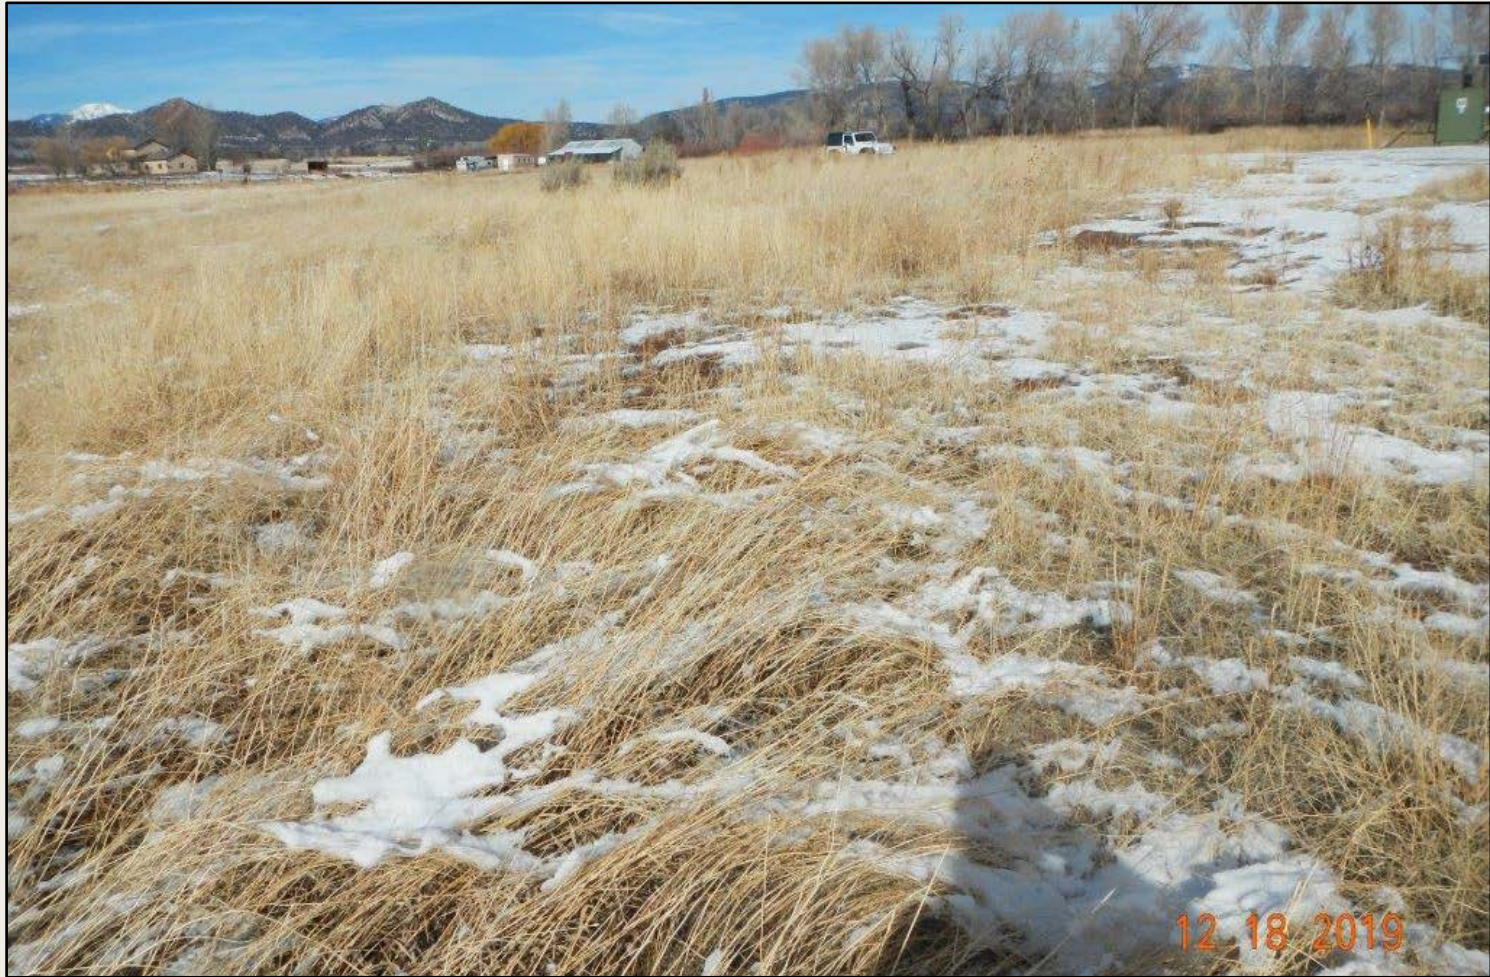
Photo 2. View of the western fill slope from the southwestern corner facing northward. Location is partially snow covered at this time. Revegetation is in a dormant vegetative condition, and largely comprised of smooth brome, western wheatgrass, and sand dropseed.

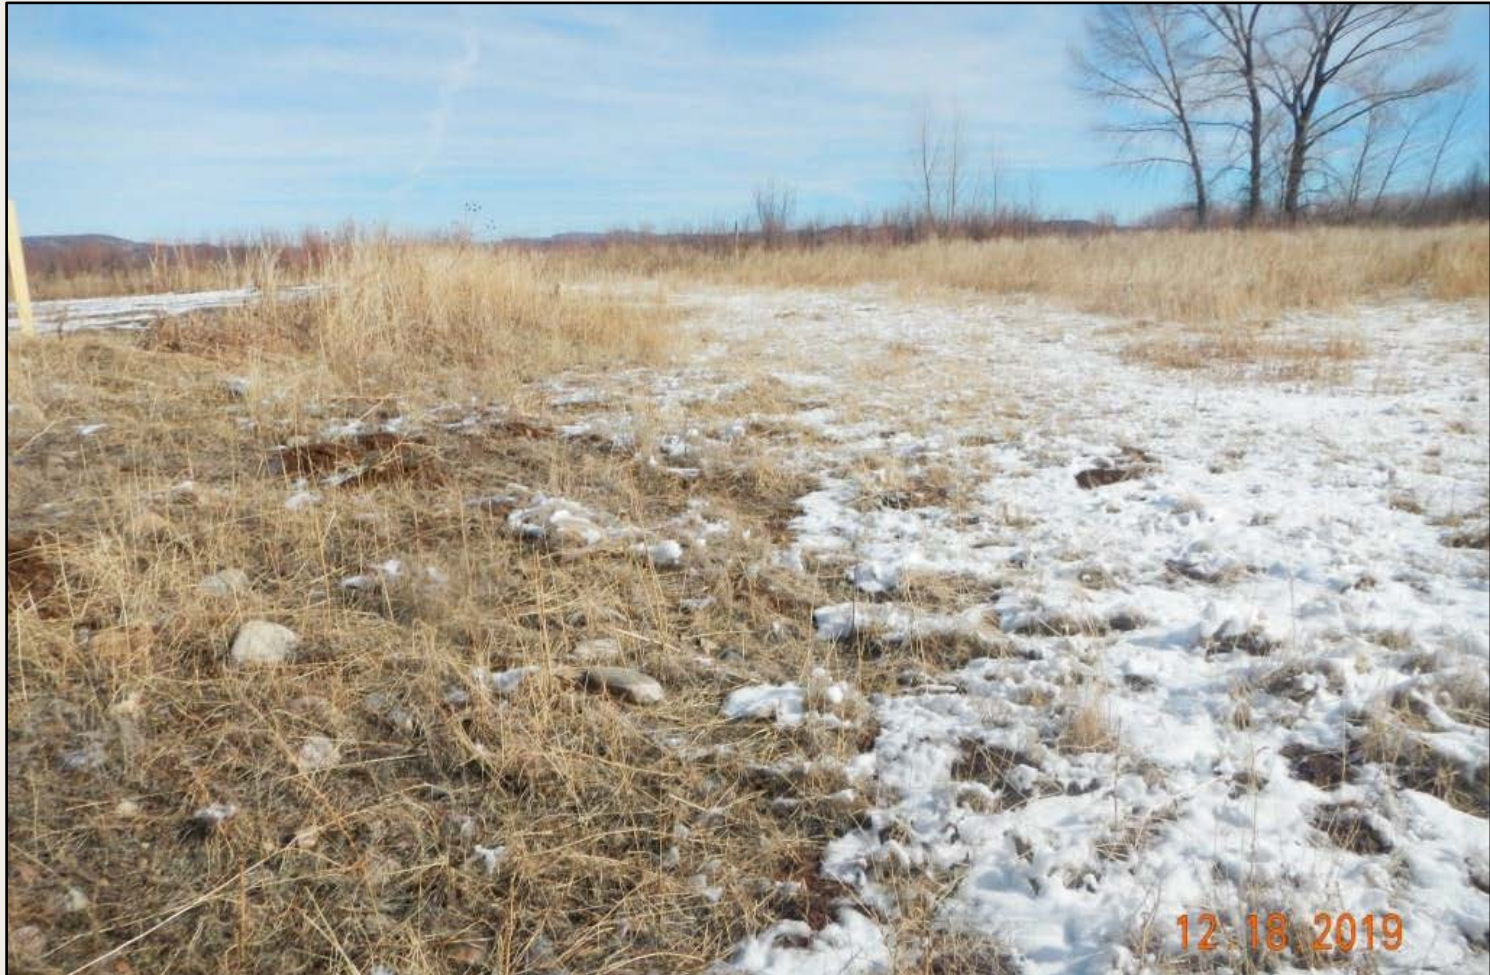
Photo 3. View of the southern project area from the southwestern corner facing eastward.

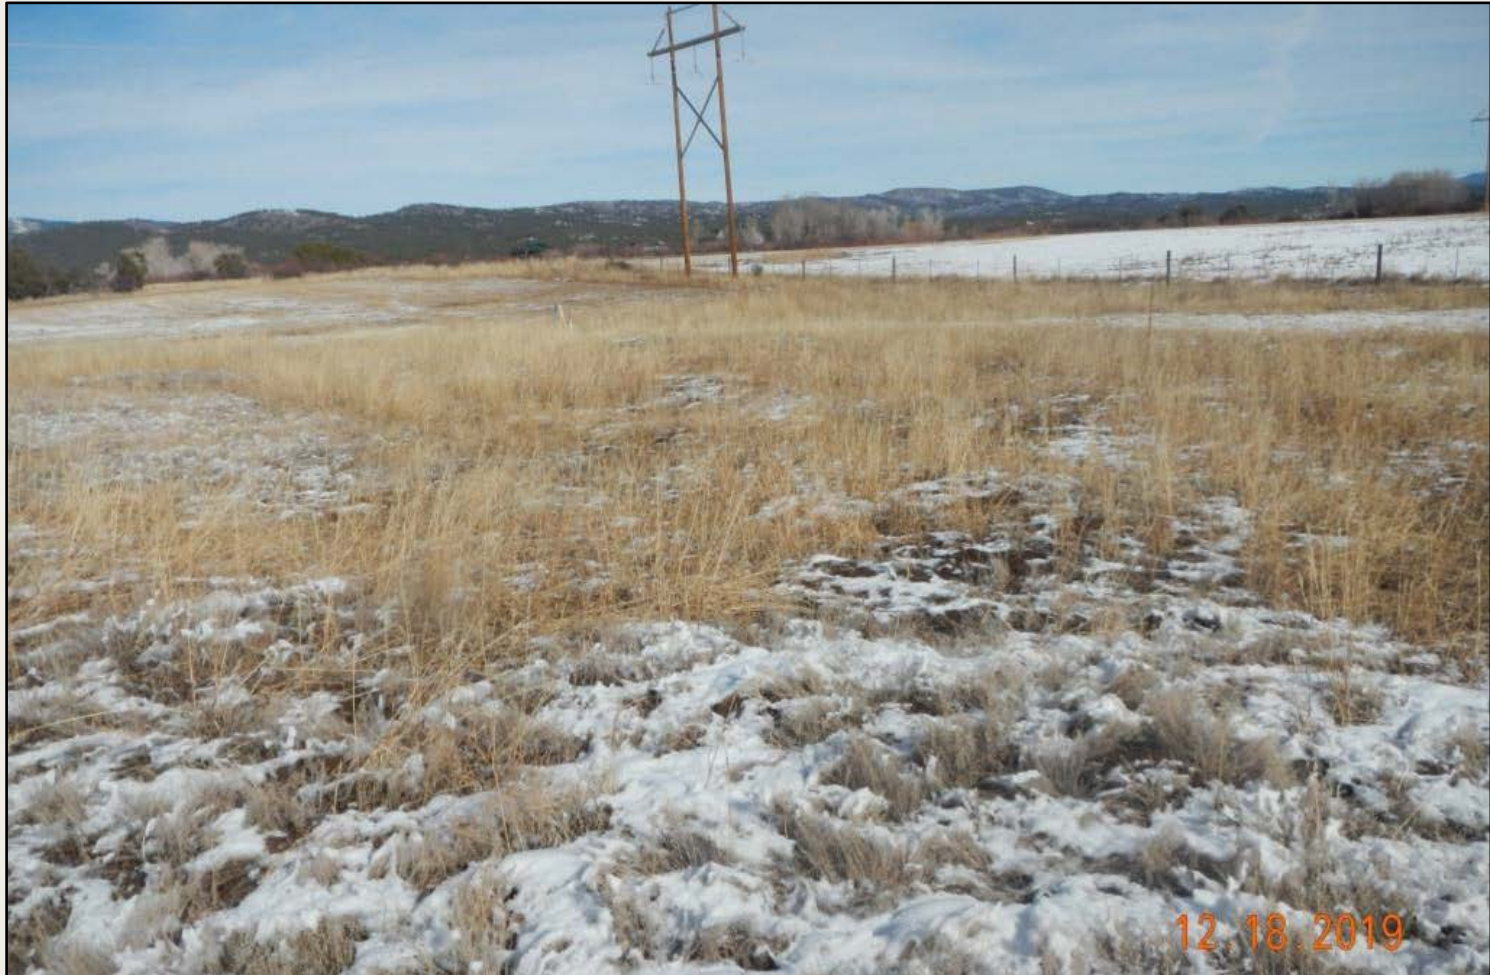
Photo 4. View of reference area, comprised grass field, largely comprised of smooth brome, in dormant vegetative condition.
