Inspection Photos
Operator: Hilcorp Energy
Location/API #: 067-07929
Date: 12-18-2019

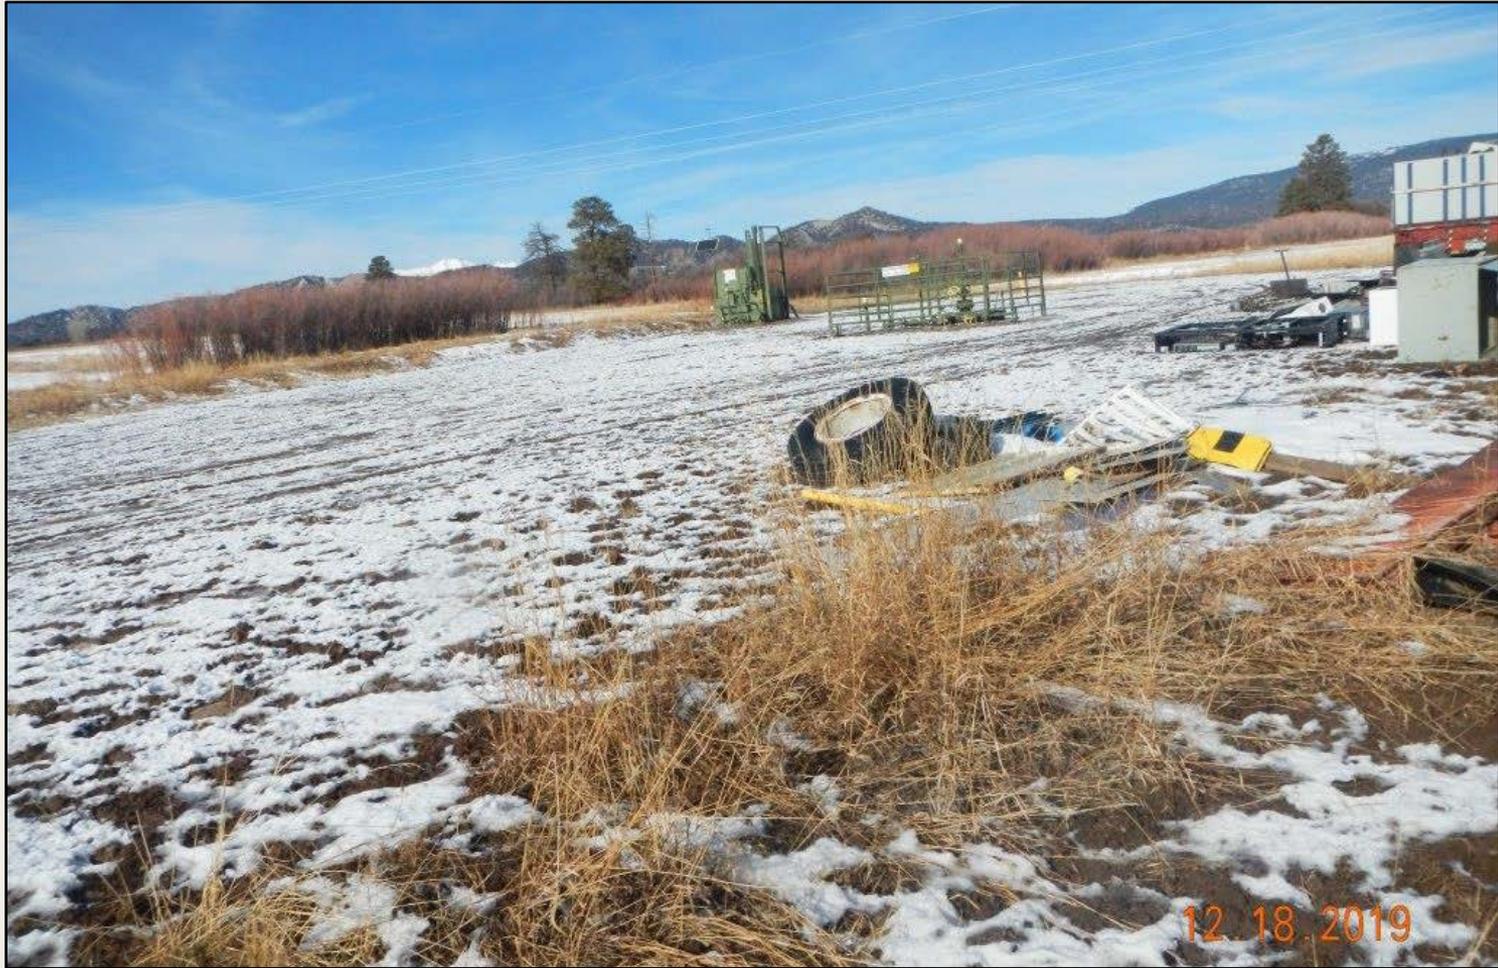
Photo 1. View of the project area from the southeastern corner facing center.

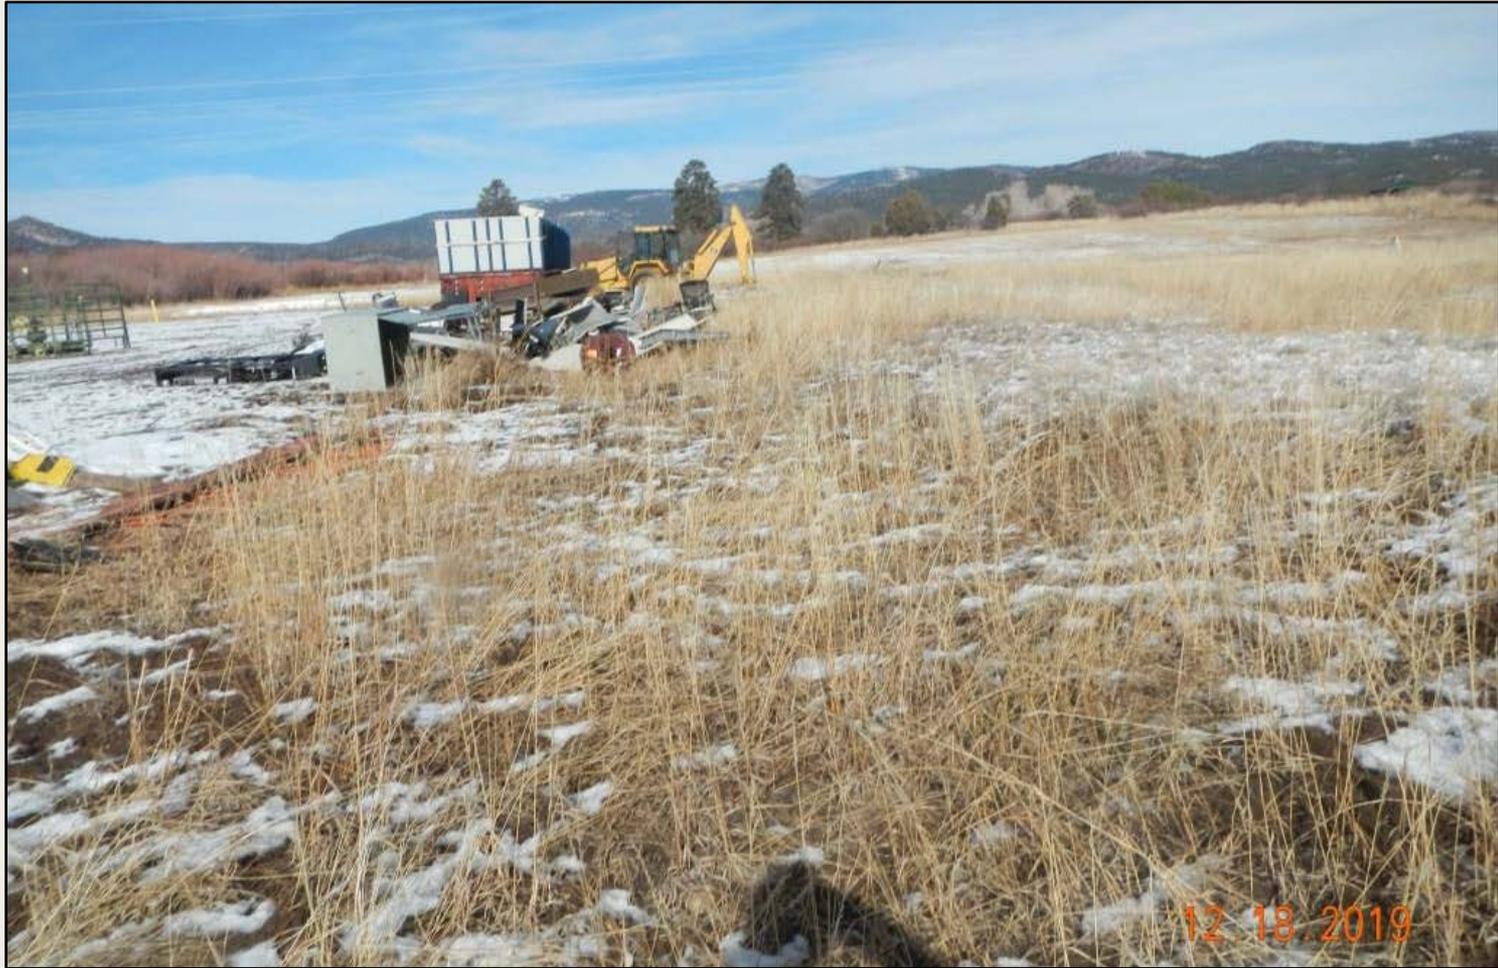
Photo 2. View of the eastern fill slope from the southeastern corner facing northward. Location is partially snow covered at this time. Revegetation is in a dormant vegetative condition, and largely comprised of smooth brome, western wheatgrass, and sand dropseed. Junk, debris, and unused equipment stored within the eastern project area.

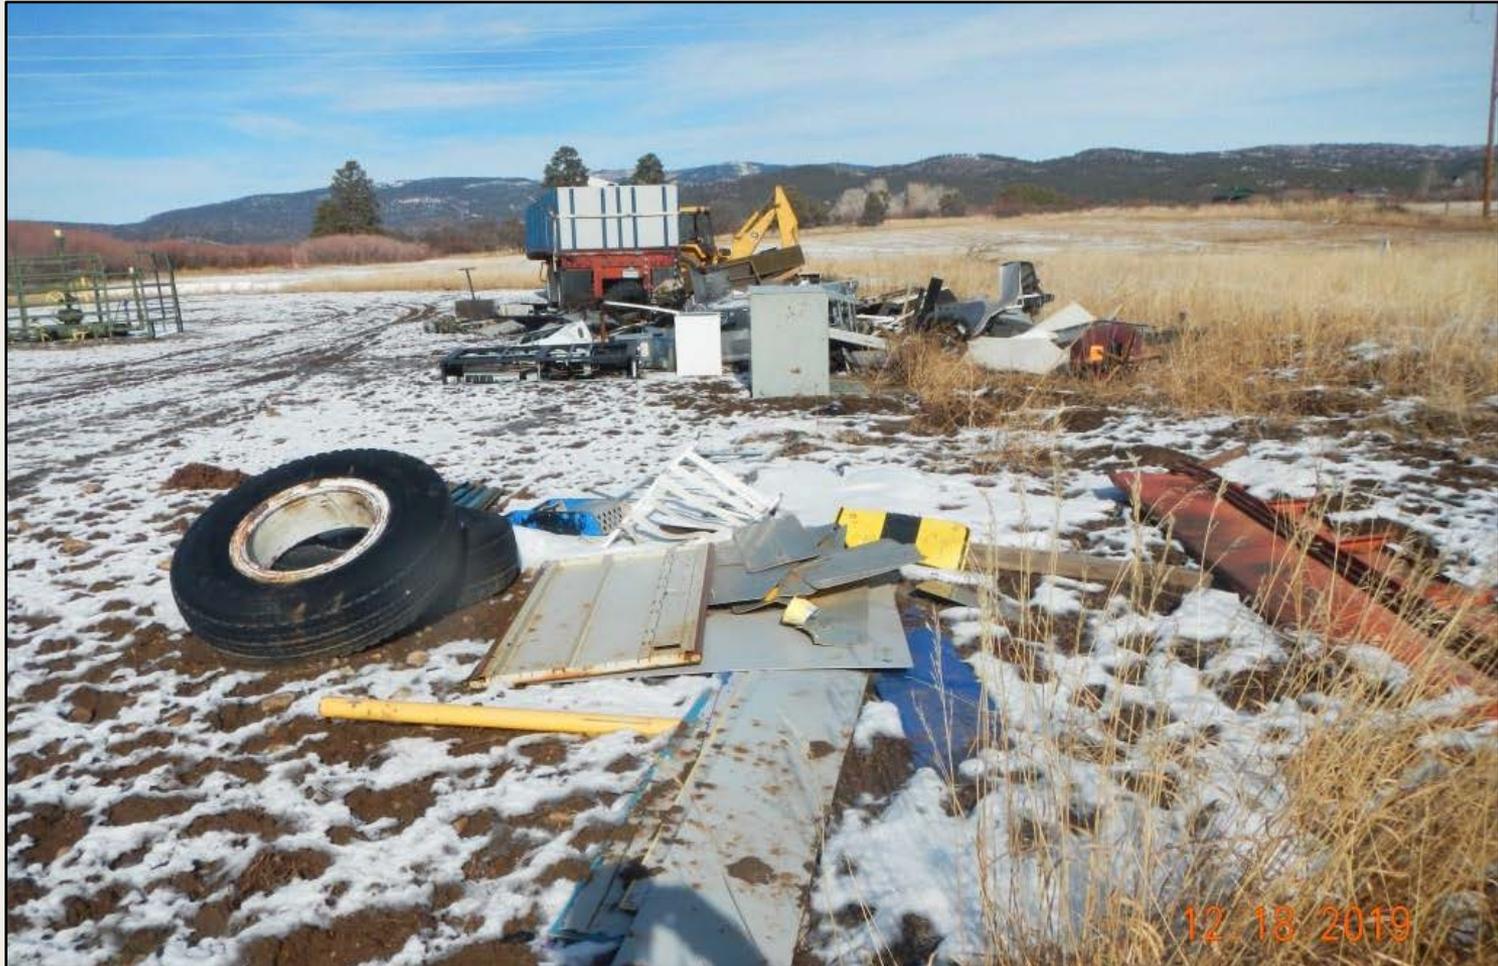
Photo 3. View of unused equipment, junk, and debris in the eastern project area, needs to be removed.

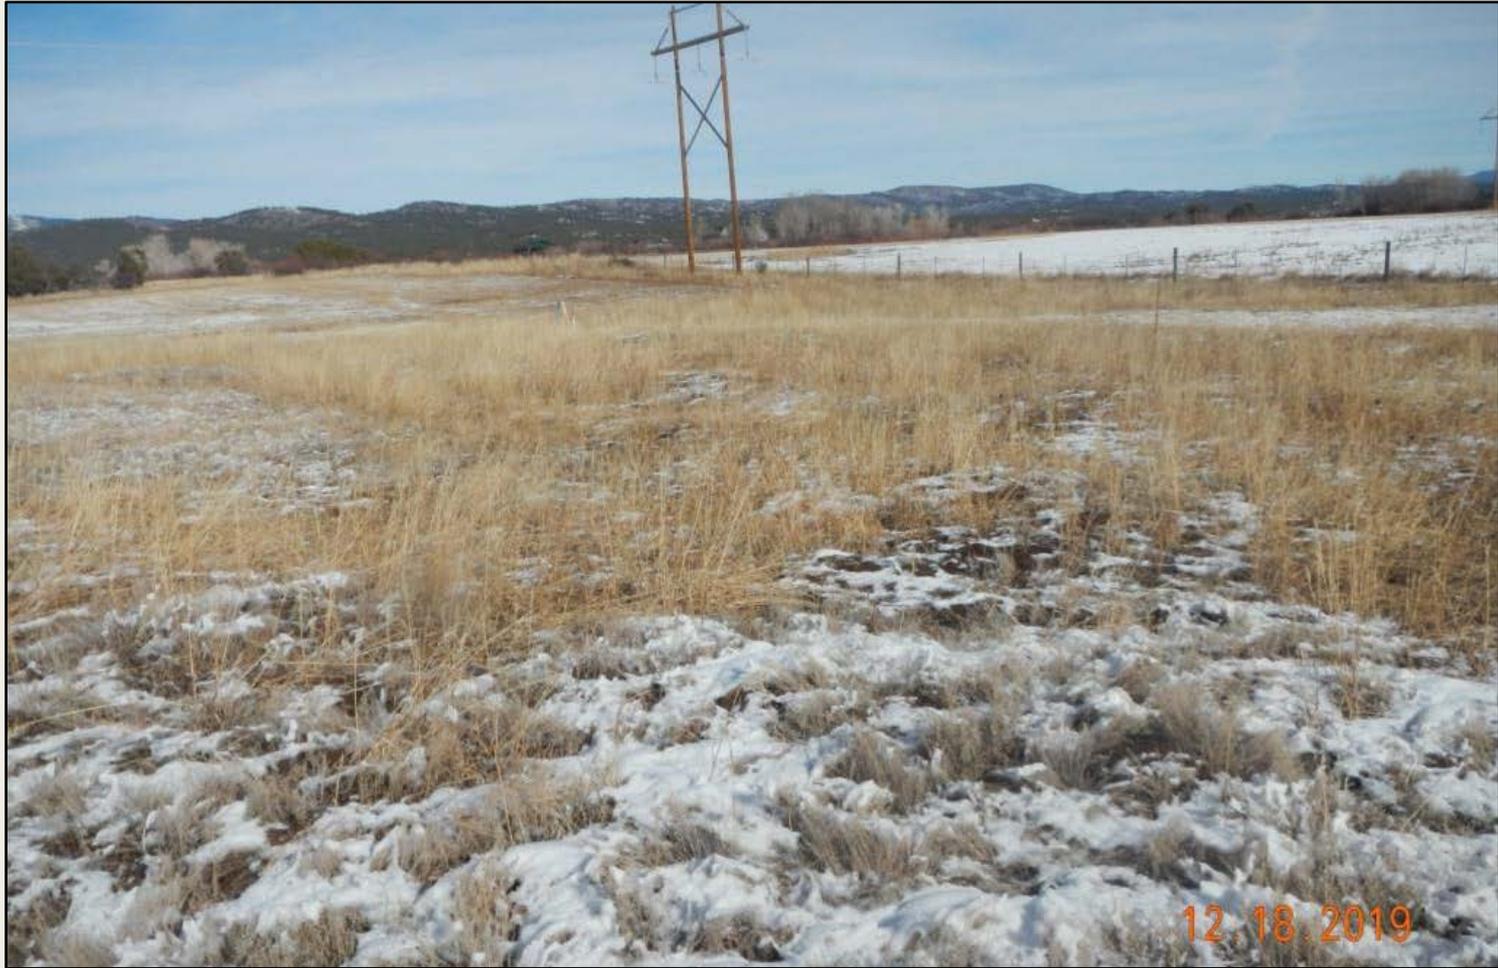
Photo 4. View of reference area comprised grass field, largely comprised of smooth brome in dormant vegetative condition.
