Inspection Photos
Operator: Enduring Resources
Location/API #: 067-07762
Date: 12-18-2019

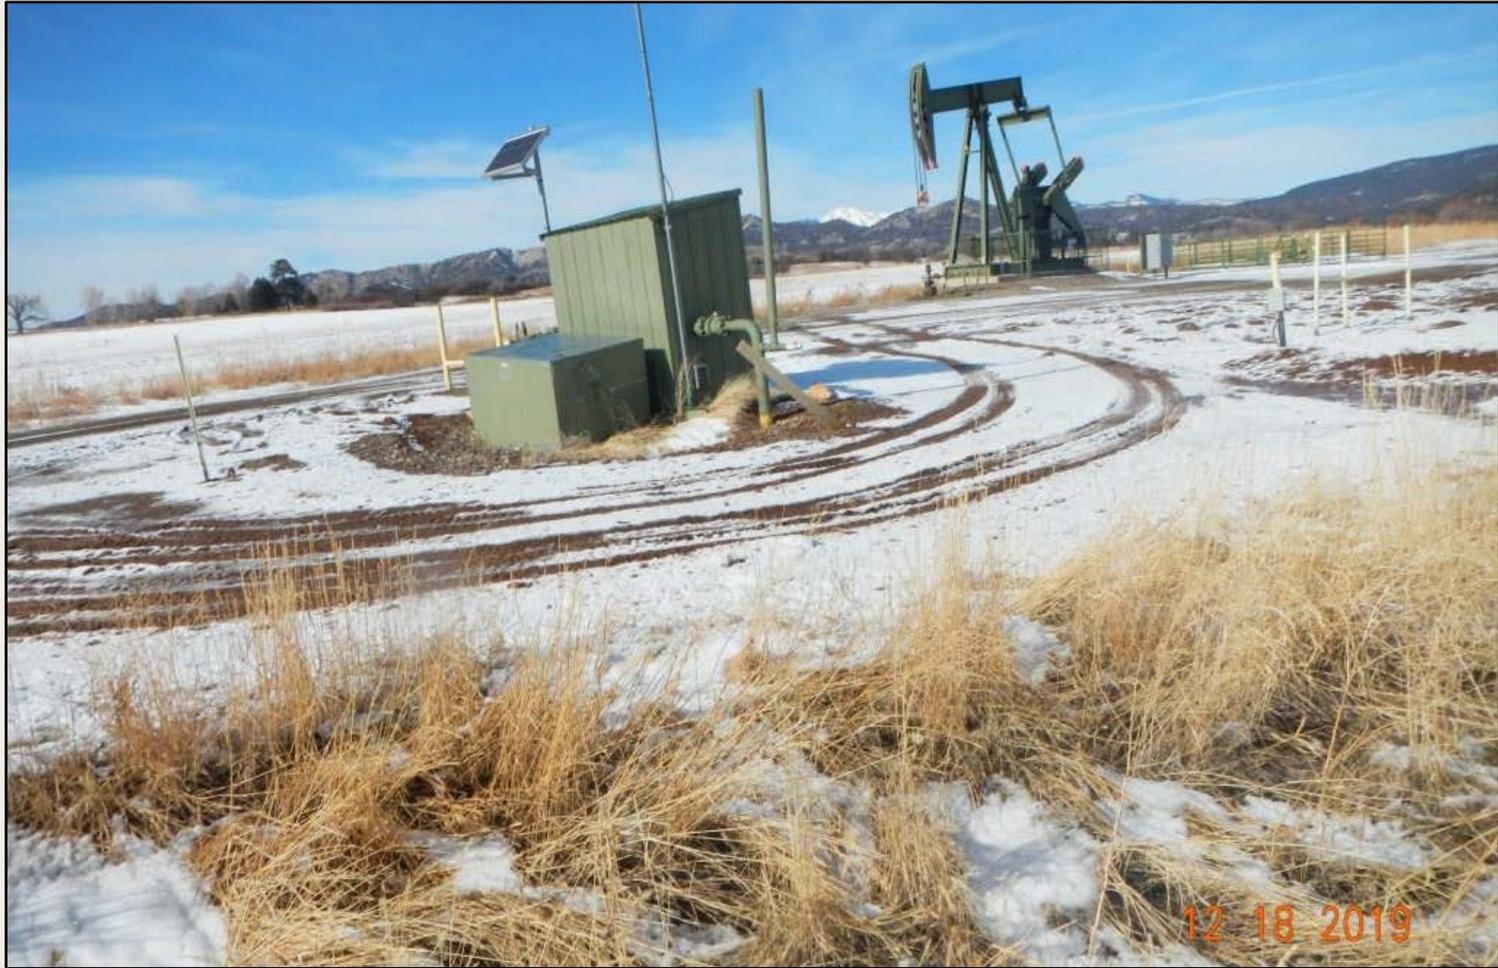
Photo 1. View of the project area from the southeastern corner facing center.

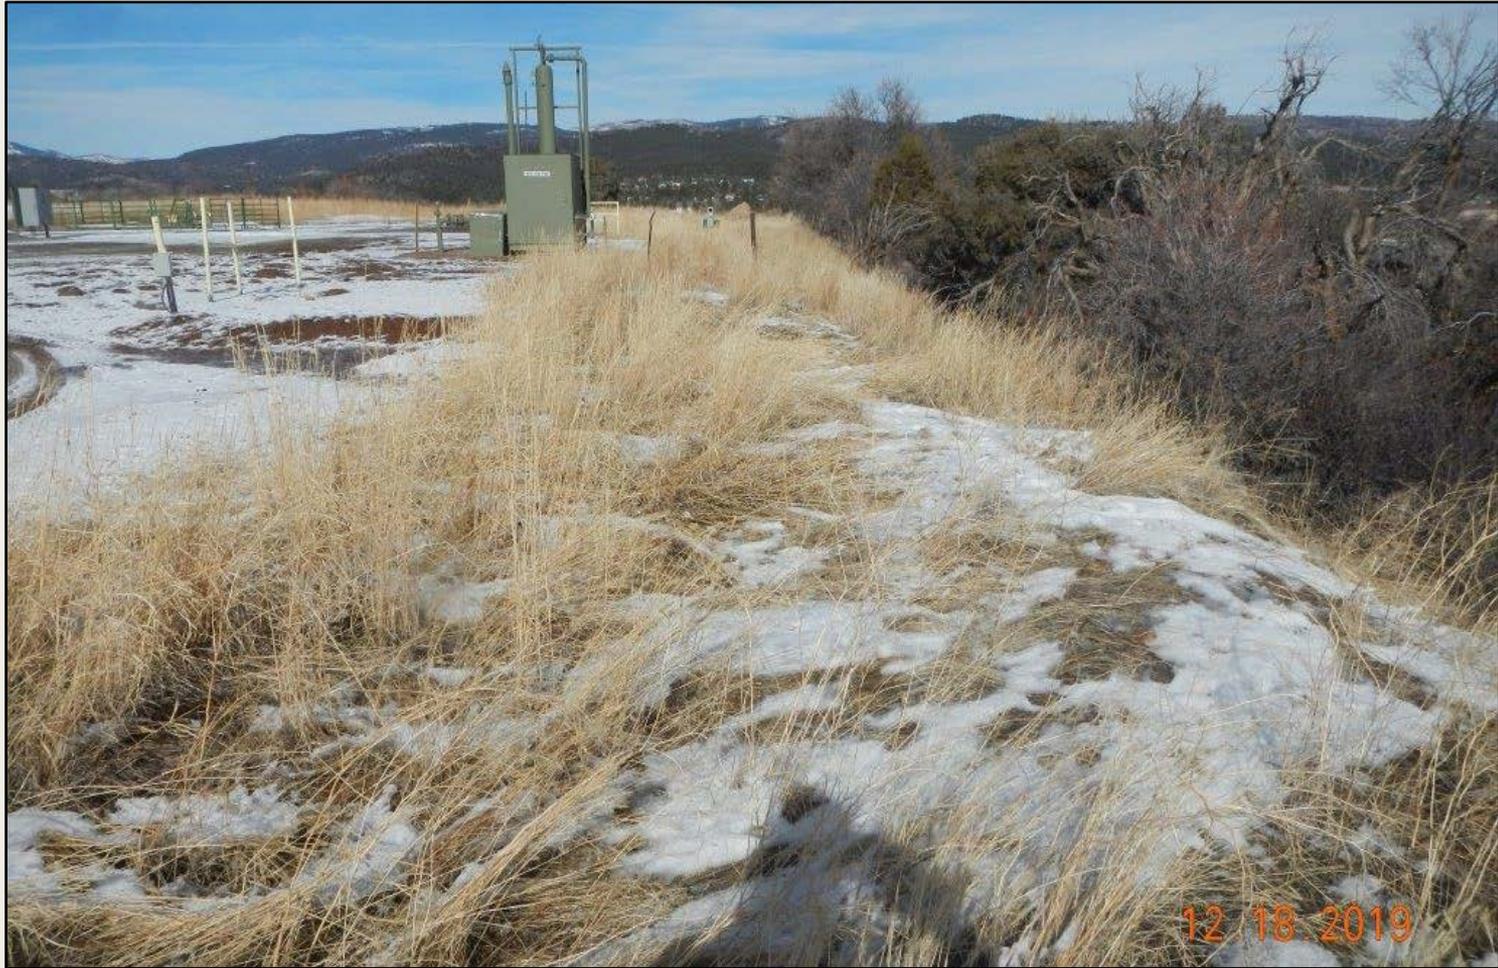
Photo 2. View of the eastern fill slope from the southeastern corner facing northward. Revegetation is progressing in this area with grasses such as western wheatgrass and crested wheatgrass.

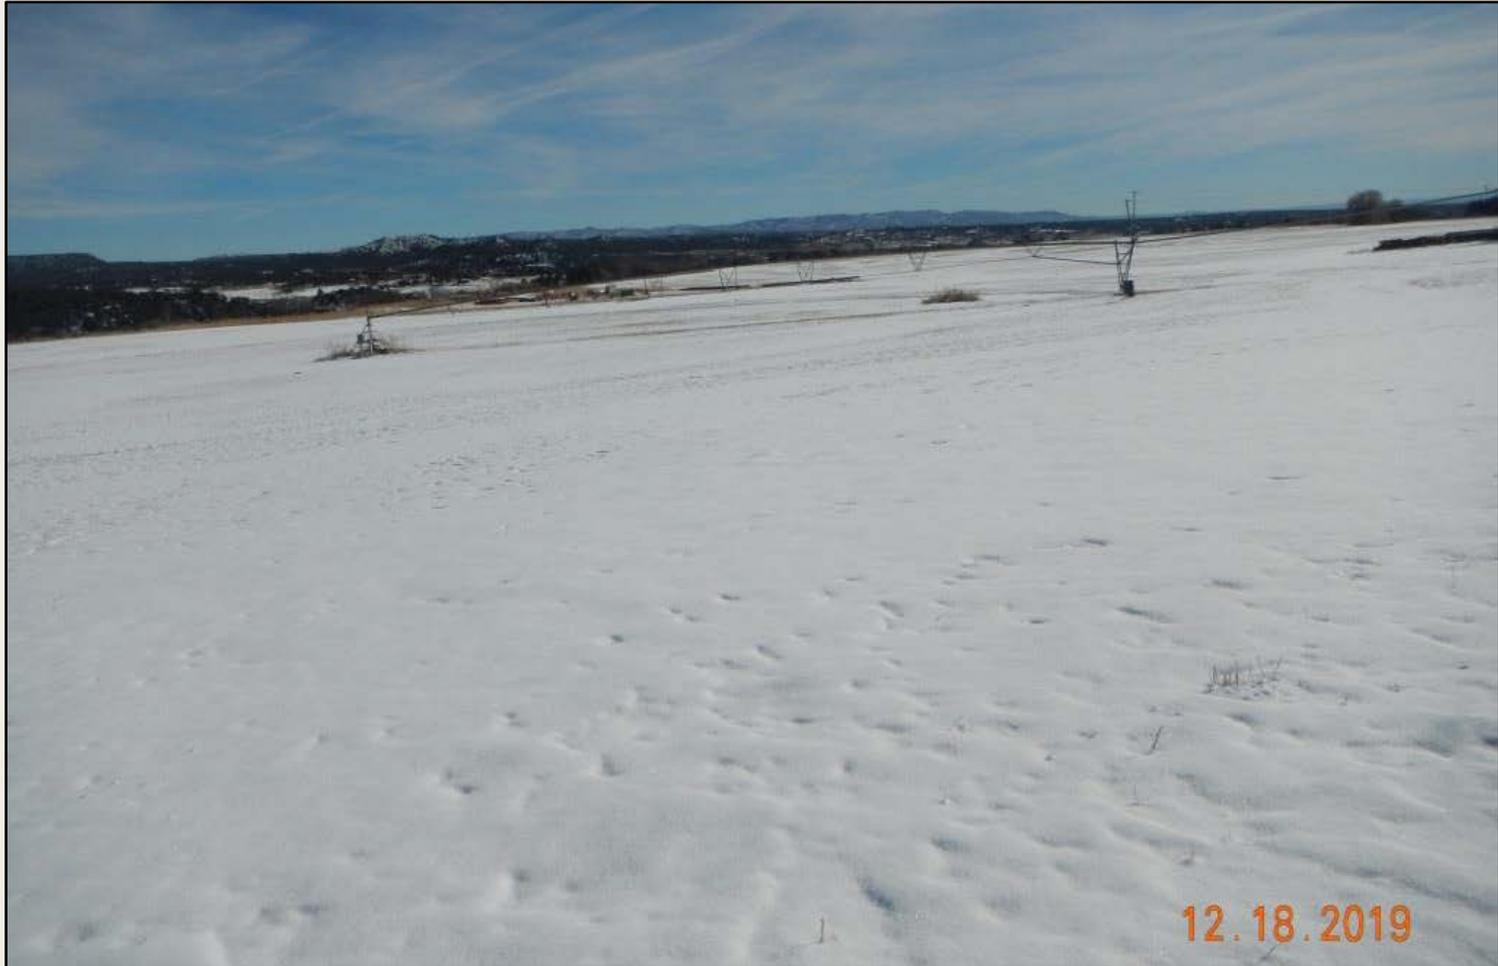
Photo 3. View of reference area comprised of irrigation grass field that is largely snow covered at this time.
