Inspection Photos
Operator: Hilcorp Energy
Location/API #: 067-07674
Date: 12-20-2019

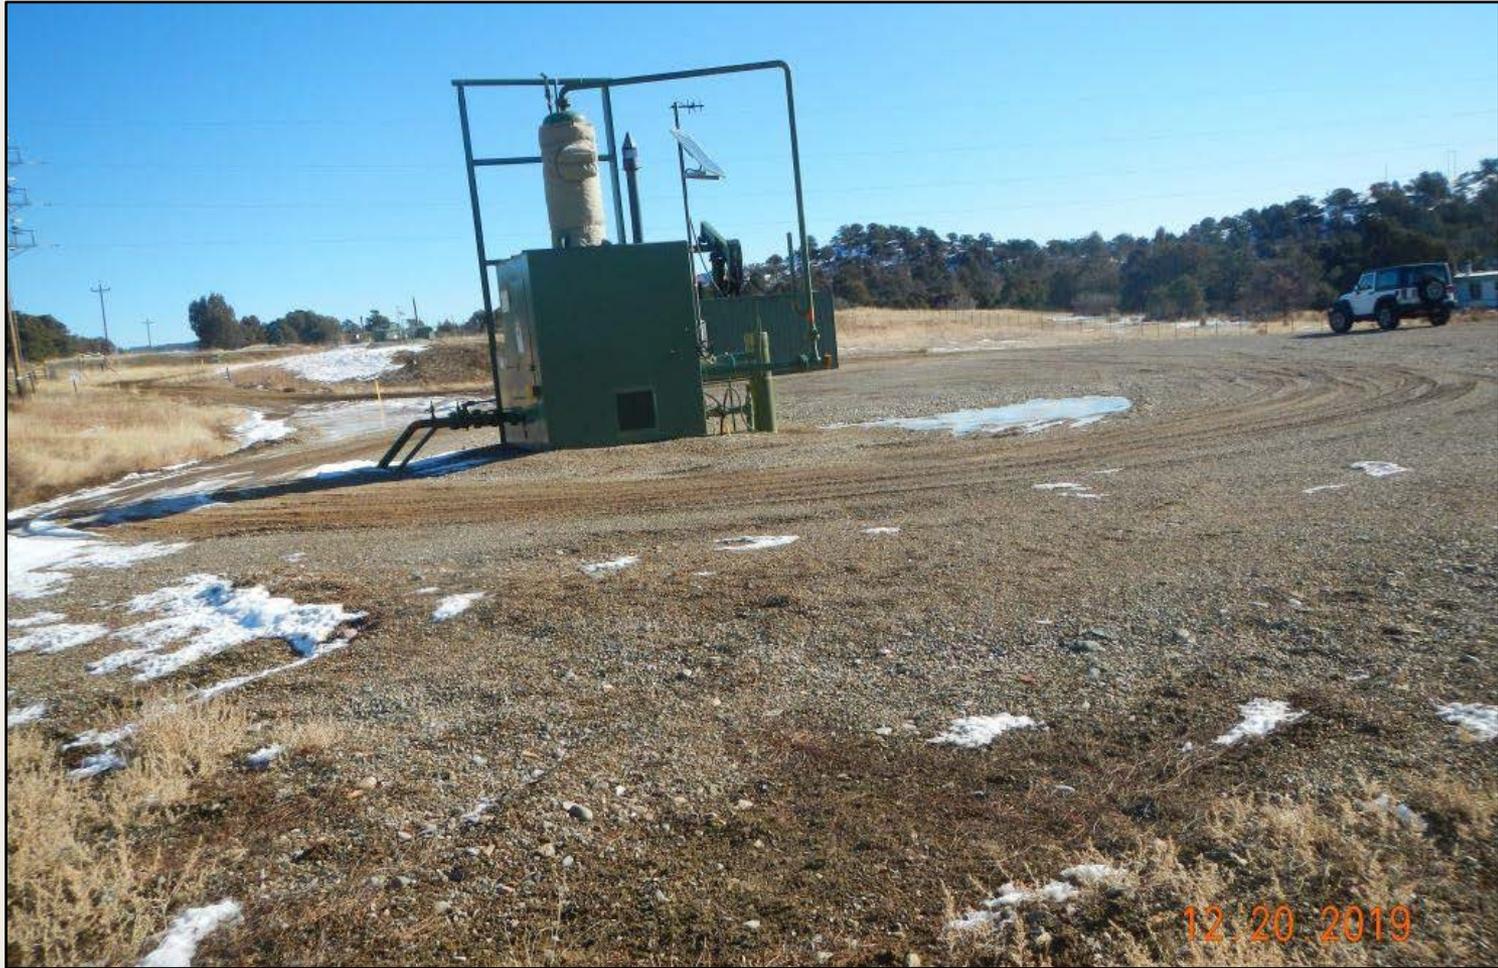
Photo 1. View of the project area from the northwestern corner facing center.

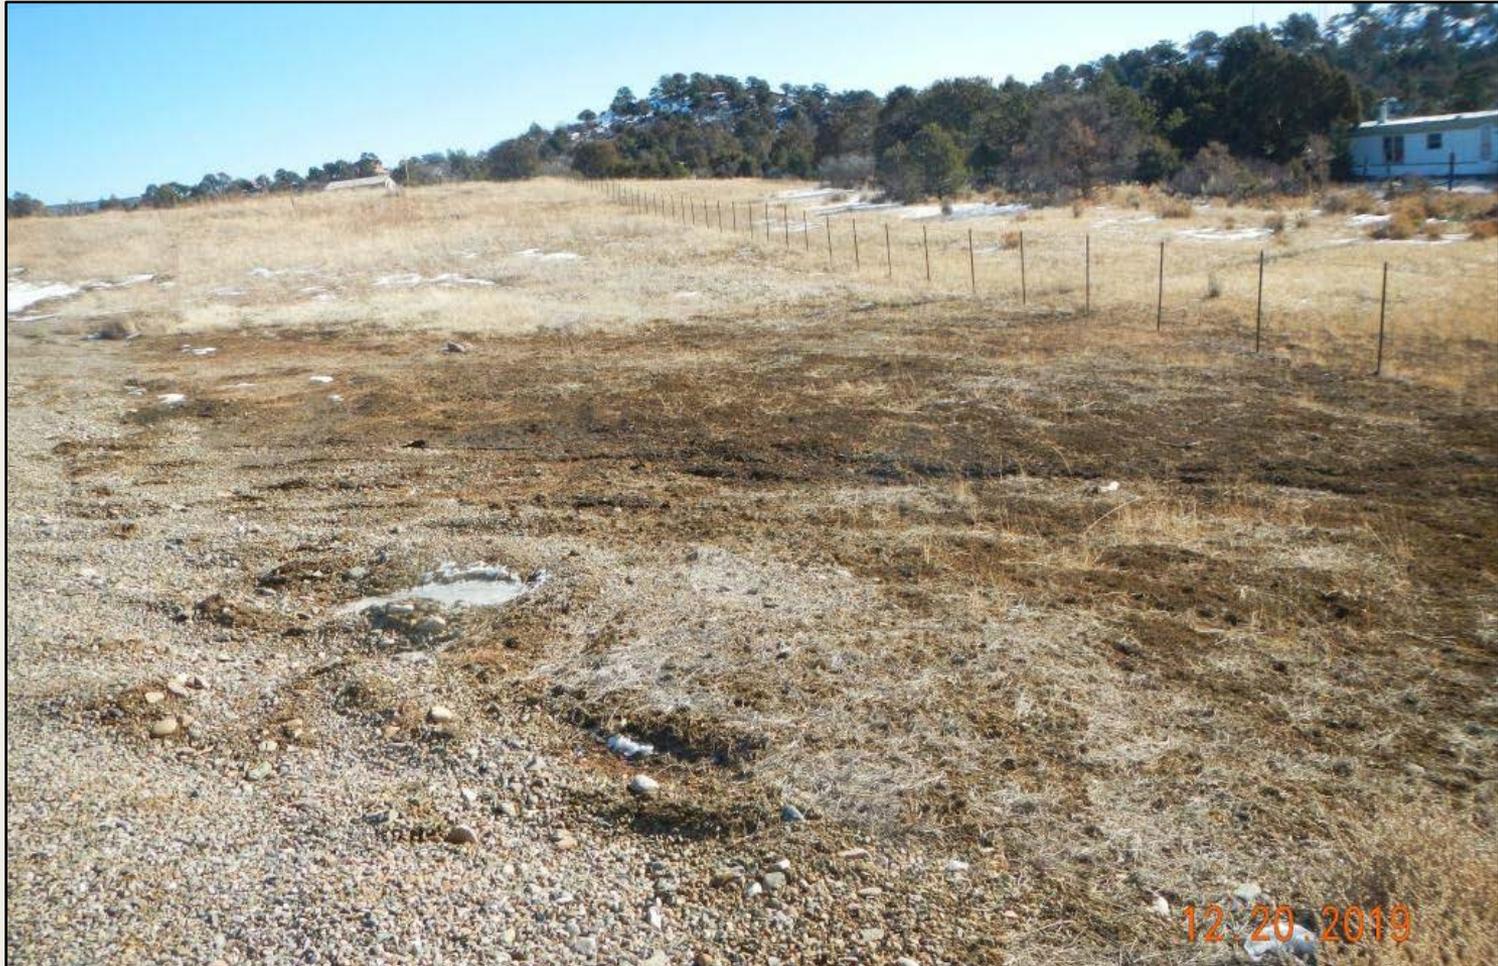
Photo 2. View of the southern project area from the southwestern corner facing eastward. Little desirable vegetation is present here. It appears that vegetation may have been killed. Area is approximately 75 feet wide and long.

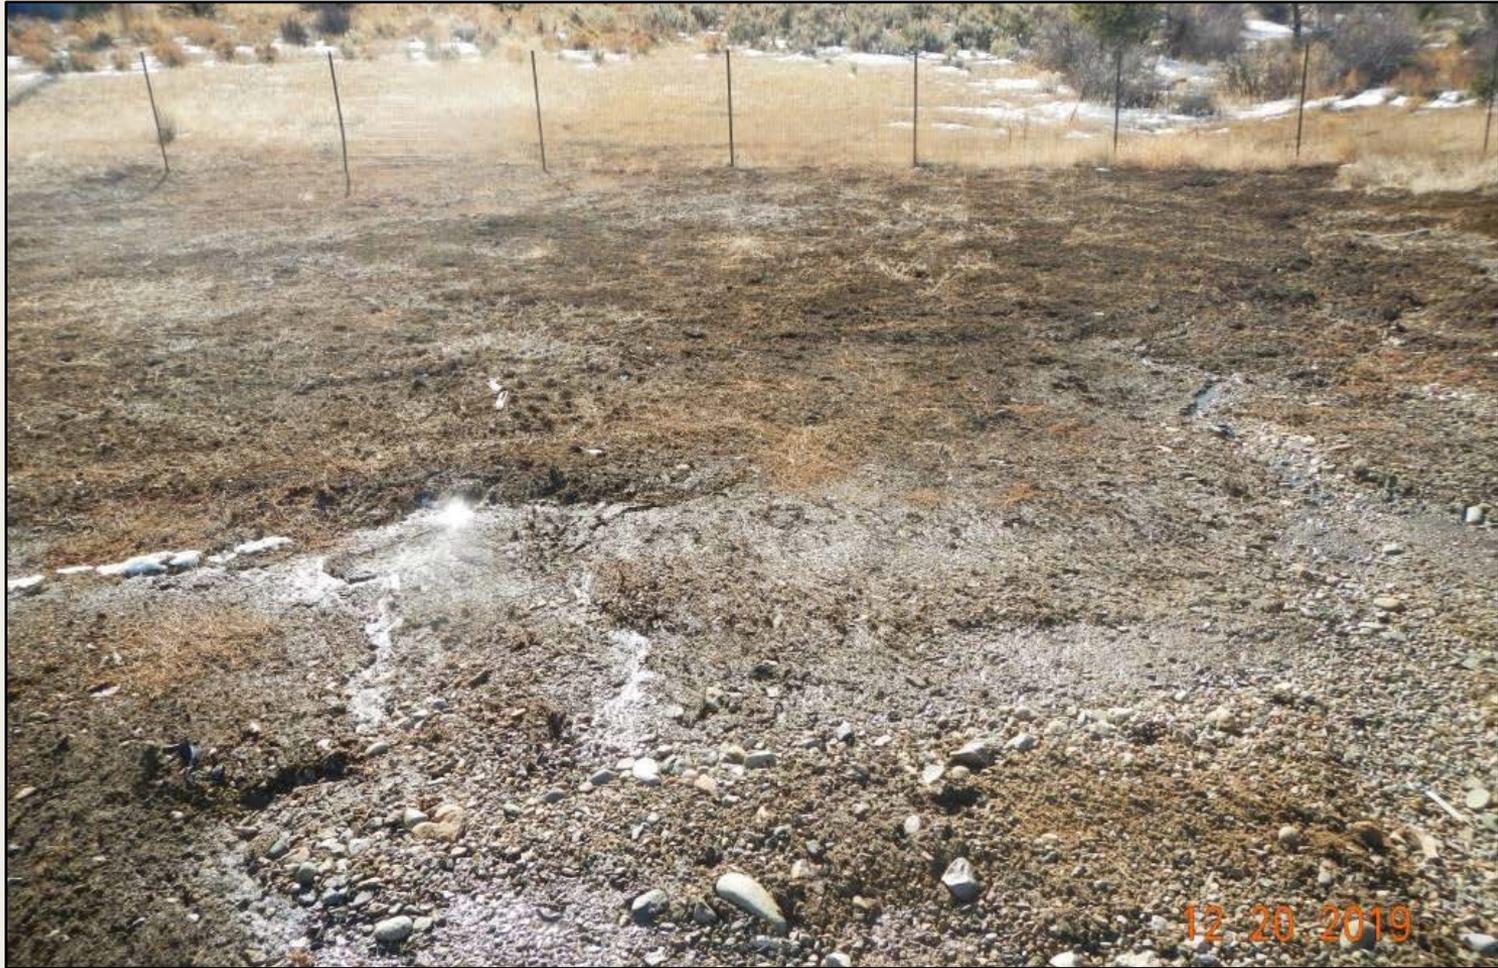
Photo 3. View of stormwater flowing downslope away from the well pad toward a drainage. No stormwater controls are in place.

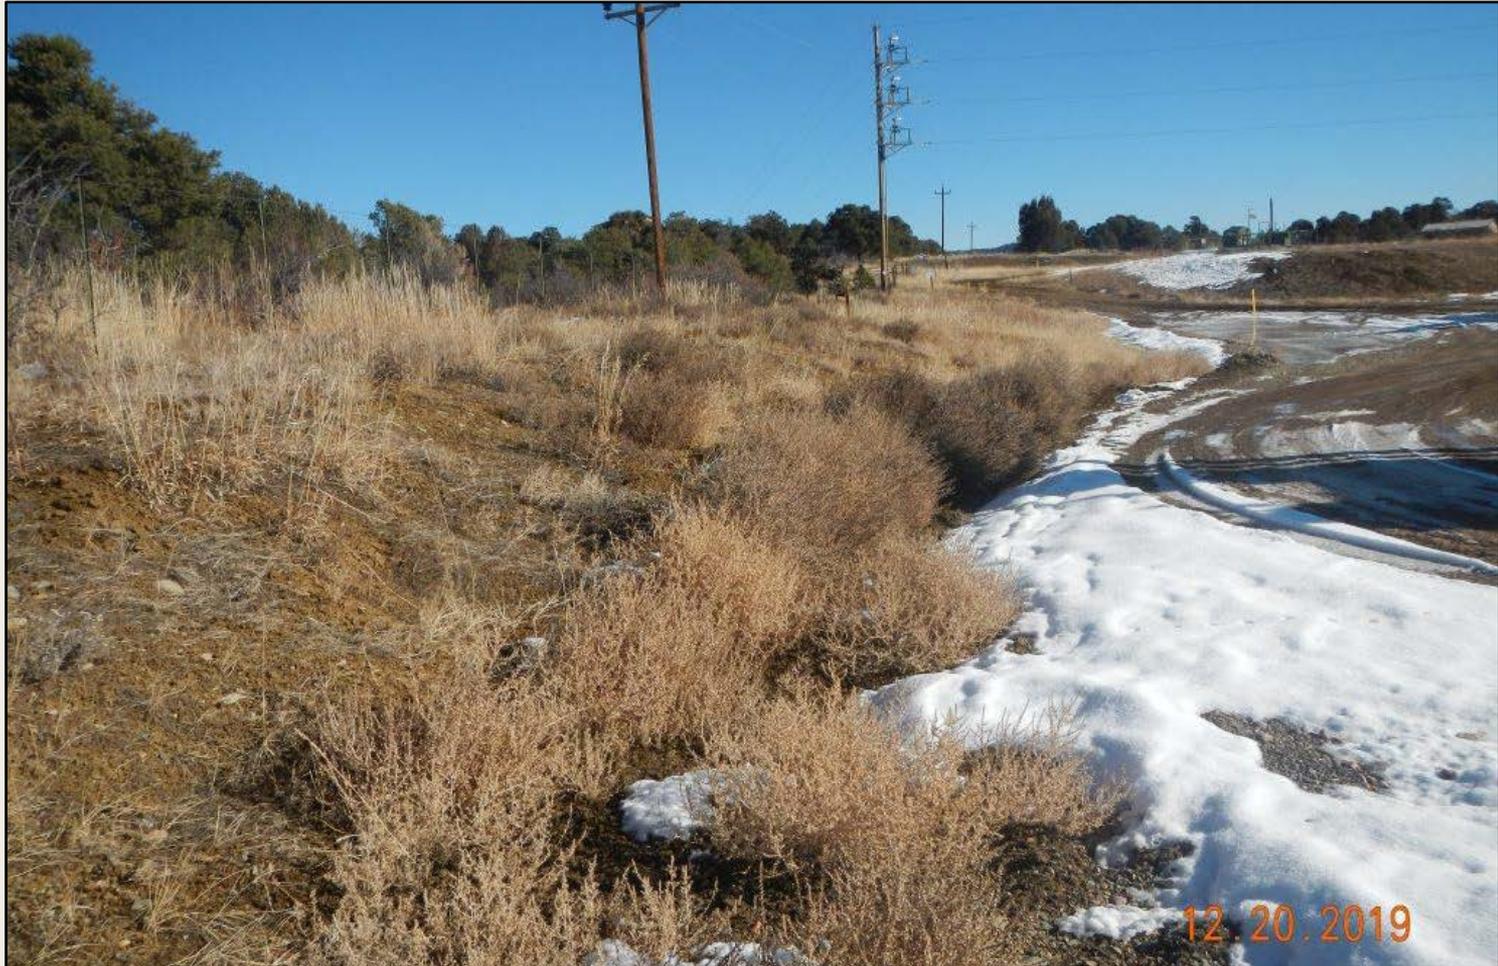
Photo 4. View of Russian thistles approximately 2-3 feet tall, within the northern project area.

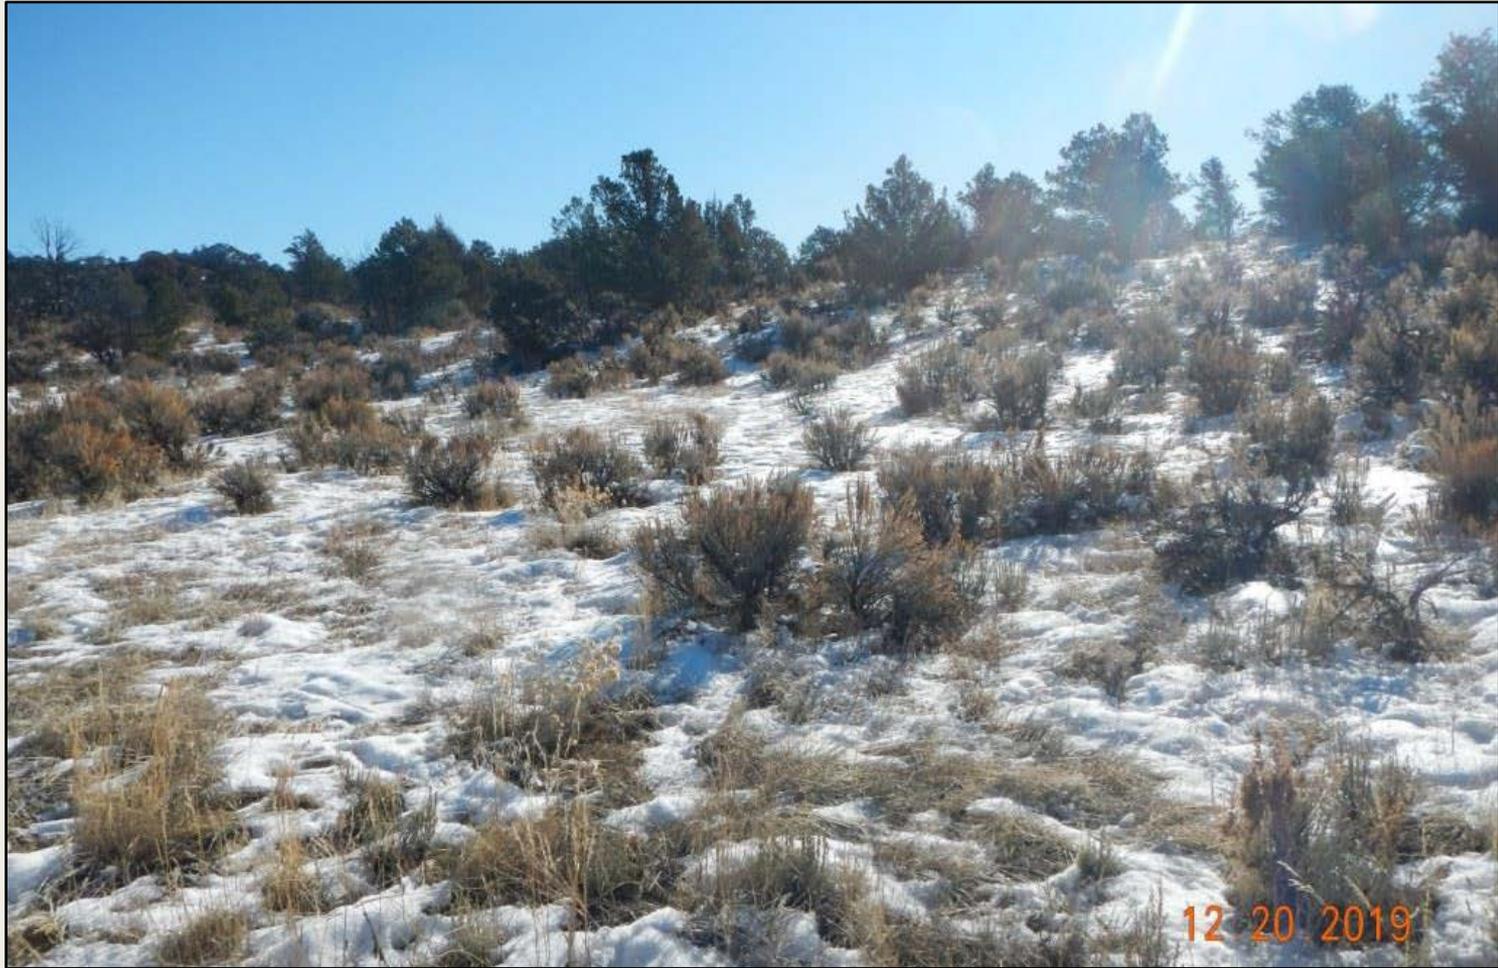
Photo 5. View of reference area vegetation comprised of sagebrush shrubland and pinyon juniper/gambel oak woodland mosaic.
