Inspection Photos
Operator: Hilcorp Energy
Location/API #: 067-06464
Date: 12-20-2019

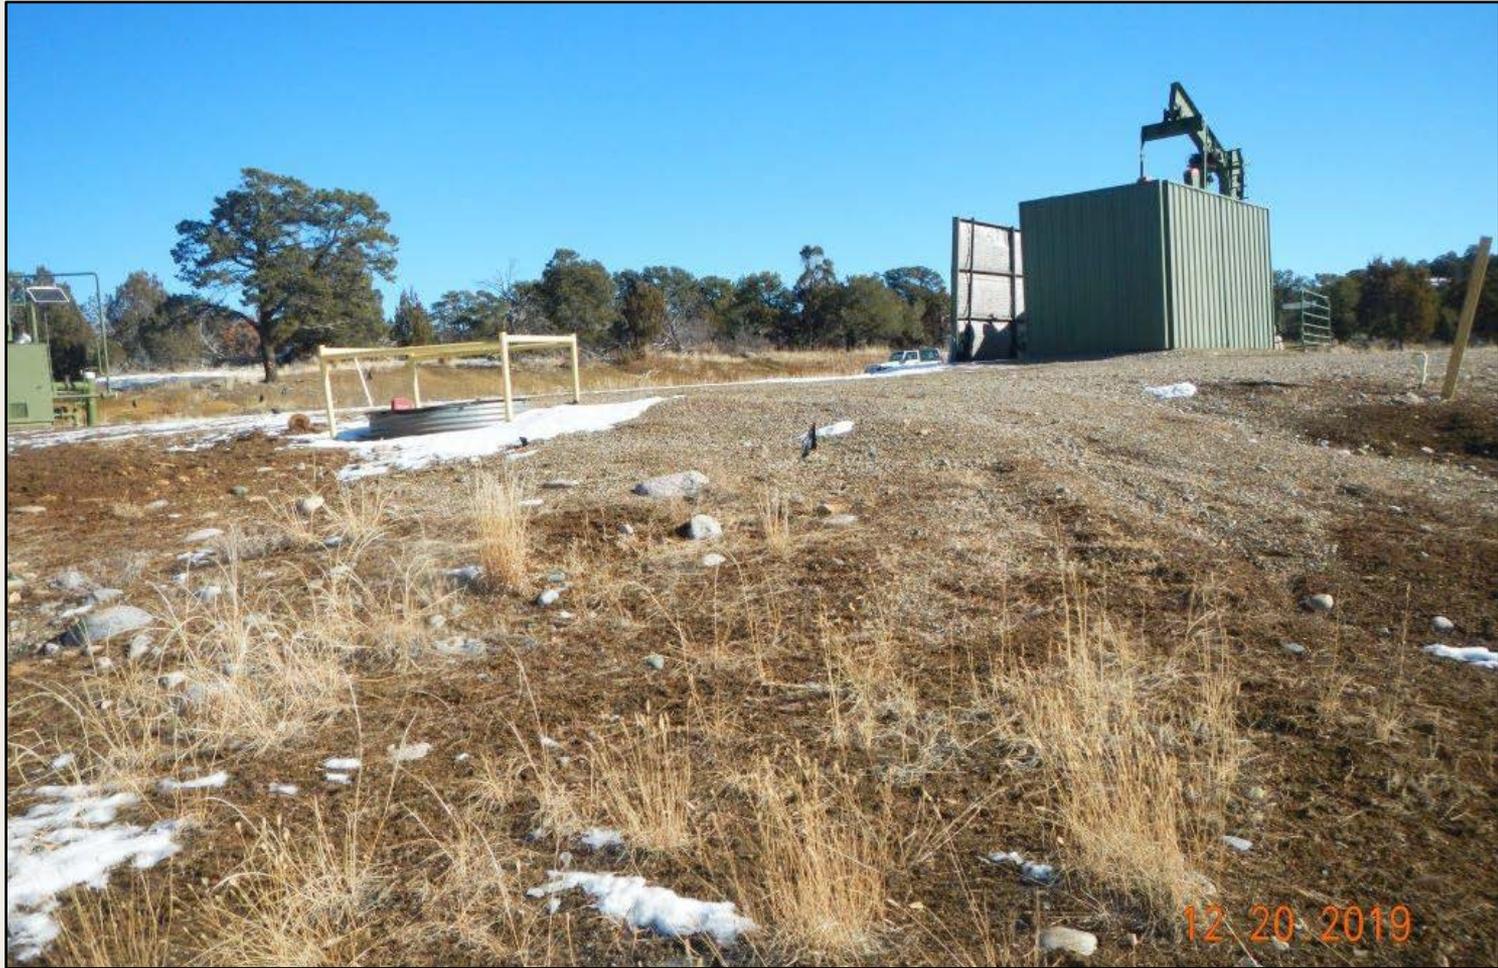
Photo 1. View of the project area from the southwestern corner facing center.

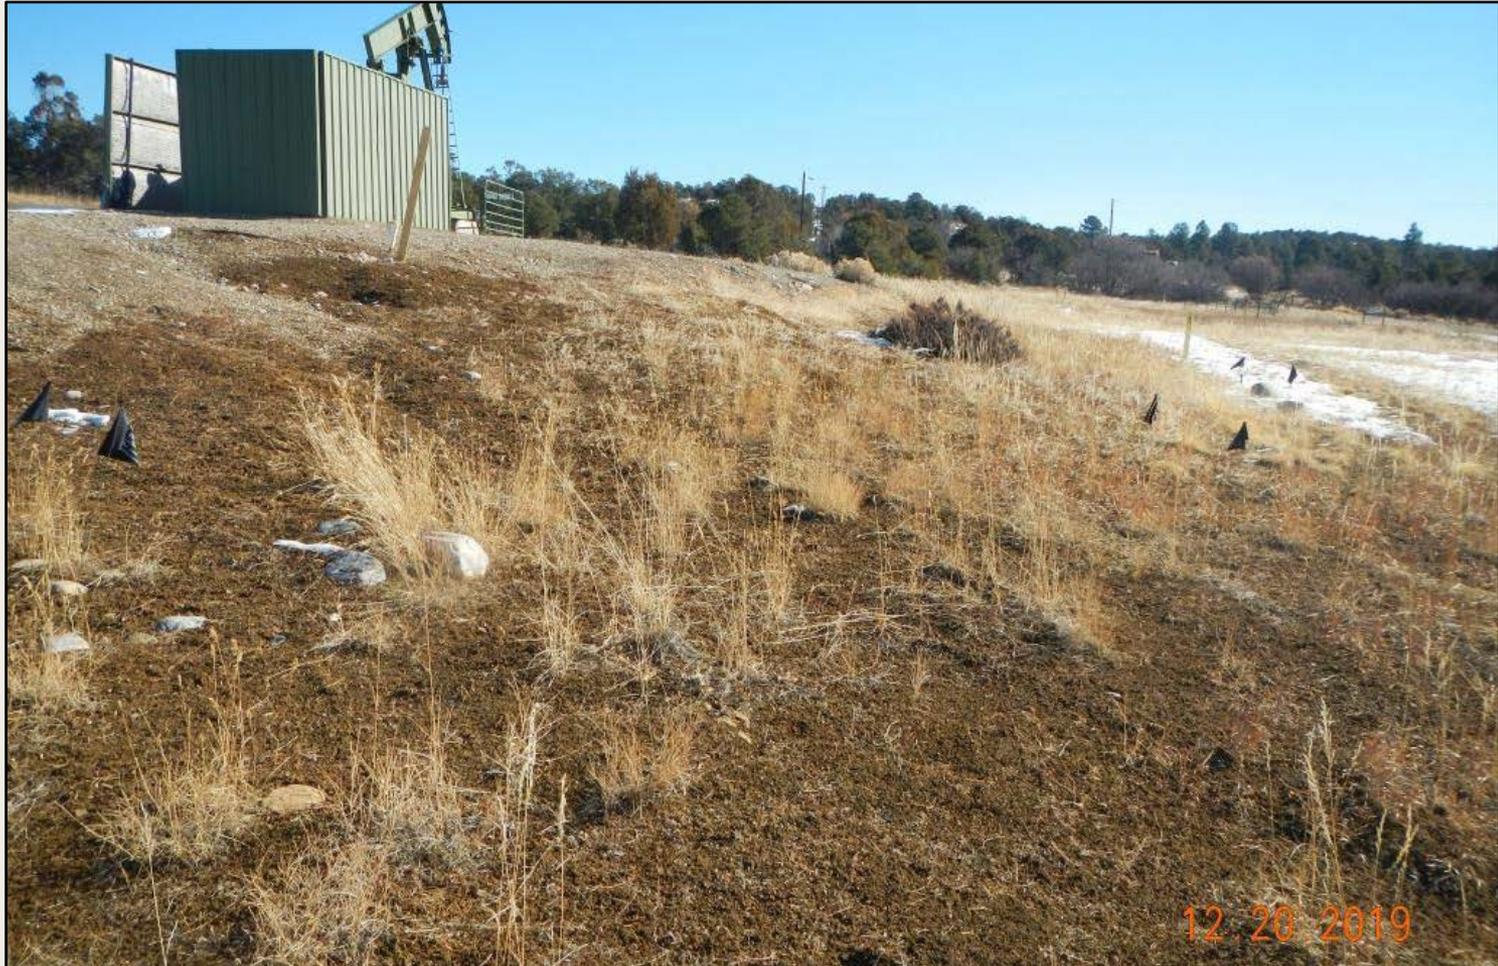
Photo 2. View of the southern fill slope from the southwestern corner facing eastward. Revegetation is progressing with grasses such as smooth brome, intermediate wheatgrass, and crested wheatgrass.

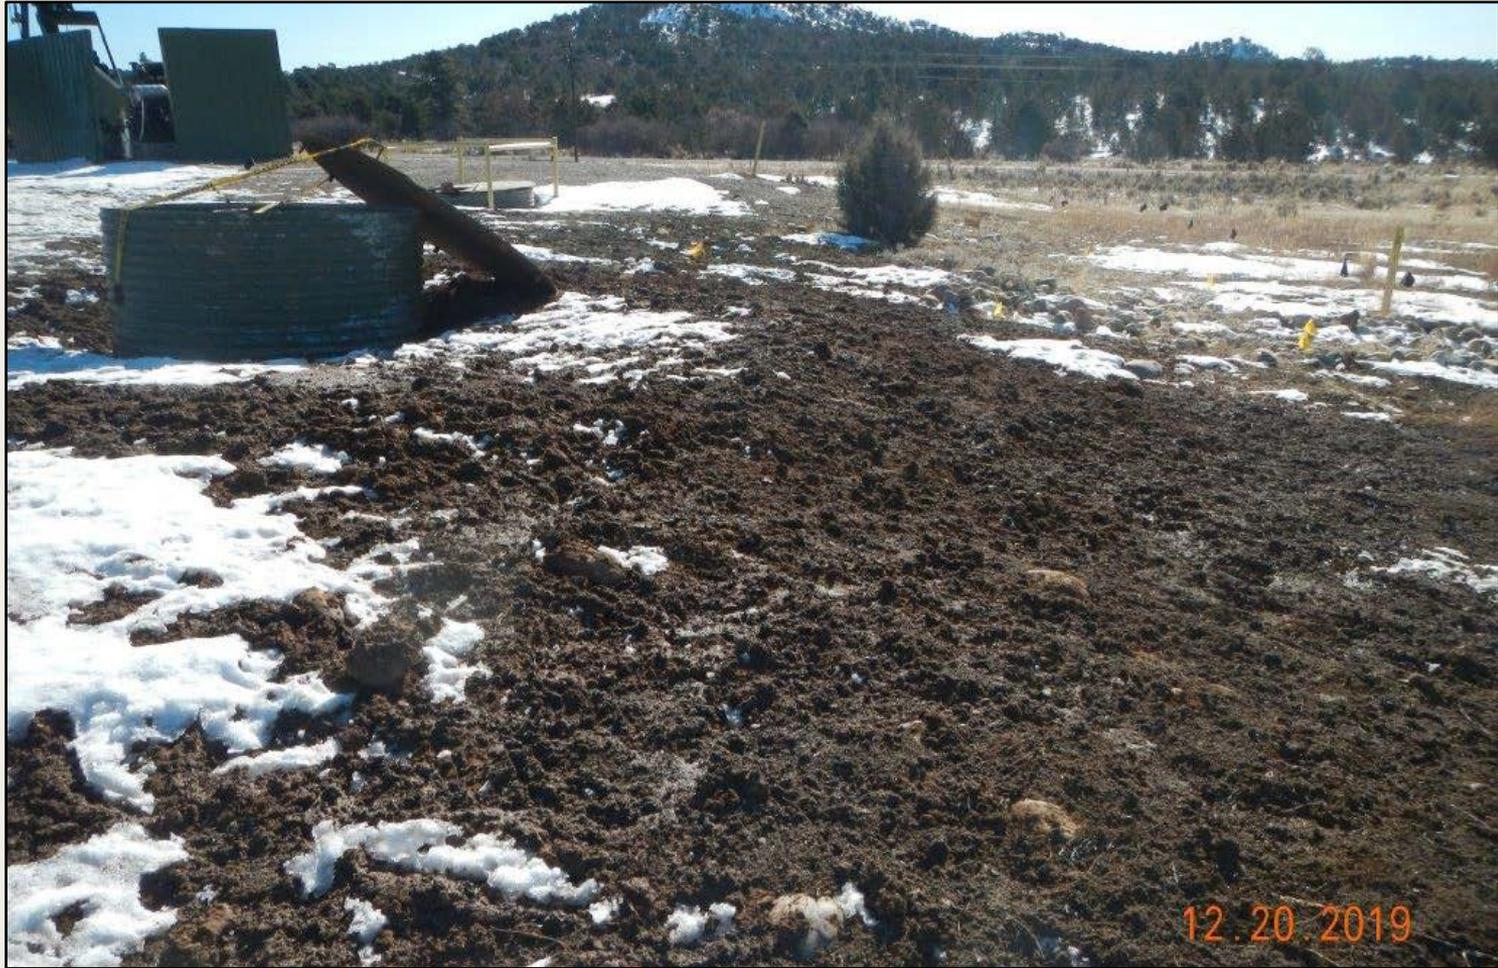
Photo 3. View of the western project area from the northwestern corner facing southward. Bare soils and little desirable vegetation present in this area. Revegetation is needed.

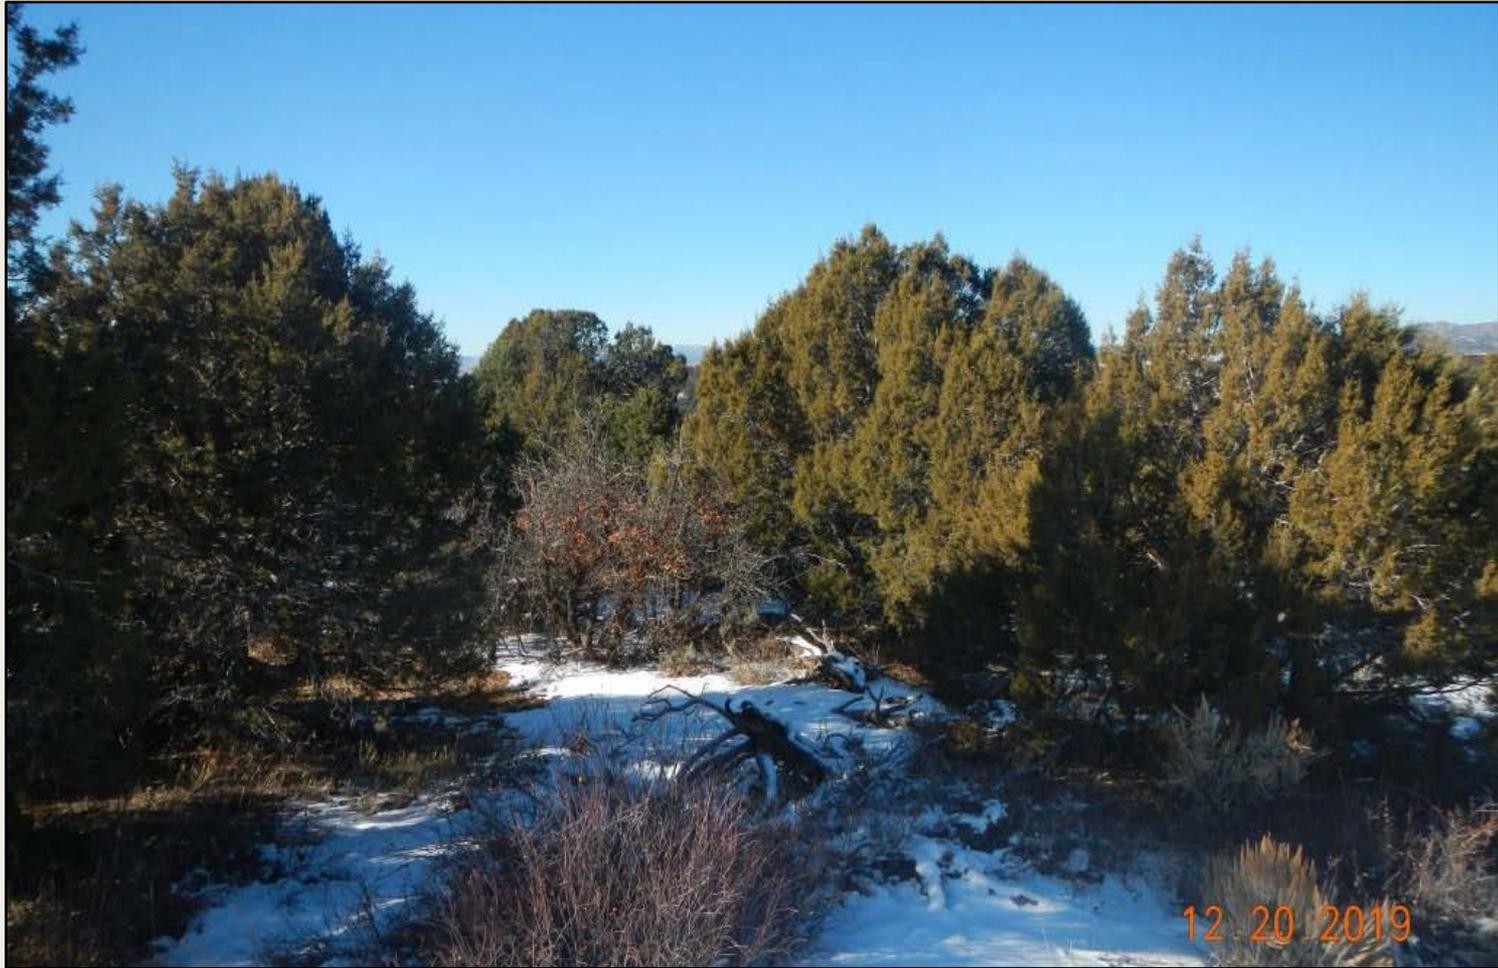
Photo 4. View of reference area vegetation comprised of pinyon, juniper, and oak woodland vegetation.
