Inspection Photos  
Operator: Hilcorp Energy  
Location/API #: 067-07545  
Date: 12-23-2019

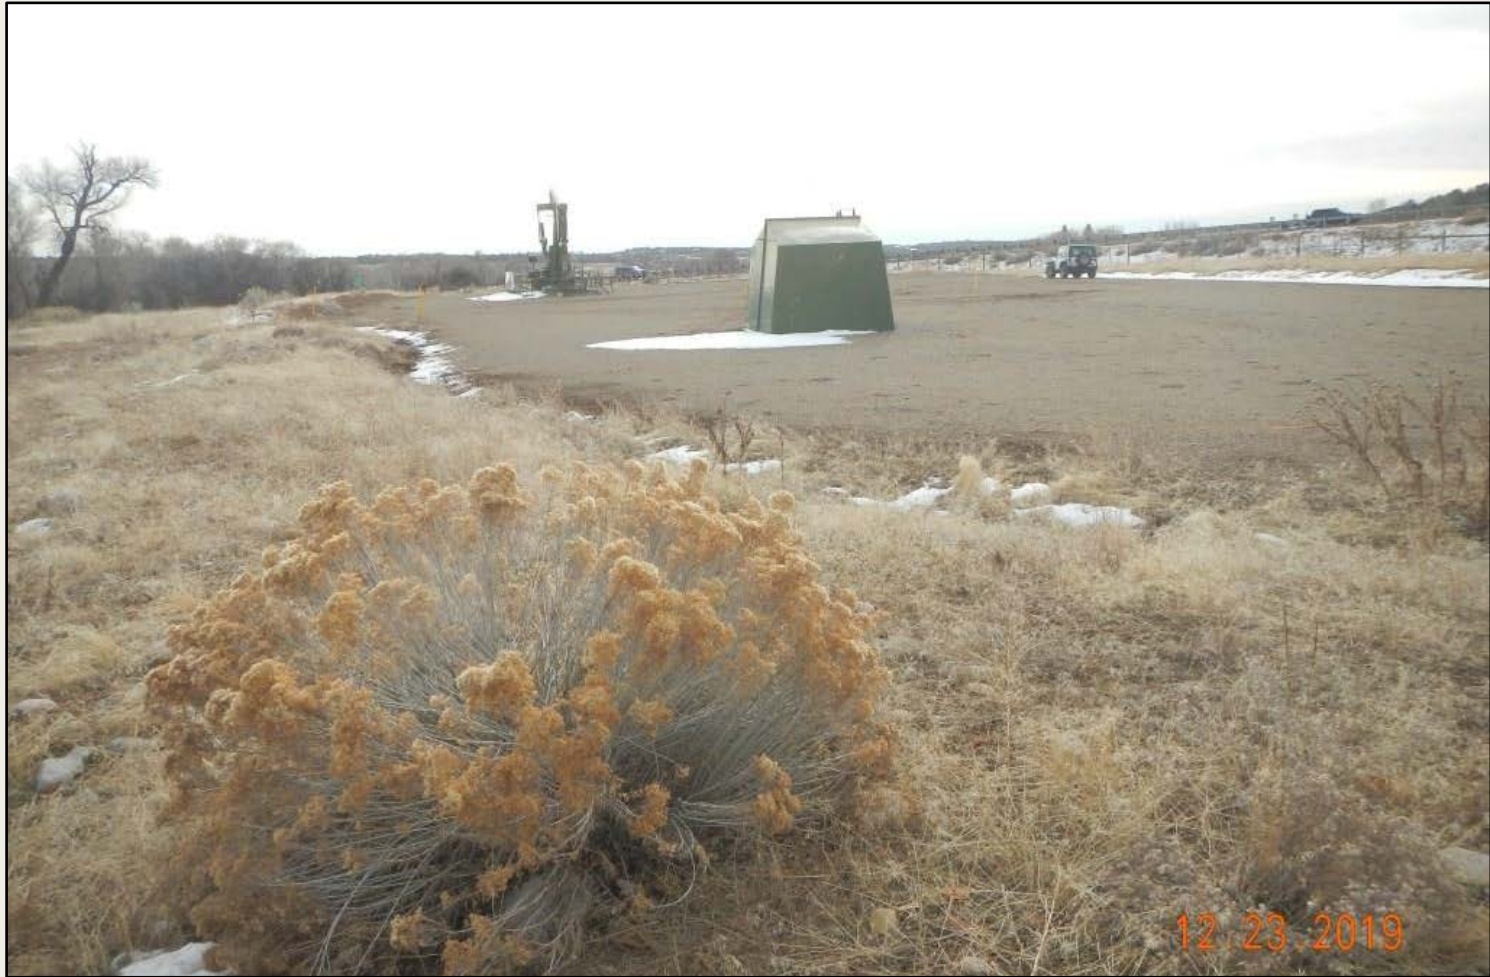
Photo 1. View of the project area from the northeastern corner facing center.

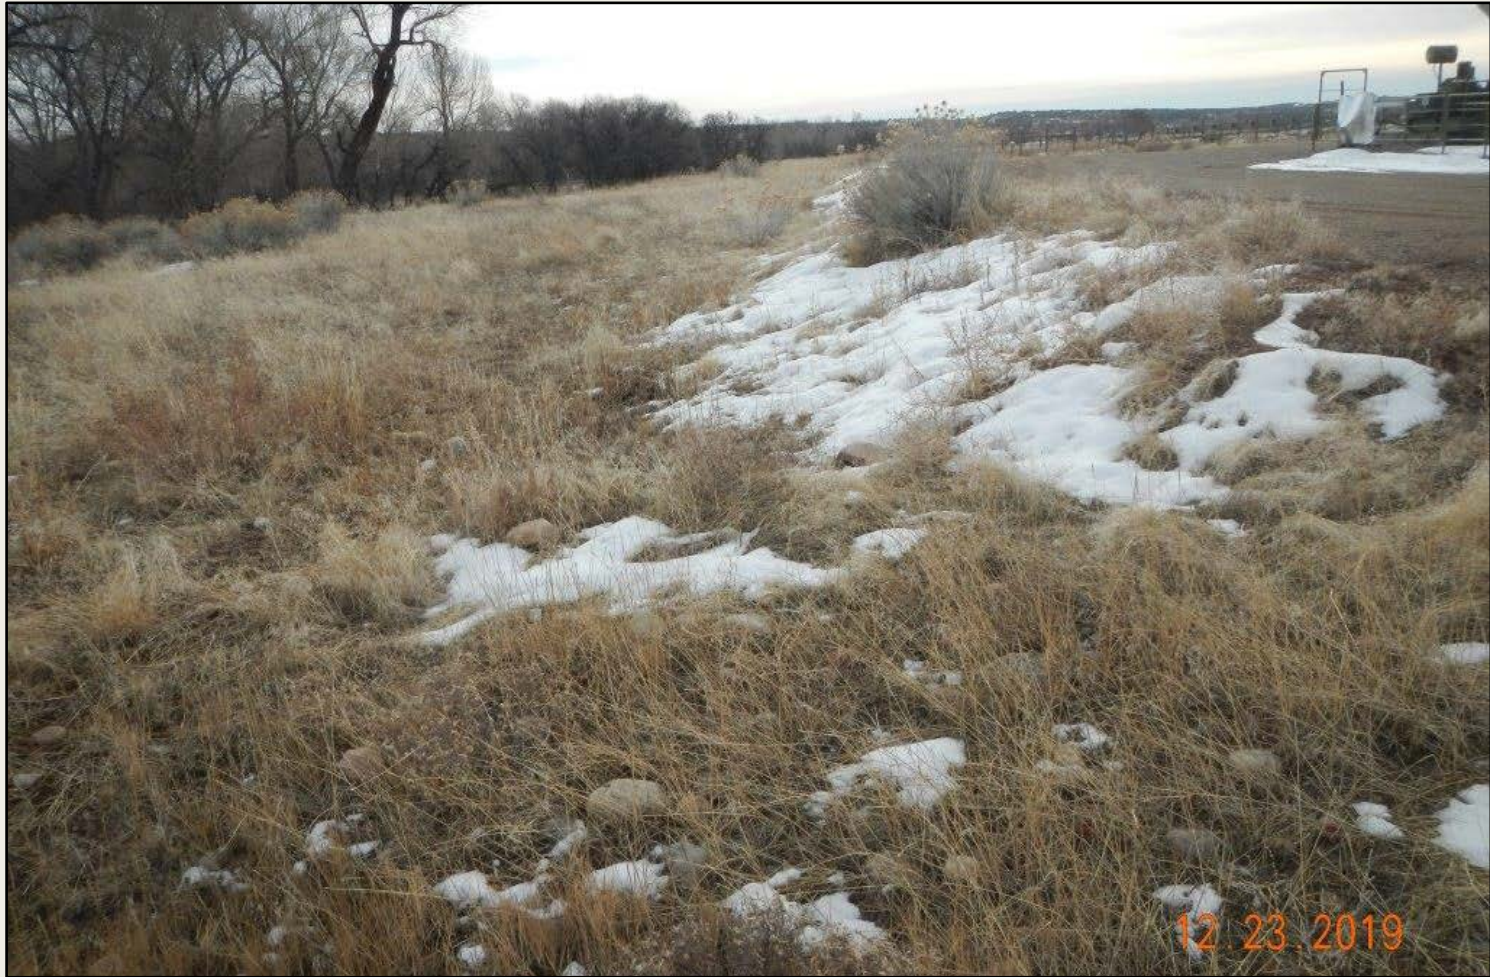
Photo 2. View of the eastern project area from the northeastern corner facing southward. Revegetation is largely comprised of crested wheatgrass, western wheatgrass, and sand dropseed.

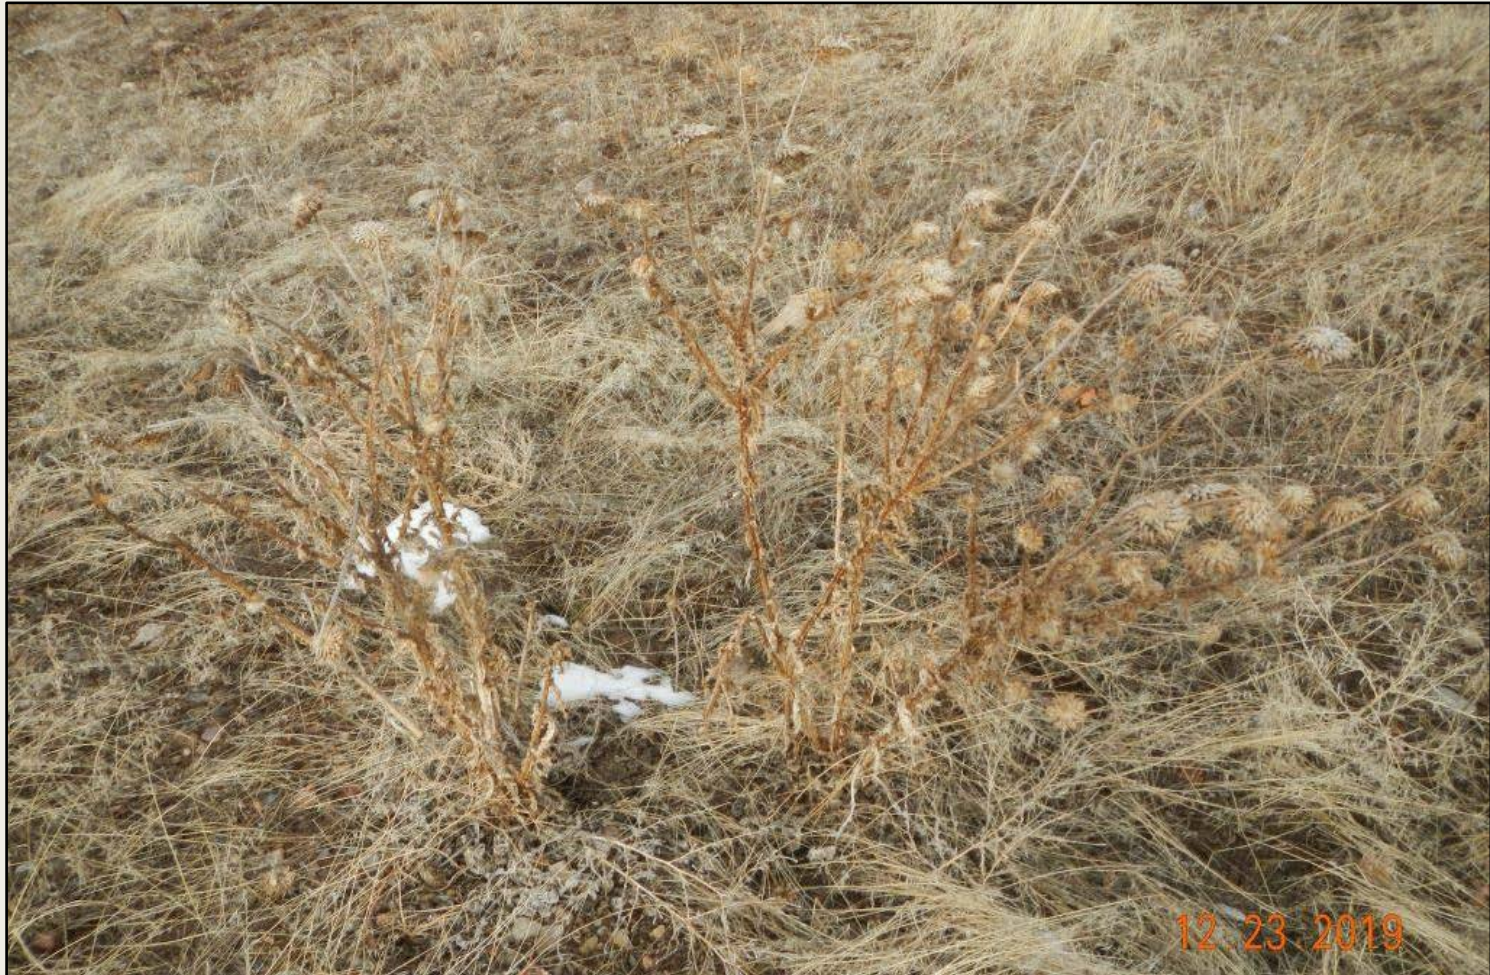
Photo 3. View of musk thistles within the northern project area.

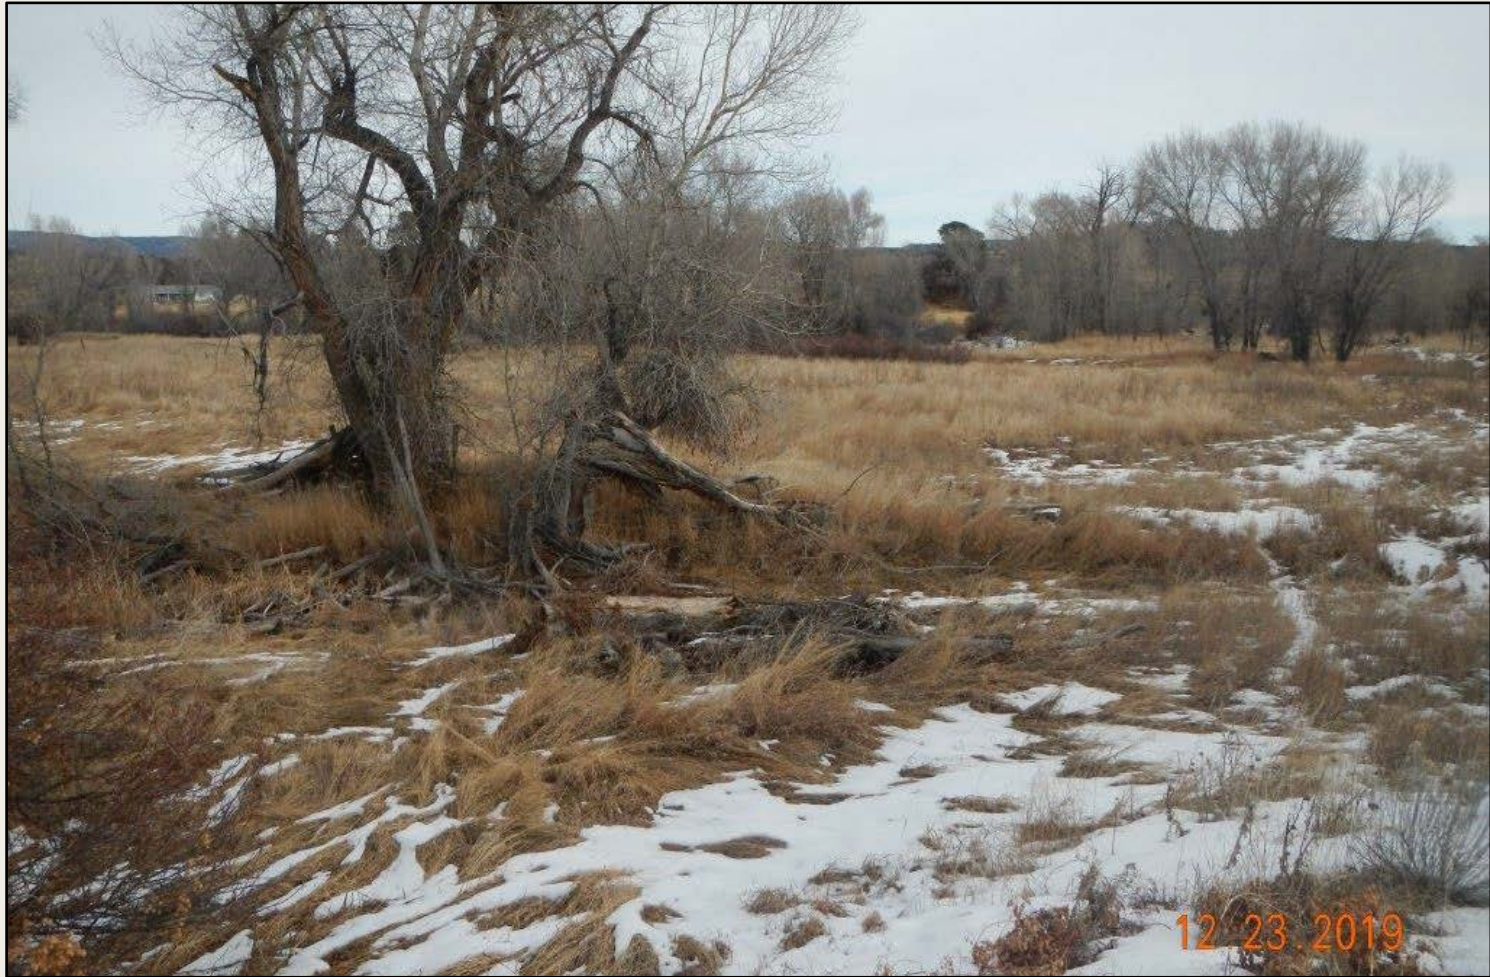
Photo 4. View of reference area vegetation comprised of open grass field with scattered cottonwood and gambel oak trees.
