# Inspection Photos

Operator: Enduring Resources  
Location/API #: 067-06574  
Date: 12-23-2019

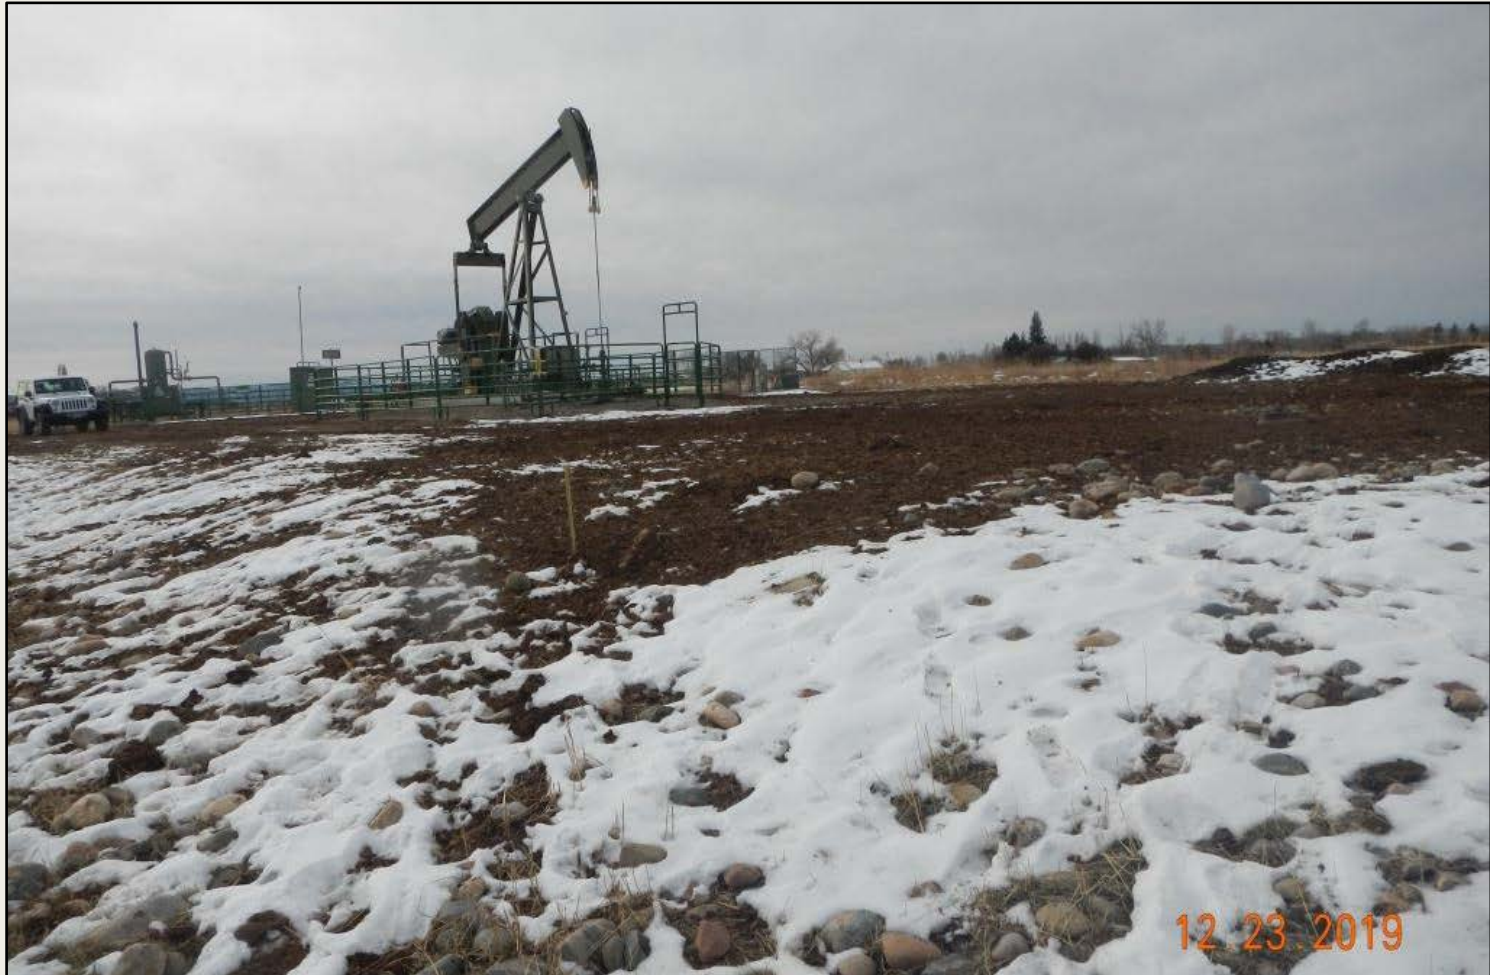
Photo 1. View of the project area from the northeastern corner facing center.

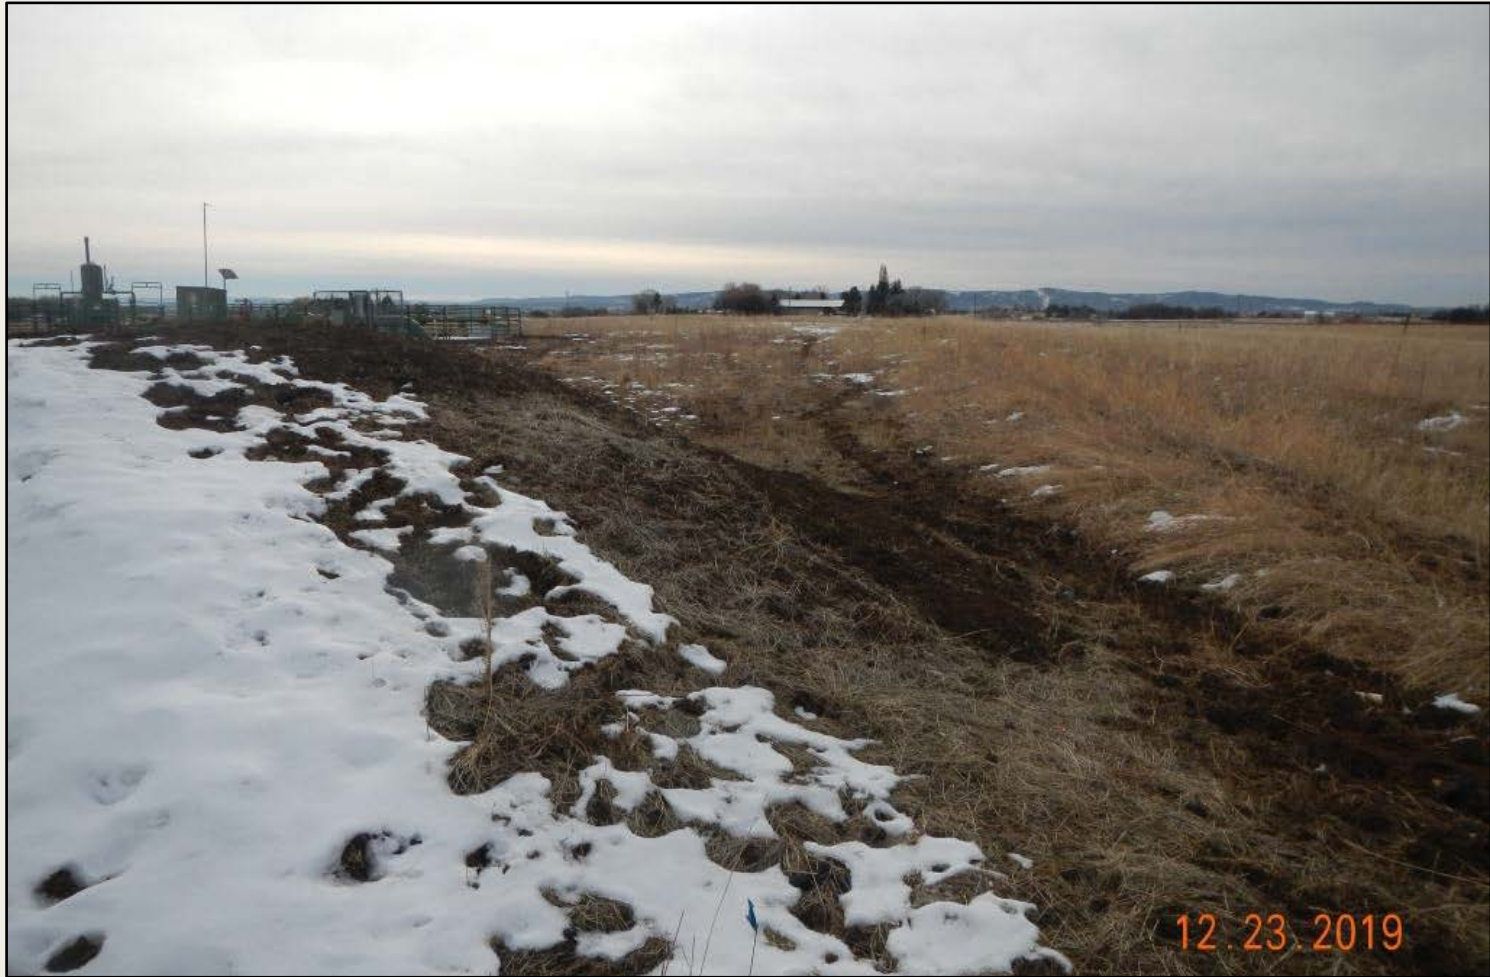
Photo 2. View of the western project area from the northwestern corner facing southward. Revegetation is largely in a dormant or snow covered condition at this time.

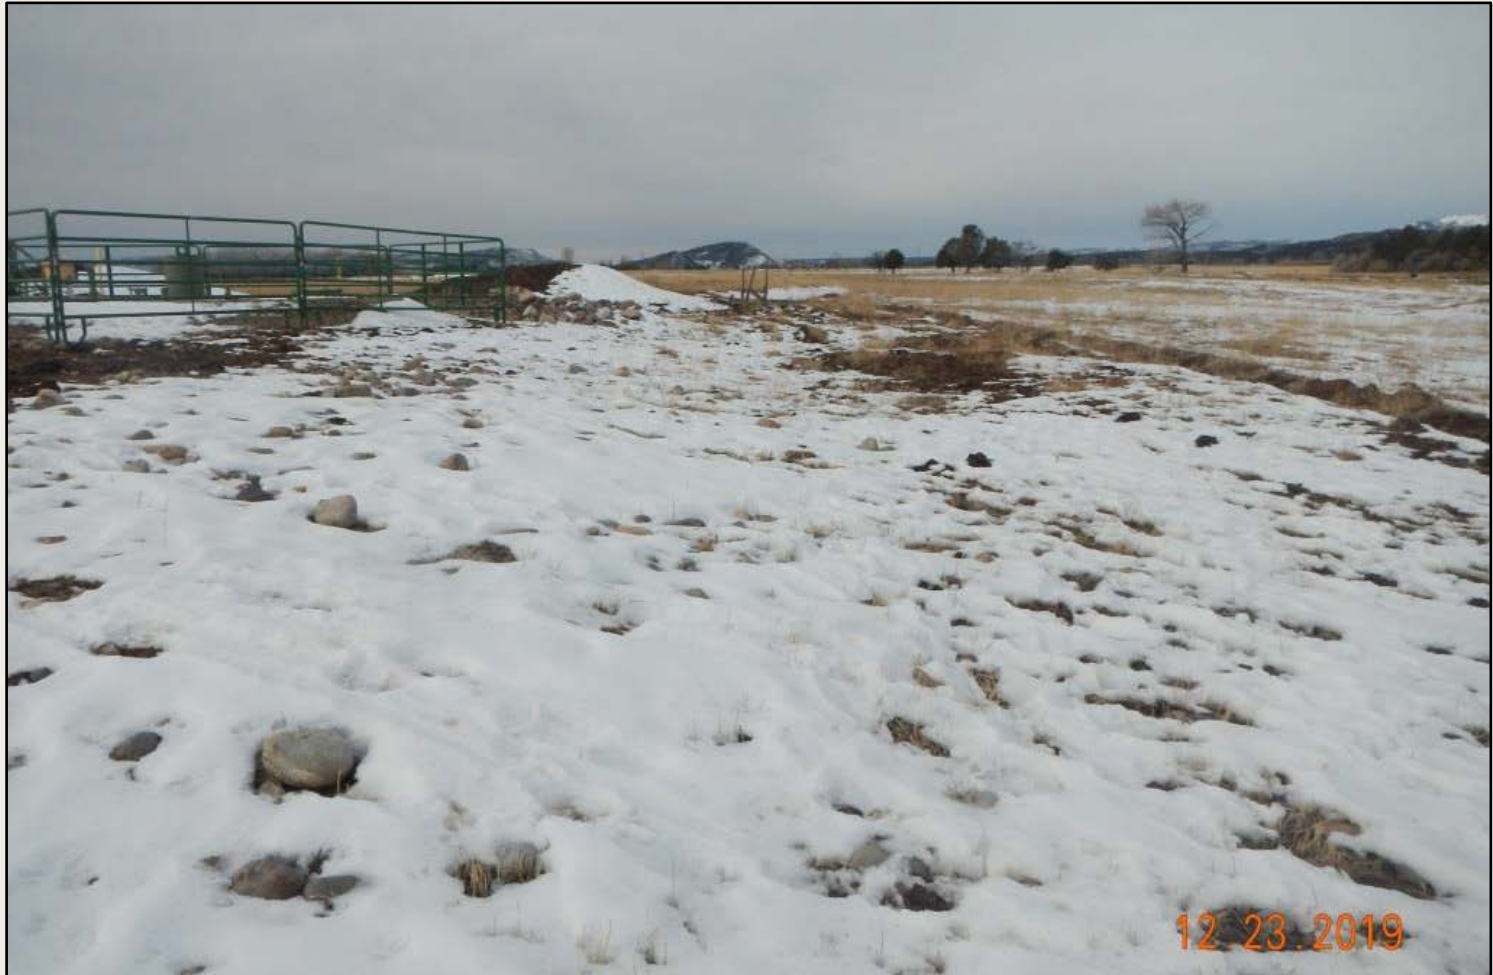
Photo 3. View of the northern project area from the northeastern corner facing westward.

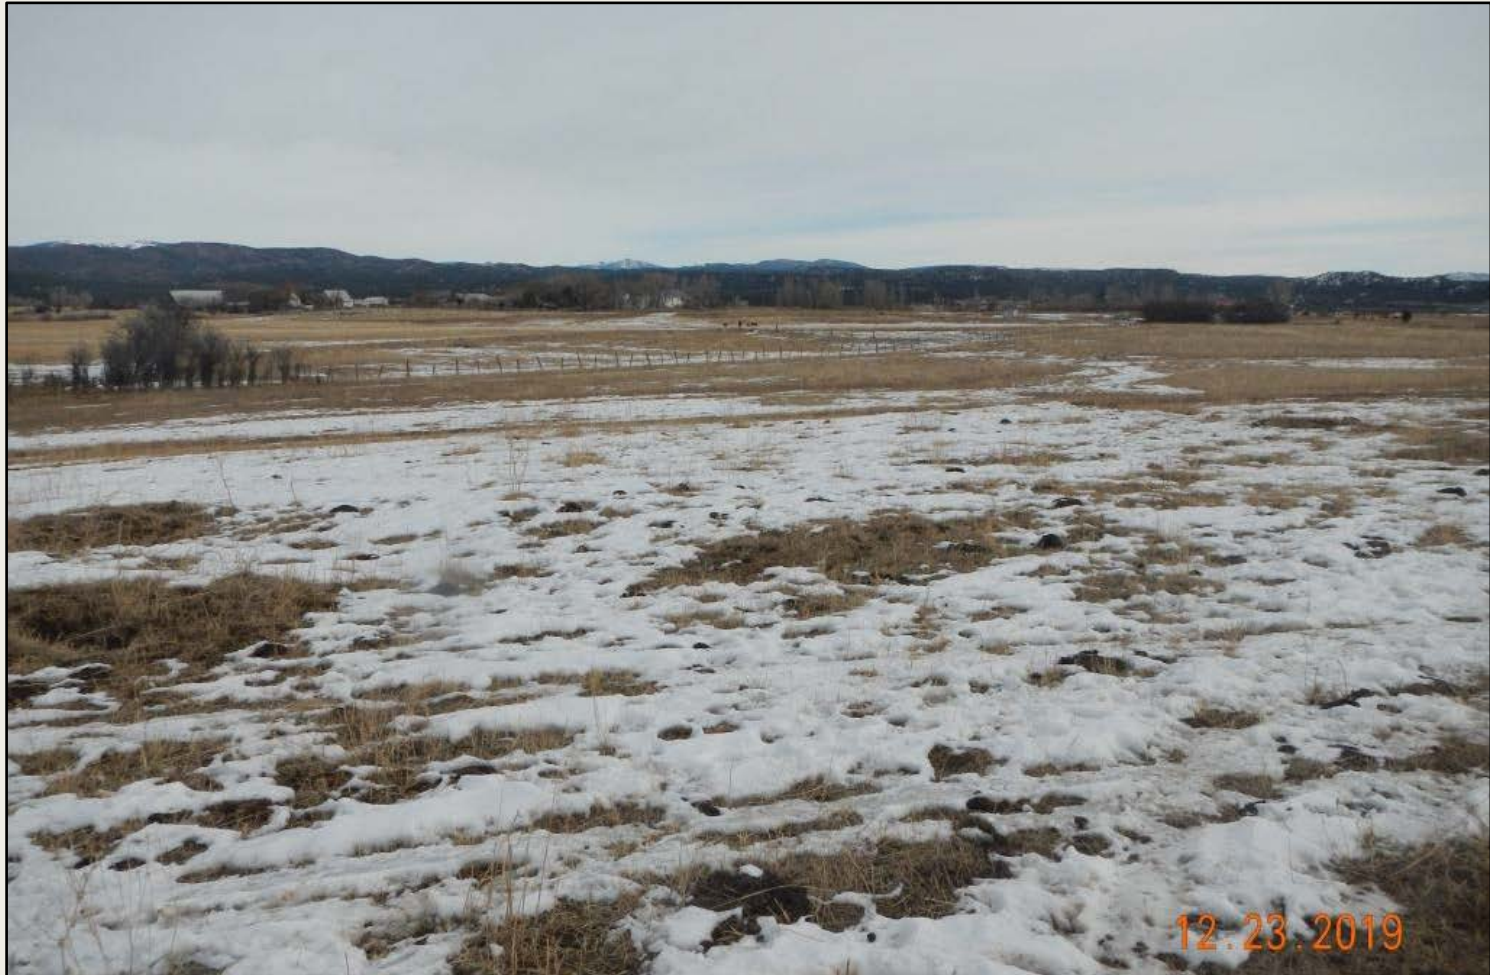
Photo 4. View of reference area vegetation comprised of open grass field with both native and introduced grasses in dormant vegetative condition.
