# Inspection Photos

API: 05-025-06022

Operator: GRAND MESA OPERATING

Inspection Date: 12/18/2019

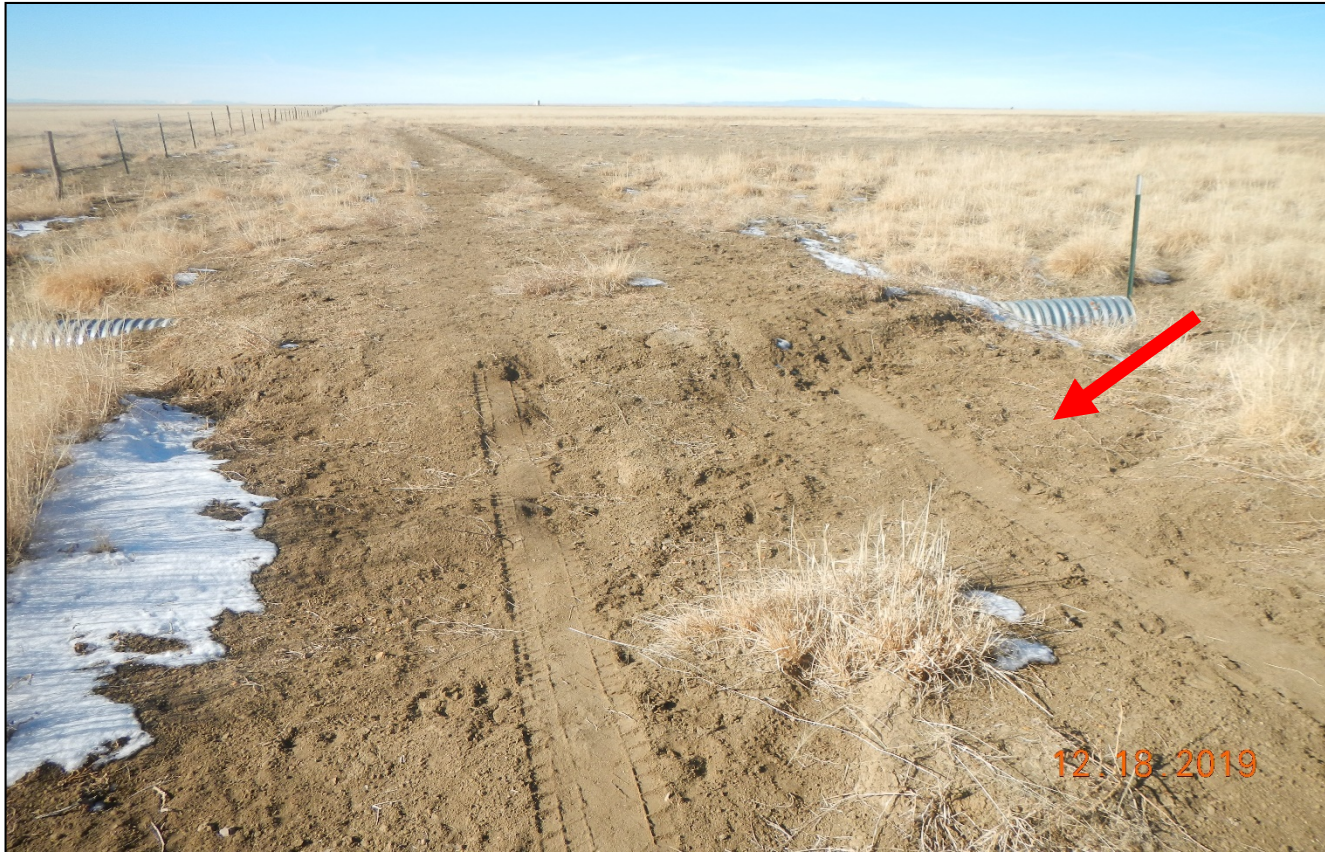
**Photo 2.** There are signs stormwater has flowed at the low point of the road crossing, shown in area of red arrow.

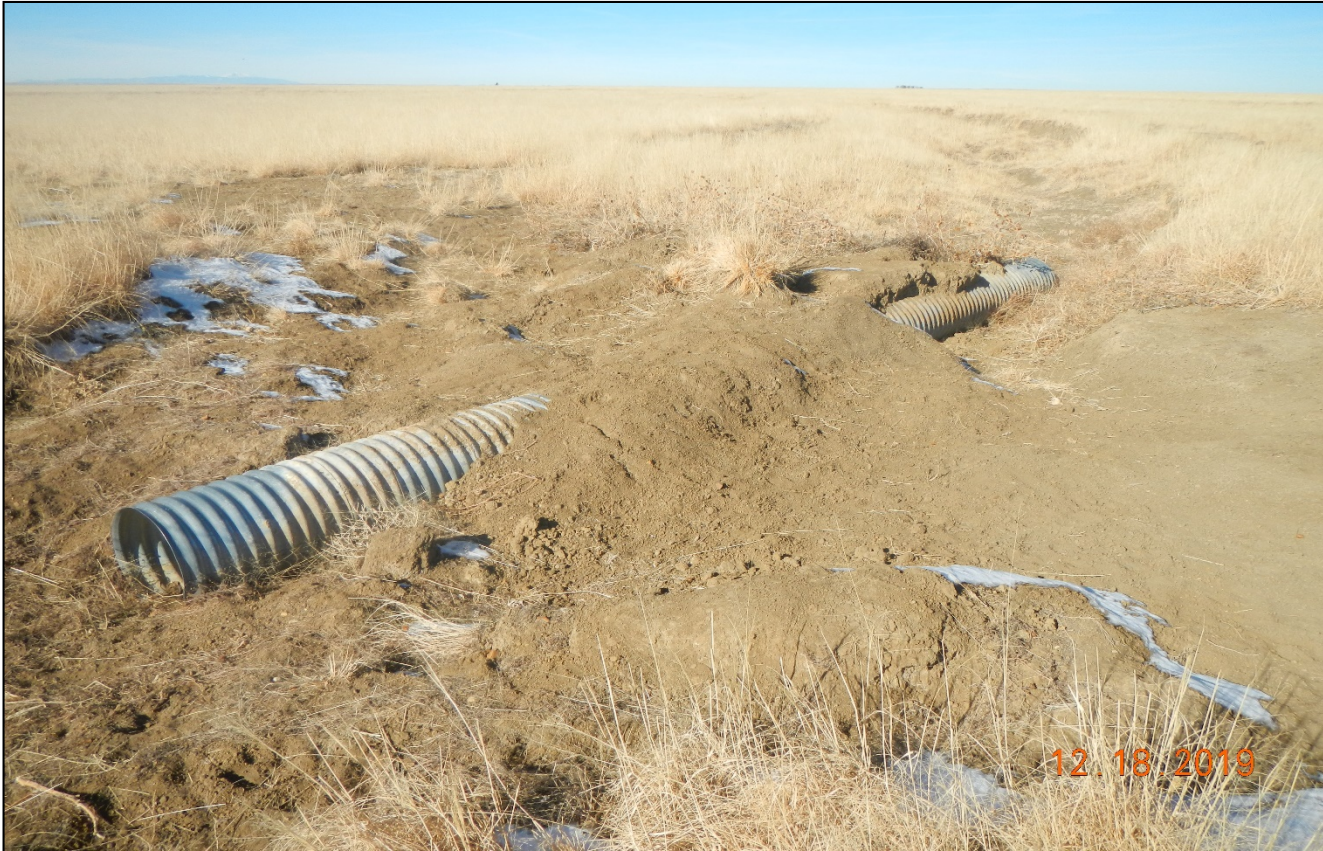
**Photo 3.** The culvert further west along the road has washed out. Erosion has occurred around the culvert.

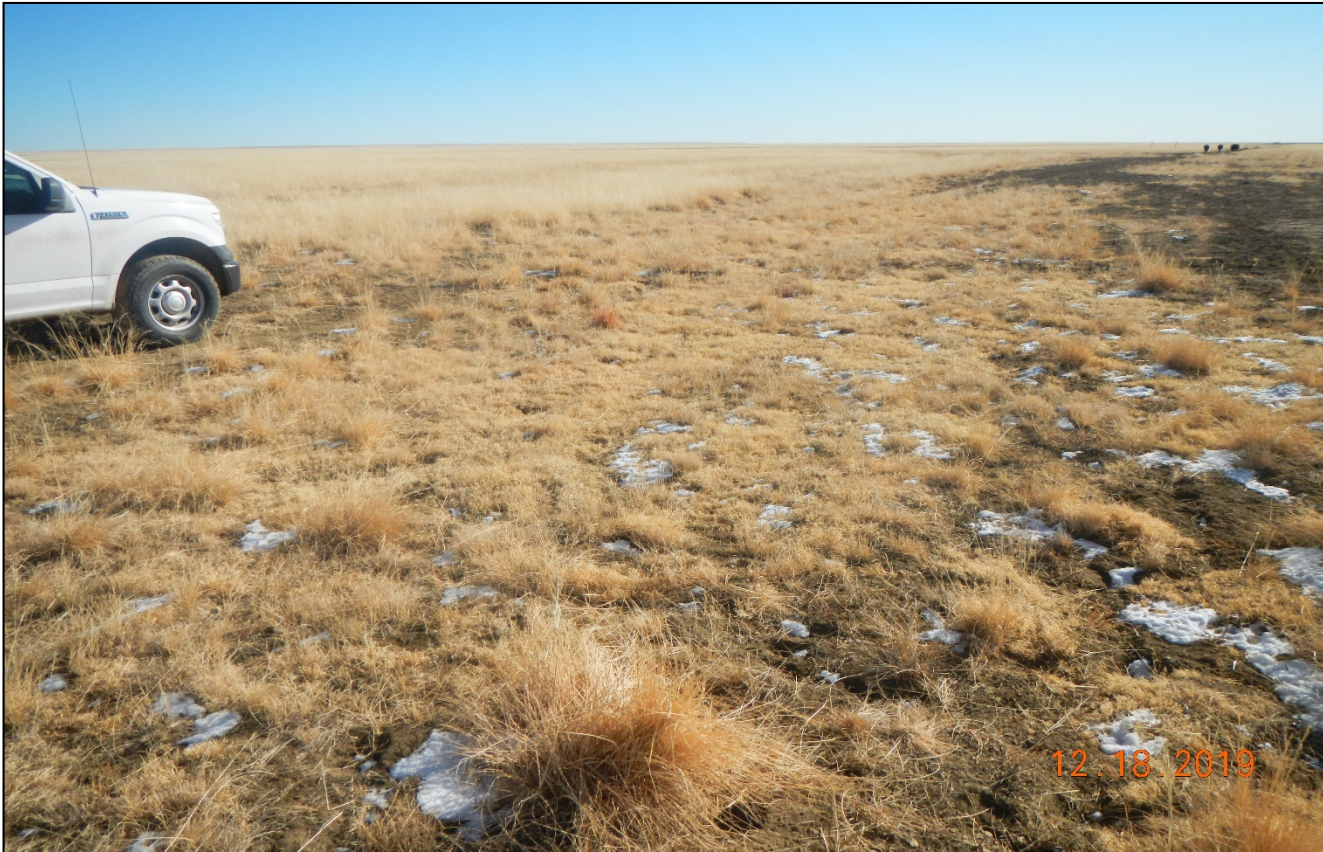
**Photo 6.** There is an ephemeral stream crossing at this point along the two track road. This area appears to be stabilized.

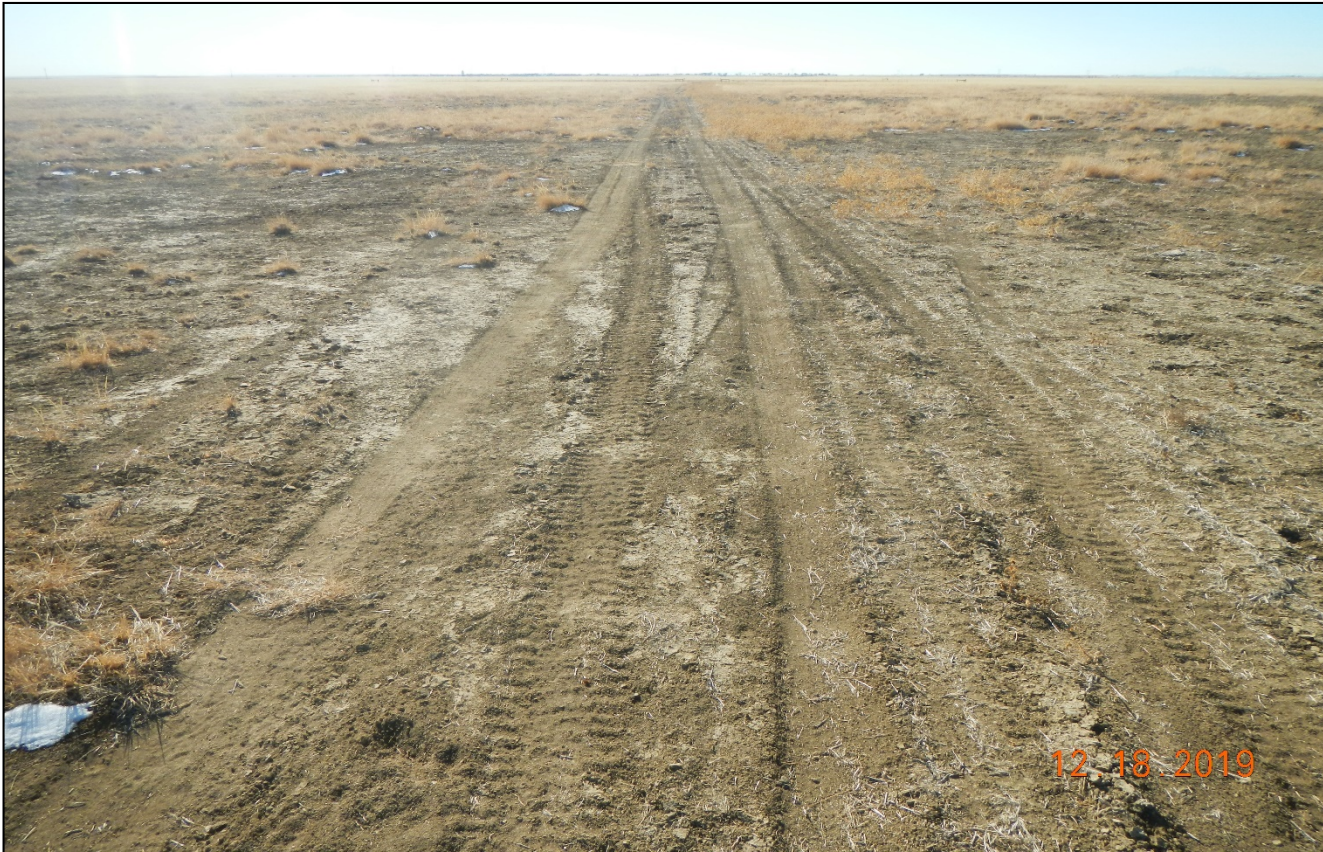
**Photo 8.** Facing southwest along the reclaimed portion of the road. It appears vehicles have been driving at this area. Vegetation does not appear to be establishing.

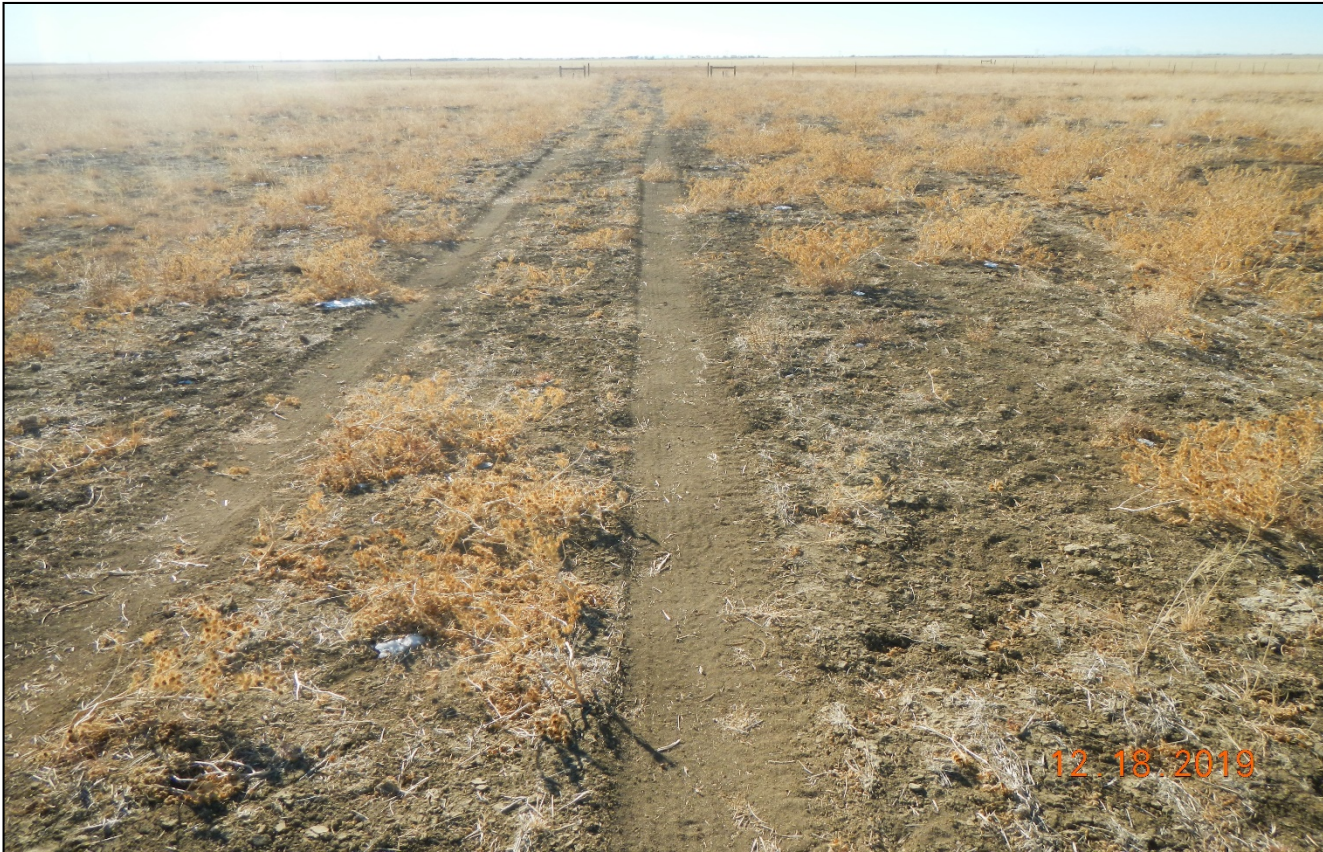
**Photo 9.** Facing southwest along the reclaimed portion of the road. It appears vehicles have been driving at this area. There are numerous Buffaloburs growing in the reclaimed area.

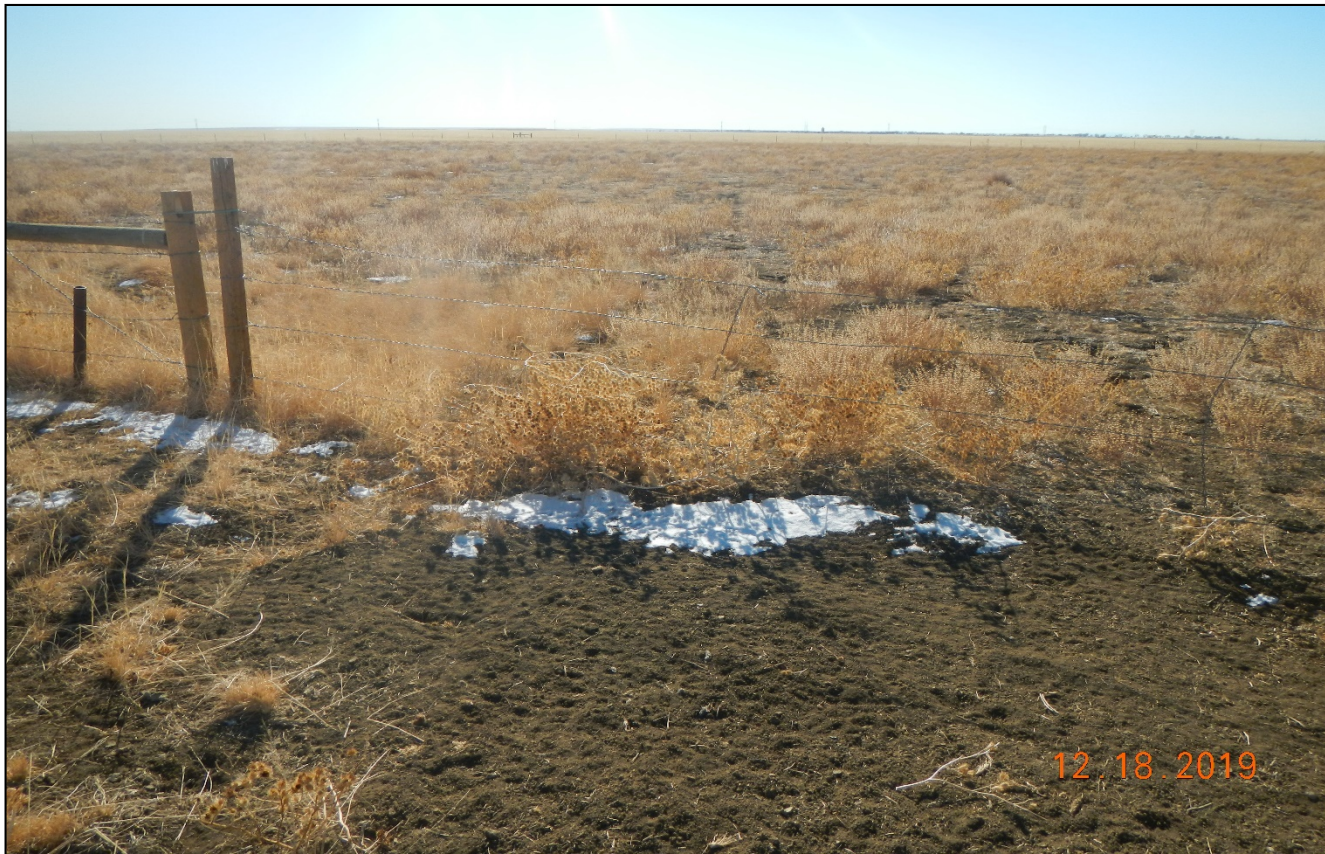
**Photo 10.** Facing south toward the location. There is a perimeter fence around the location.

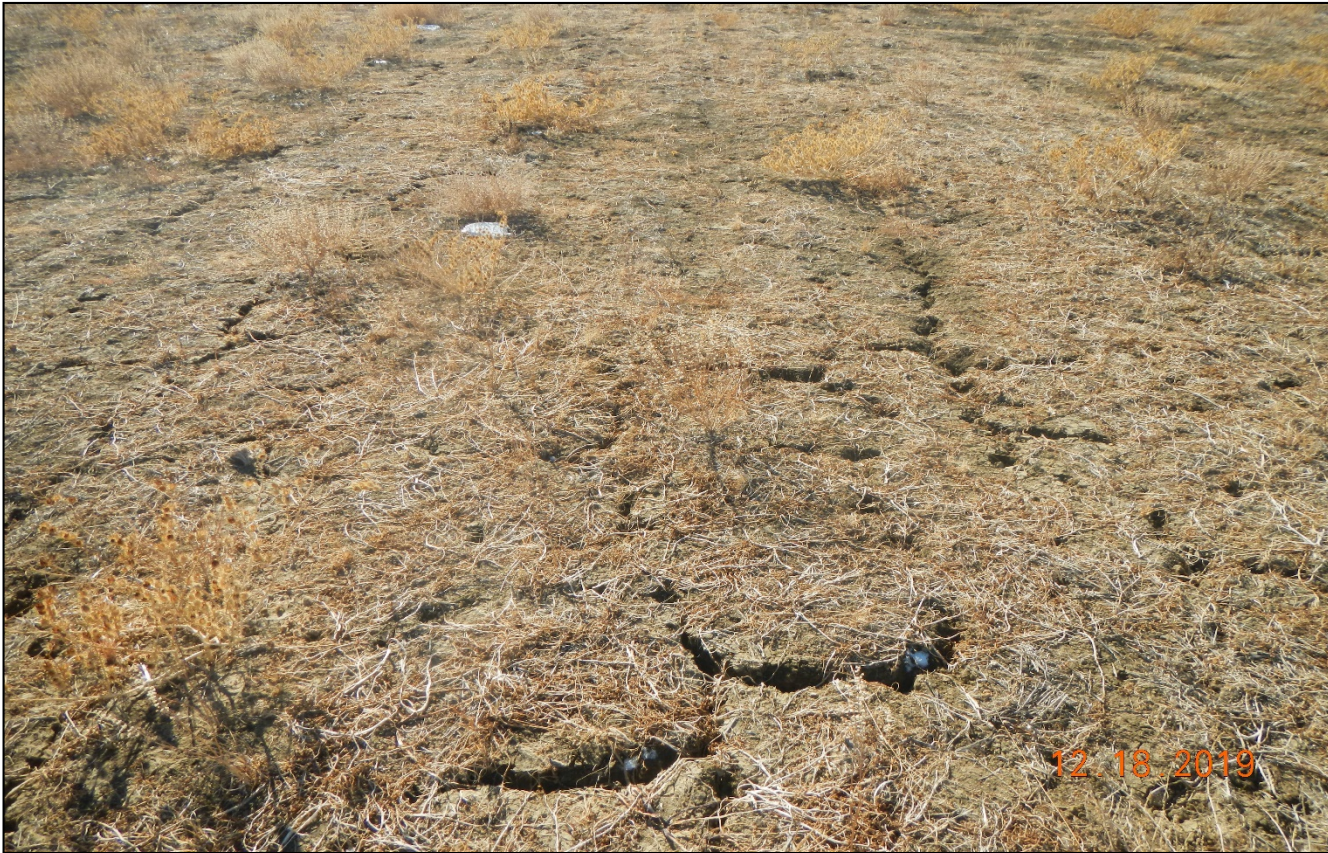
**Photo 15.** View of groundcover. There is cracks along the ground.

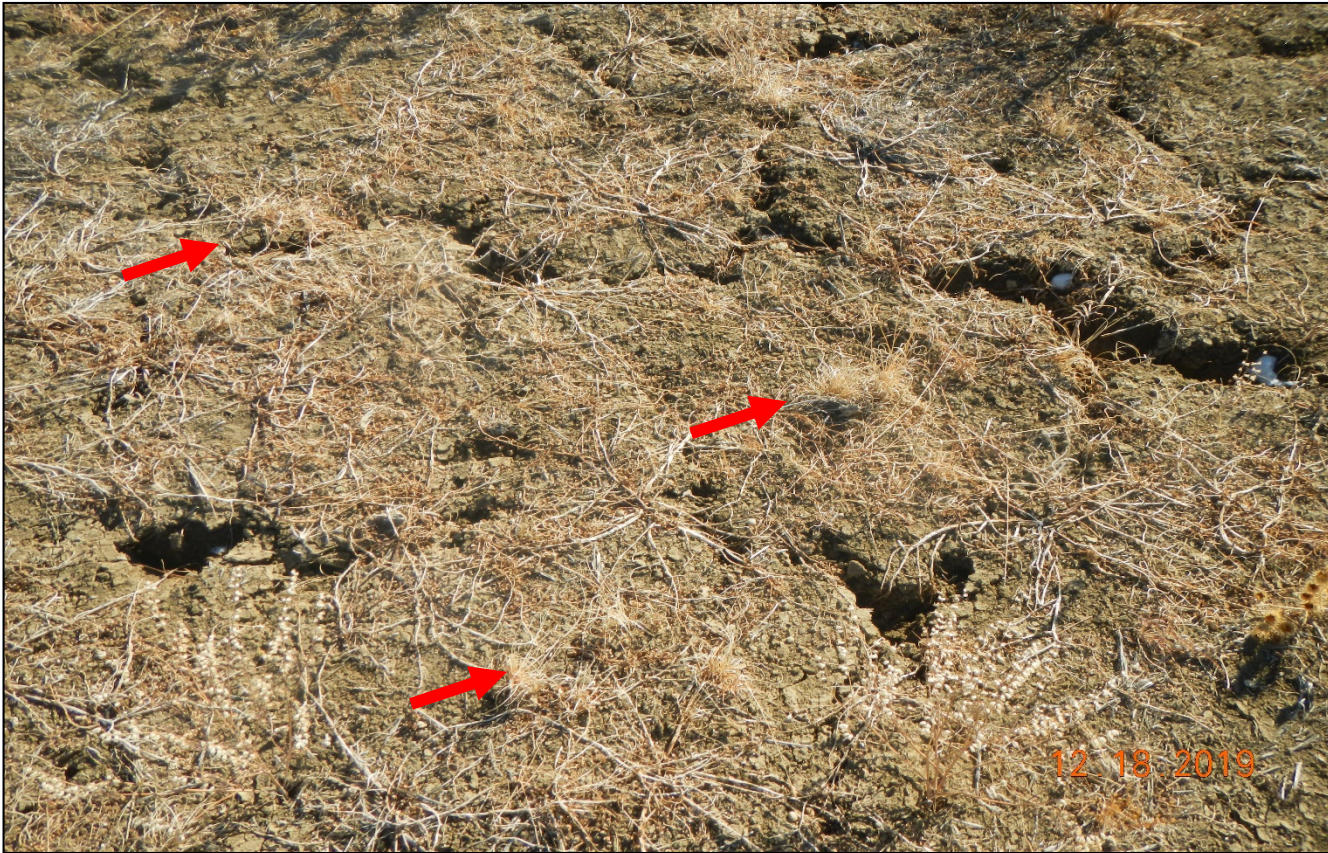
**Photo 16.** There is some vegetation establishing in areas. Vegetation noticed was Sideoats grama, Blue grama, and Sand dropseed.

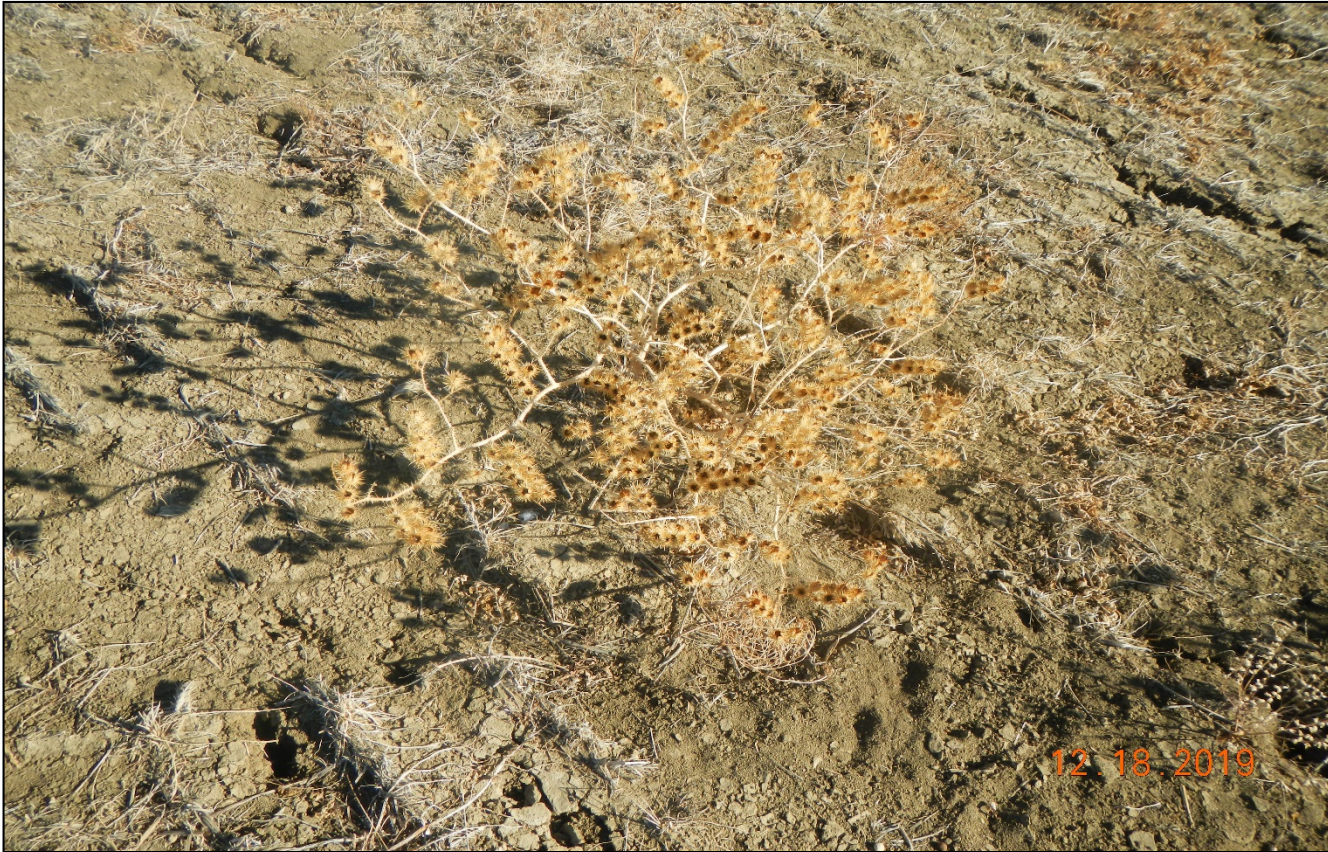
**Photo 17.** There is numerous Buffalobur throughout the location, which is a native annual specie.

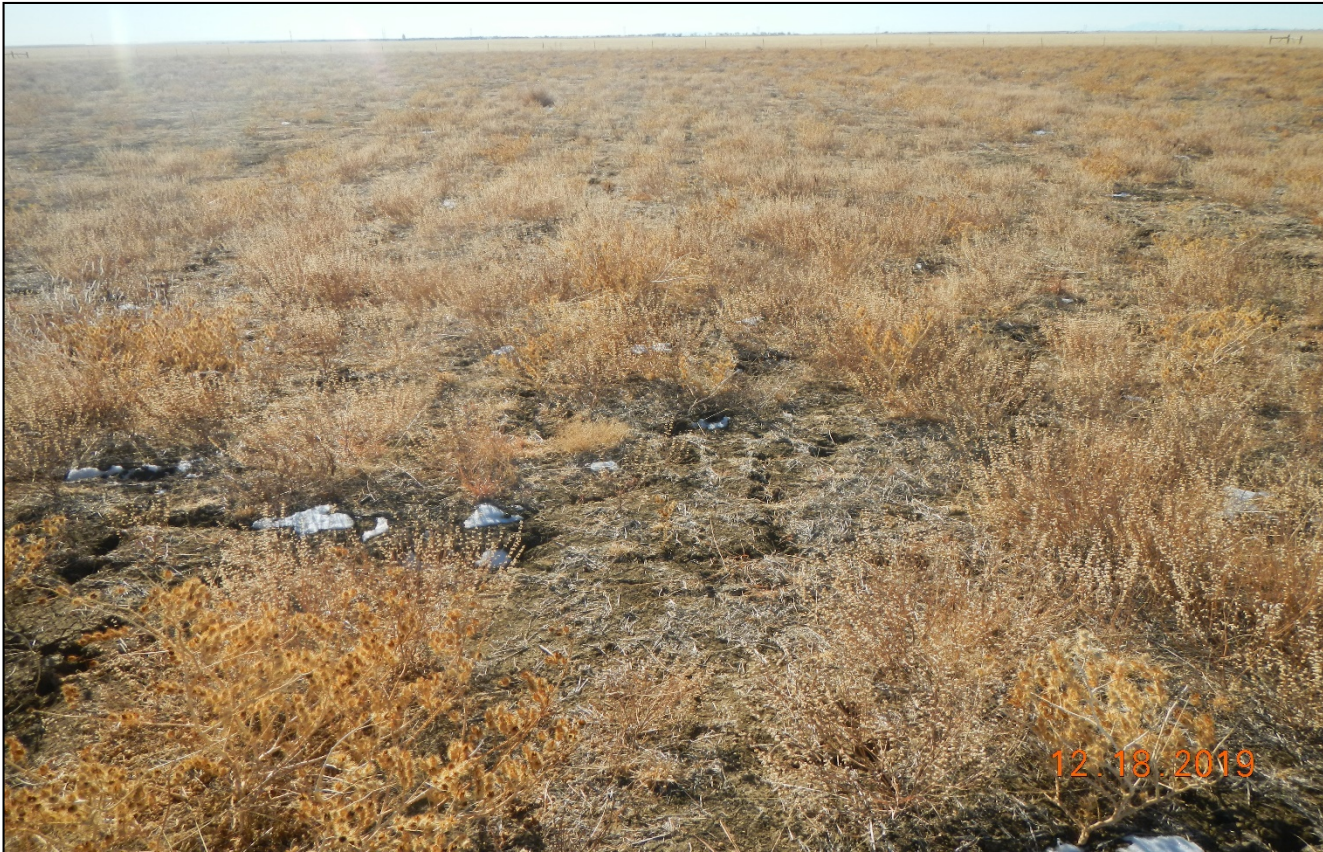
**Photo 18.** Facing southwest toward the location. There is predominately undesirable species growing at the location.

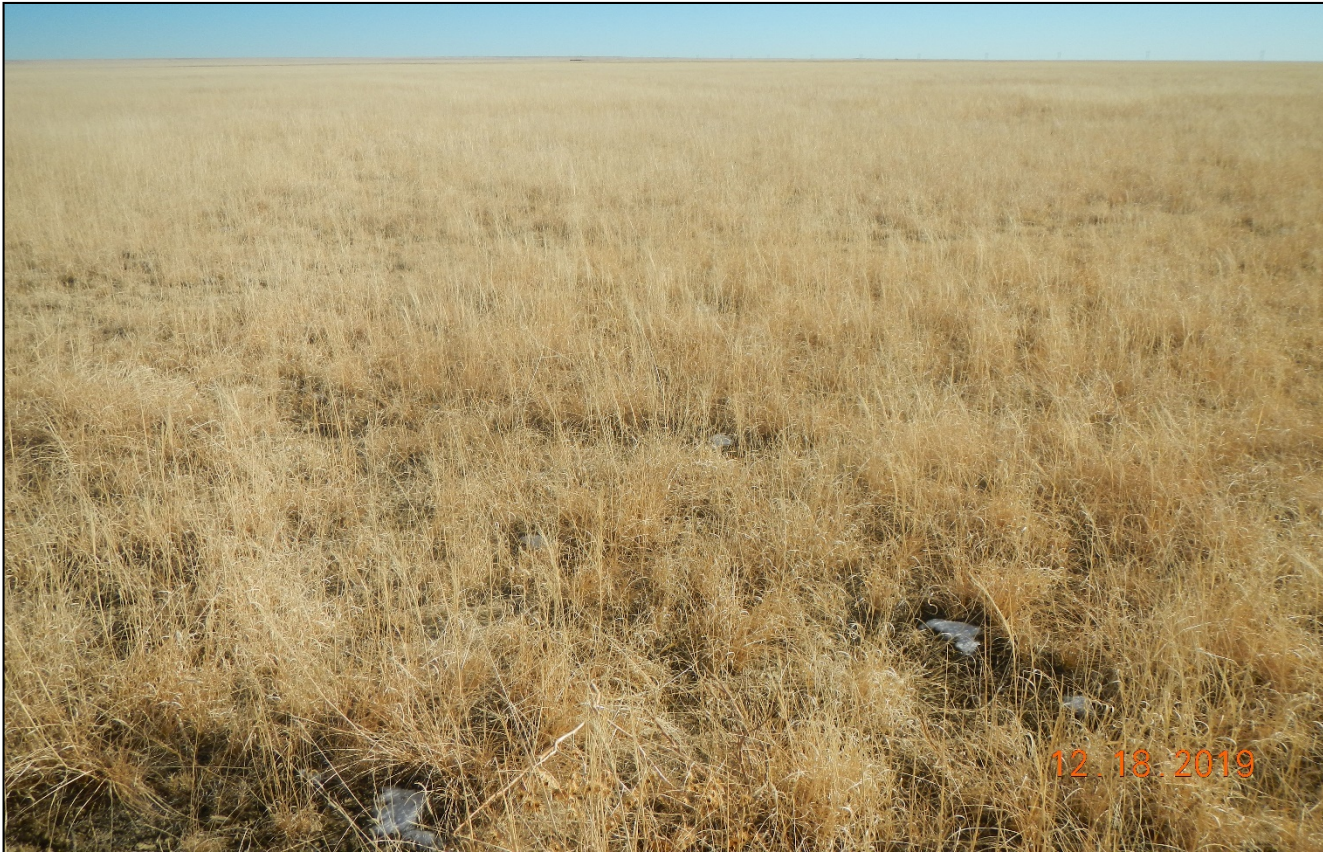
**Photo 19.** Facing east toward the surrounding reference area which consists of predominately Blue grama and Sand dropseed.
