Construction and Stormwater Inspection

December 26, 2019

Operator: CONFLUENCE DJ LLC- #10518

Location ID: 453535

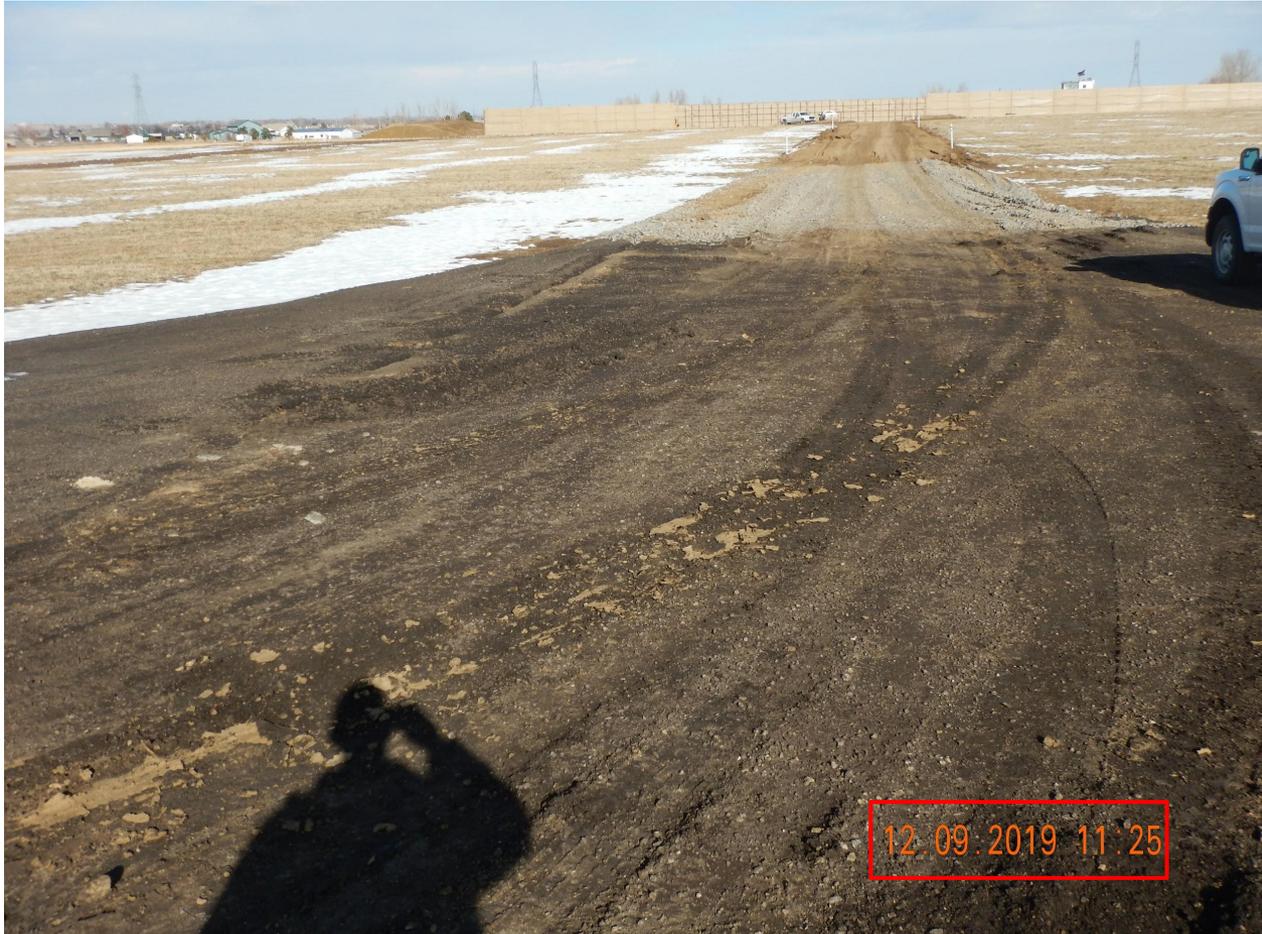
Photo 1. Photo taken from the entrance of the location on 12/9/2019, facing North. The current vehicle tracking device BMPs are not adequate to be in compliance with Rule 1002.f.(2)F.

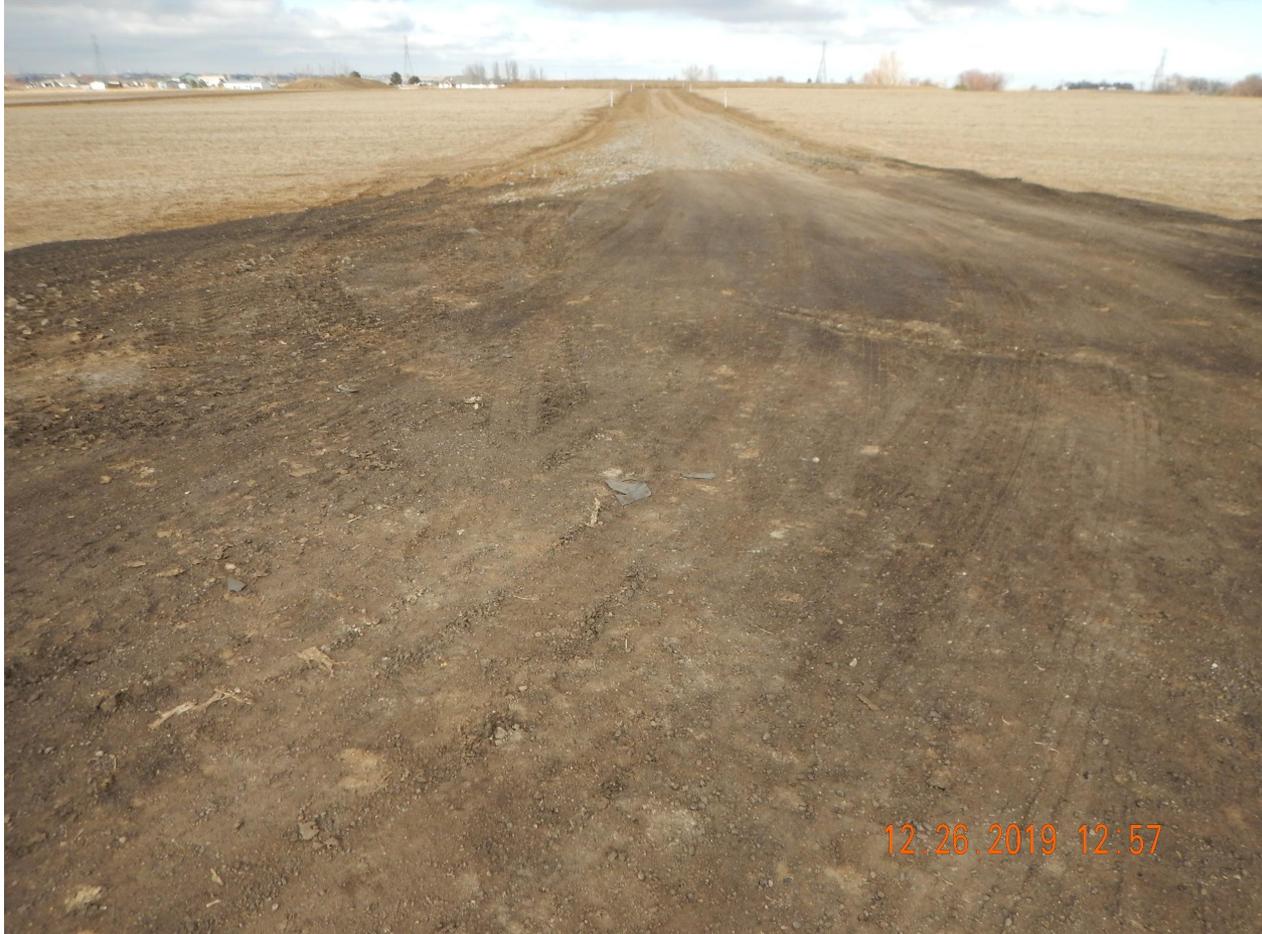
Photo 2. Photo taken from the entrance of the location on 12/26/2019, facing North. The current vehicle tracking device BMPs are not adequate to be in compliance with Rule 1002.f.(2)F.

Note: Operator has not installed any additional vehicle tracking device BMPs to access road since the previous inspection. As the previous inspection noted, the current vehicle tracking device BMPs were not adequate and remain inadequate.

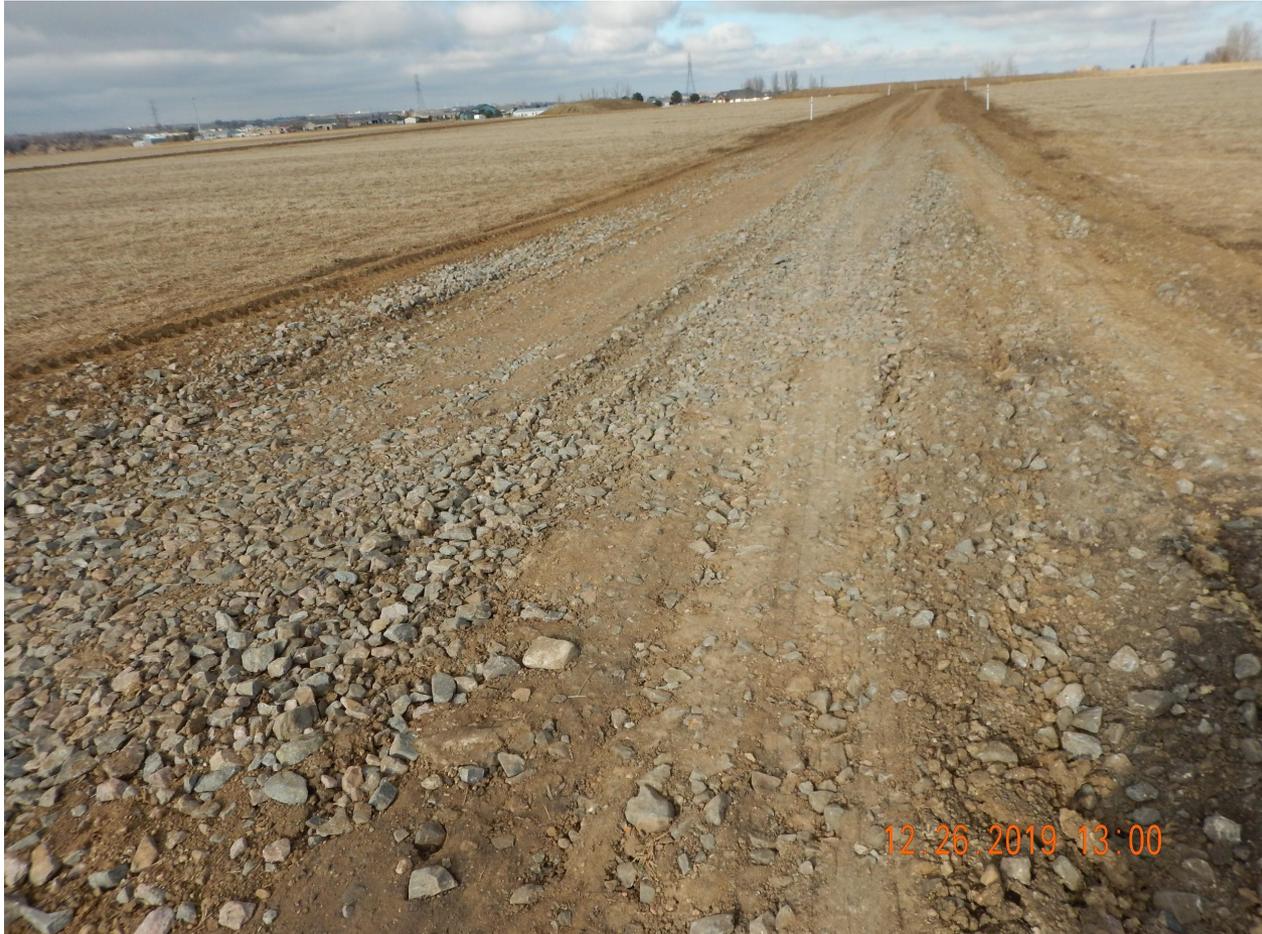
Photo 3. Photo taken from a portion of the vehicle tracking device BMP, facing North. The current vehicle tracking device BMPs are not adequate BMPs for this location.

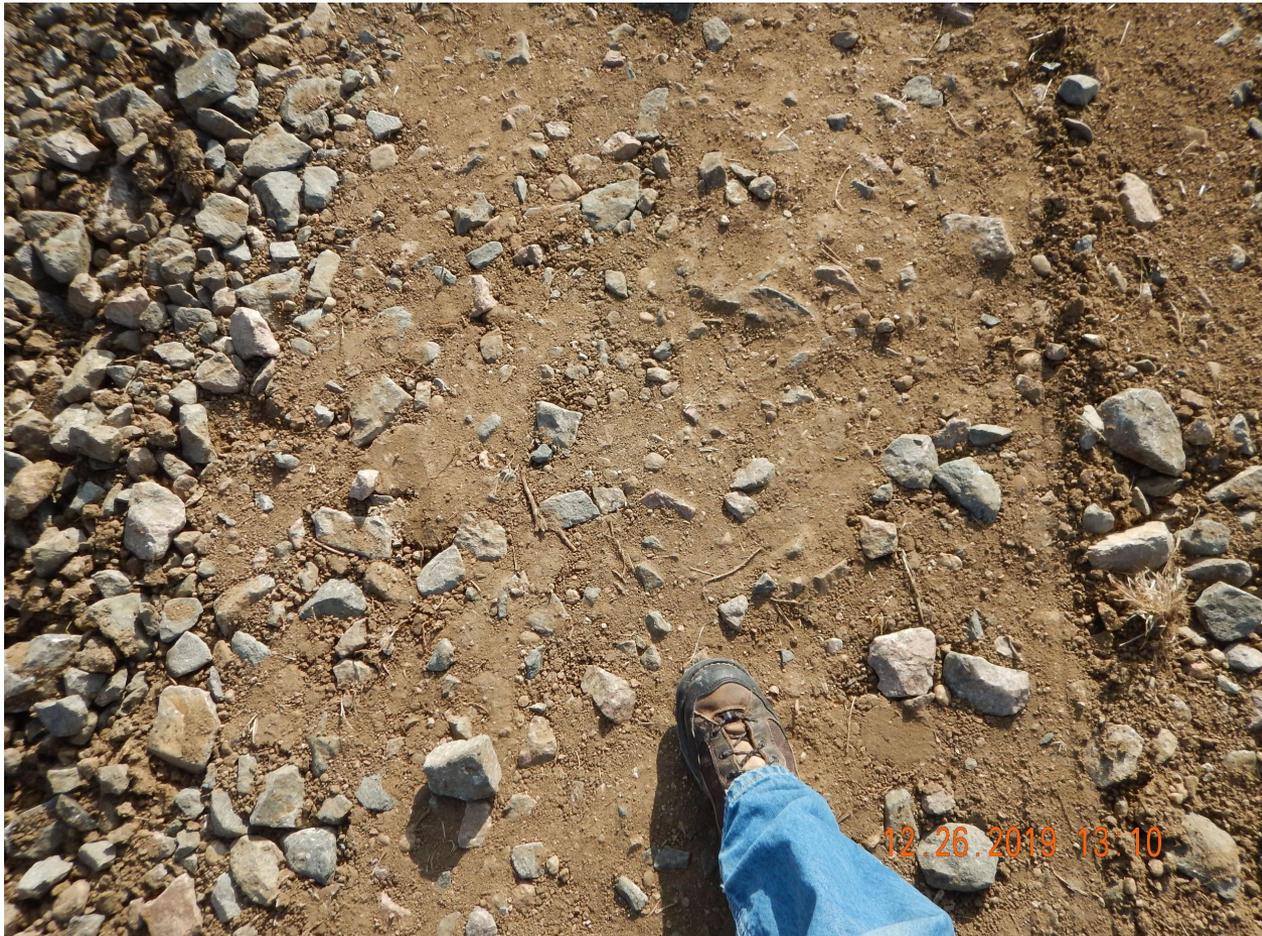
Photo 4. Close up photo taken from a portion of the rip-rap BMP that is not in proper functioning condition.

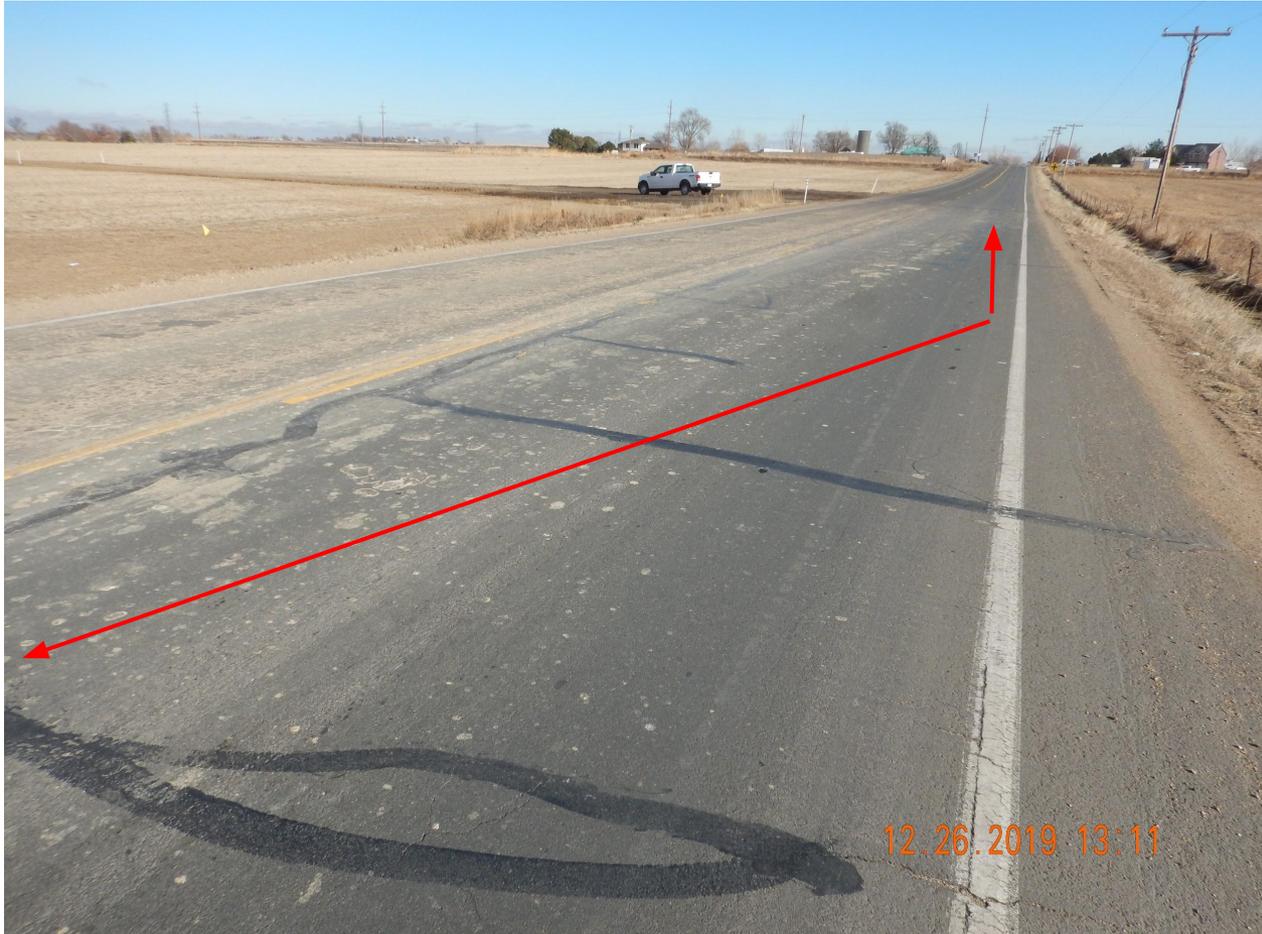
Photo 5. Photo taken west of the entrance on CR 2, facing East. Photo illustrates material tracked onto the county road.

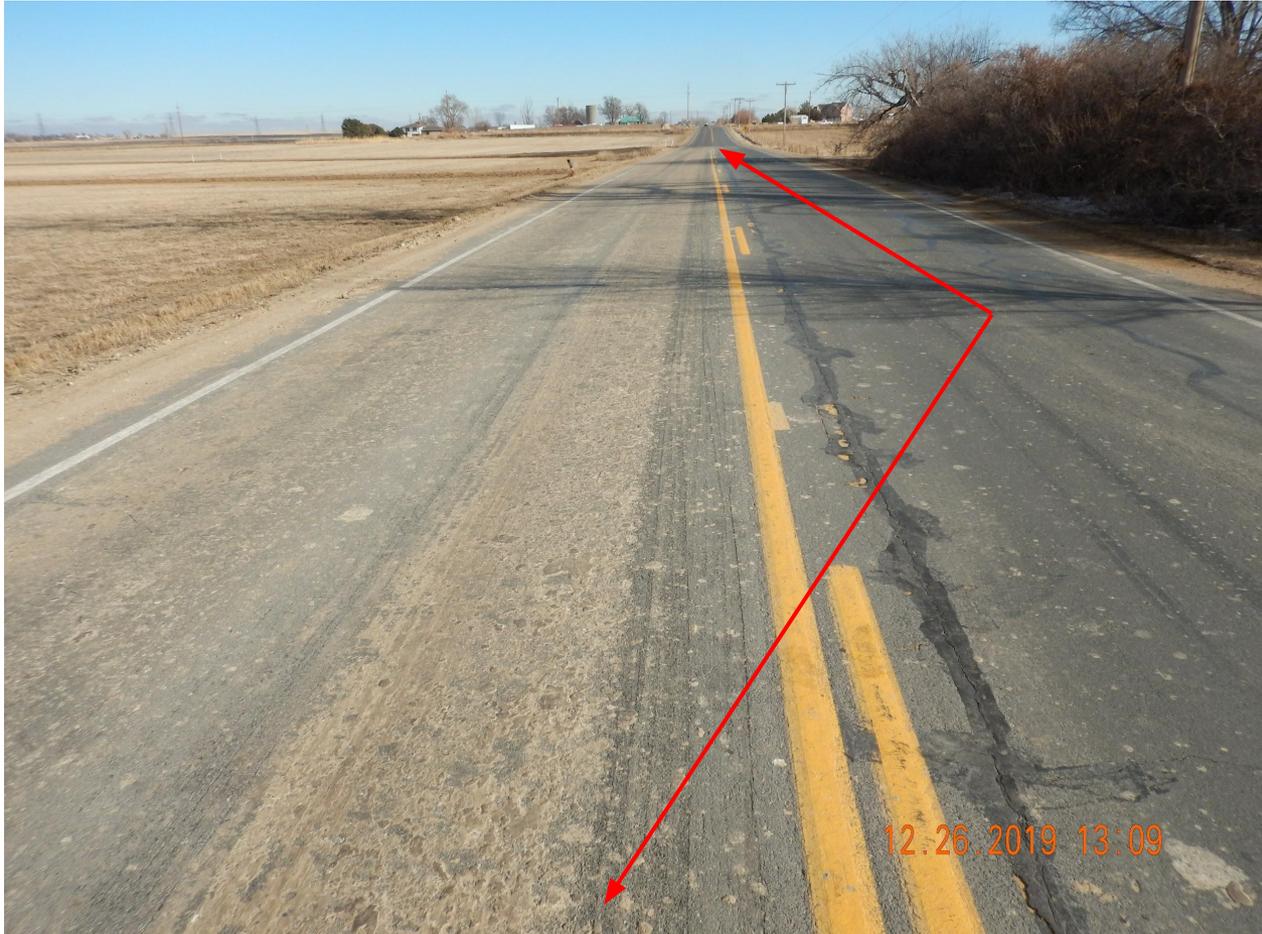
Photo 6. Photo taken ~500 feet west of the entrance on CR 2, facing East. Photo illustrates material tracked onto the county road.
