## Inspection Photos

Location Name: Clem Jr. 67S95W 15NWE (PB-15) Pad & PB15 Dumpline Failure

Location ID: #334653 & Spill/Release ID: #470298

Inspection Date: December 20, 2019

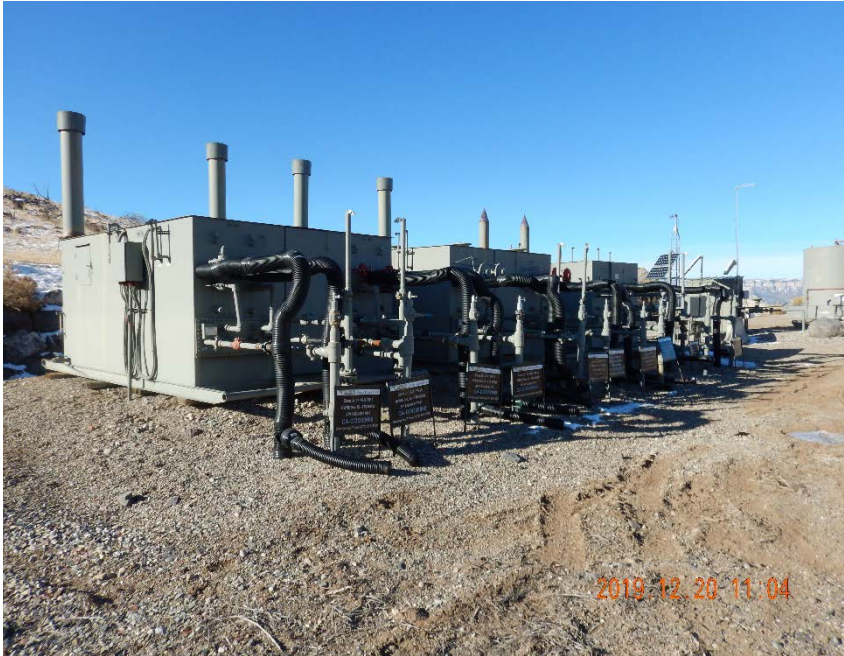
Photo #1 – View of separators on south side of pad.

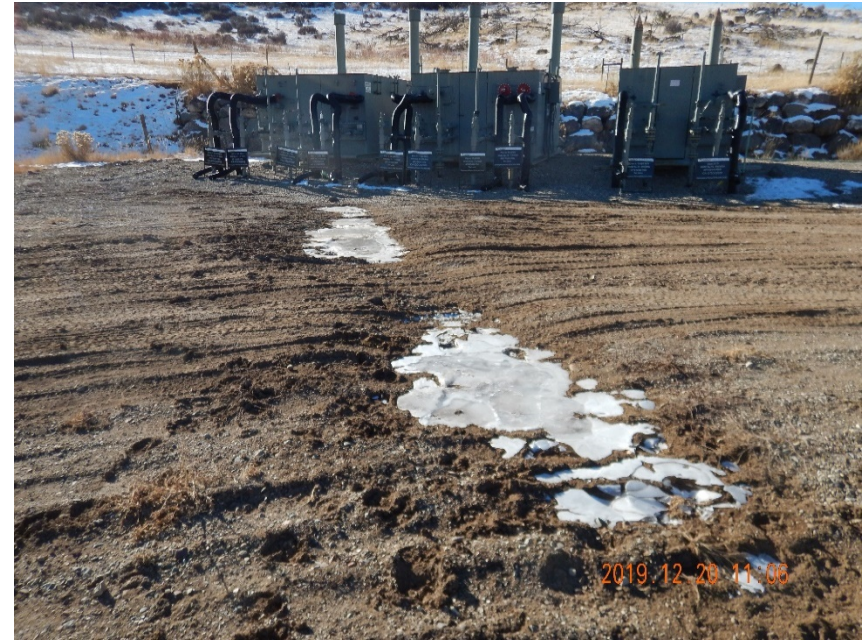
Photo #2 – Subsidence area north of separators.

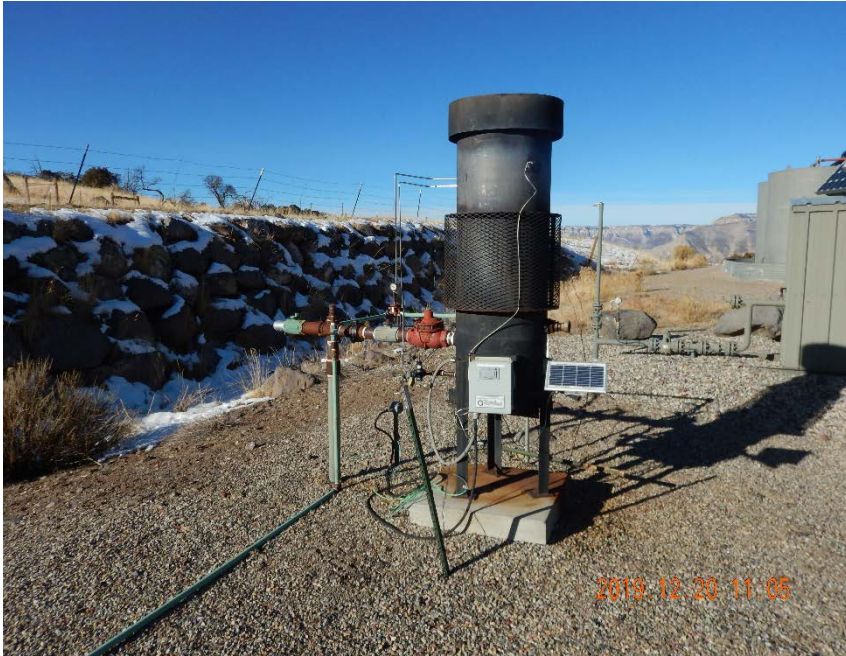
Photo #3 – ECD located west of separators.

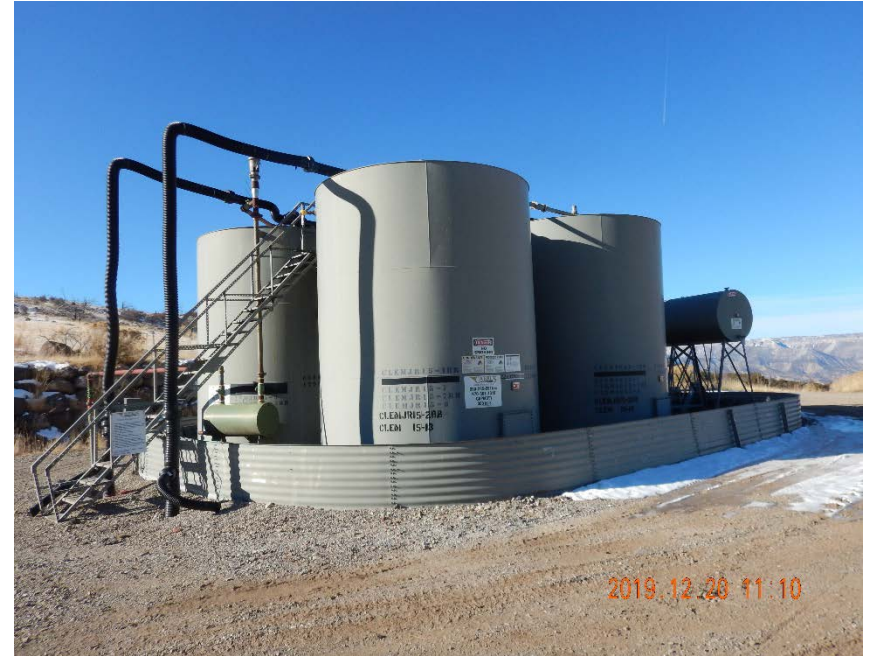
Photo #4 – View of tank battery, from east.

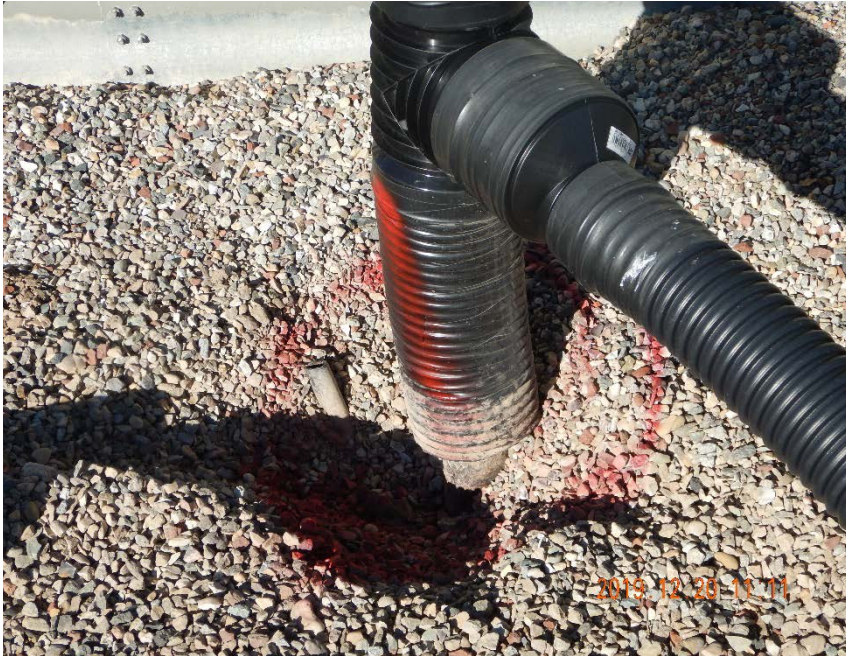
**Photo #5 – Dump line located outside SE corner of tank battery.**

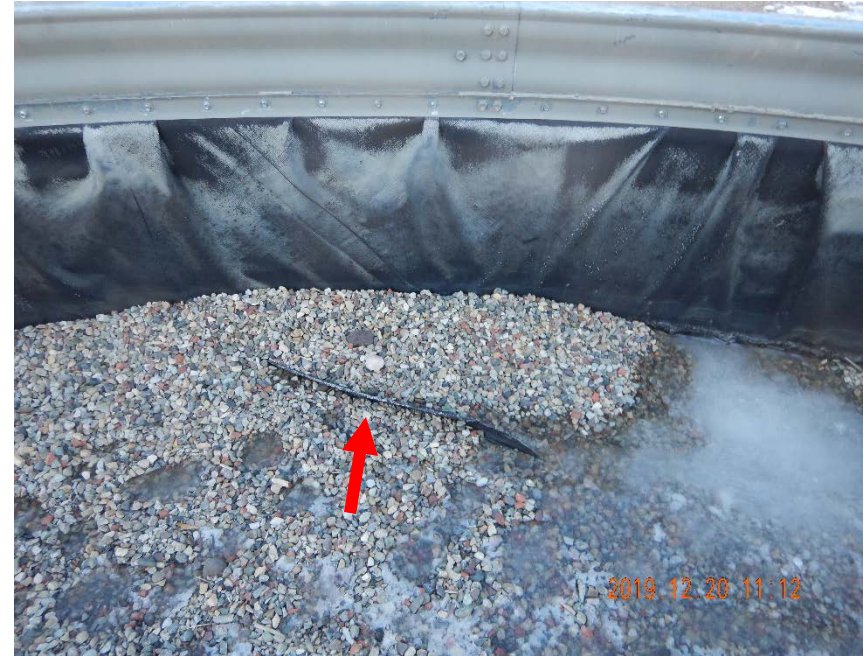
**Photo #6 – Tank battery secondary containment area contained ice and fluid on inspection date. No hydrocarbon sheens or odors were observed inside of secondary containment area on inspection date.**

**Ends of liner panels were observed sticking up from bottom of containment area on inspection date.**

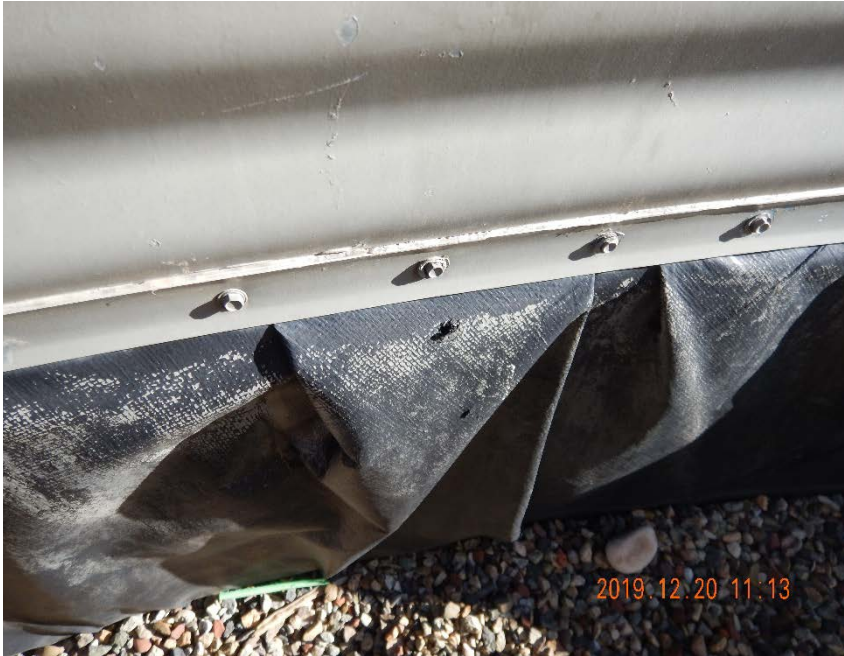
**Photo #7 – Pinhole observed in liner inside of tank battery secondary containment area.**

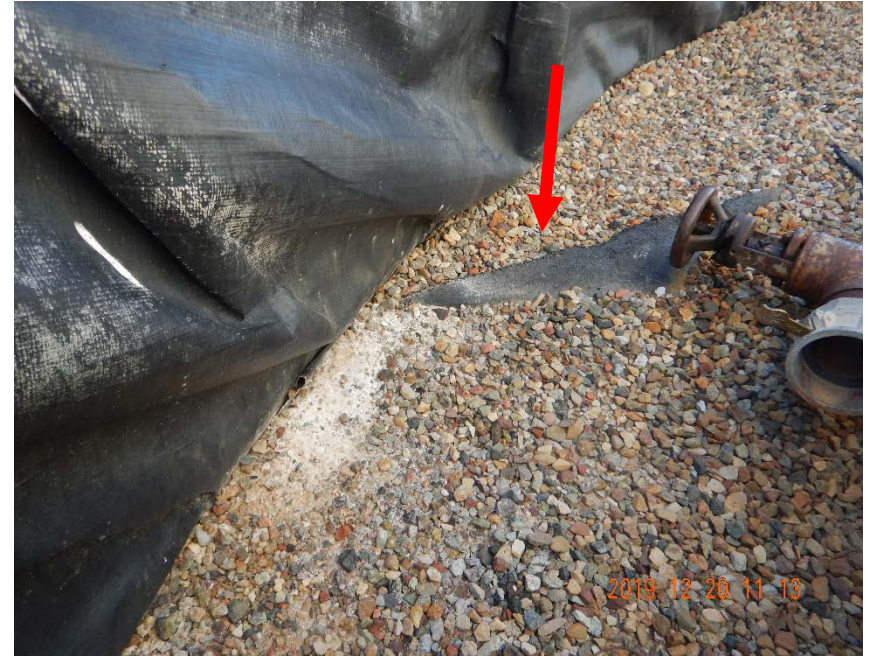
**Photo #8 – Ends of liner panels were observed sticking up from bottom of containment area on inspection date.**

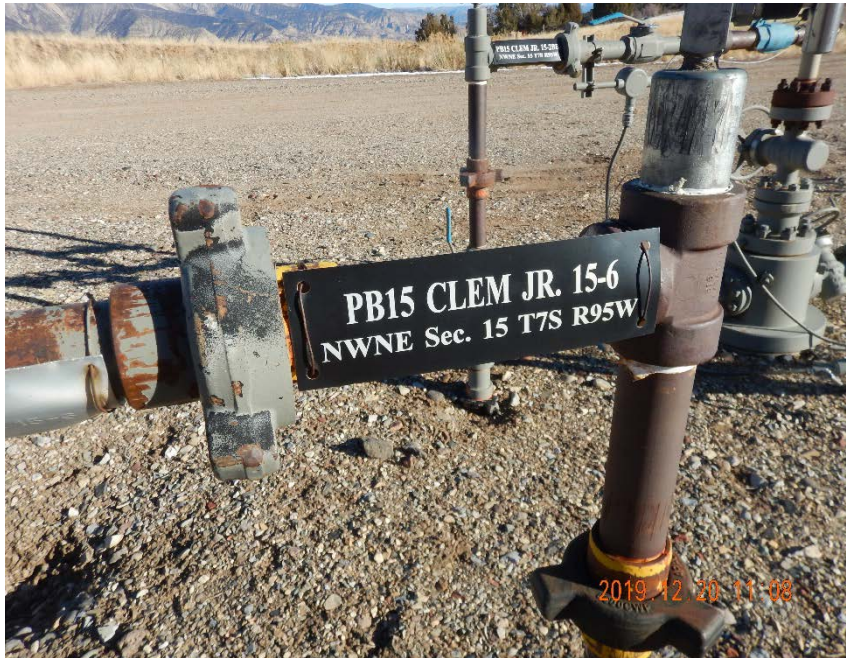
Photo #9 – Sign for PB15 Clem Jr. 15-6 wellhead.

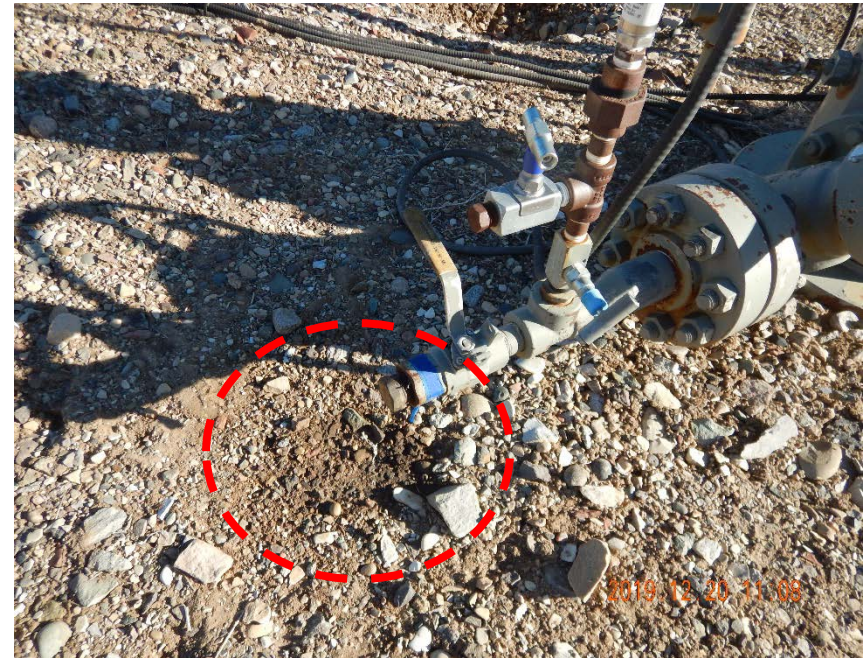
Photo #10 – Localized accumulation of oil-stained soil observed on north side of PB15 Clem Jr. 15-6 wellhead.

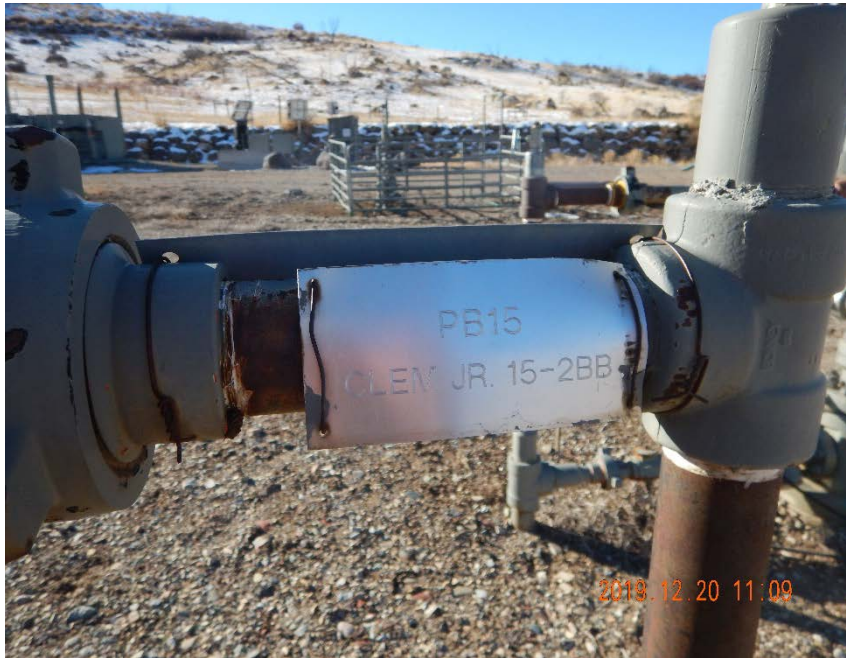
Photo #11 - Sign for PB15 Clem Jr. 15-2BB wellhead.

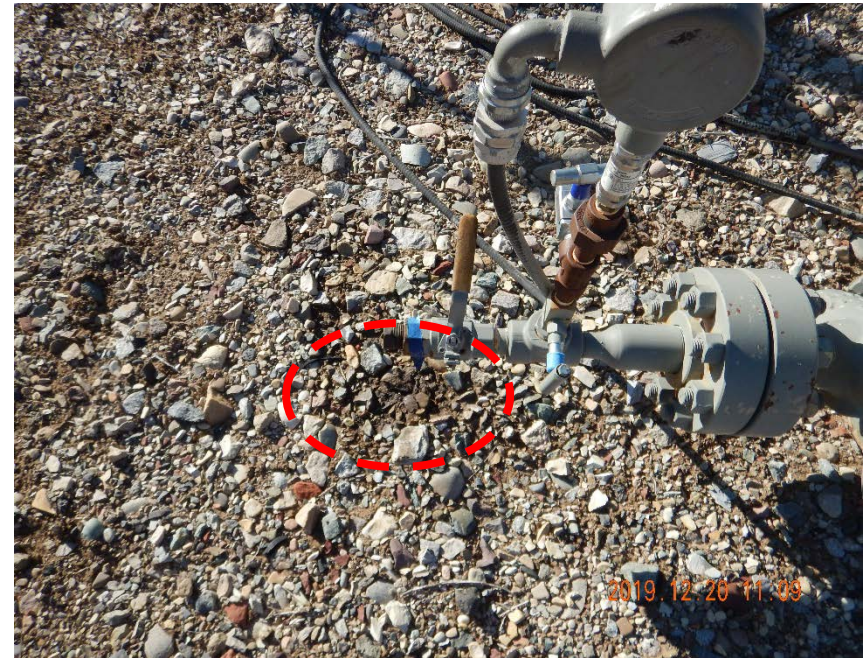
Photo #12 - Localized accumulation of oil-stained soil observed on north side of PB15 Clem Jr. 15-2BB wellhead.
