Inspection Photos

Location Name: N Parachute WF15A-23 F23596 Pad

Location ID: #335667 & Spill/Release ID: #470366

Inspection Date: December 20, 2019

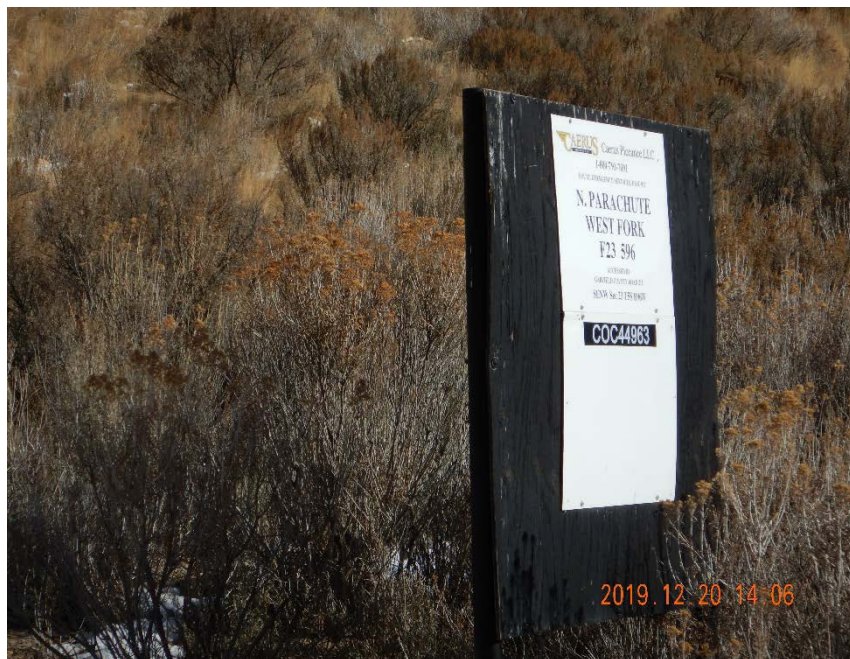
Photo #1 – Sign at entrance to pad.

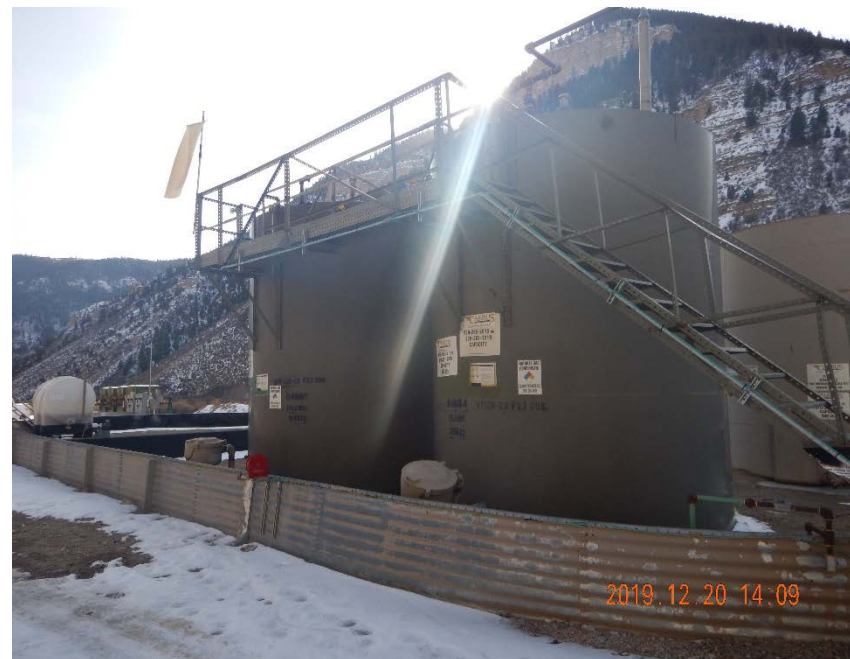
Photo #2 – View of tank battery from northeast.

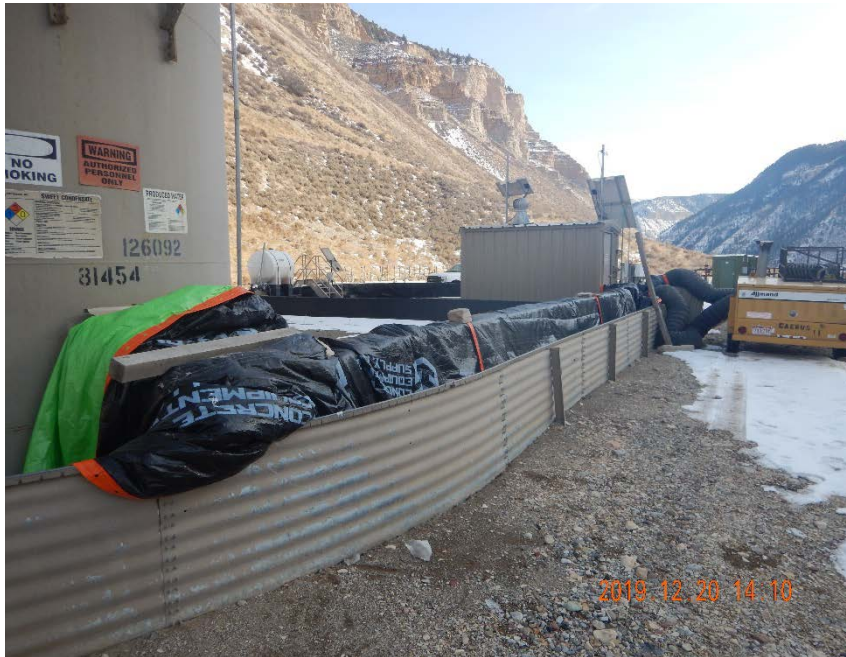
Photo #3 – View of equipment on west side of tank battery.

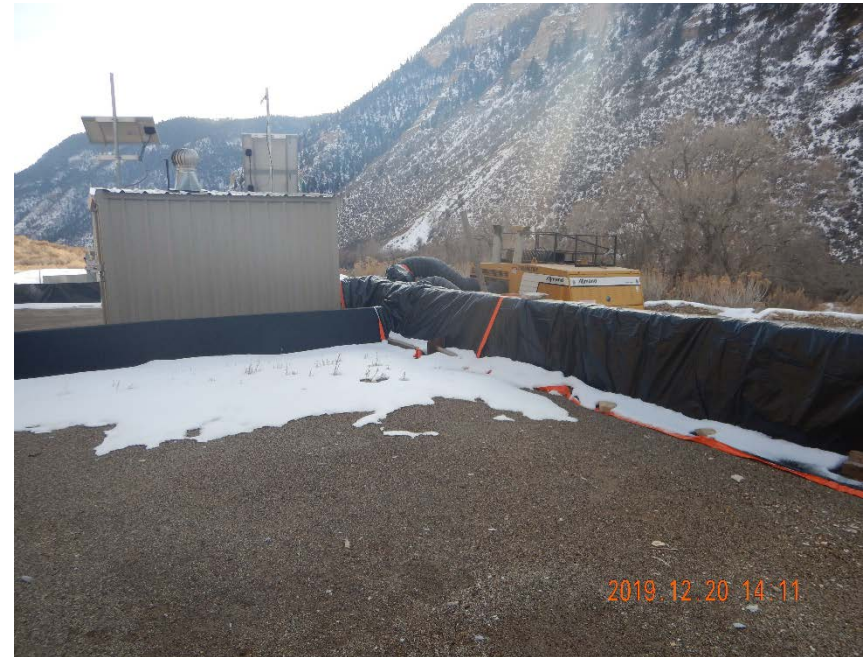
Photo #4 – West side of tank battery berm was covered on inspection date.

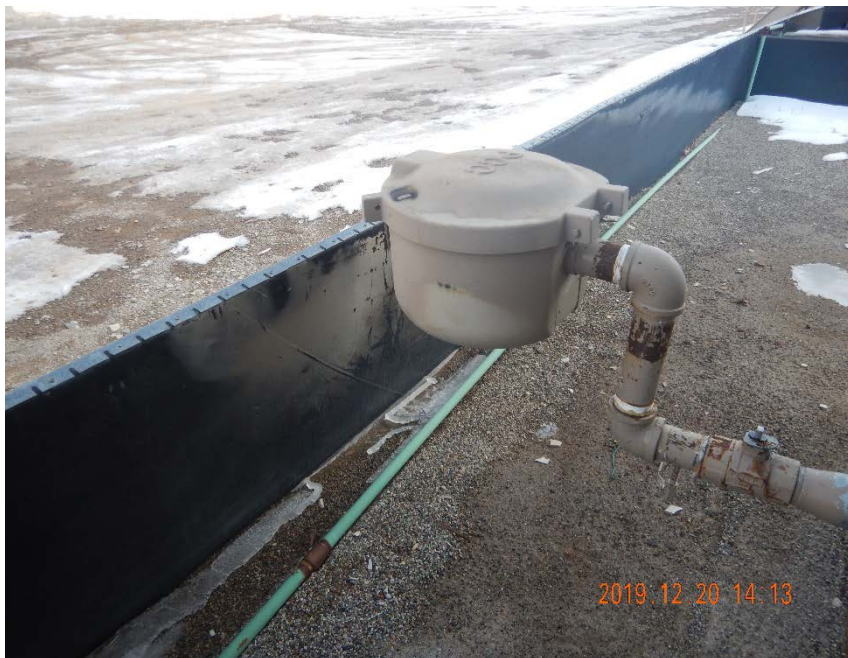
Photo #5 – Tank battery loadout.

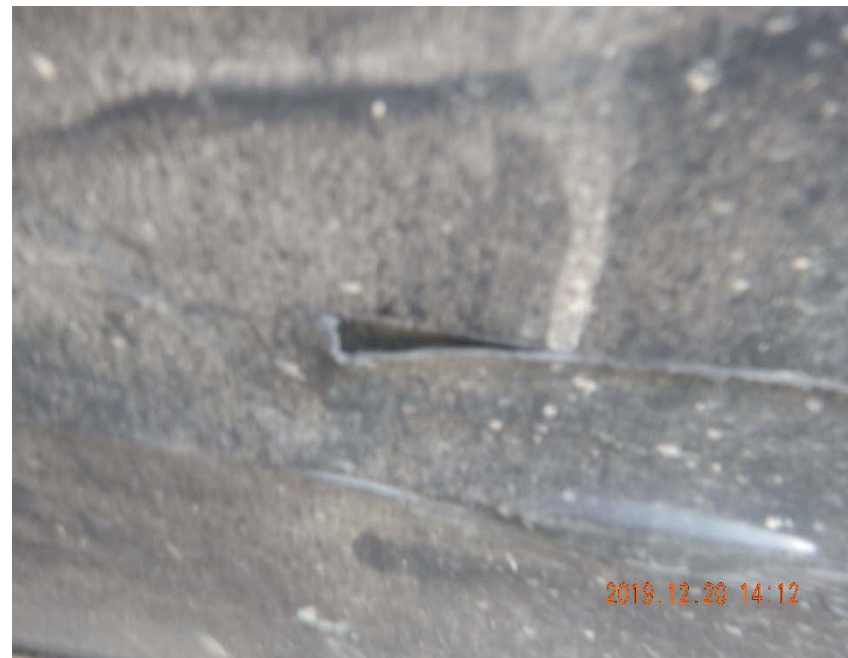
Photo #6 – Damaged section of tank battery liner, near tank battery loadout (1).

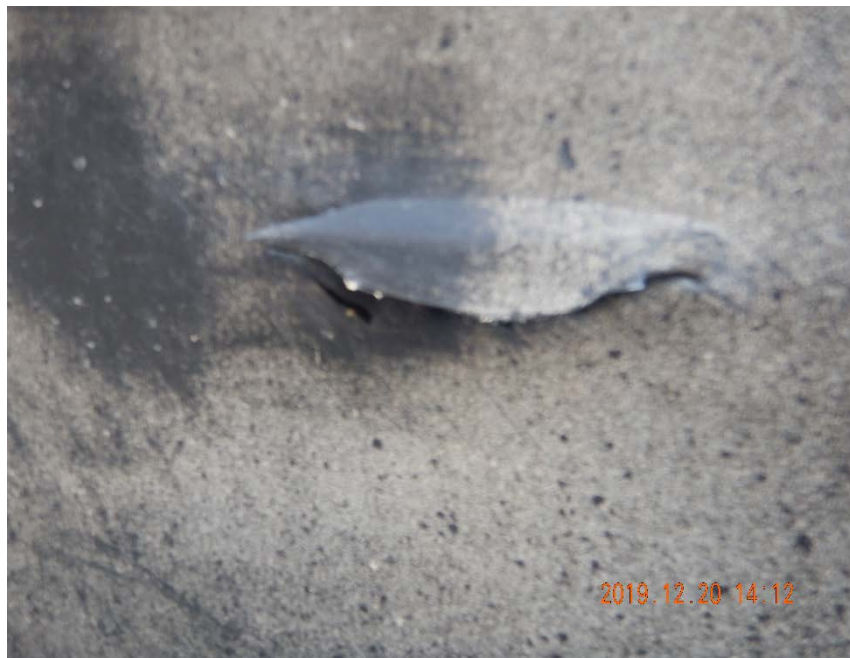
Photo #7 - Damaged section of tank battery liner, near tank battery loadout (2).

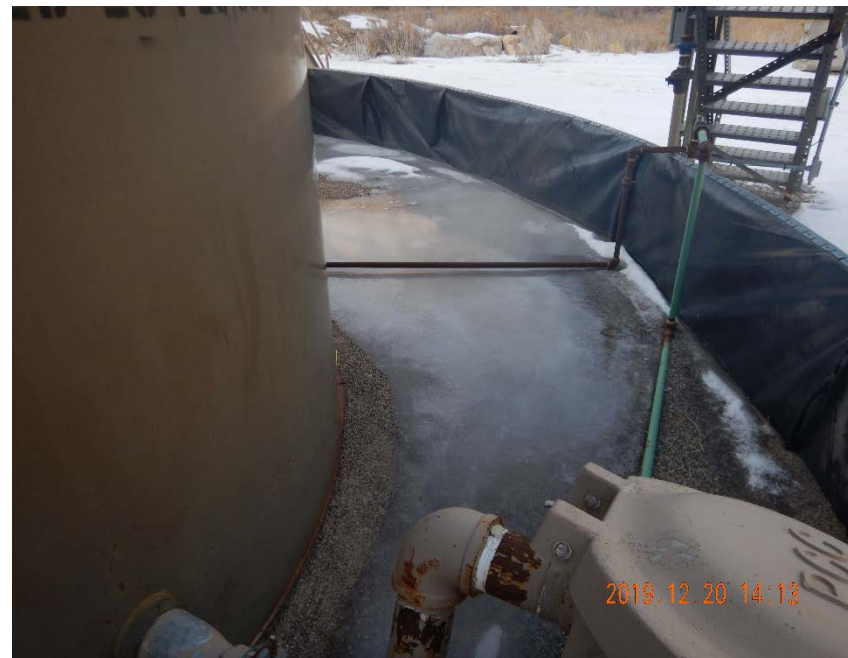
Photo #8 – Ice and snow inside of tank battery containment area.

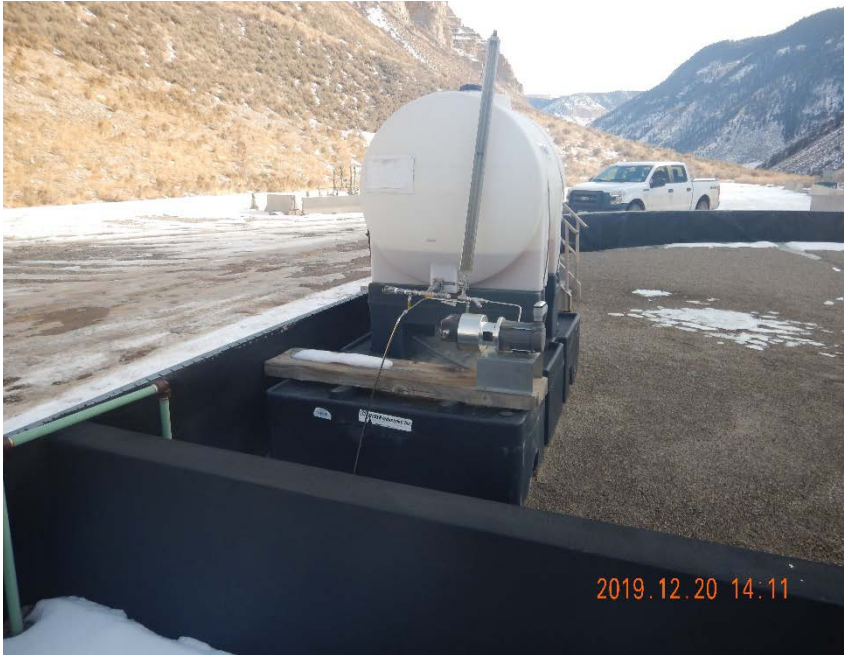
Photo #9 – Day tank inside of secondary containment.

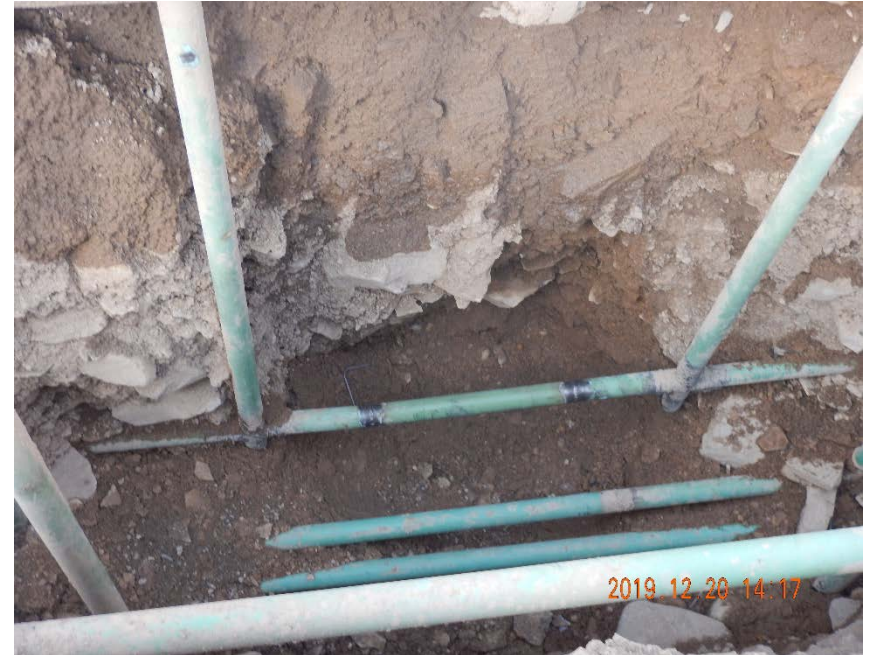
Photo #10 – View of repaired dumphine inside of excavation.
