## Inspection Photos

Location Name: MARALEX RESOURCES INC SULFUR GULCH-69S98W /2SWSW

Location ID: 312662

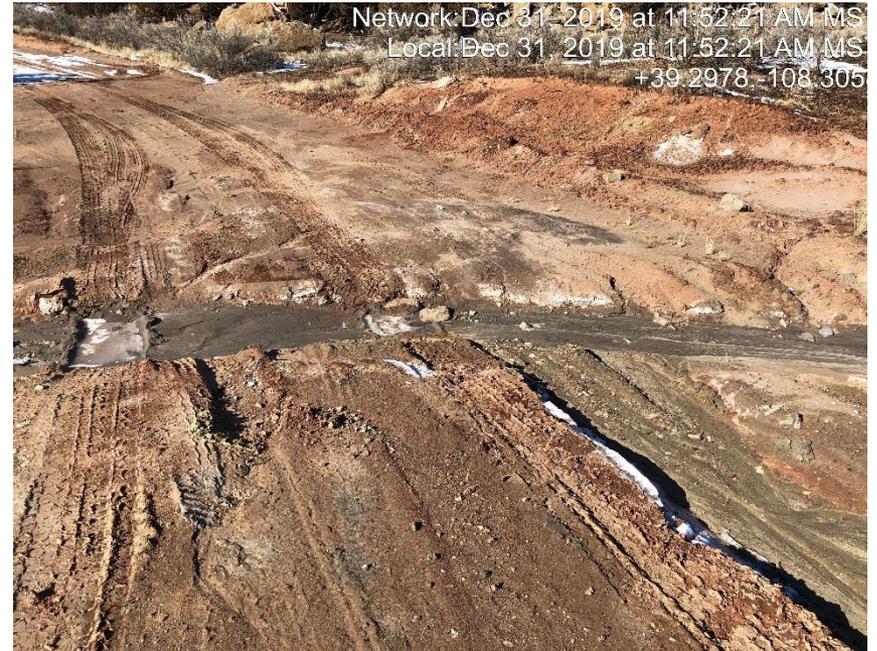
**Photo #0334 access road has not been adequately maintained.**

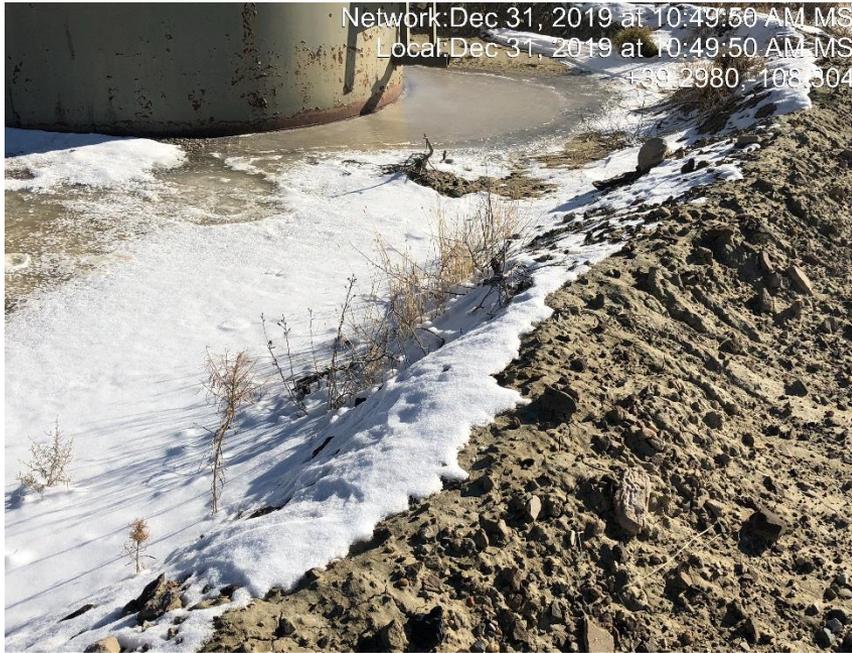
**Photo #0330 weeds inside tank containment**

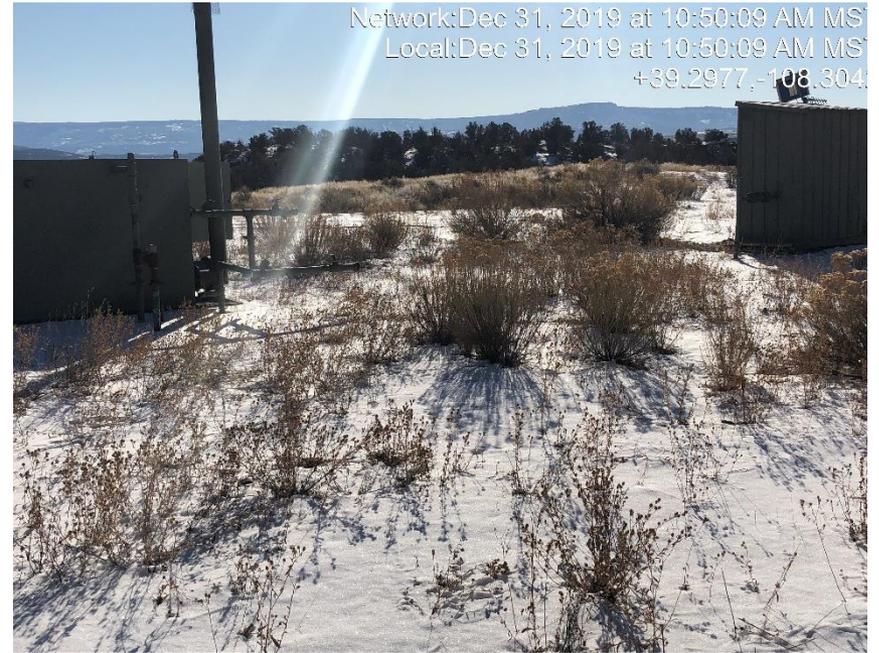
**Photo #0331 weeds around equipment.**

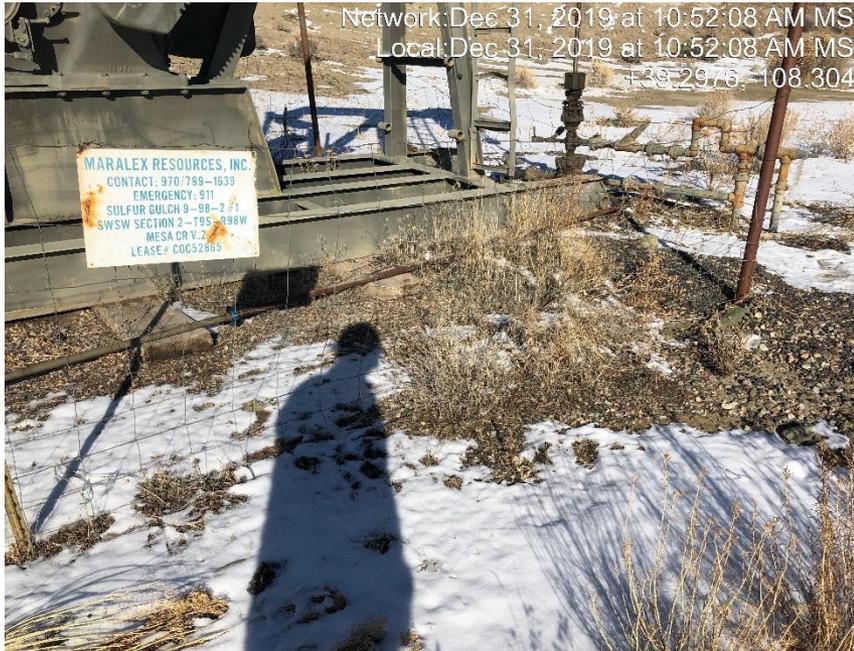
Photo #0332 weeds around pump jack.
