Inspection Photos
Operator: Southland Royalty
Location/API #: 007-06211
Date: 12-30-2019

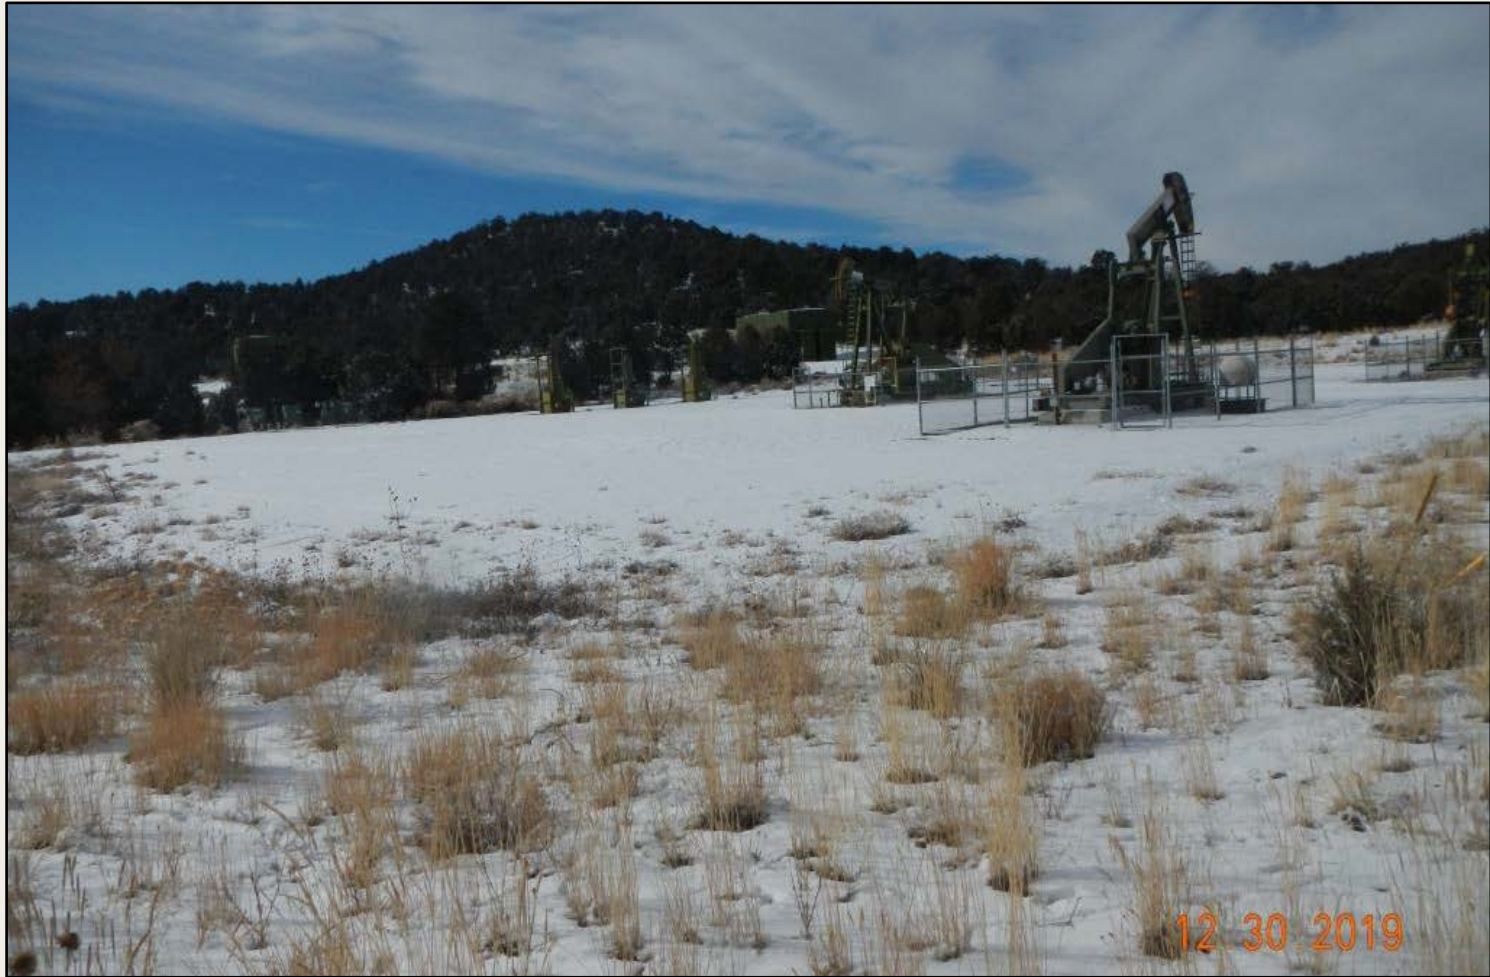
Photo 1. View of the project area from the eastern corner facing center.

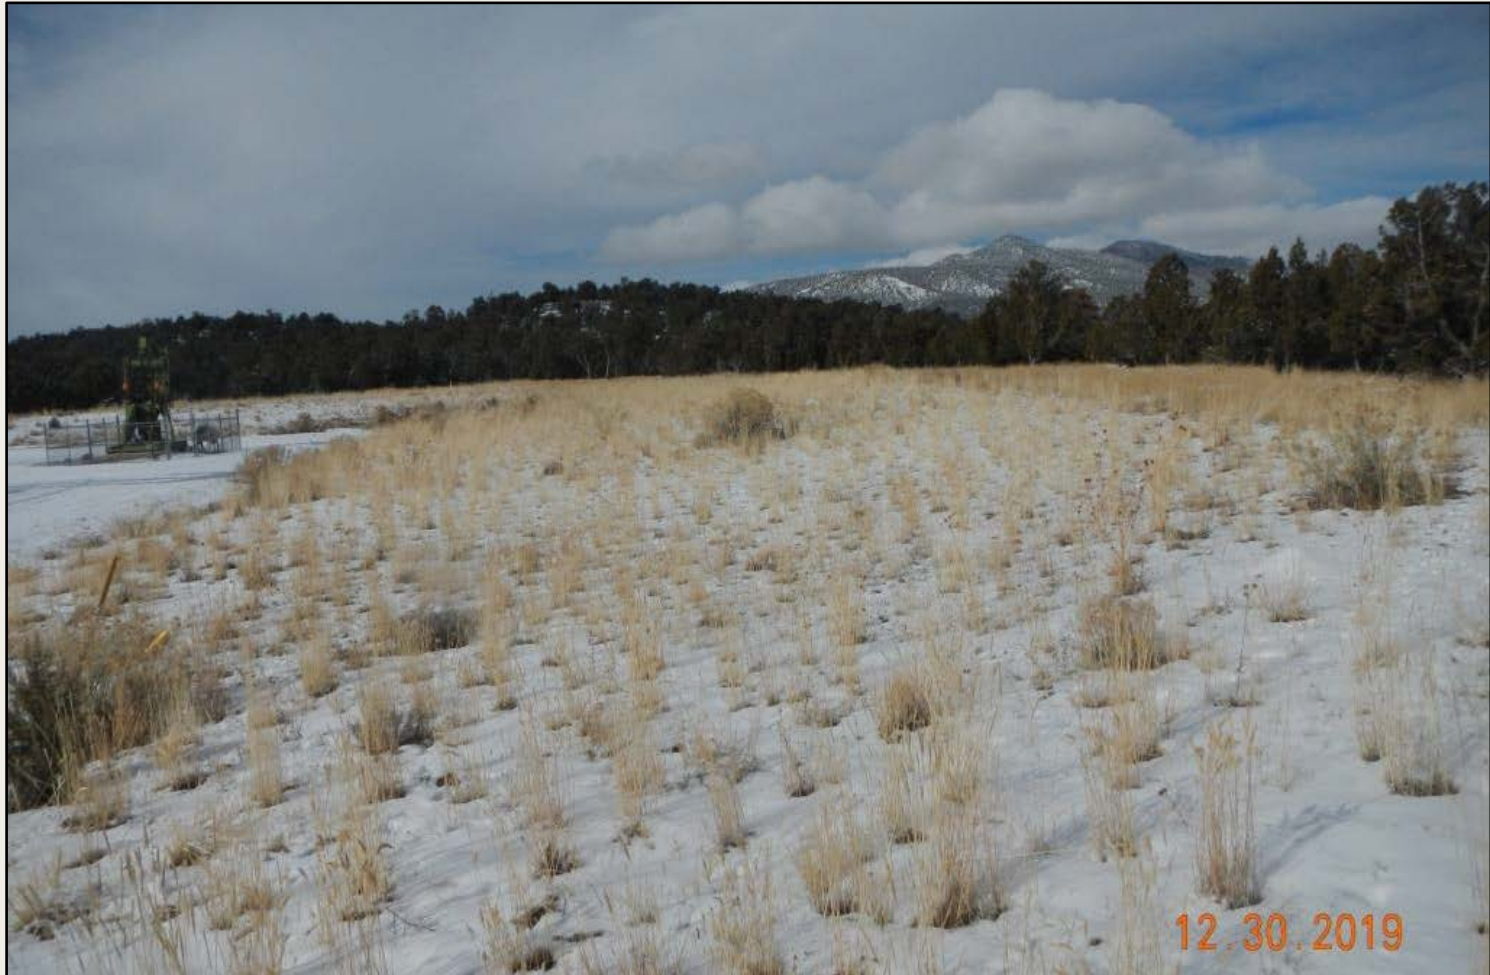
Photo 2. View of the eastern project area from the eastern corner facing northwestward.

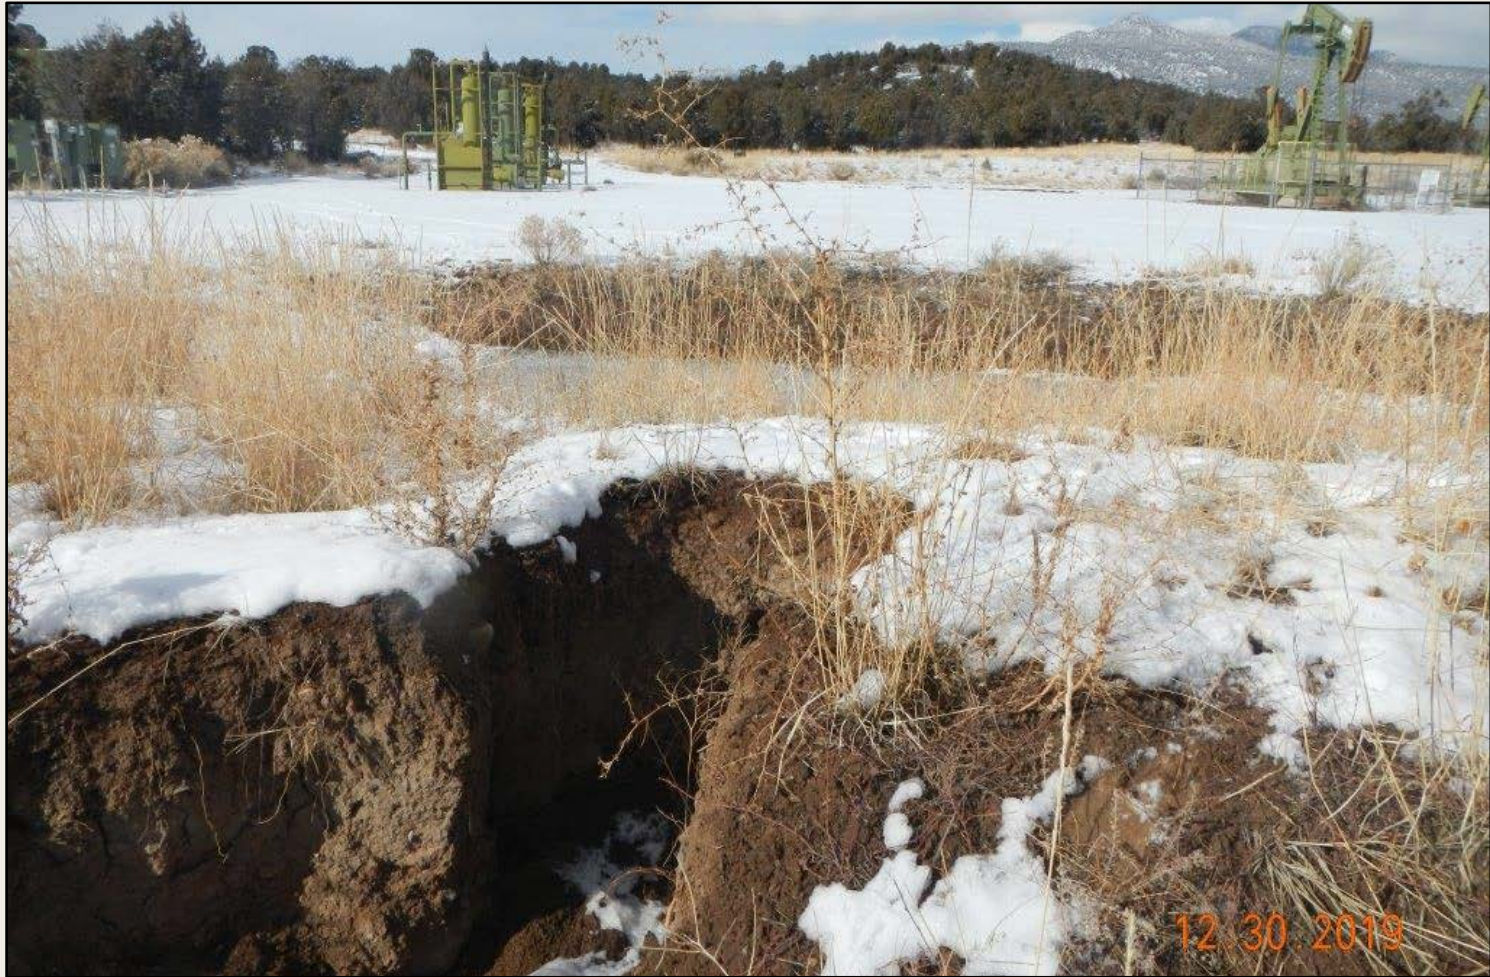
Photo 3. View of erosional channel where the southern sediment trap is breeched. This sediment trap does not have a stabilized overflow outlet.

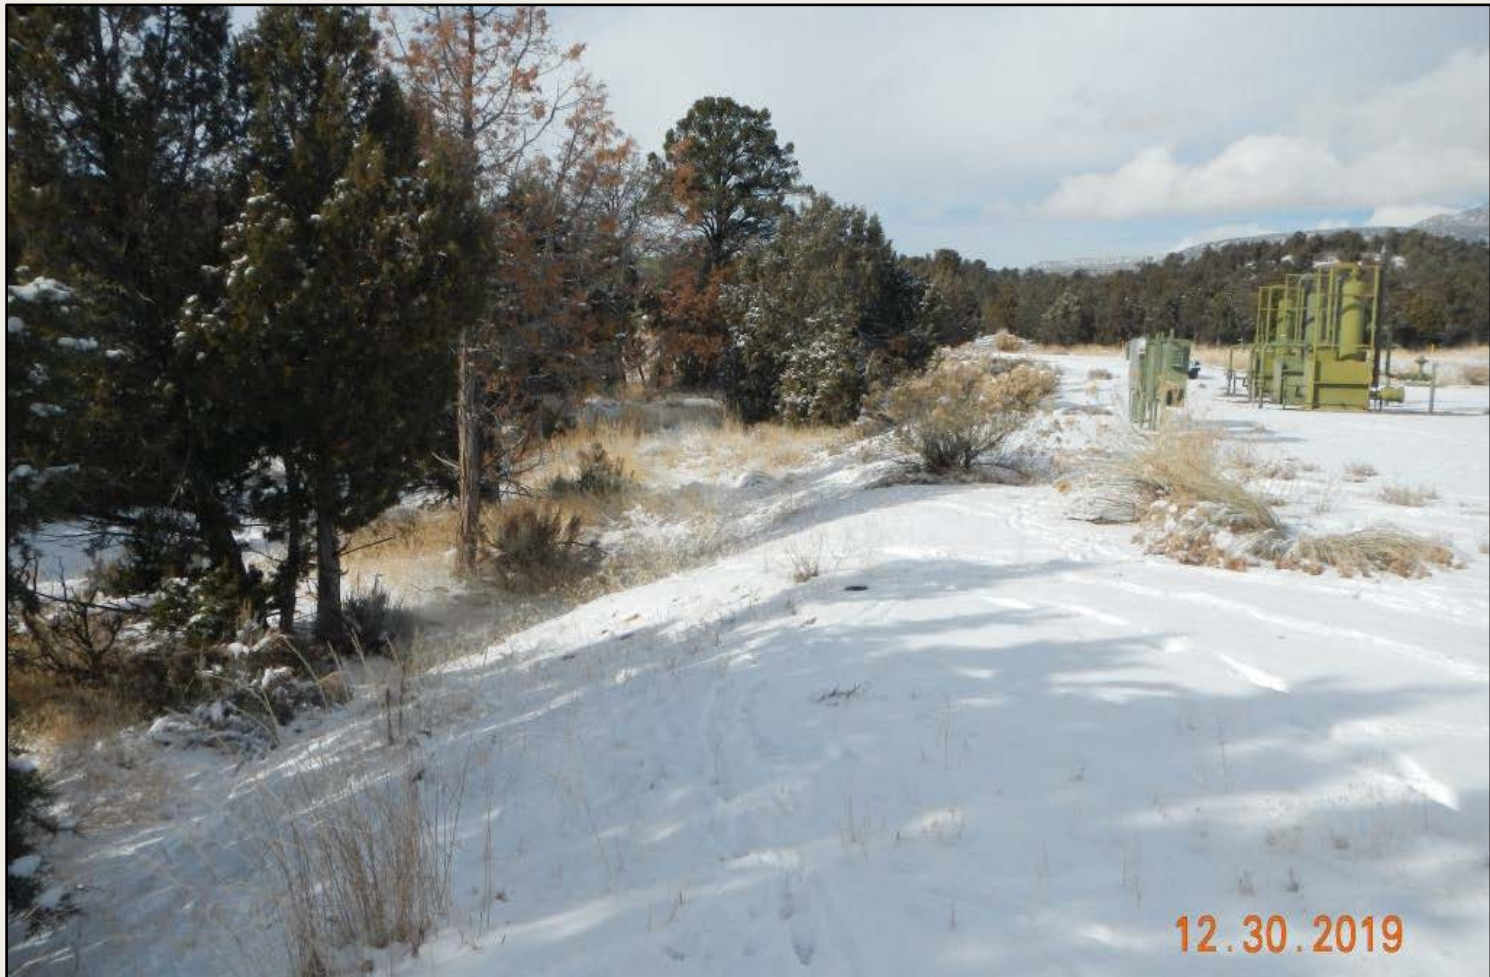
Photo 4. View of the western project area from the southern corner facing northwestward.

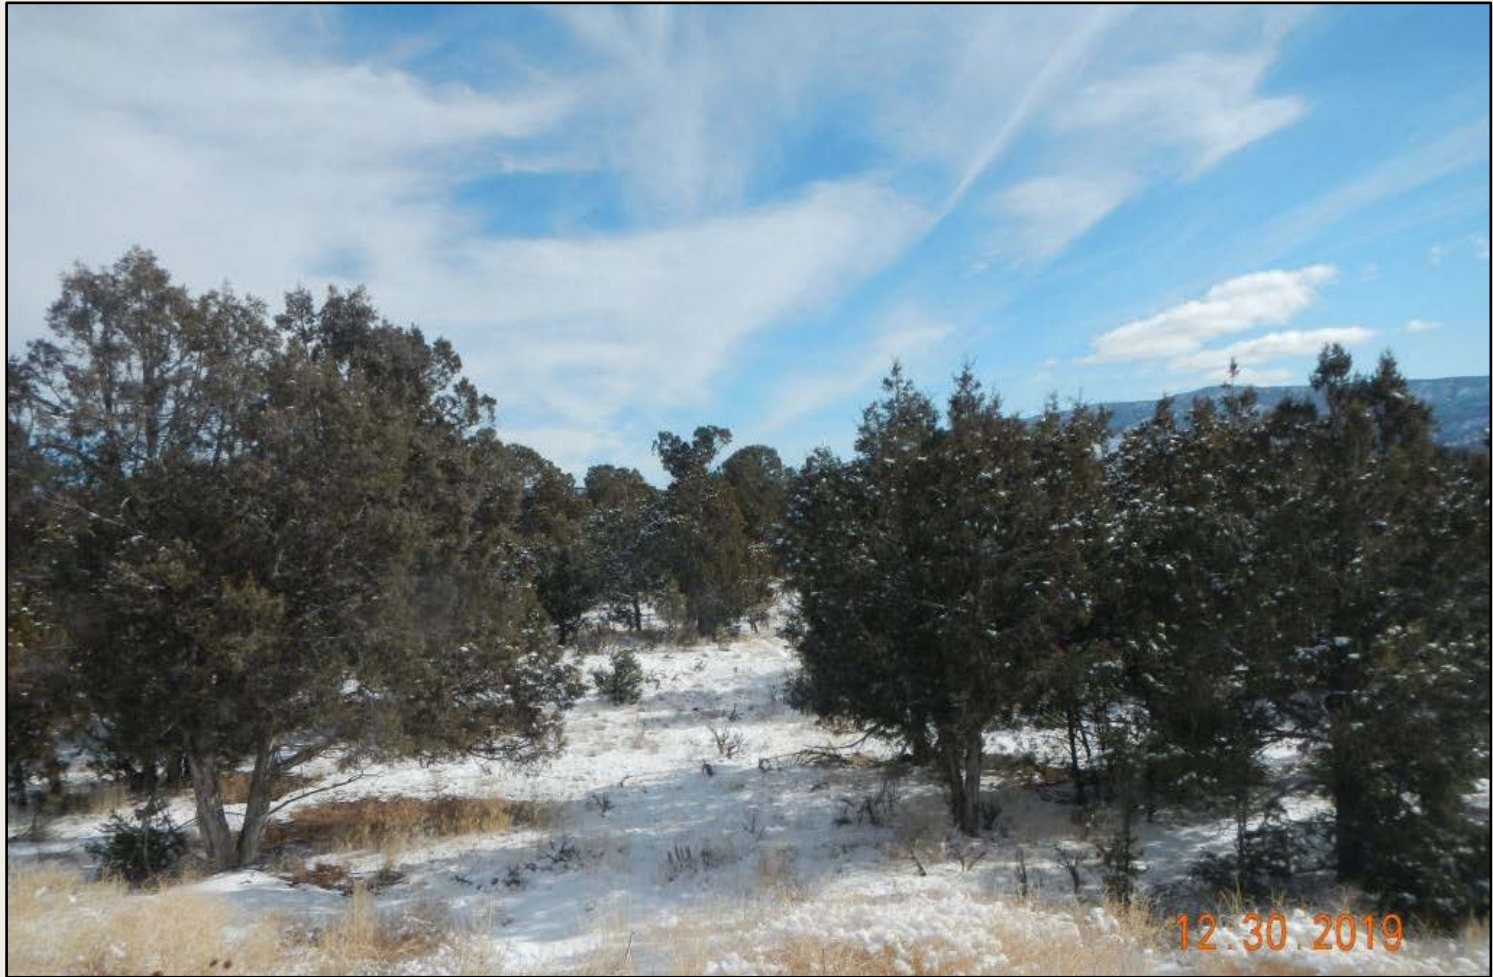
Photo 5. View of reference area, comprised of pinyon and juniper woodland.
