Well Name: Davis MV 1A      API #    05-067-08478  
Well Name: Davis FR 1A      API #    05-067-08481  
Well Name: IGS 155            API #    05-067-09578

Inspection Number:    693900300

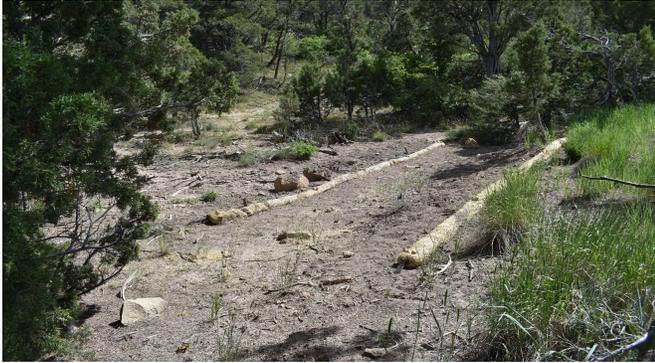
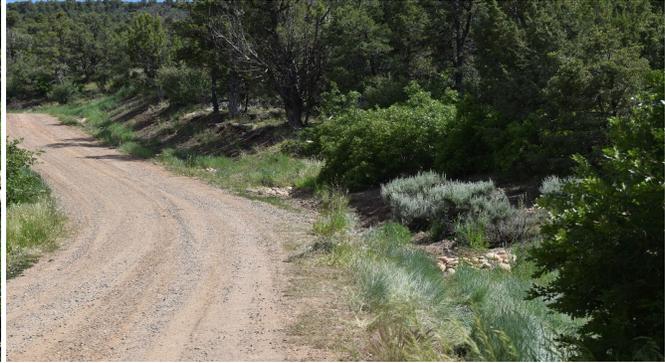
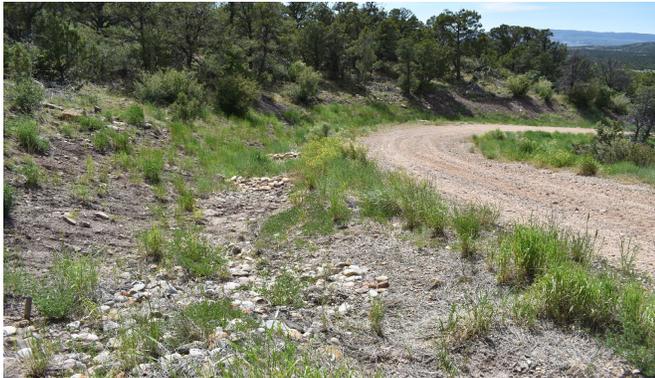
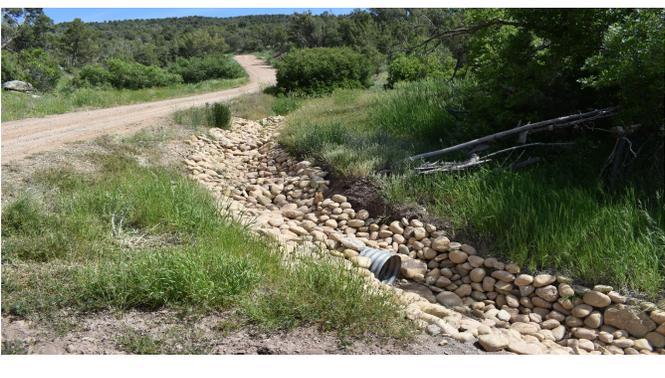
**Corrective Action:**    Storm water erosion along the eastern edge of the location, flows are not sufficiently de-energized and wattles are no longer functioning

**Corrective Action:**    Storm water erosion along access road where rock velocity checks are not slowing flow velocity sufficiently

**Corrective Action:**    Russian knapweed observed along the eastern edge of the location and along the access road.

**Action Taken:**        Install additional wattles and clean out and re-enforce other wattles along eastern edge of location,

**Action Taken:**        Repair, clean out and add more rock velocity checks along access road, install rock rundown at culvert outlet at the bottom of the hill.

**Action Taken:**        Sprayed for noxious weeds along the eastern edge of the location and along the access road.
