Pit Status Evaluation Form

Pit Name: MELISSA 1	Facility ID: 114247
Current Status: Unknown	Status Date: 9/23/1999
Current Operator: VERDAD RESOURCES LLC / 10651	
Updated Operator:	
Form 15 Pit Permit Doc #:	Permit Date:
Related Facilities: MELISSA #1 (API 05-001-07623, Facility ID 202218, Loc ID 320004)

County: ADAMS			
Township: 1S	Range: 65W	Section: 8	QQ: CSW
Original Latitude/ Longitude: 39.97601 / -104.692756			
Updated Latitude/ Longitude: /			
Basis for Location Change:

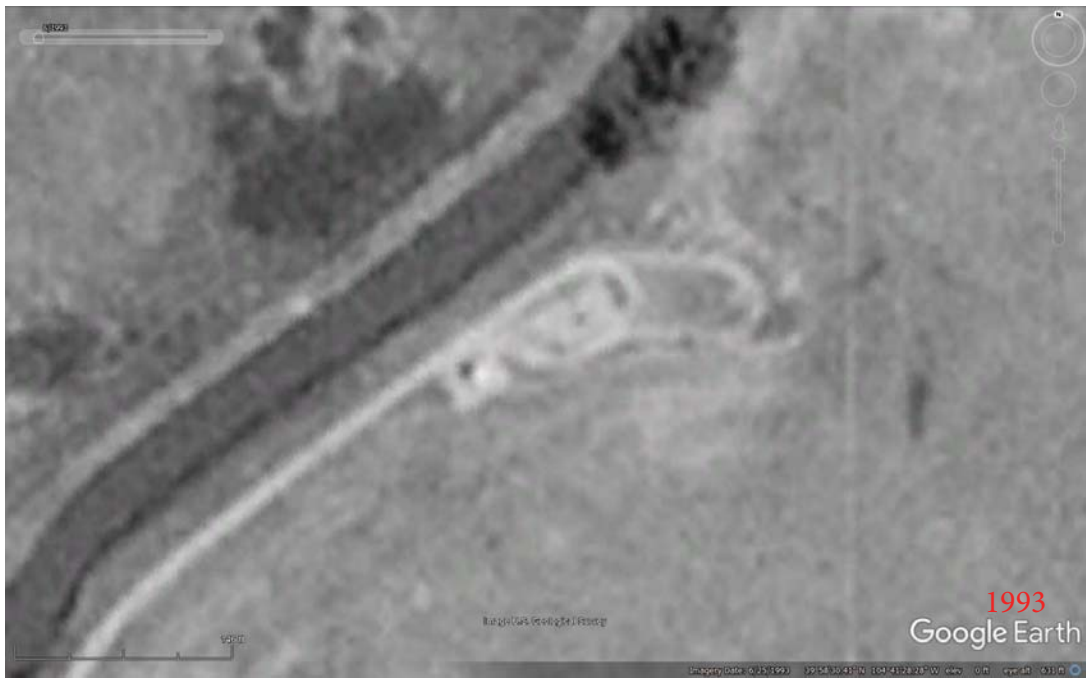
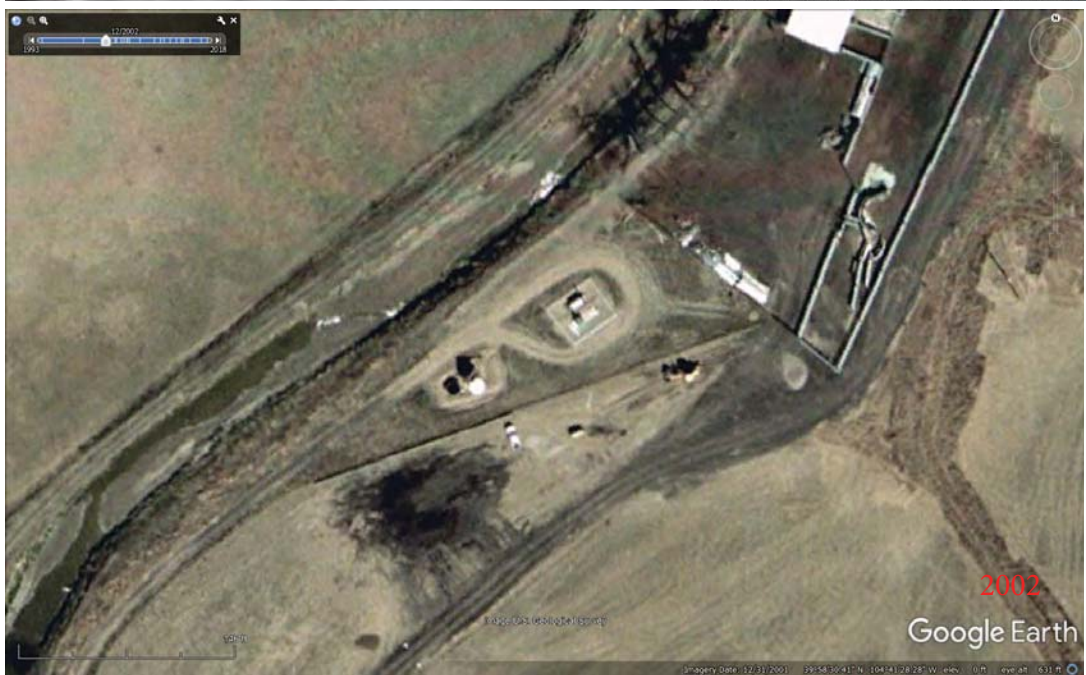
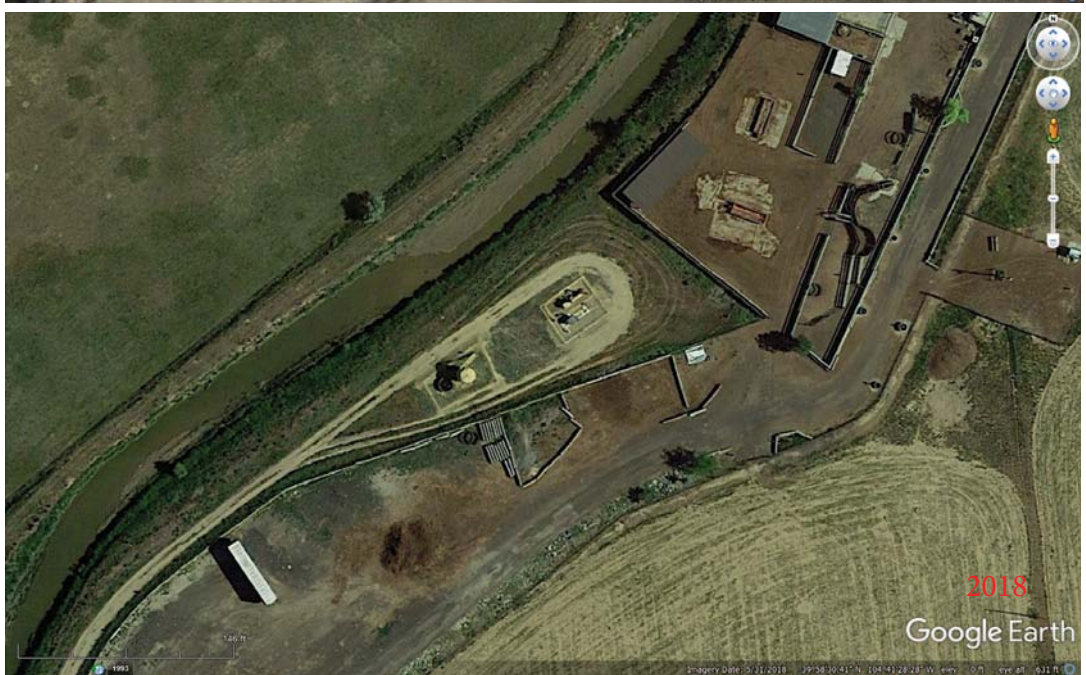
| <input checked="" type="checkbox"/> | Aerial Photo Verification (photos attached) | |

No evidence of a pit on location

Based on records review there is no evidence that there was a pit on location; inspections and pit inventory report document a concrete water vault then fiberglass tank on location. Pit status has been changed to Closed.
