Pit Status Evaluation Form

Pit Name: BOX ELDER 1	Facility ID: 114261
Current Status: Unknown	Status Date: 9/23/1999
Current Operator: MACEY & MERSHON OIL INC / 52225	
Updated Operator:	
Form 15 Pit Permit Doc #:	Permit Date:
Related Facilities: BOX ELDER FARMS #1 (API 05-001-08351, Facility ID 202946, Loc ID 320186)

County: ADAMS			
Township: 1S	Range: 65W	Section: 22	QQ: SENE
Original Latitude/ Longitude: 39.95198 / -104.643054			
Updated Latitude/ Longitude: /			
Basis for Location Change:

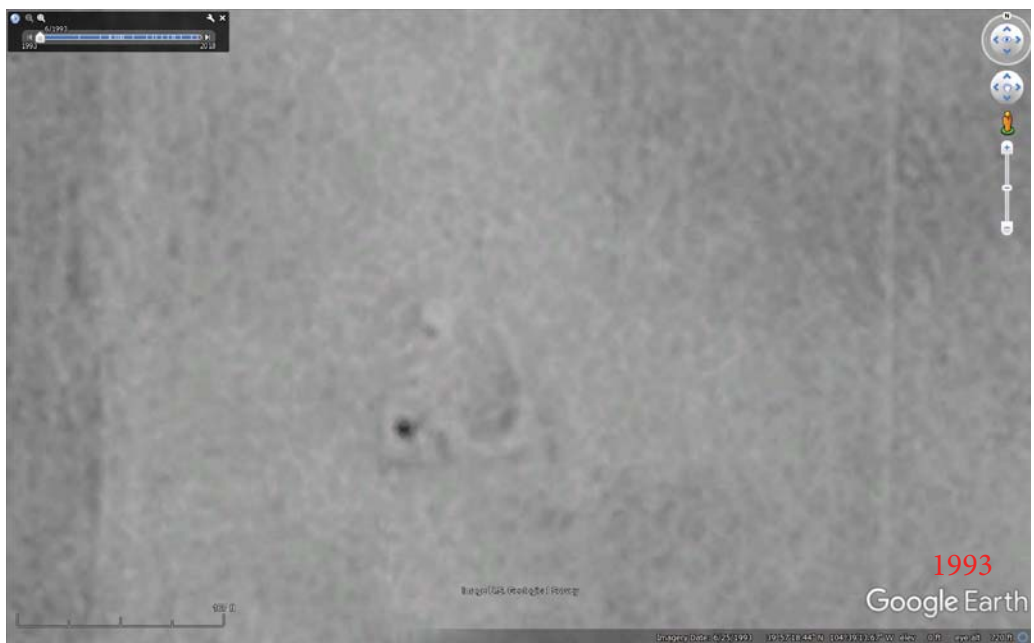
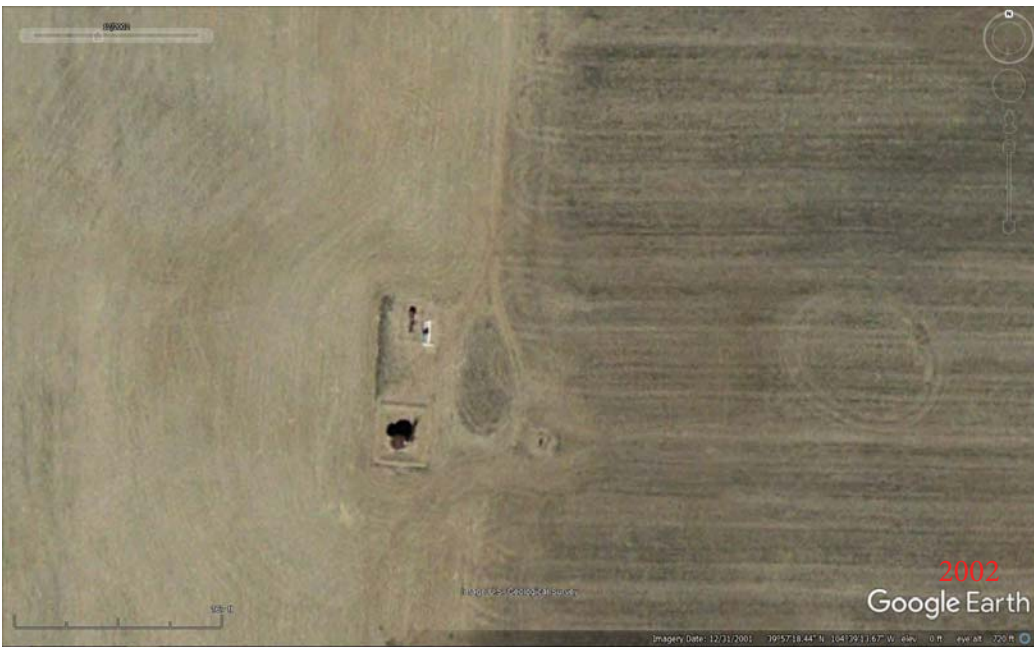
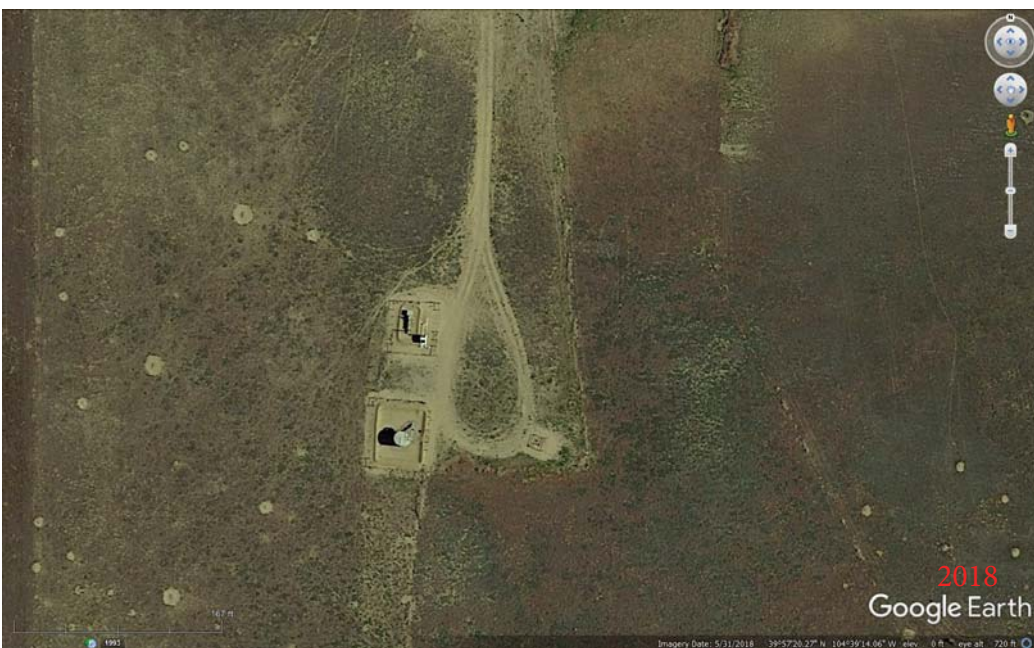
| <input checked="" type="checkbox"/> | Aerial Photo Verification (photos attached) | |

Based on records review there is no evidence that there was a pit on location; inspections and pit inventory report document a concrete water vault and tinhorn then a fiberglass tank on location. Pit status has been changed to Closed.
