Inspection Photos
Operator Name: Caerus Piceance LLC
Location: 335622

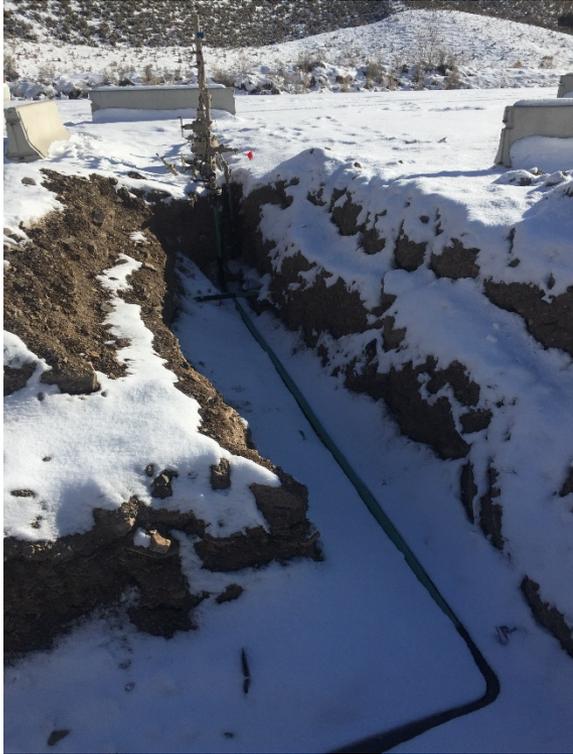
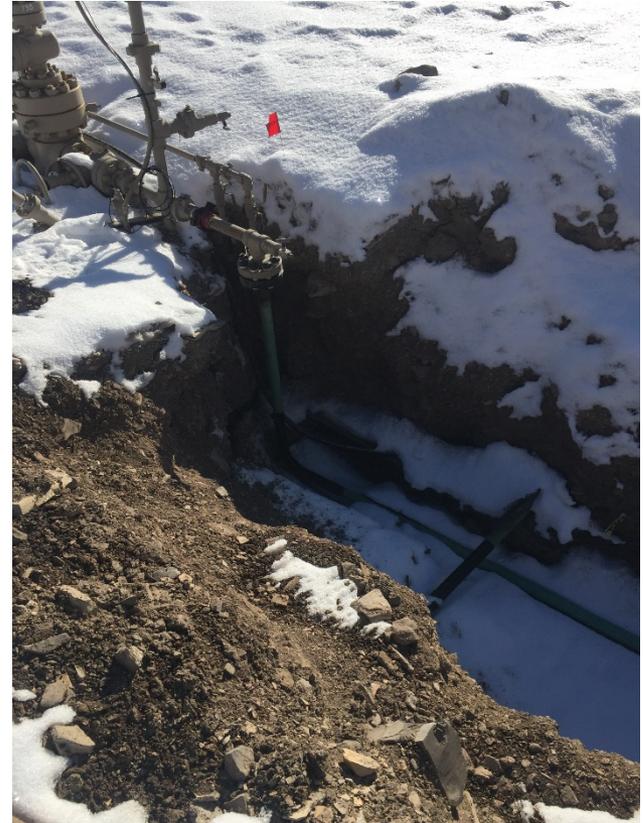
Well head and repaired Flowline. Well was producing at time of inspection
