Inspection Photos
Location Name: Schaefer Pad
Location ID: 440718

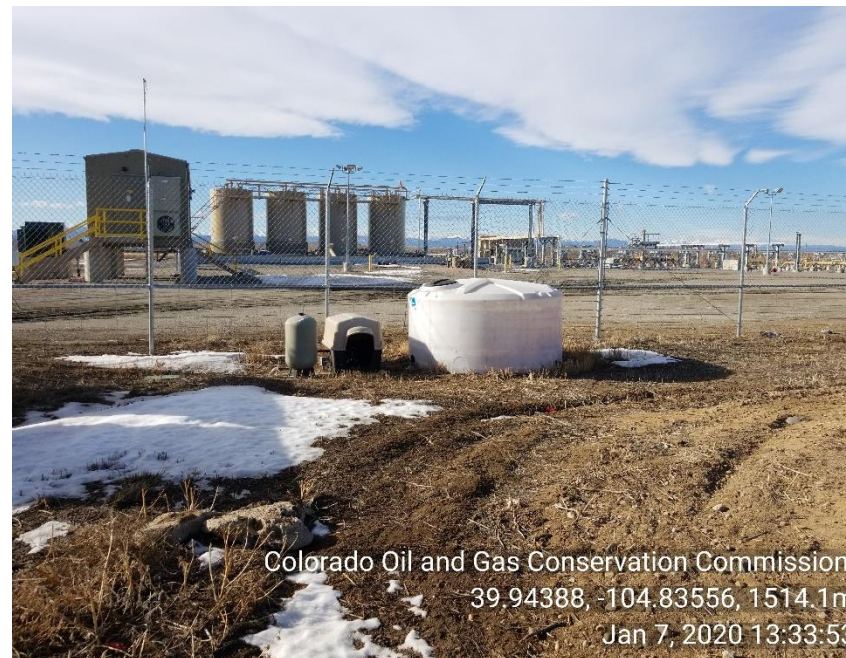
Photo 2 unused equipment

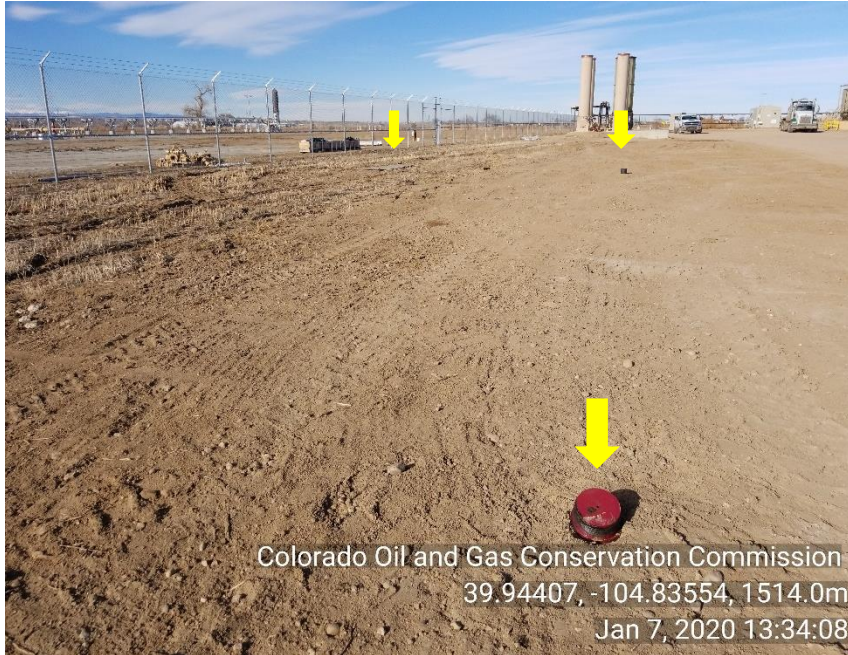
Photo 3 Trash

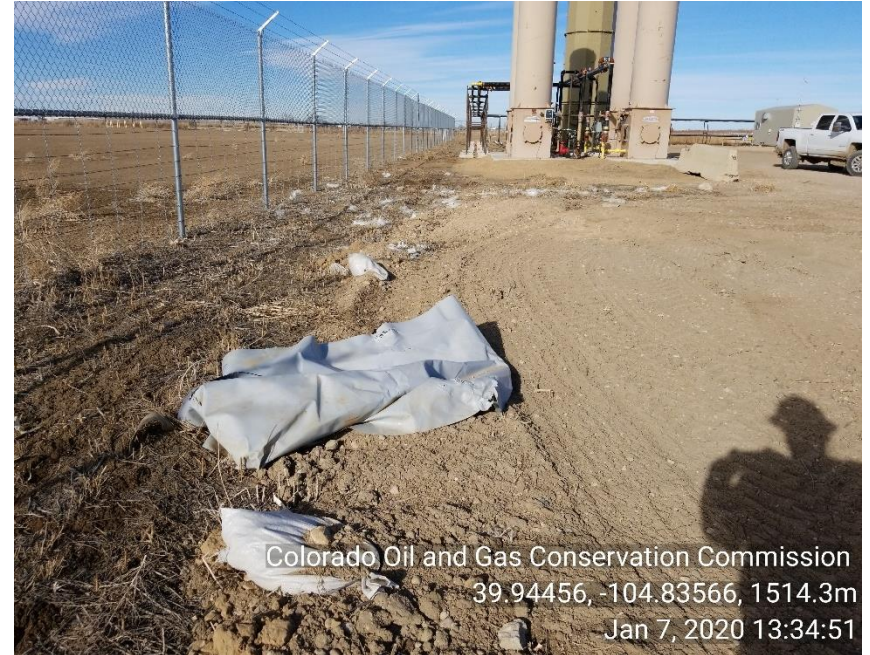
Photo 4 Trash

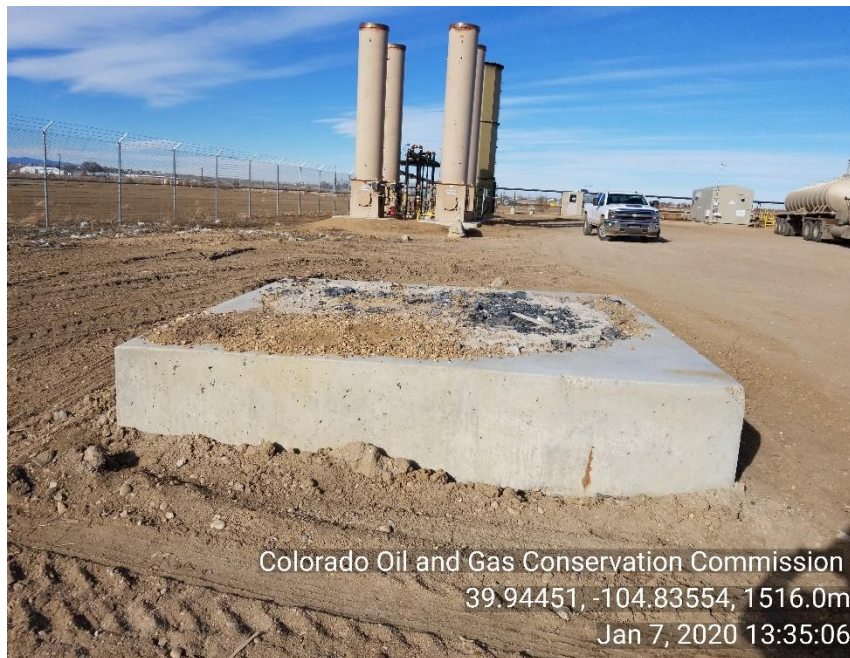
Photo 5 Unused equipment (cement pad)

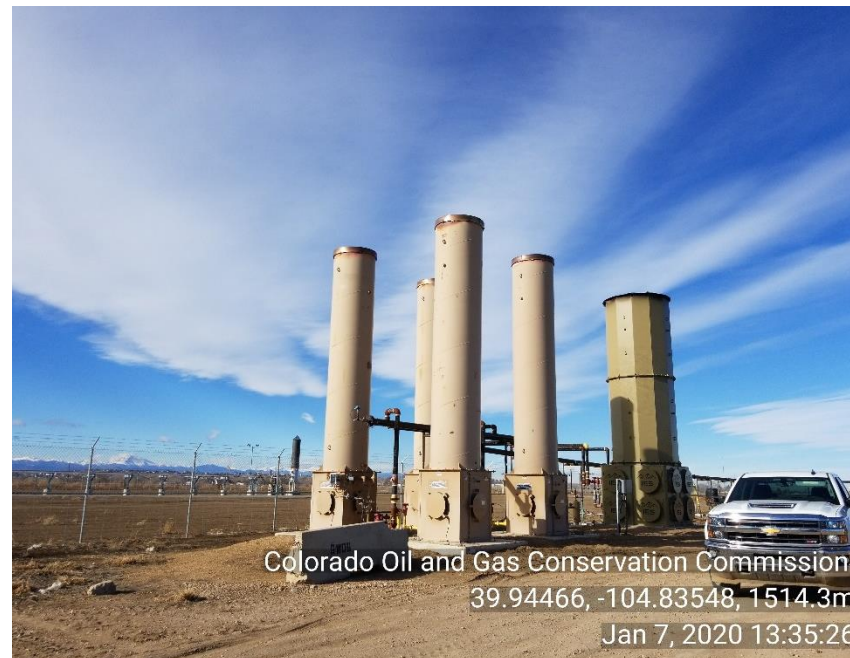
Phtoto 6 ECD's

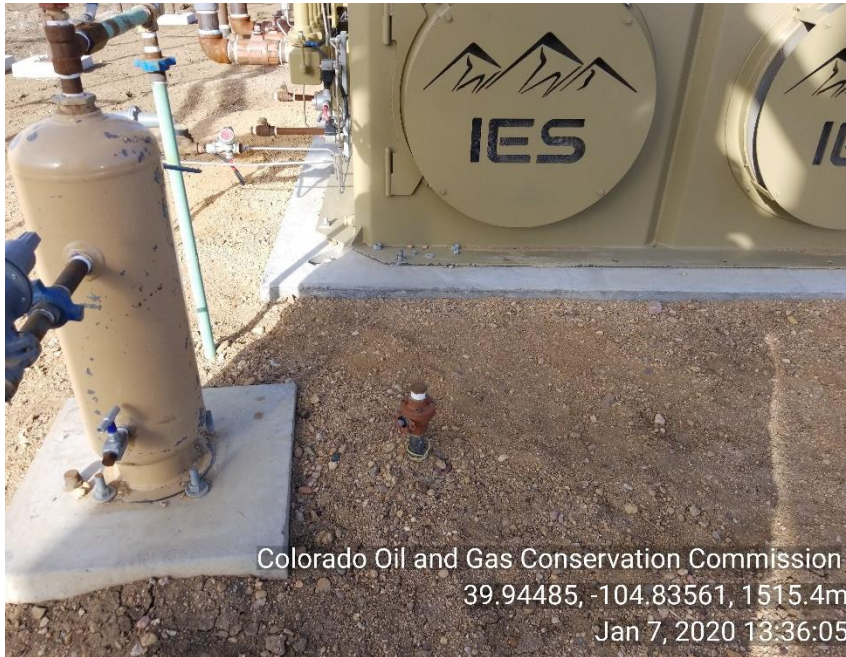
Photo 7 Unused Unmarked not LOTO riser

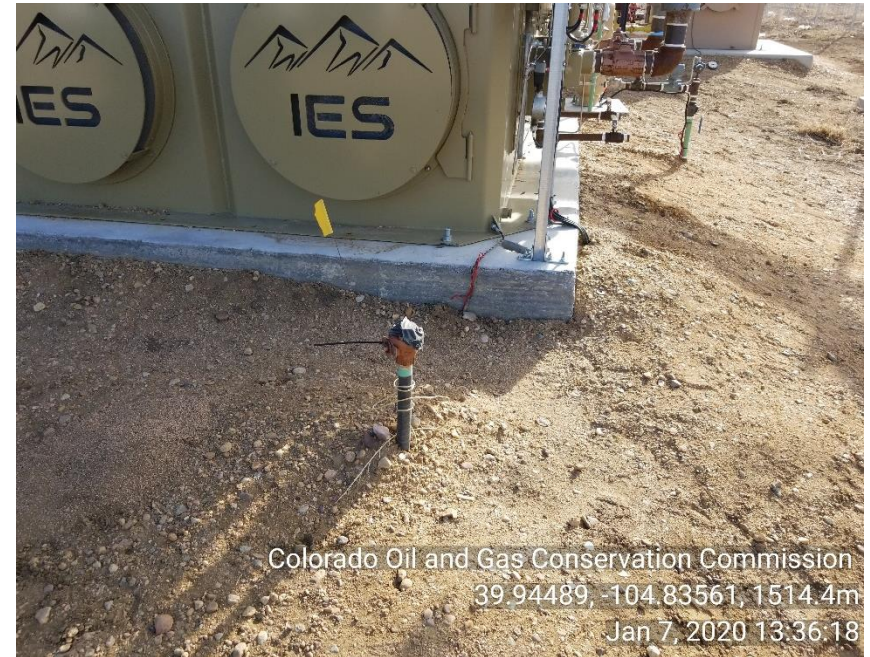
Photo 8 Unused Unmarked not LOTO riser

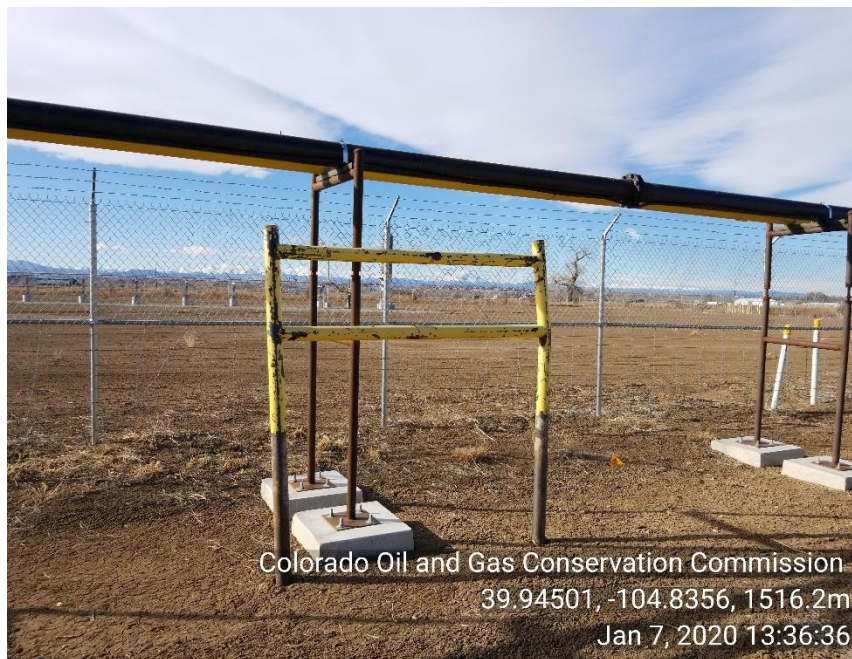
Photo 9 Unused equipment: H brace

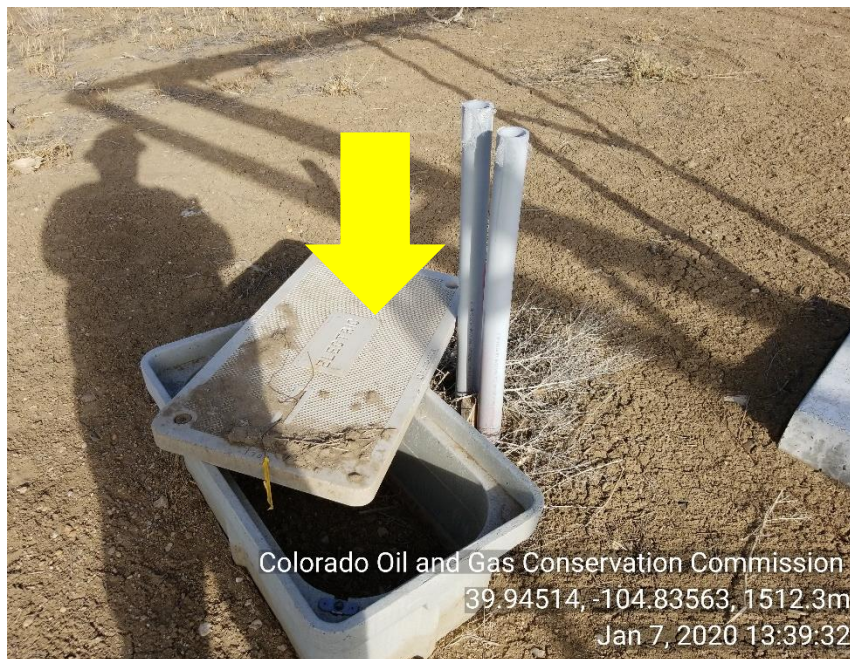
Photo 11 Unused equipment

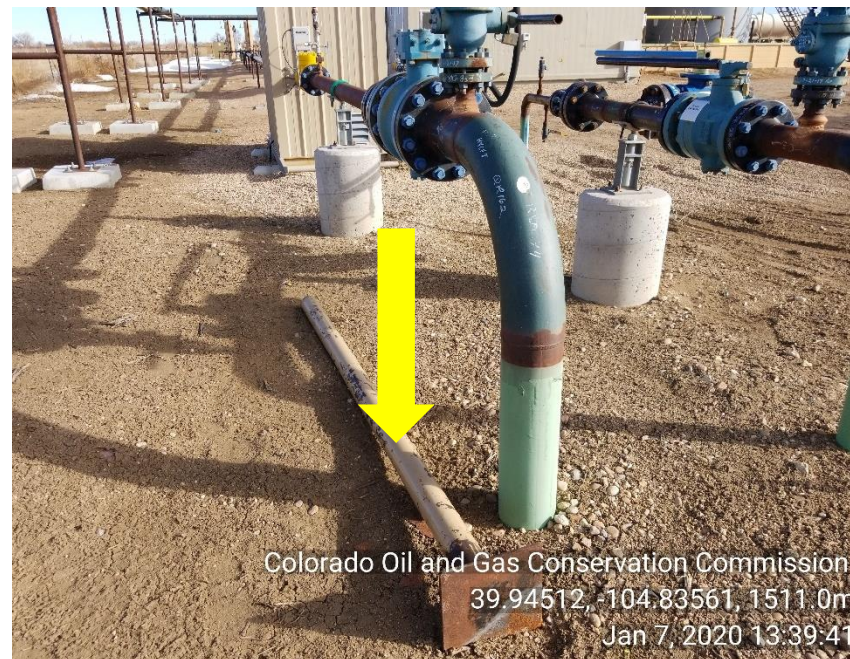
Photo 12 Unused equipment

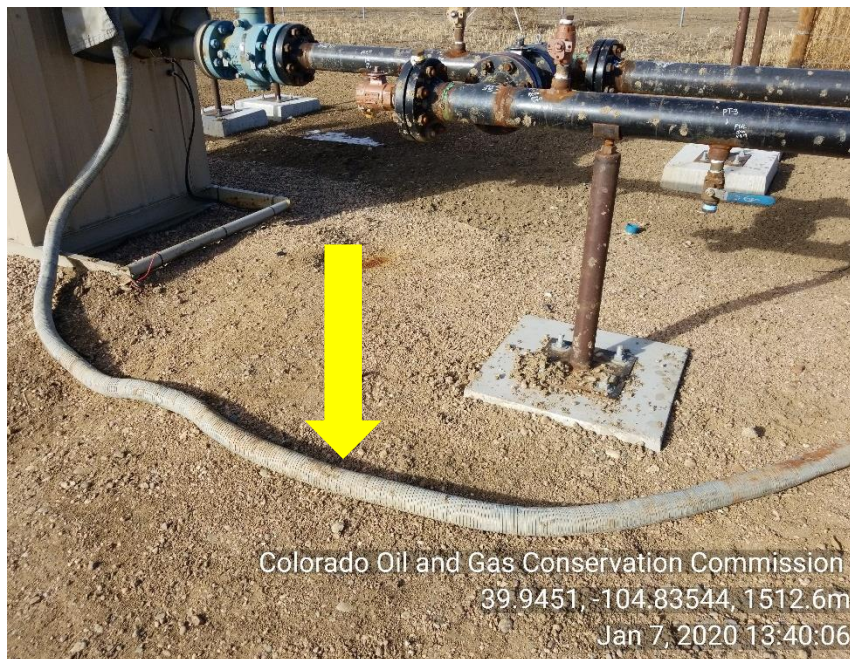
Photo 13 unused equipment

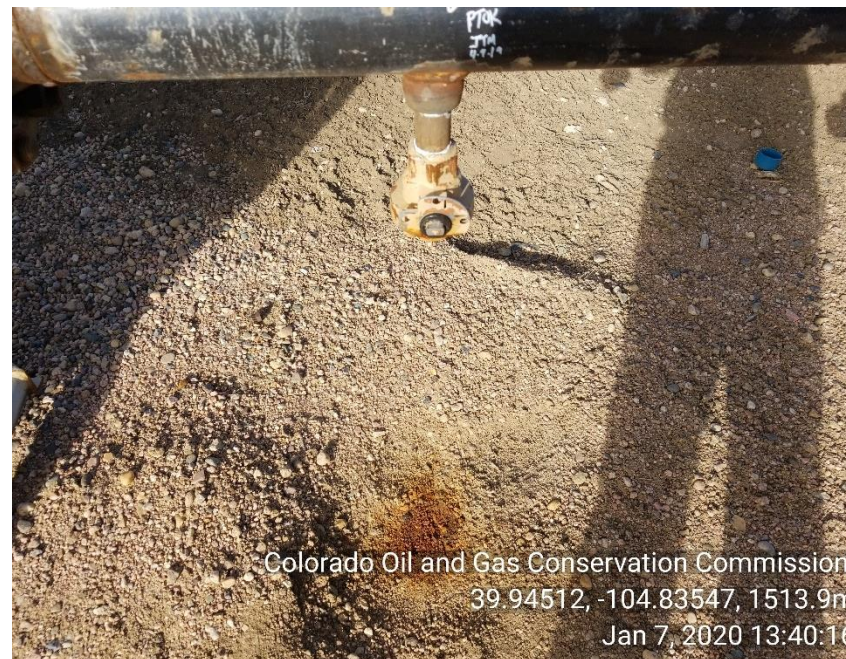
Photo 14 Stained soil and mechanical issue 1" valve leaking

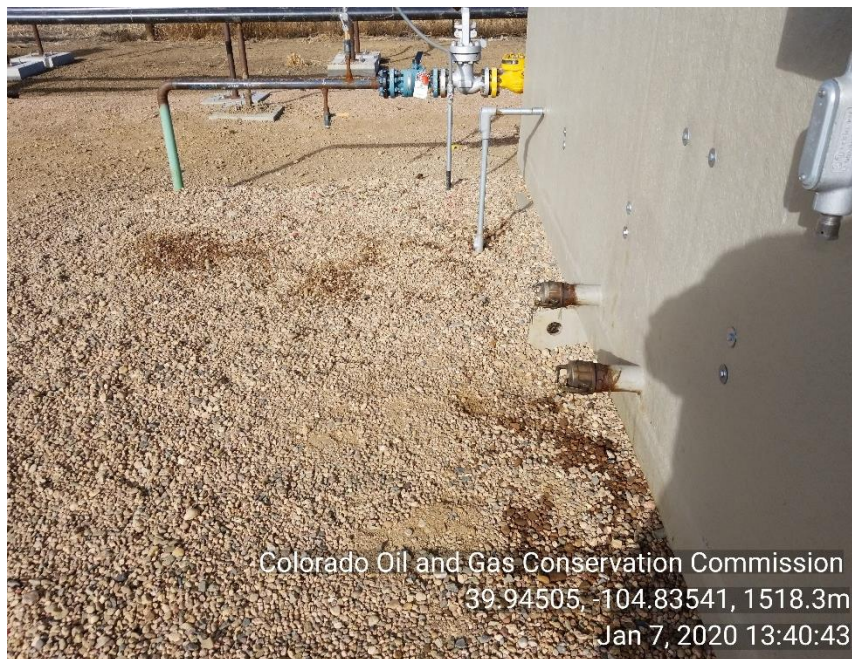
Photo 15 Stained soil on side of LACT Building

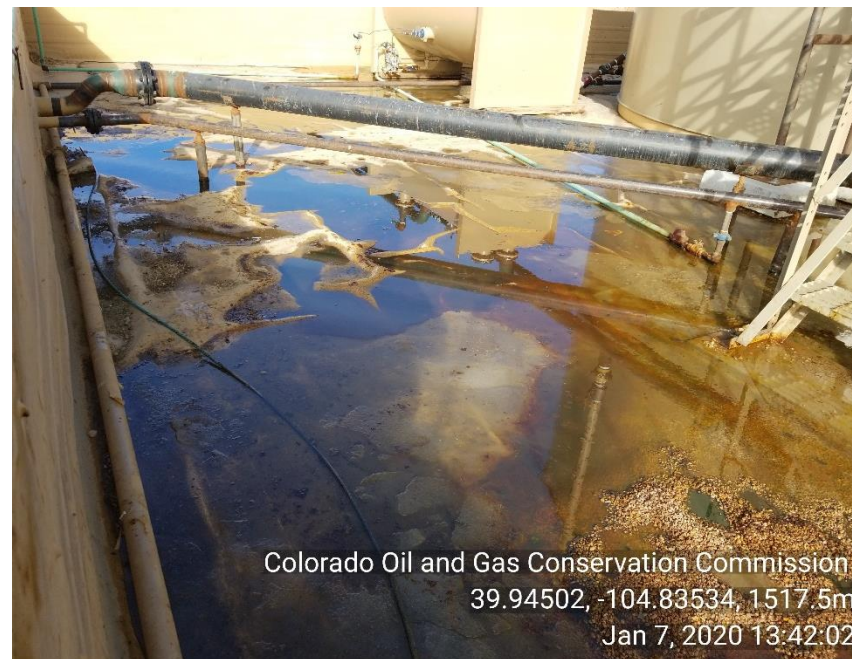
Photo 16 Stained soil What appears to be oil and water in containment due to leak on 3" line.

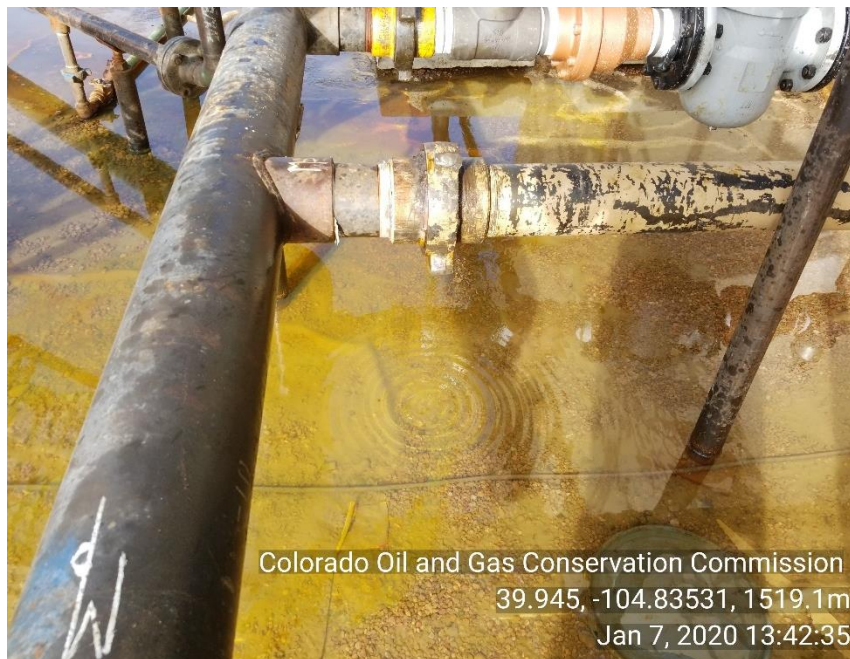
Photo 17 3" hammer Union leaking off production tanks

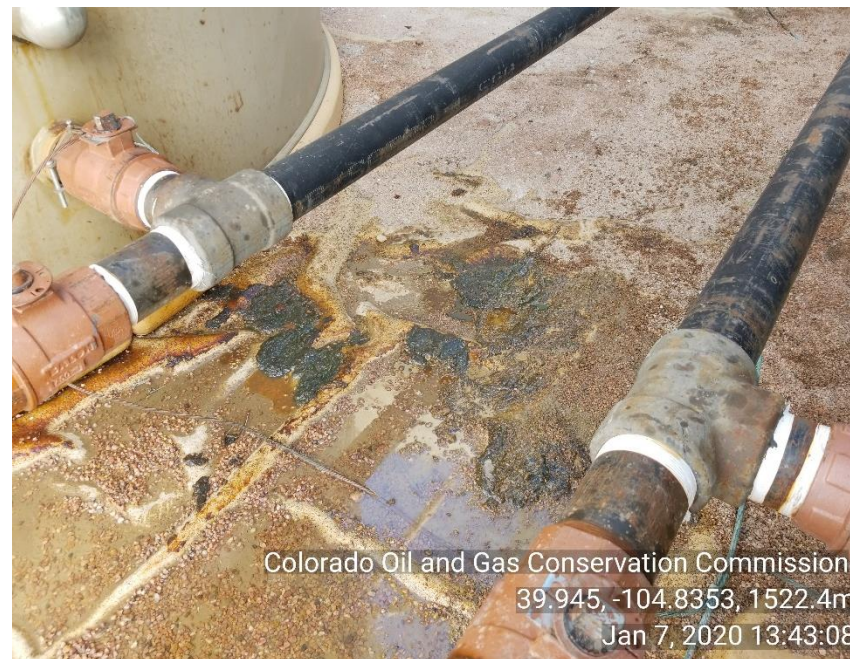
Photo 18 Stained soil next to production tanks.

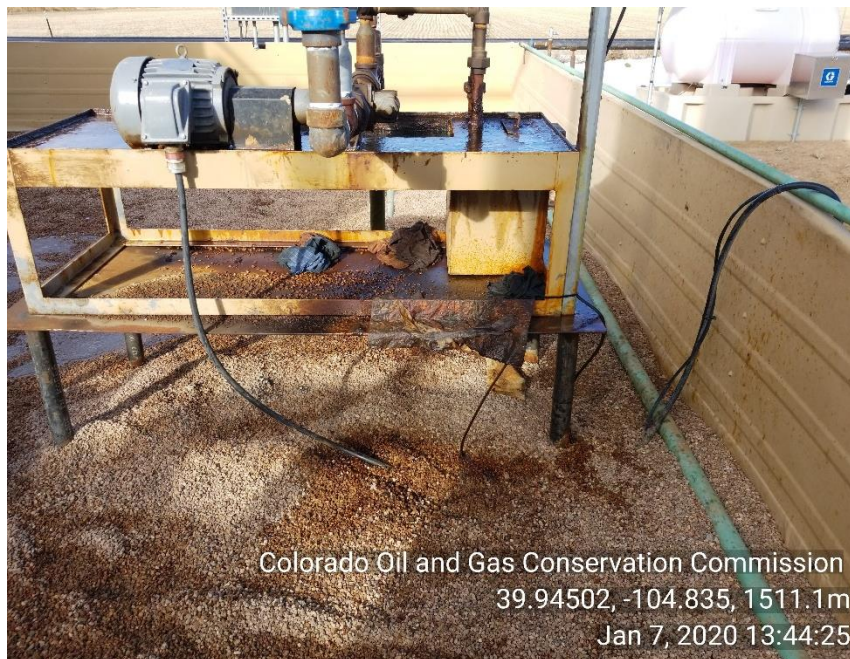
Photo 19 Stained soil under recirc pump and trash dirty rags.

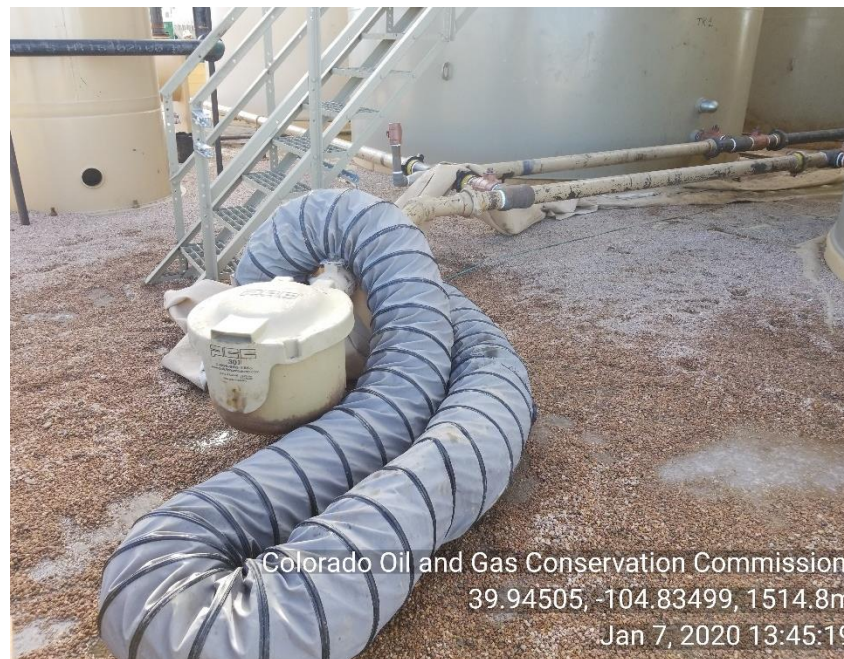
Photo 20 Unused equipment heater house and canvas next to VRT

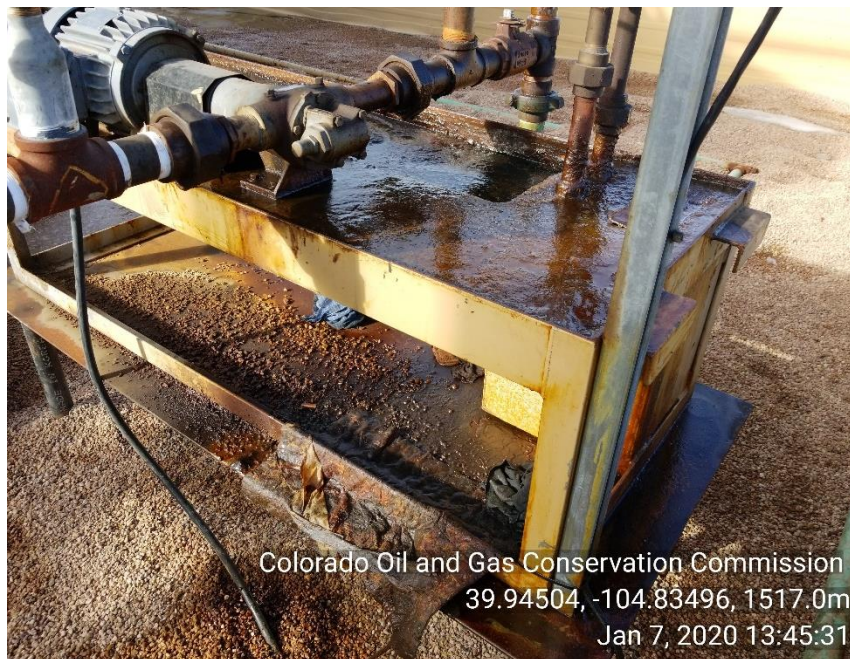
Photo 21 Stained soil around recirc pump

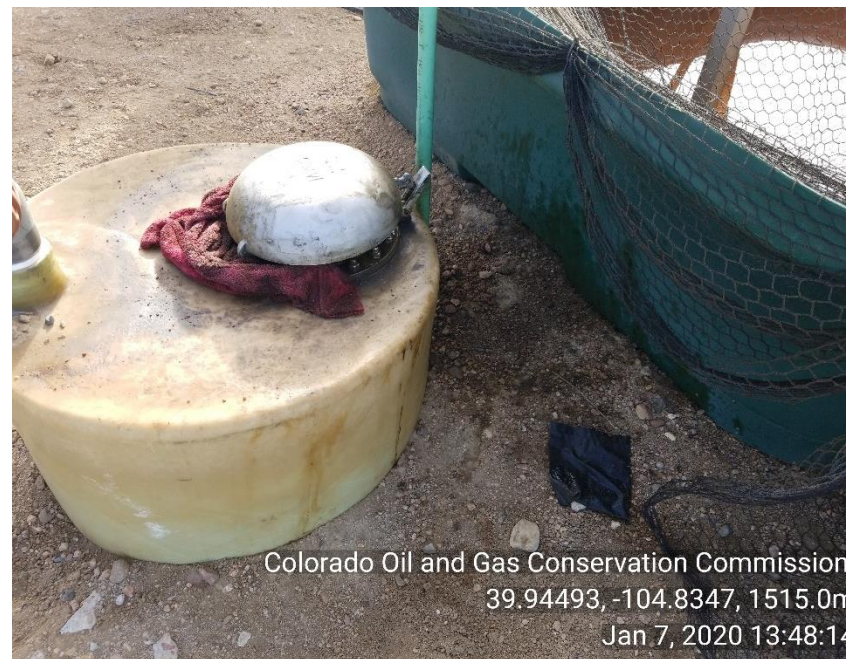
Stained 22 soil around oil tanks.

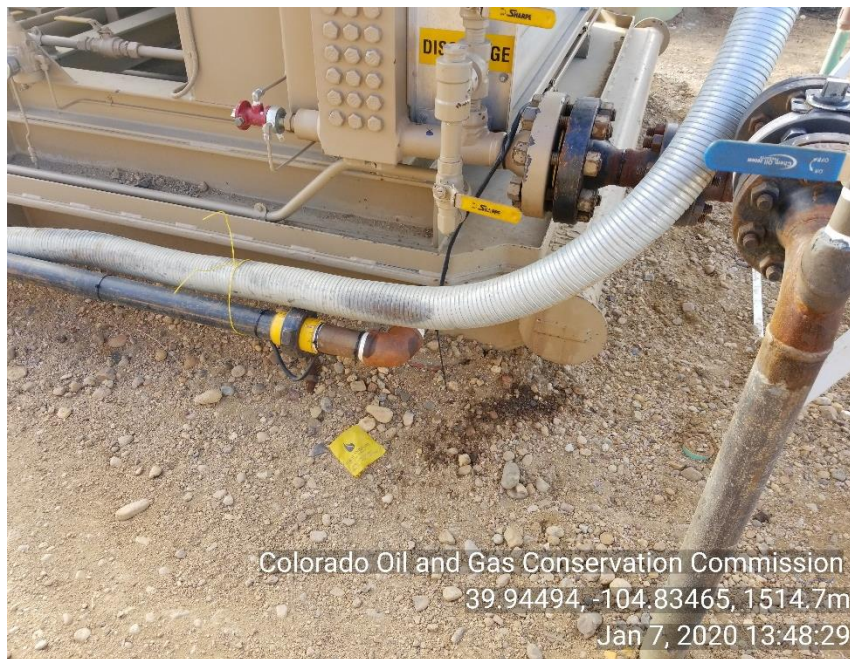
Photo 23 Stained soil around VRU compressor

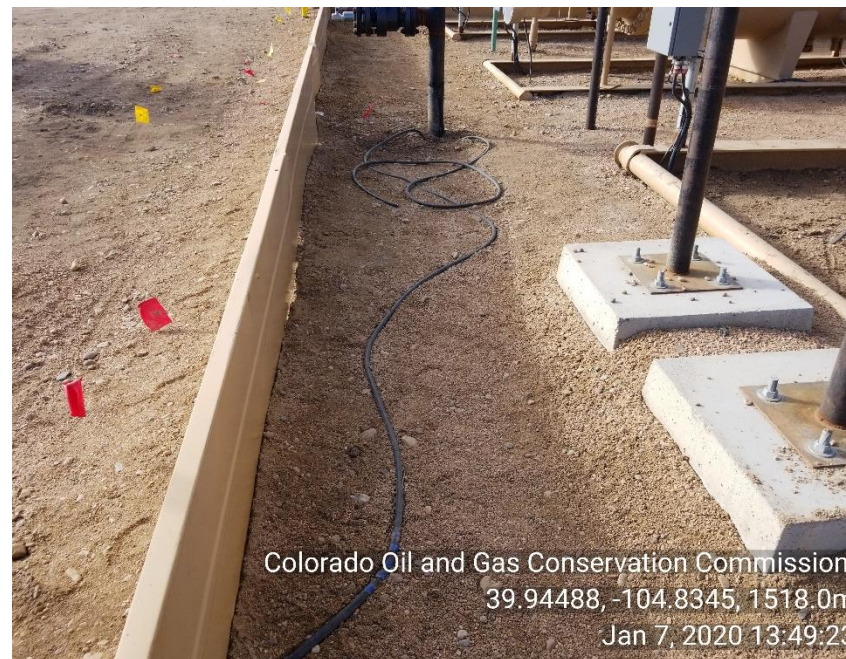
Photo 24 Unused equipment: Electric cables next to low pressure separator

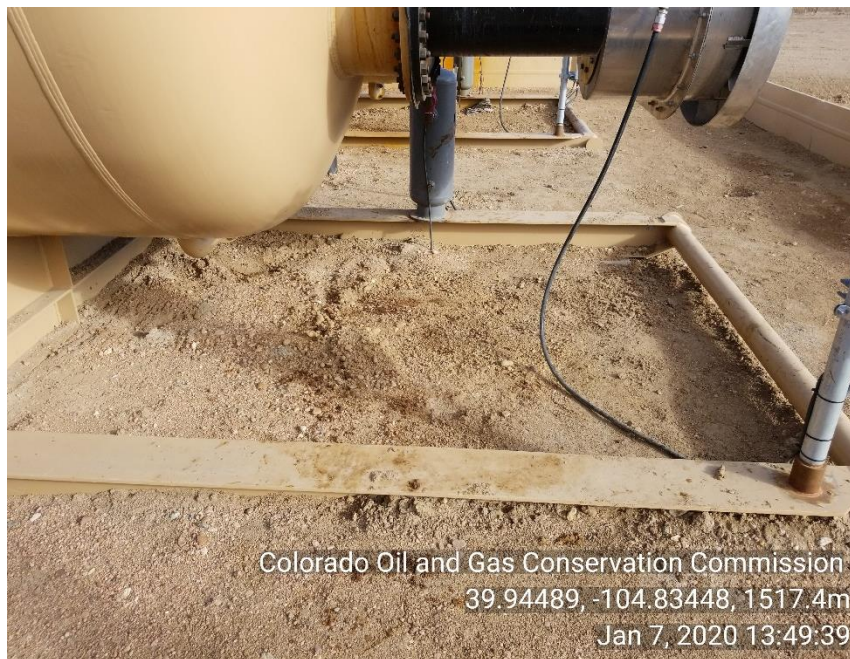
Photo 25 Stained soil under heater of HOZ sew

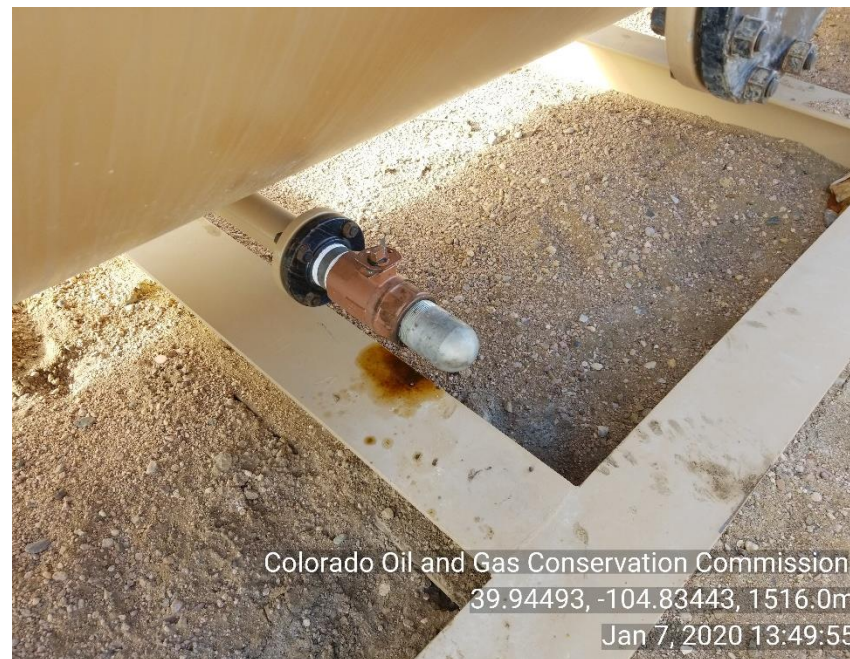
Photo 26 Mechanical issue: 2" VLV leaking on HOZ sep

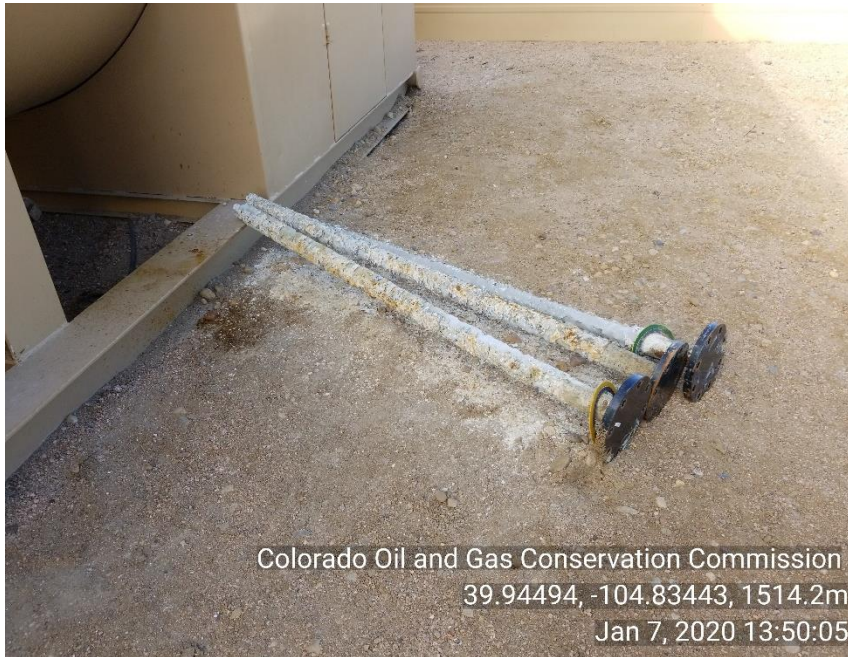
Photo 27 Unused equipment next separators

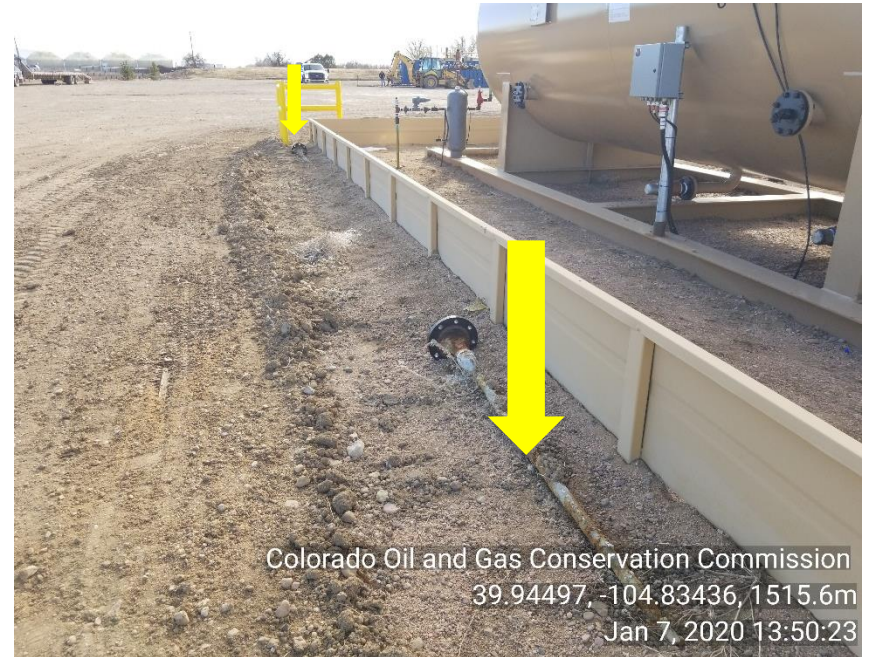
Photo 28 Unused equipment next separators

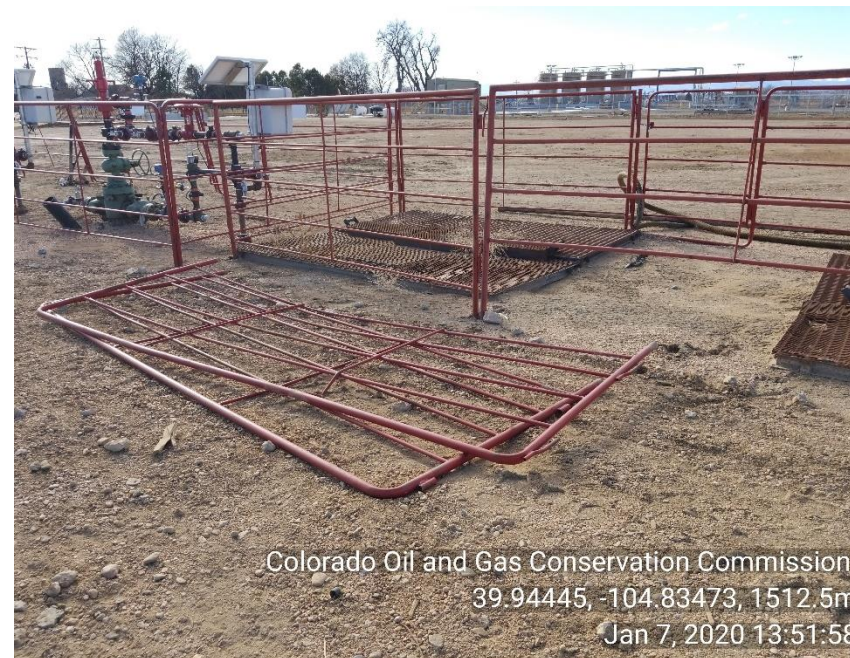
Photo 32 unused equipment: Cattle panels

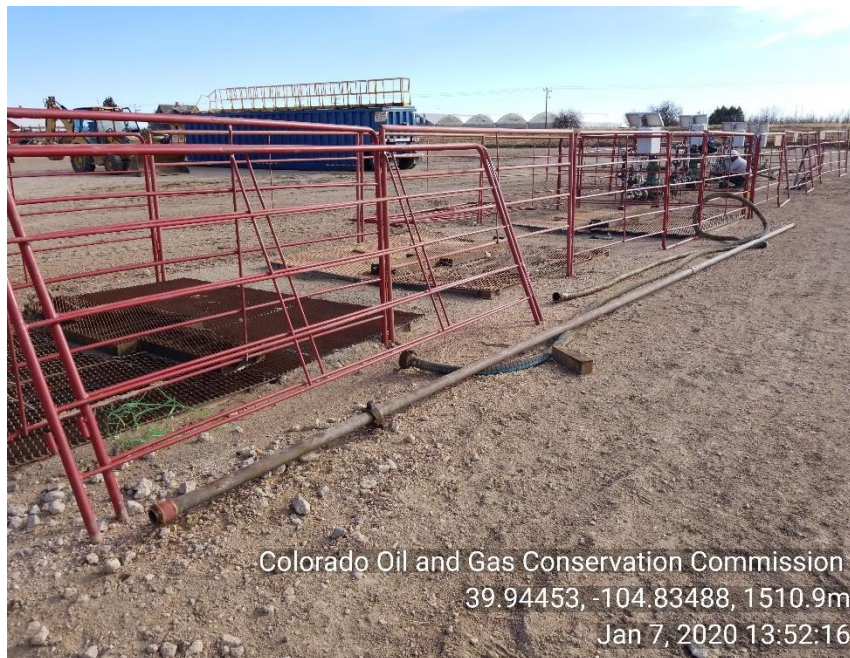
Photo 33 Unused equipment: tubing and cattle panels

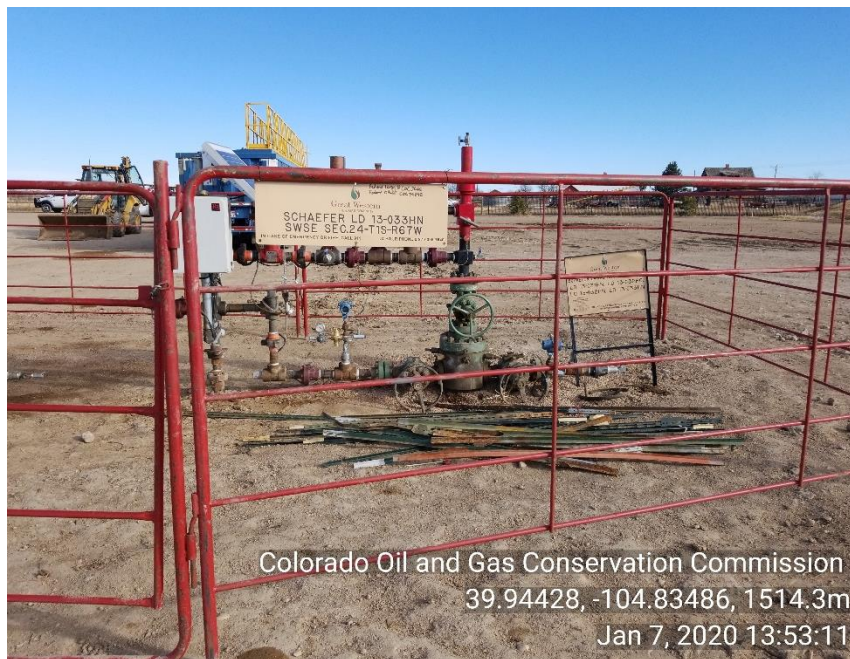
Photo 37 WH and unused equipment T-Posts

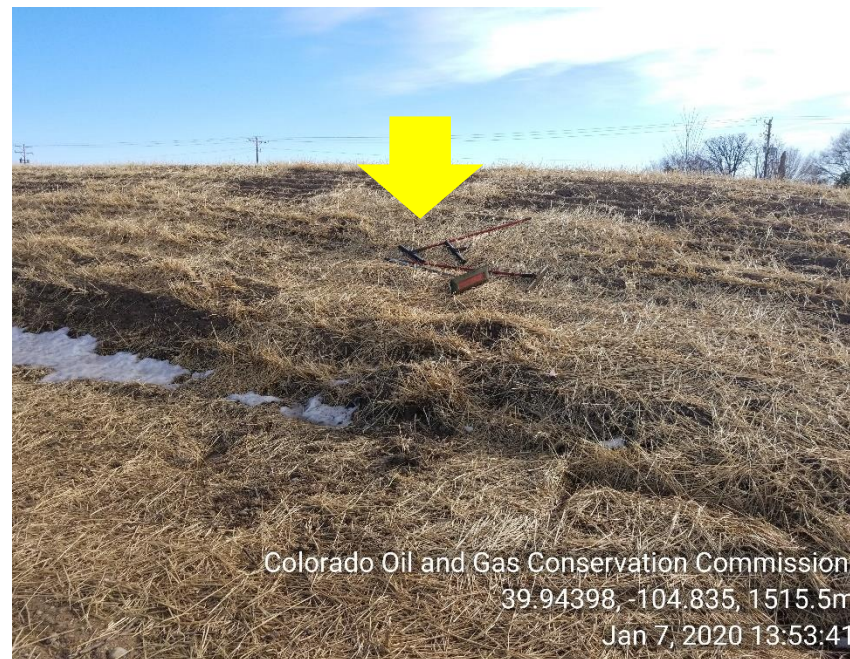
Photo 38 Unused equipment Tools

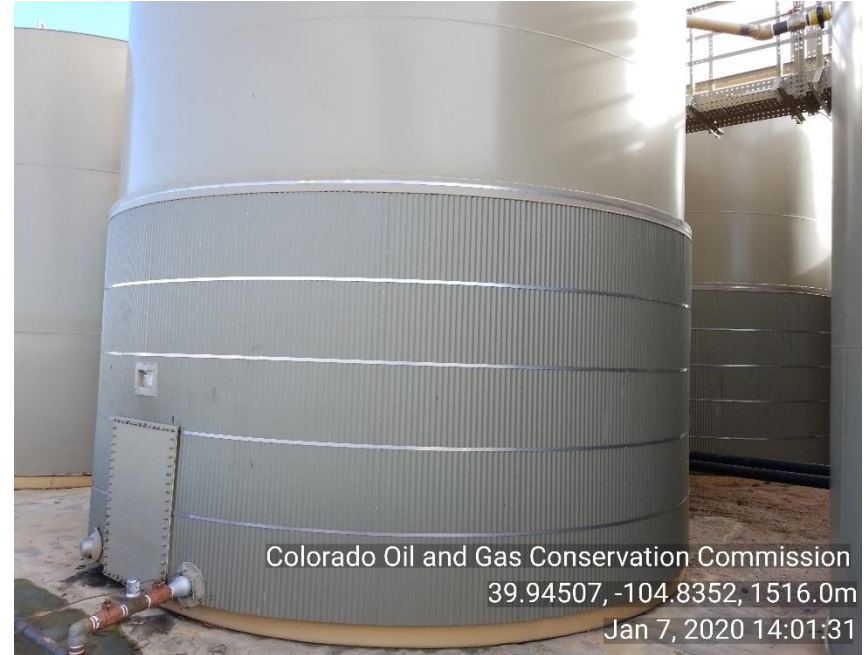
Photo 40 Crude oil tank no placards

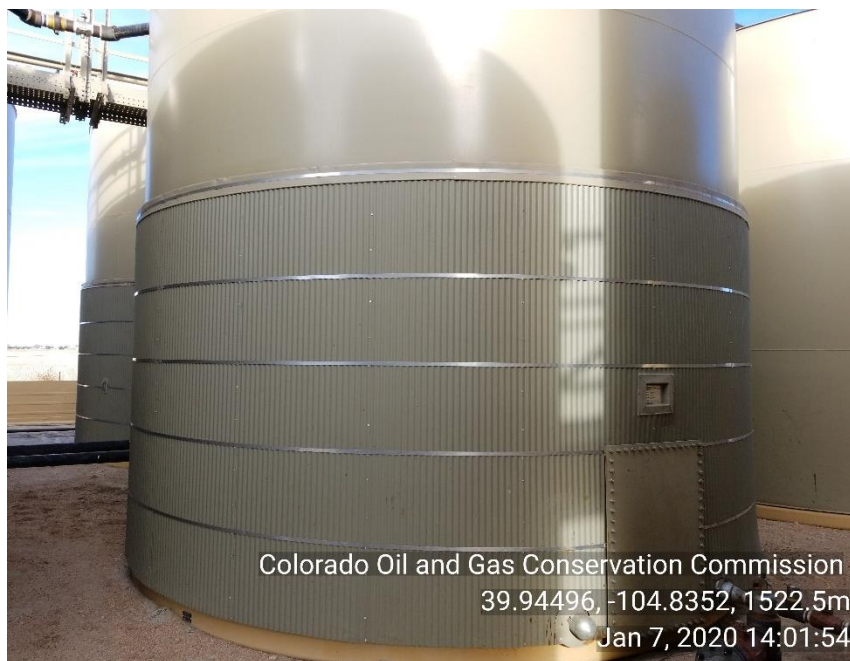
Photo 41 Crude oil tank no placards

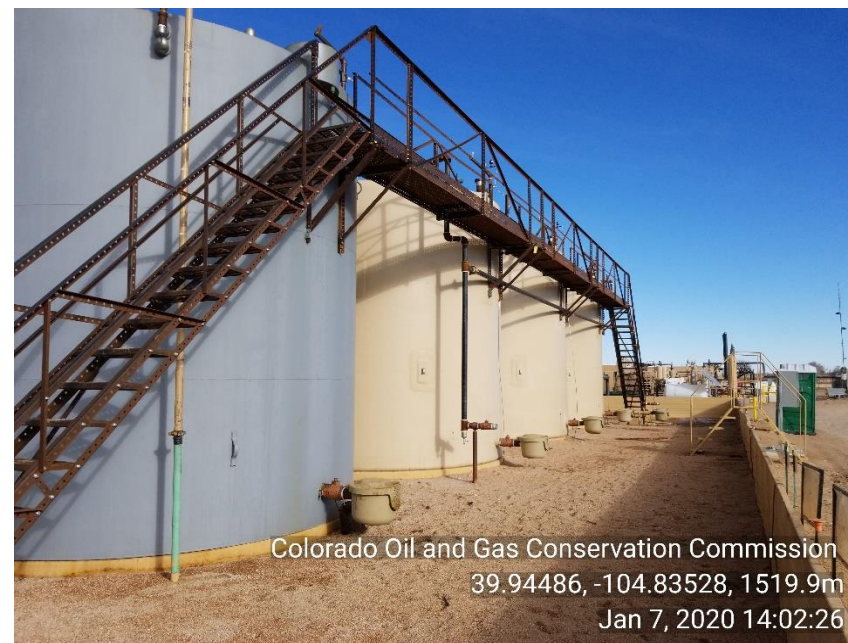
**Photo 42 Three fiberglass produced water tanks no placards. 1
Steel maintenance tank no placards . Maintenance tank not
painted**

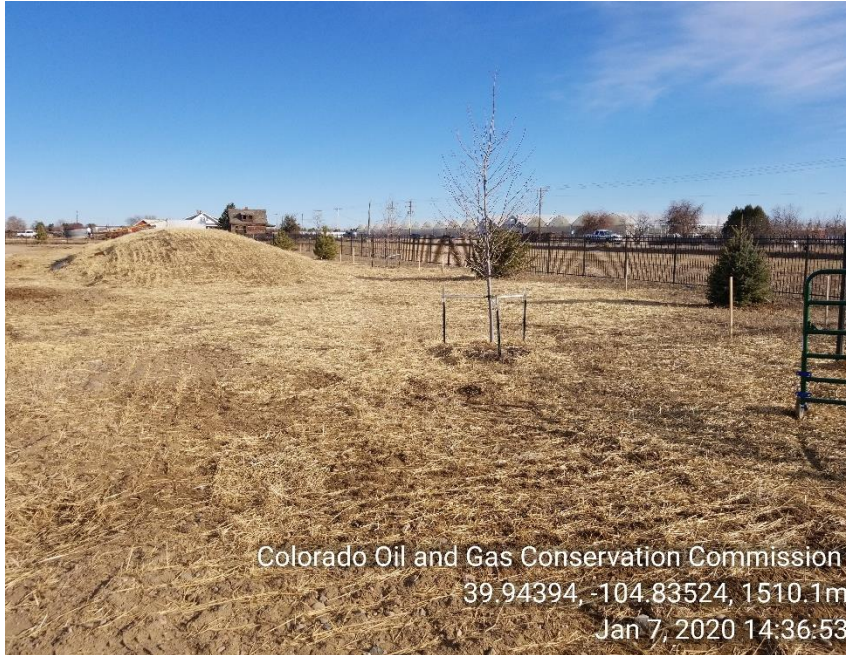
Photo 43 Topsoil pile and area next to fence appears to be seeded and crimped .
