Inspection Photos

Location Name: ADAMIC 1-20 CA DATE 2-8-20

API#: 05-071-06020

INSP. #: 695101985

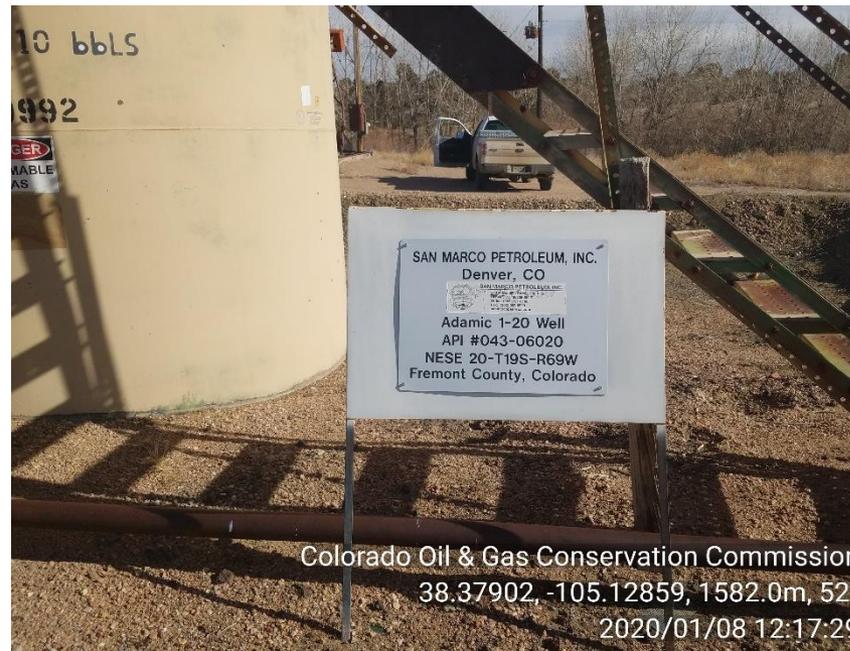
PHOTO 2: WELL SIGN, CONTACT PHONE NUMBER SIZE IS INADEQUATE AND 911 IS NOT POST ON SIGHT. **INSTALL SIGN THAT COMPLIES WITH RULE 210.d. 24 HOURS TO POST EMERGENCY CONTACT NUMBER. CA DATE 1-9-20**

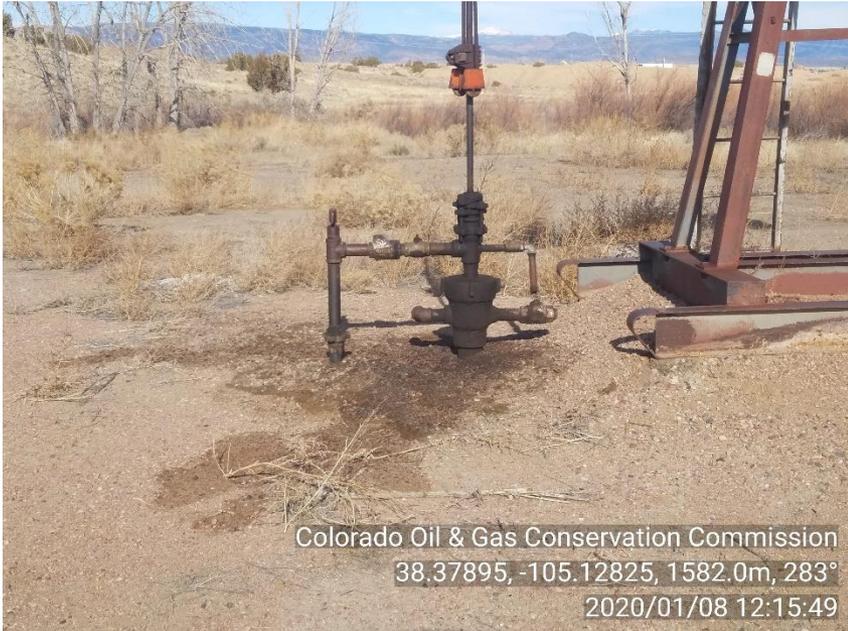
PHOTO 3: IT APPEARS THAT WELLHEAD IS LEAKING PRODUCED OIL, AREA OF IMPACTED SOIL APP. 6' BY 3' AROUND WELLHEAD.

Securely fasten all valves, pipes, and fittings to ensure good mechanical condition, inspect at regular intervals and maintain in good mechanical condition per Rule 605.d. Properly treat or dispose of oily waste in accordance with 907.e." CA DATE 2-8-20.

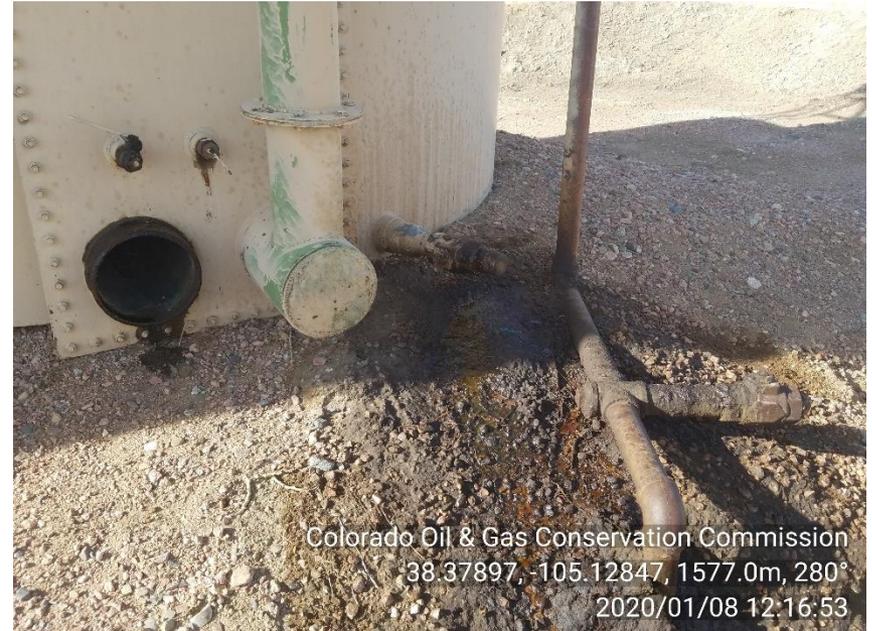
PHOTO 4: A BULLPLUG ON 210 BBL TANK IS LEAKING. THERE IS AN AREA OF IMPACTED SOIL APP. 3' BY 6' NEAR LEAKING PLUG. CALLED CONTACT NUMBER POSTED ON BATTERY SIGN AND HAD TO LEAVE A MESSAGE.

Securely fasten all valves, pipes, and fittings to ensure good mechanical condition, inspect at regular intervals and maintain in good mechanical condition per Rule 605.d. Properly treat or dispose of oily waste in accordance with 907.e." 24 HOURS TO REPAIR LEAKING BULLPLUG 30 DAYS FOR SOIL. CA DATE 1-9-20.

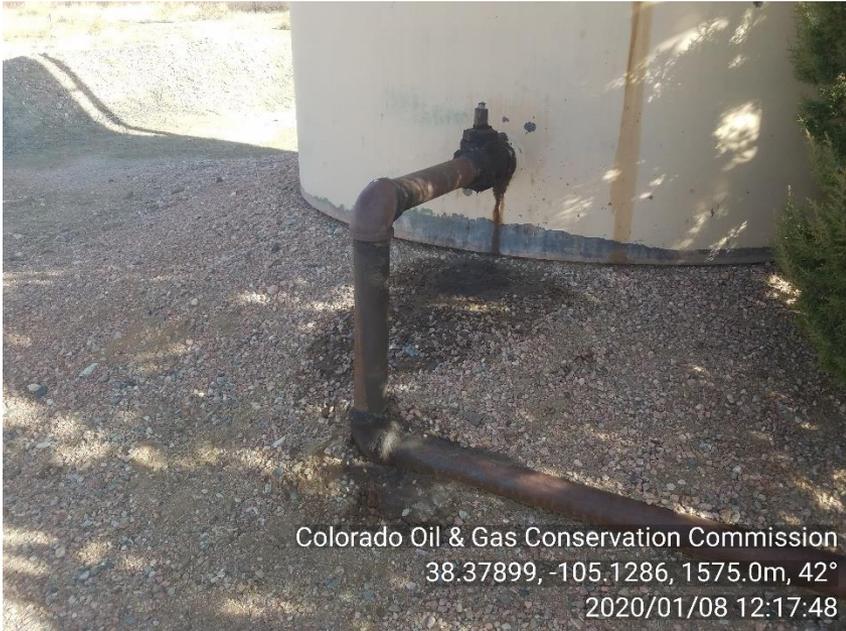
PHOTO 5: VALVE ON 210 BBL TANK IS SEEPING. THERE IS AN AREA OF IMPACTED SOIL APP. 3' BY 1' NEAR SEEPING VALVE.. *Securely fasten all valves, pipes, and fittings to ensure good mechanical condition, inspect at regular intervals and maintain in good mechanical condition per Rule 605.d. Properly treat or dispose of oily waste in accordance with 907.e. CA DATE 2-8-20.*

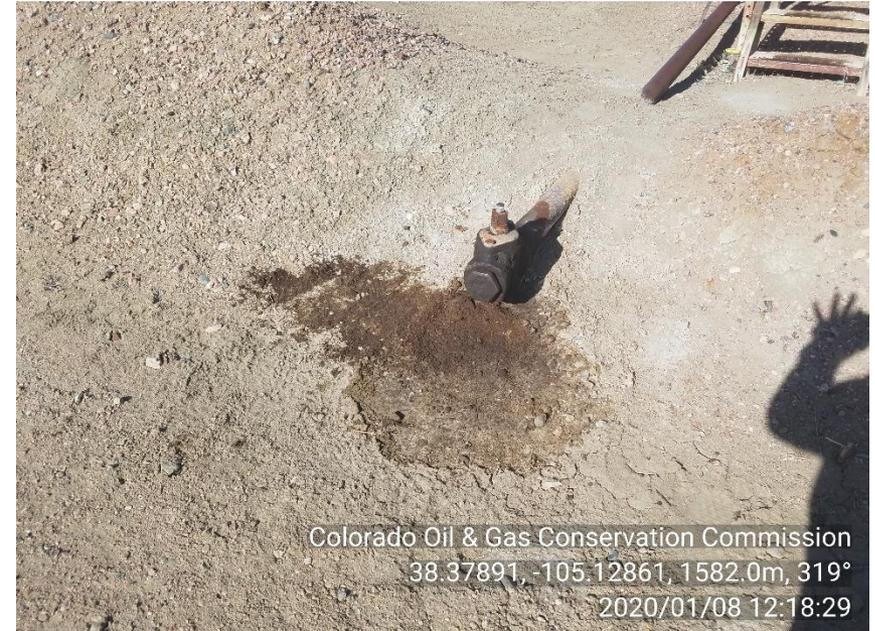
PHOTO 6: LOADOUT LINE IS PLUMBED OUTSIDE SECONDARY BMP. THERE IS AN AREA OF IMPACTED SOIL OUSIDE OF BURM) APP. 1' BY 2' AROUND LOADOUT. *INSTALL SECONDARY BMP TO PREENT OILY WASTE FROM MIXING WITH STORM WATER PER RULE 1002.f. Properly treat or dispose of oily waste in accordance with 907.e. CA DATE 2-8-20.*

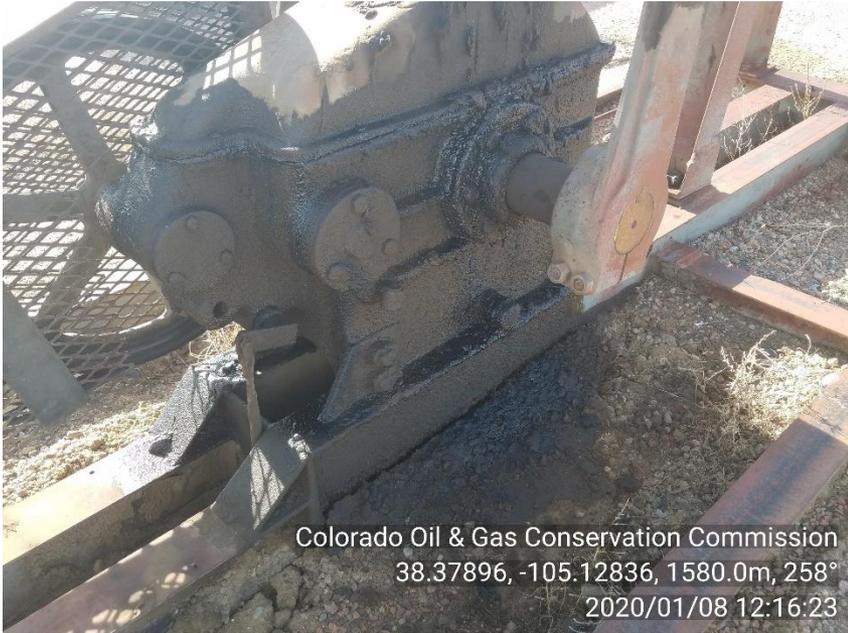
**PHOTO 7: APPEARS THAT GEAR BOX ON PUMPJAKE IS LEAKING,
THERE IS AN AREA OF IMPACTED SOIL BENEATH GEARBOX.**

**Securely fasten all valves, pipes, and fittings to ensure good
mechanical condition, inspect at regular intervals and maintain in
good mechanical condition per Rule 605.d. Properly treat or
dispose of oily waste in accordance with 907.f. CA DATE 2-8-20.**
