Dover Atwood Corporation (#10626) - COGCC Inspection Photos 1/7/2020

Well: Bear Creek 1-3

API # 009-06598

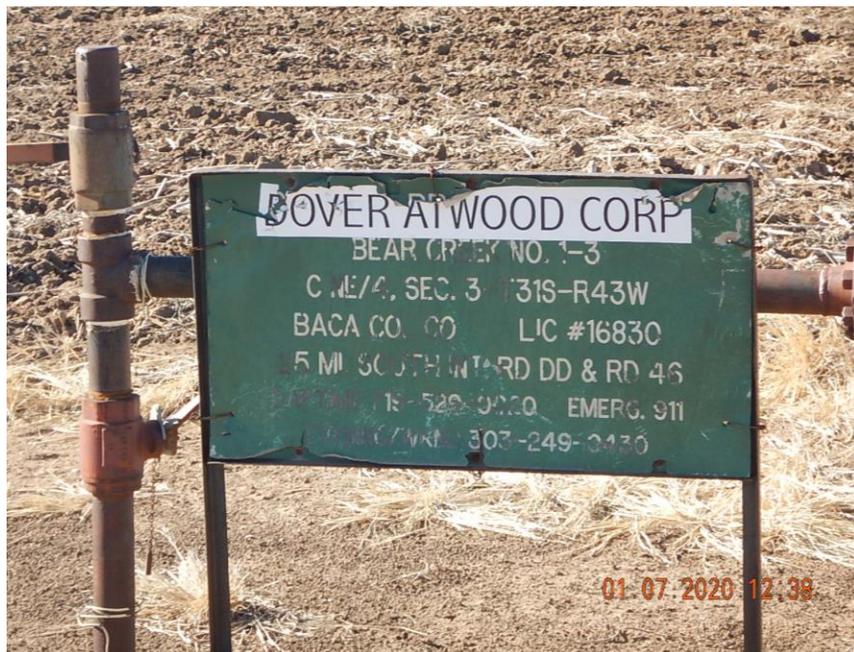
Signage at facility/ battery; Information not fully legible.

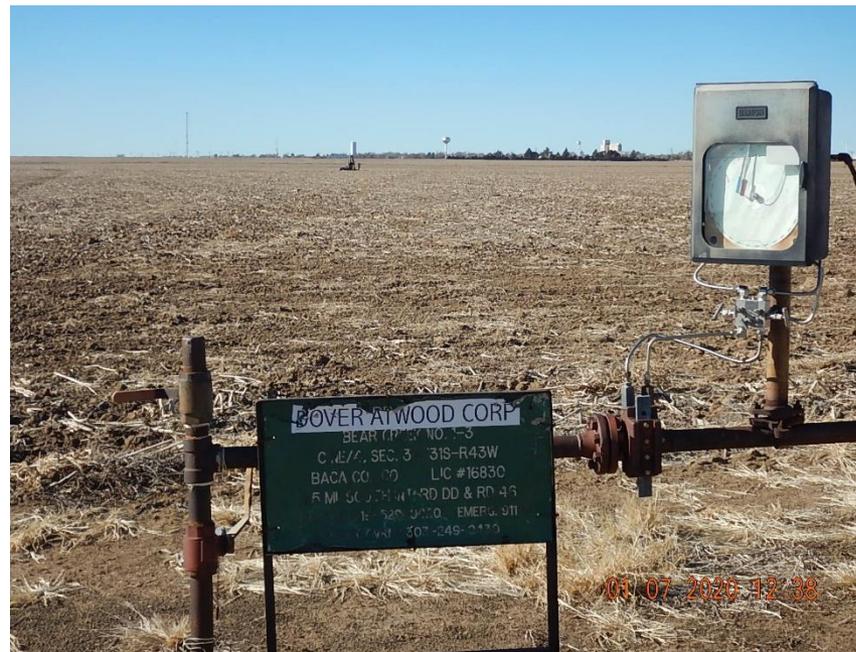
View from meter run to wellhead located approximately 1270' west of facility/ battery.

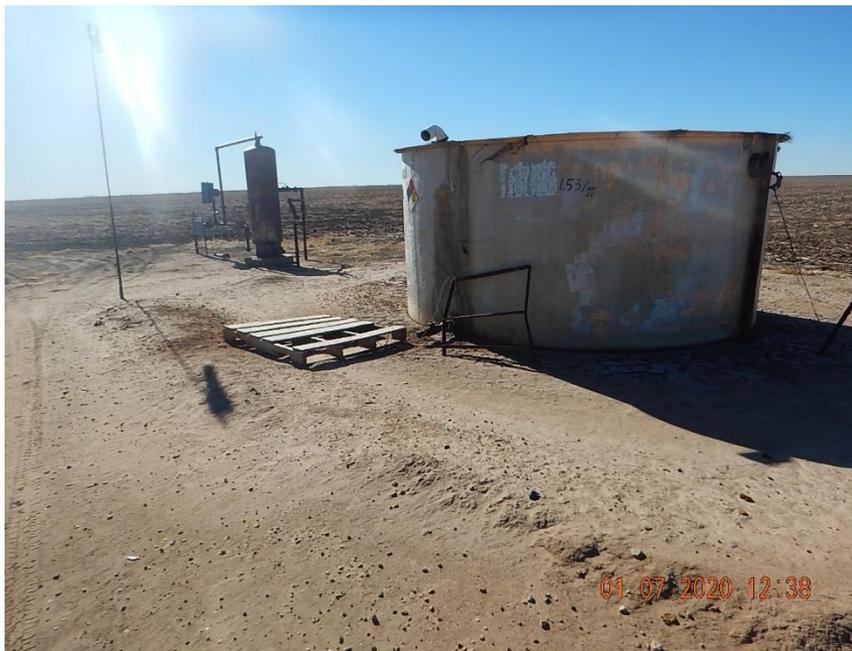
View of facility/ battery. Earthen berms have eroded; inadequate berm capacity. Trash (pallet) on location.

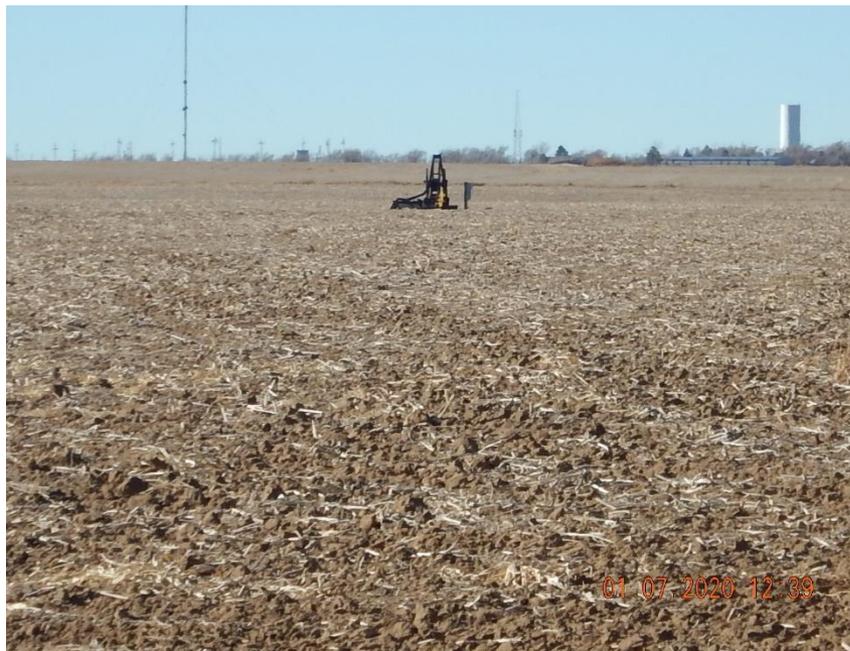
View of wellhead looking west from facility. Off location flowline runs between wellhead and facility; approximately 1270' in length.
