# Construction and Stormwater Inspection

January 7, 2020

Operator: MALLARD EXPLORATION LLC- #10670

Inspection Photos  
Location Name: Shoveler /Pad  
Location ID: 455365

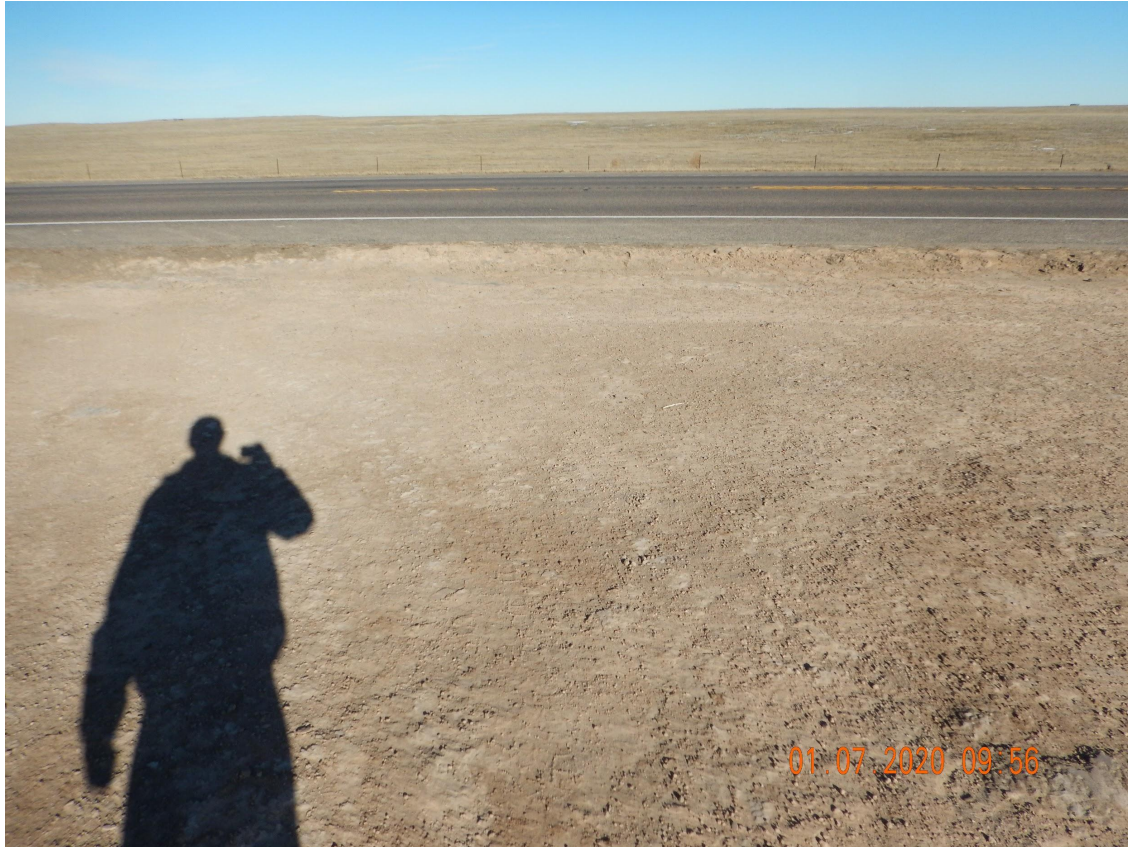
**Photo 1.** Photo taken from the entrance of location, facing North. Photo illustrates no vehicle tracking device BMPs have been installed. At the time of this inspection, there was no track out issues observed.

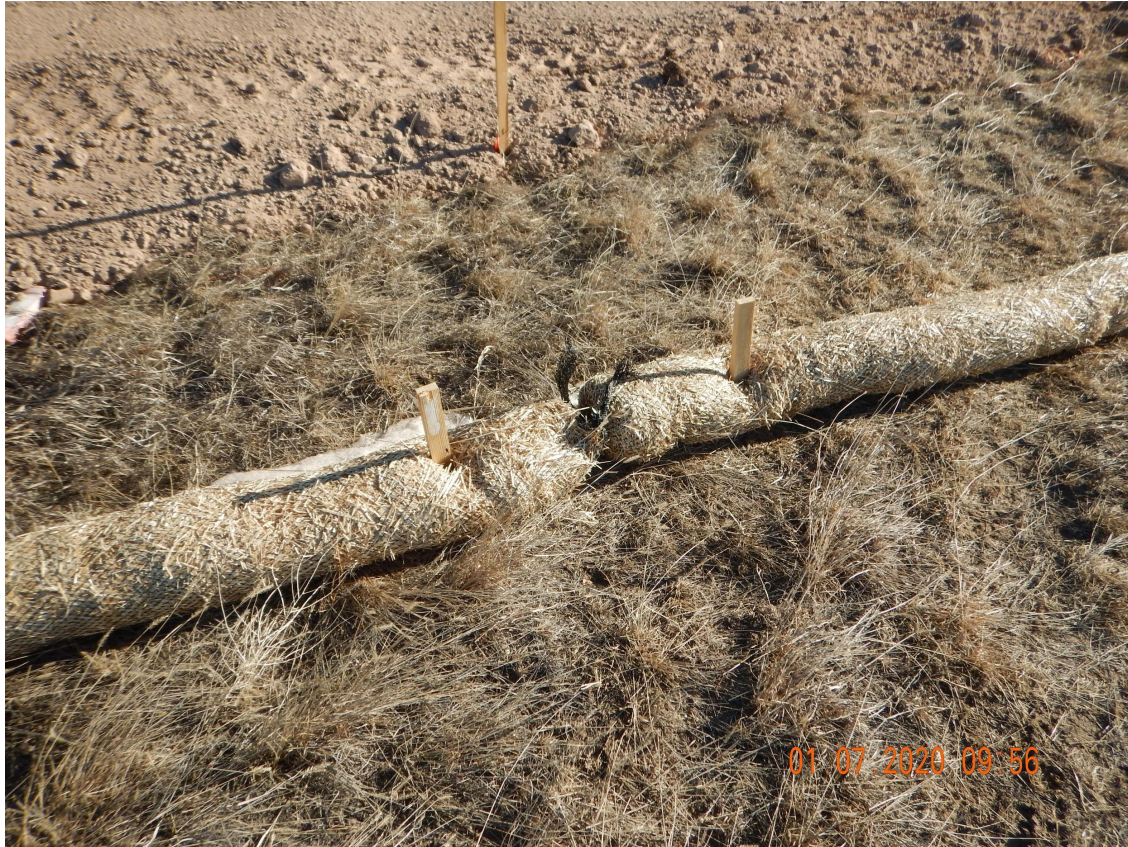
**Photo 2.** Photo taken from the entrance of location. Photo illustrates the wattle BMP has not been properly installed. Wattle BMP shall be trenched and back-filled and the ends shall overlap.

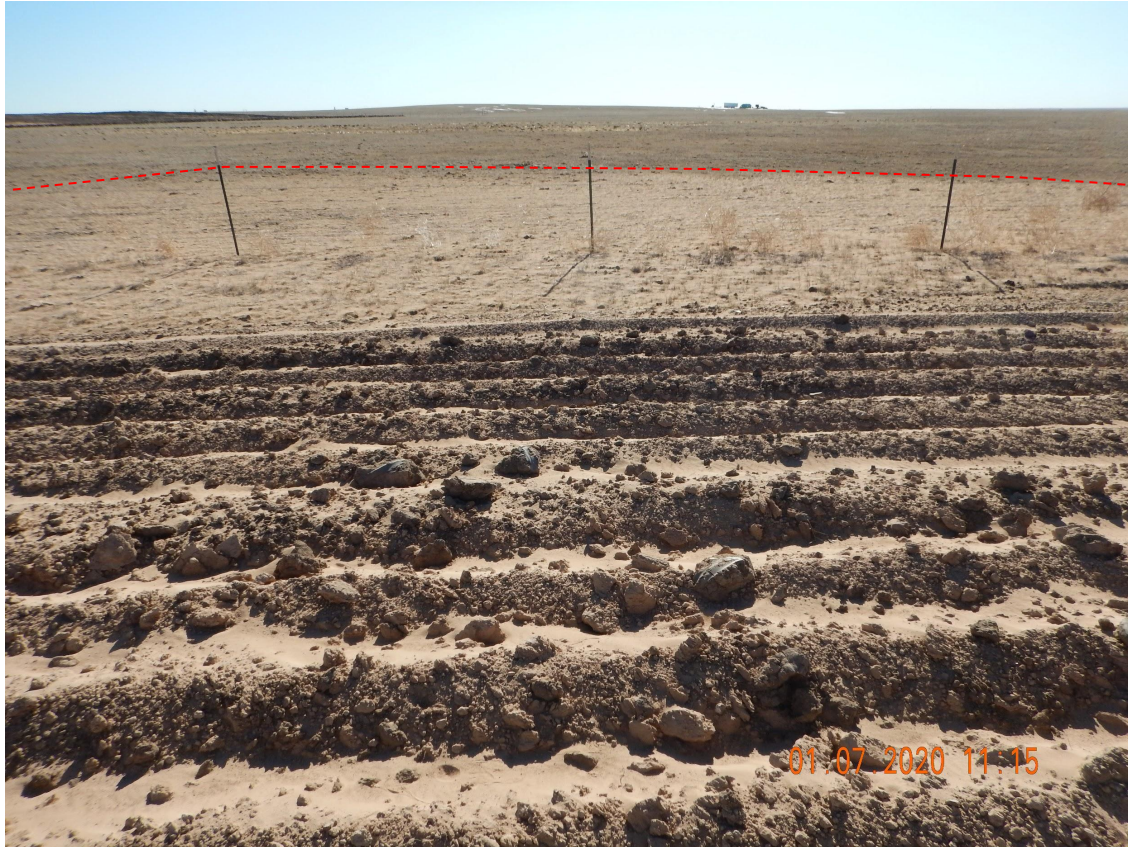
**Photo 3.** Photo taken from the western access road, facing South. Photo illustrates soil particle deposition off the access road from wind erosion (everything below the red-dashed line). Operator attempted to minimize soil particle deposition by installing furrow-like BMPs along portions of the access road.

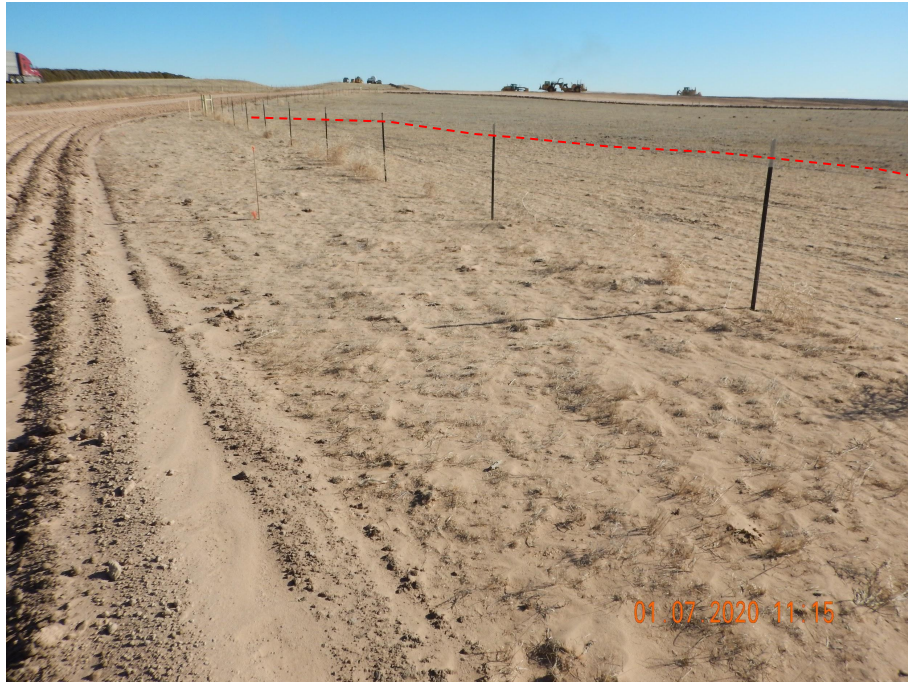
**Photo 4.** Photo taken from a portion of the western access road, facing East. See comments under Photo 3.

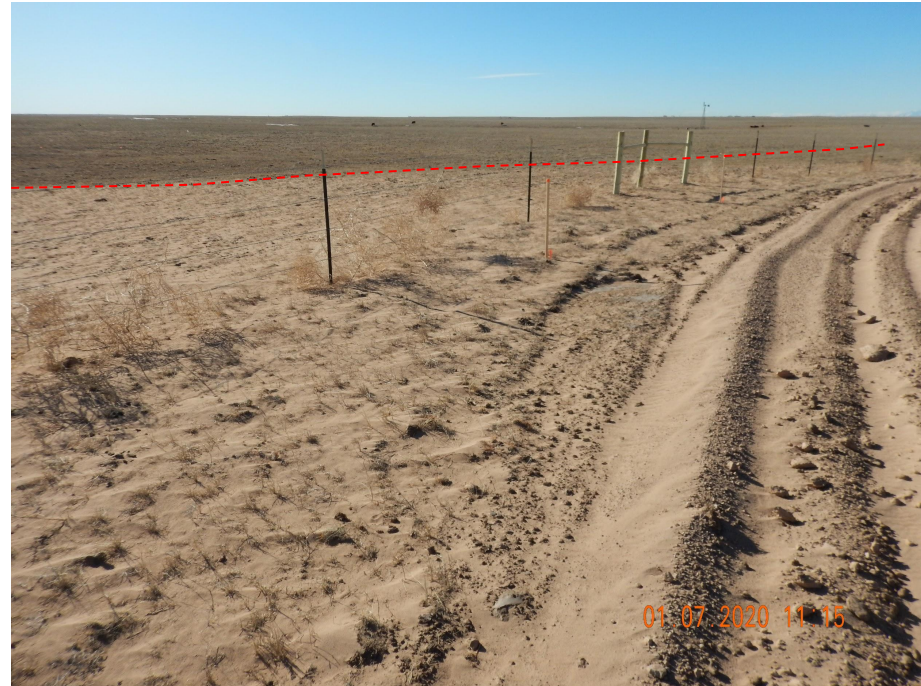
**Photo 5.** Photo taken from a portion of the western access road, facing West. See comments under Photo 3.

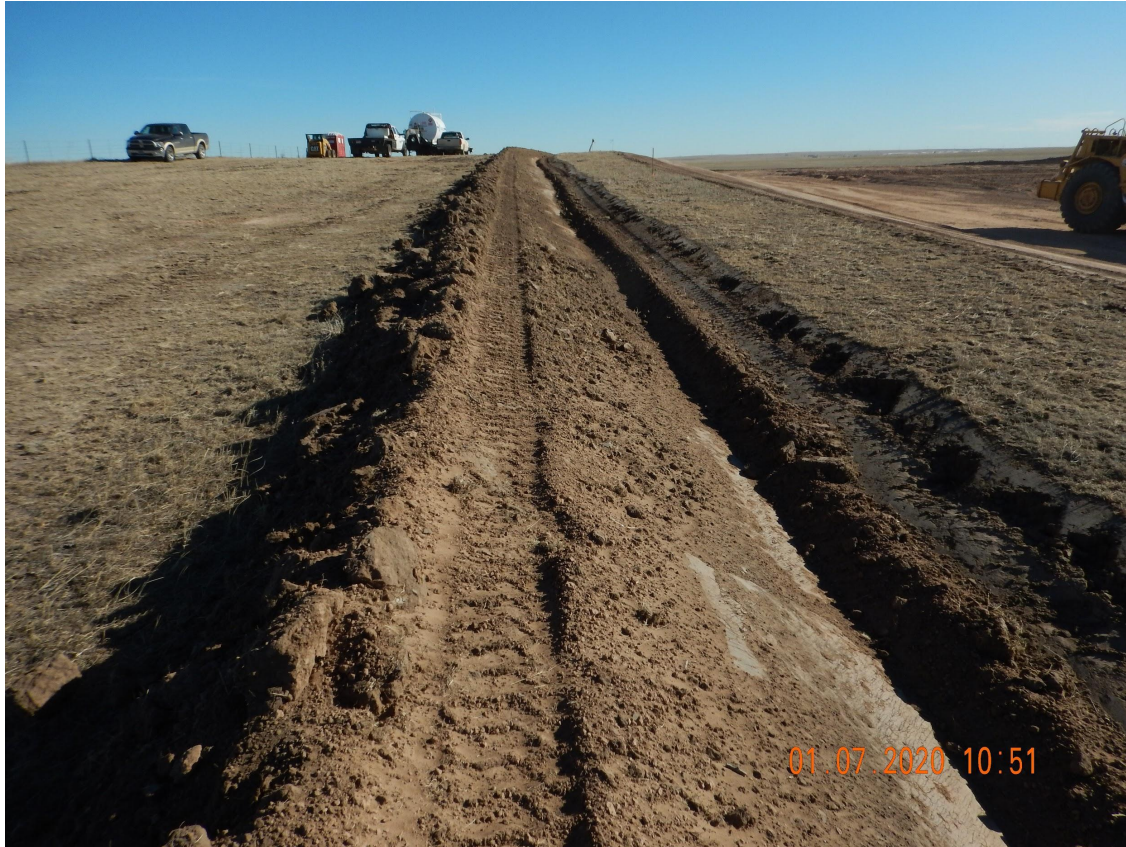
**Photo 6.** Photo taken from the northwestern perimeter of location, facing East. Photo illustrates a ditch and berm BMP. Berm portion of the BMP has not been installed in accordance with good engineering practices, as the berm has been left unconsolidated.

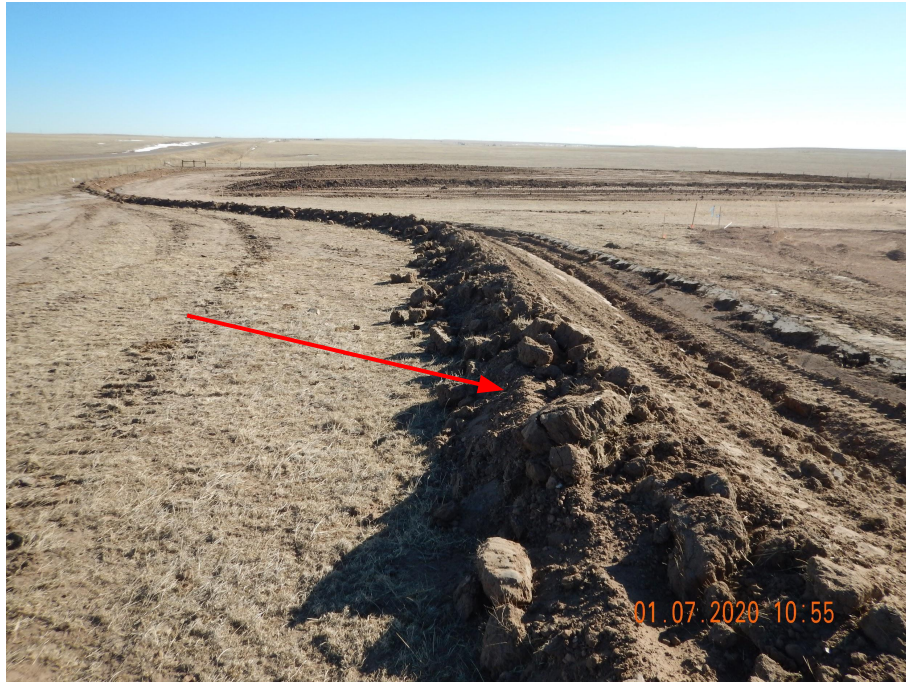
**Photo 7.** Photo taken from the northern perimeter of location, facing East. See comments under Photo 6 regarding the berm BMP.

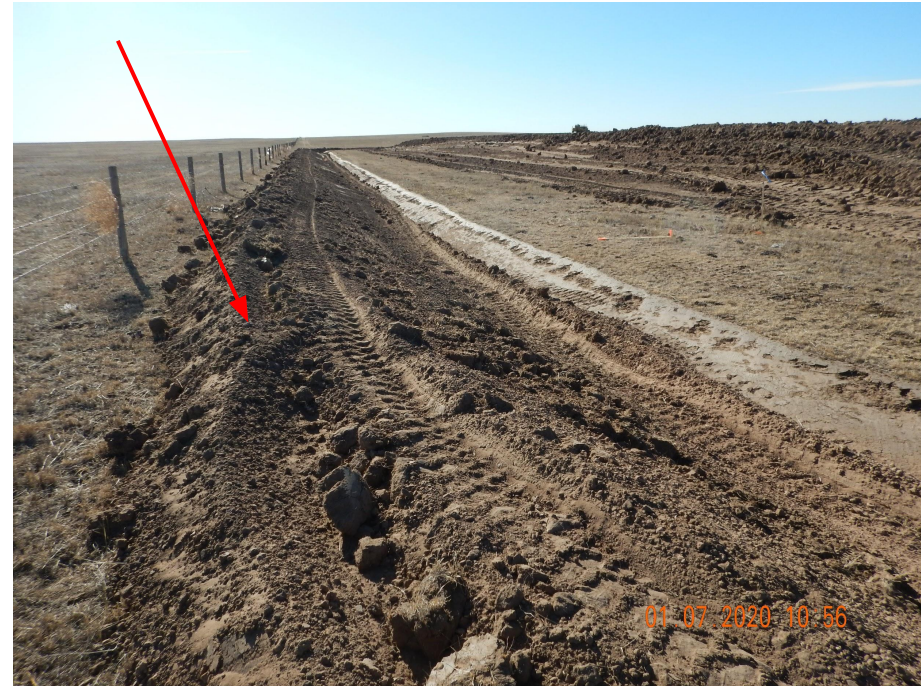
**Photo 8.** Photo taken from the northeastern perimeter of location, facing South. See comments under Photo 6 regarding the berm BMP.

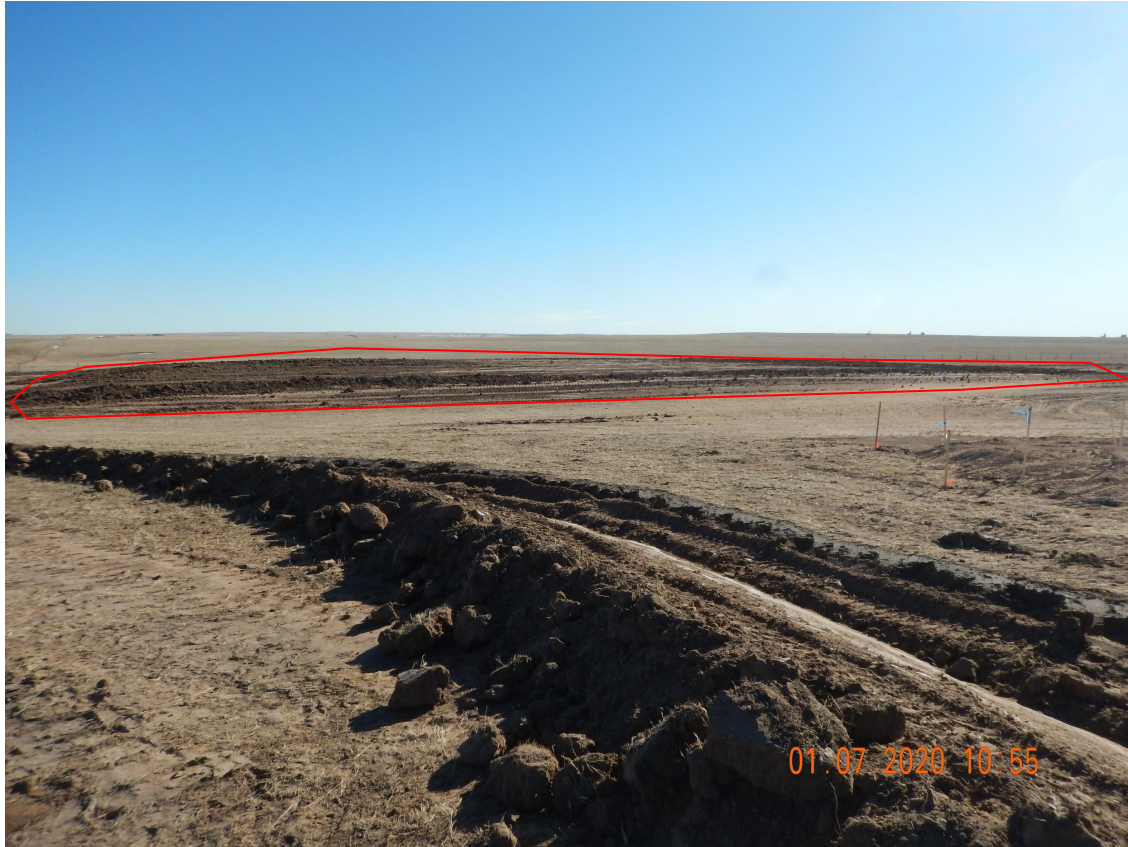
**Photo 9.** Photo taken from the northern perimeter of location, facing East. Photo illustrates the topsoil stockpile which is being stored along the northeastern portion of the location (highlighted in red).

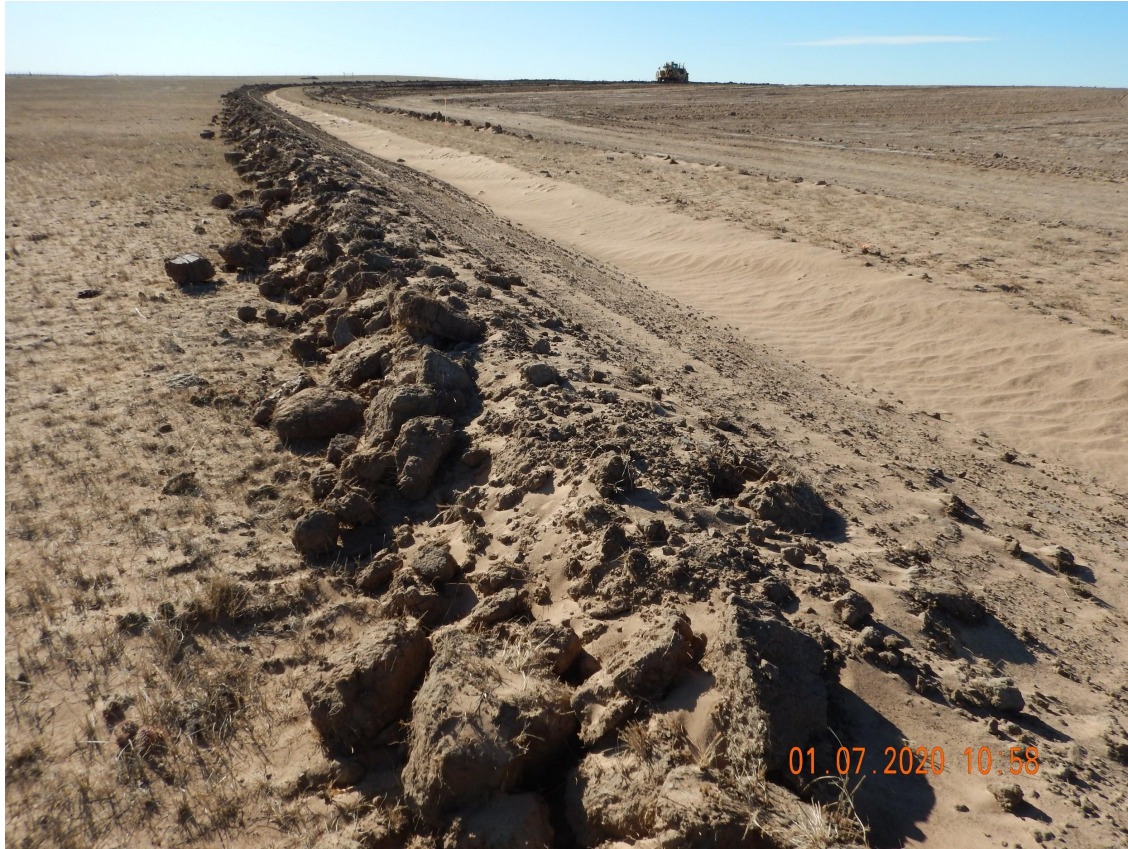
**Photo 10.** Photo taken from the eastern perimeter of location, facing South. Photo illustrates soil particle deposition accumulation within the ditch BMP and the unconsolidated berm BMP.

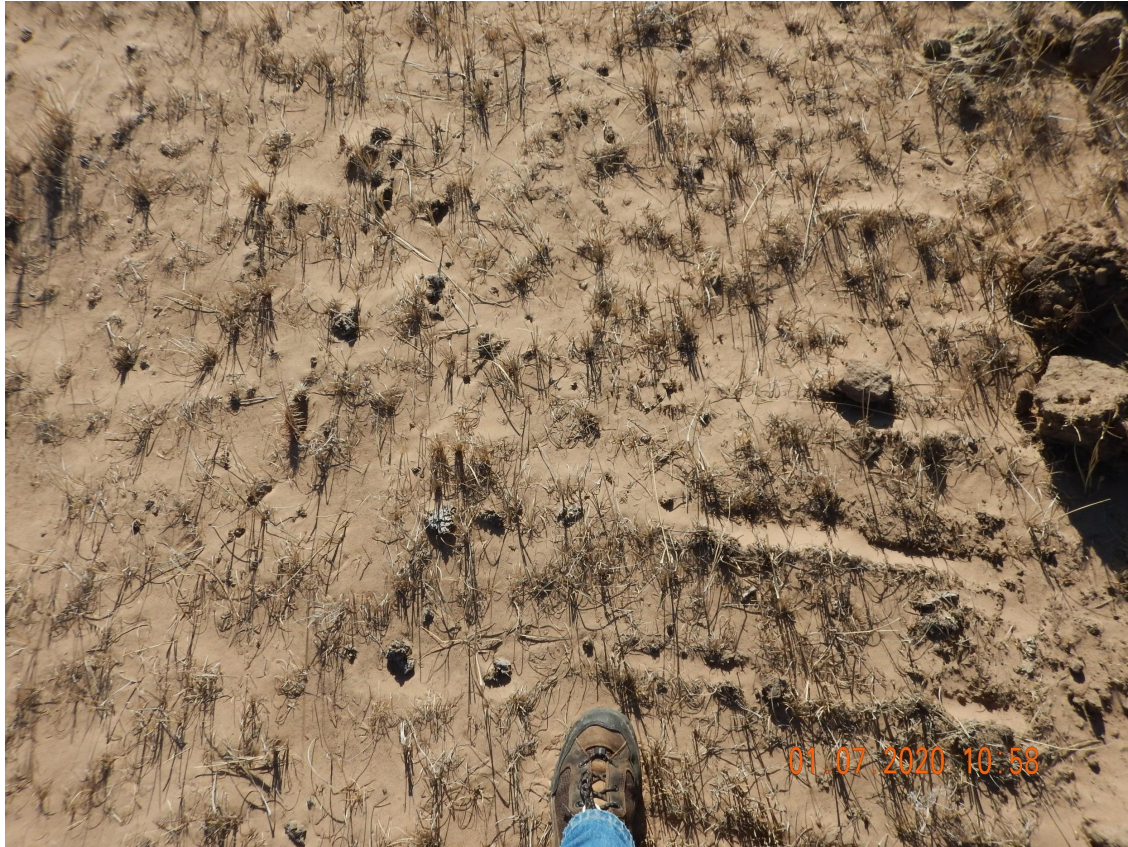
**Photo 11.** Close up photo taken from the eastern perimeter of location. Photo illustrates soil particle deposition accumulation outside the perimeter BMPs.

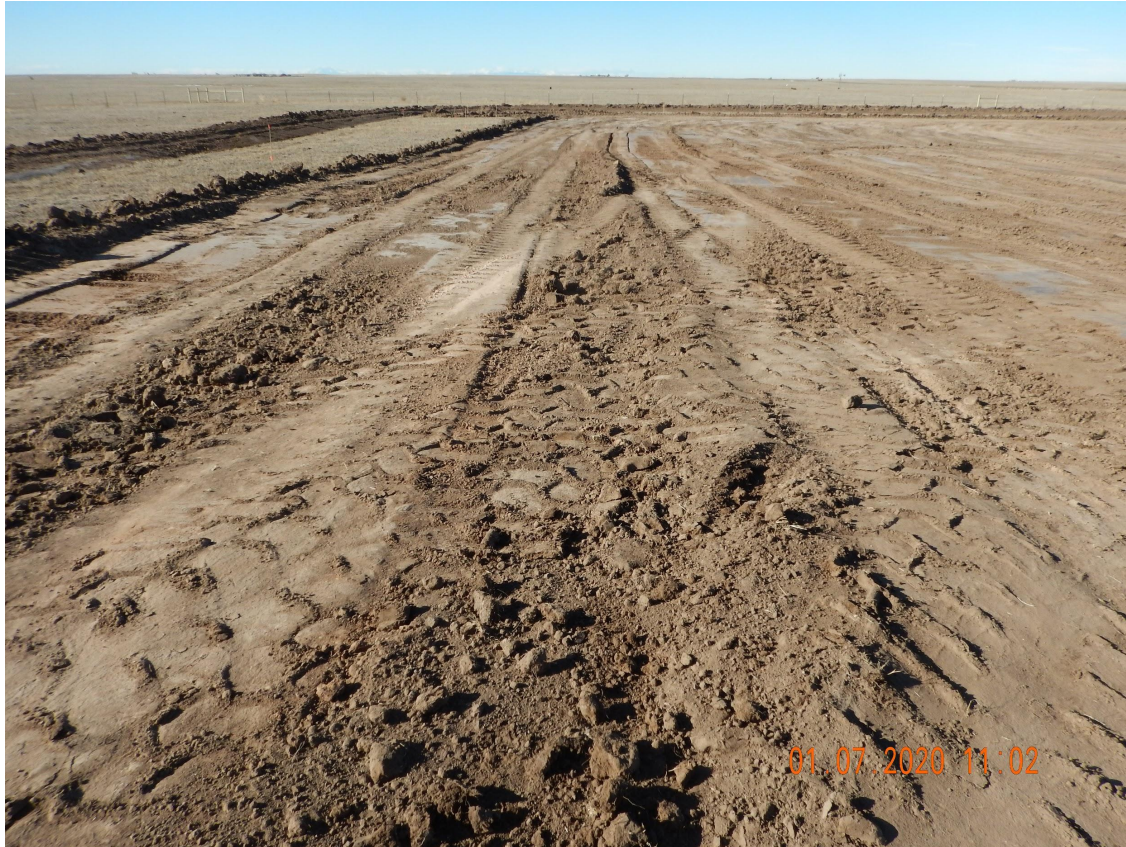
**Photo 12.** Close up photo taken from the southern location, facing West. Photo illustrates Operator is in process of conducting topsoil salvage operations. Based on field observations, it appears the Operator is salvaging to the appropriate depth.
