Inspection Photos
Location Name: Rulison CE&P WMF
Location ID: 149006
Inspection Date: December 30, 31, 2019

COLORADO
Oil & Gas Conservation
Commission
Department of Natural Resources

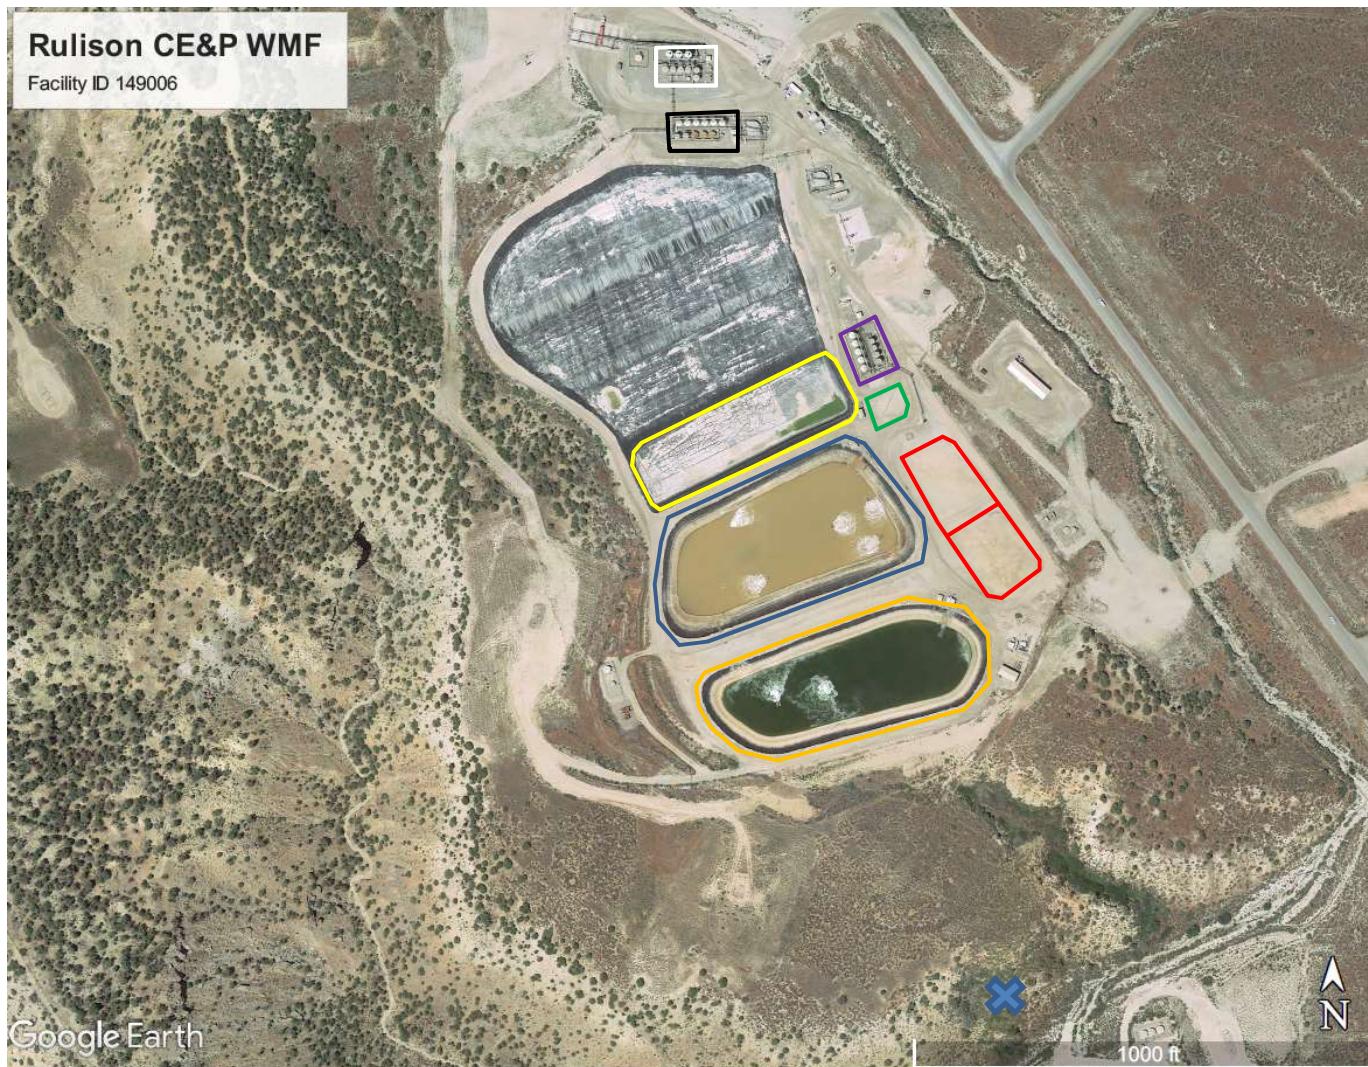
Aerial view of the location. The blue cross is a seep located south of the location.

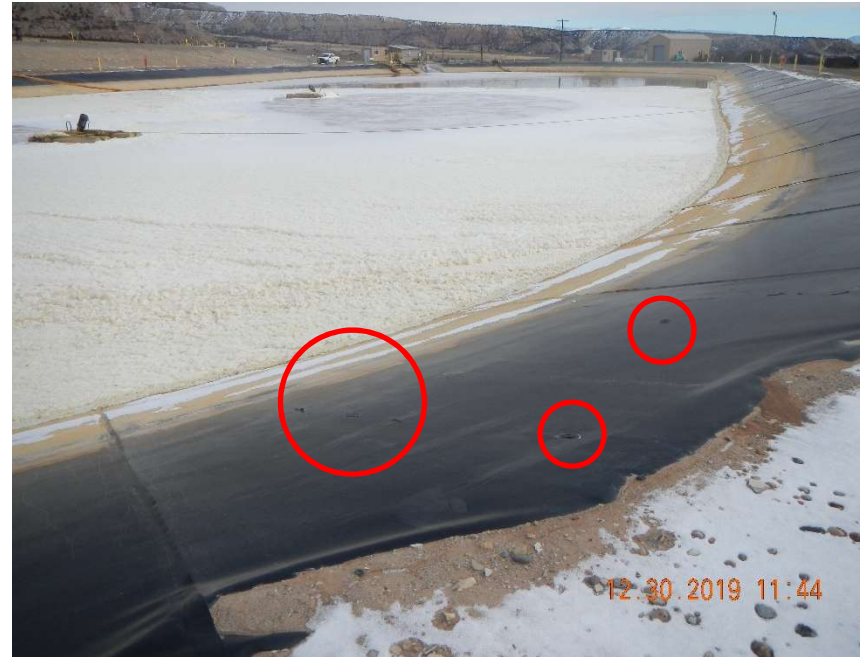
Photo #2 – Various size patches on the pit liner (Red circles).

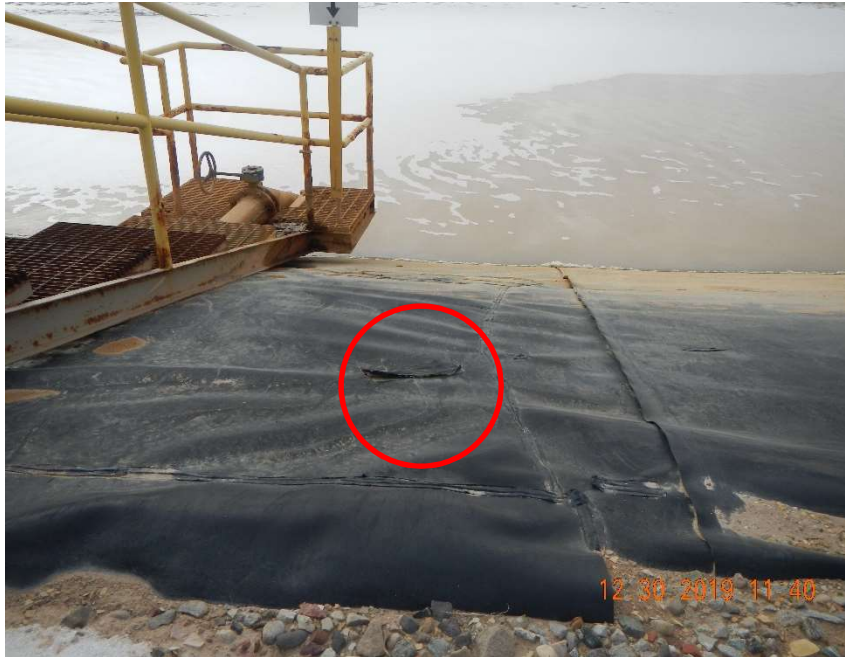
Photo #3 – Patch in disrepair on the northeast corner of the pit liner (Red circle) and a flowline penetrating the liner.

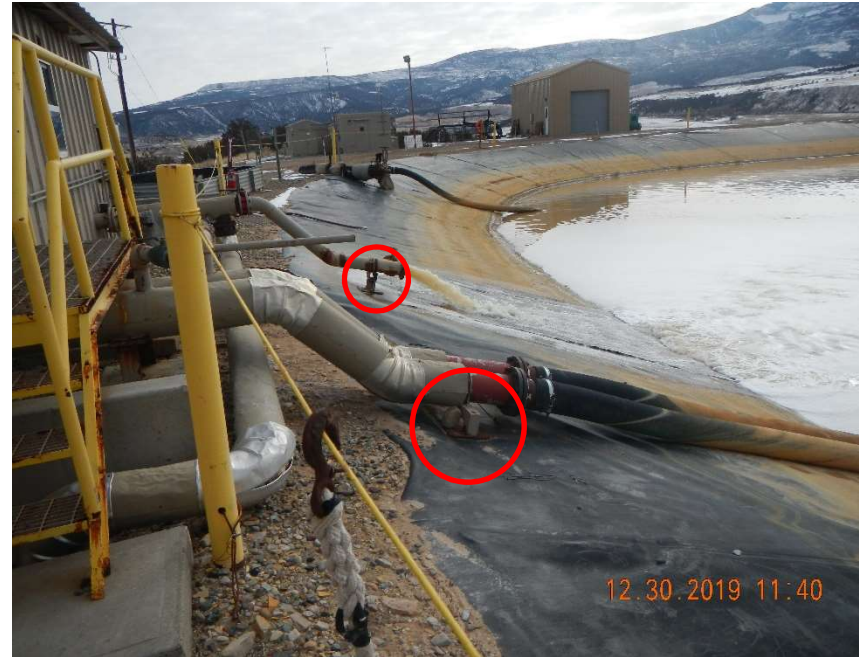
Photo #4 – Metal flowline supports resting directly on the pit liner (Red circles) and staining on the pit liner.

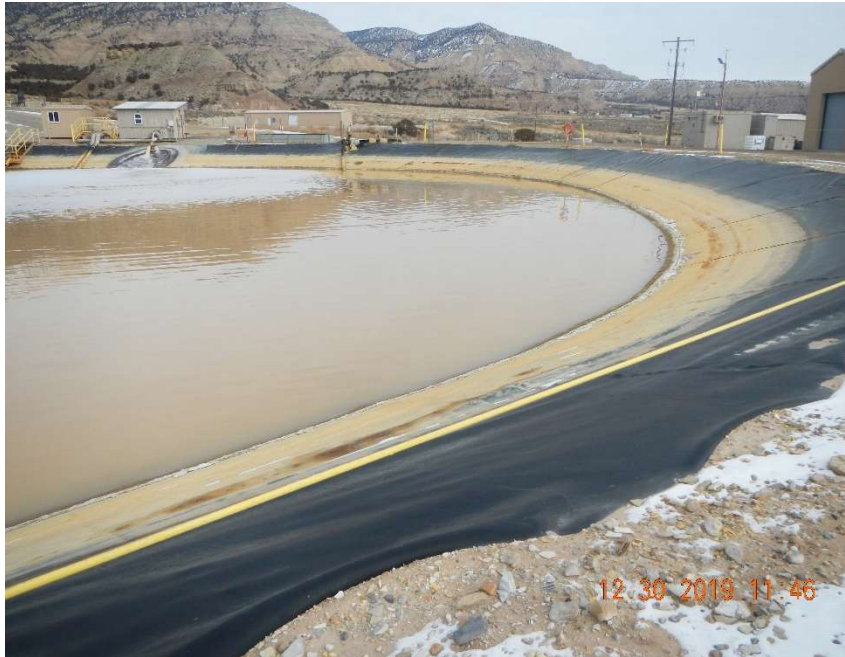
Photo #5 – Four feet of freeboard and staining on the pit liner.

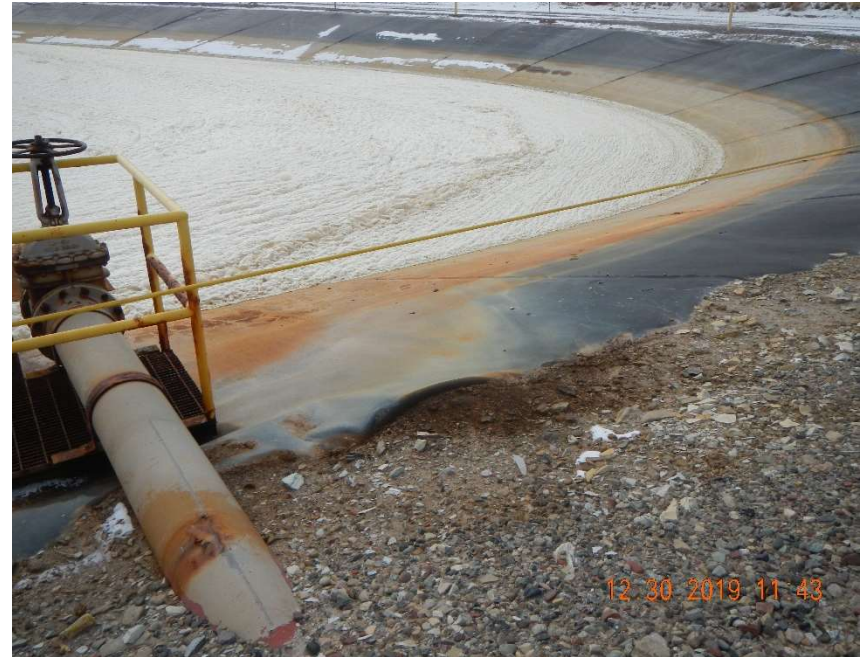
Photo #6 – Impacted soil located on the north side of the pit and staining on the pit liner.

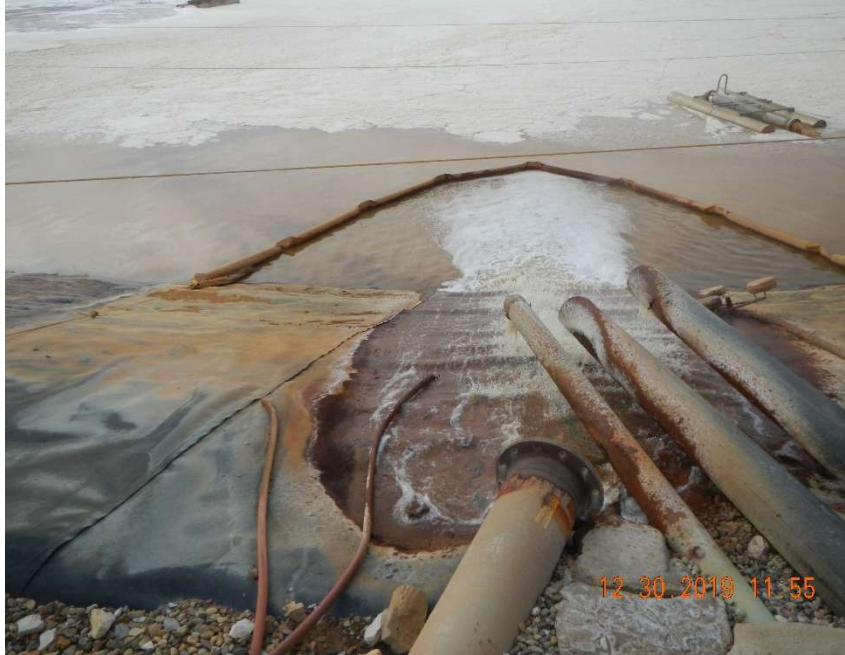
Photo #7 – Hydrocarbons on the east side of the pit.

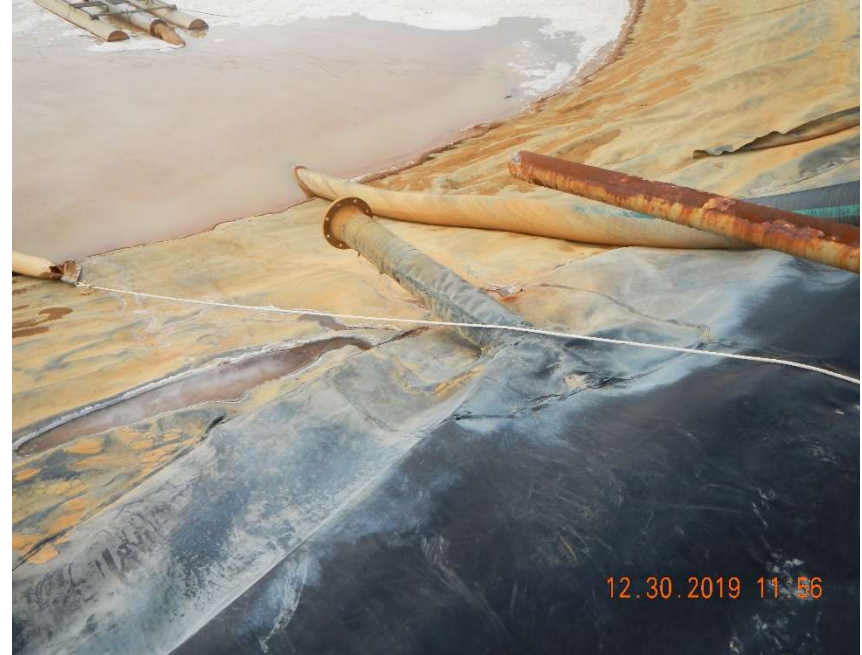
Photo #8 – Flowline penetrating the liner on the east side of the pit.

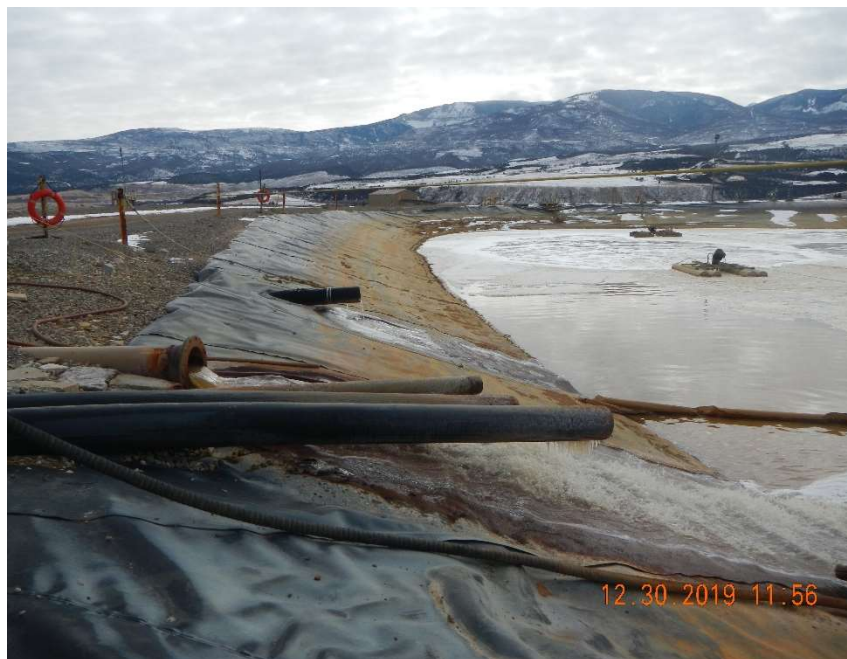
Photo #9 – Flowline penetrating the liner on the east side of the pit.

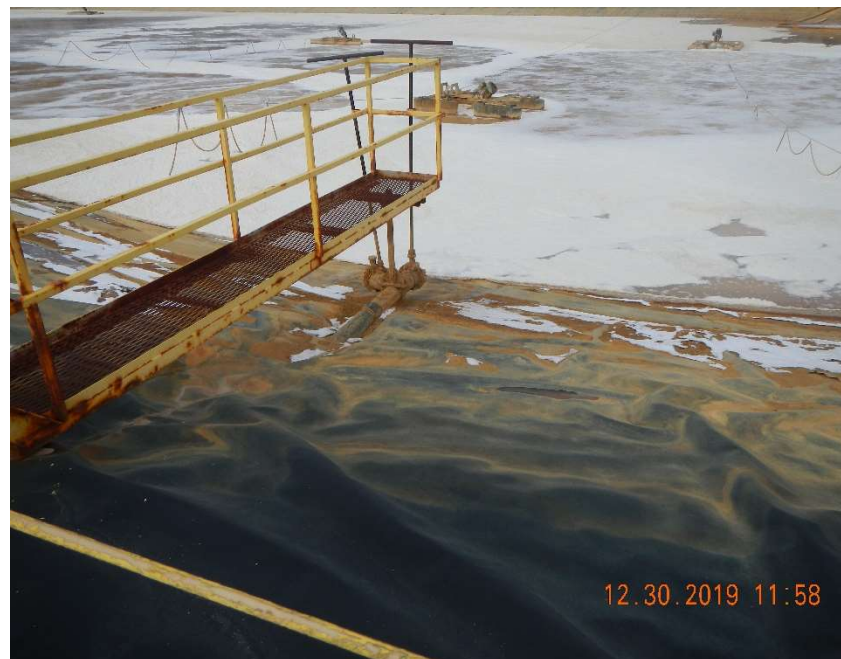
Photo #10 – Flowline penetrating the liner on the south side of the pit.

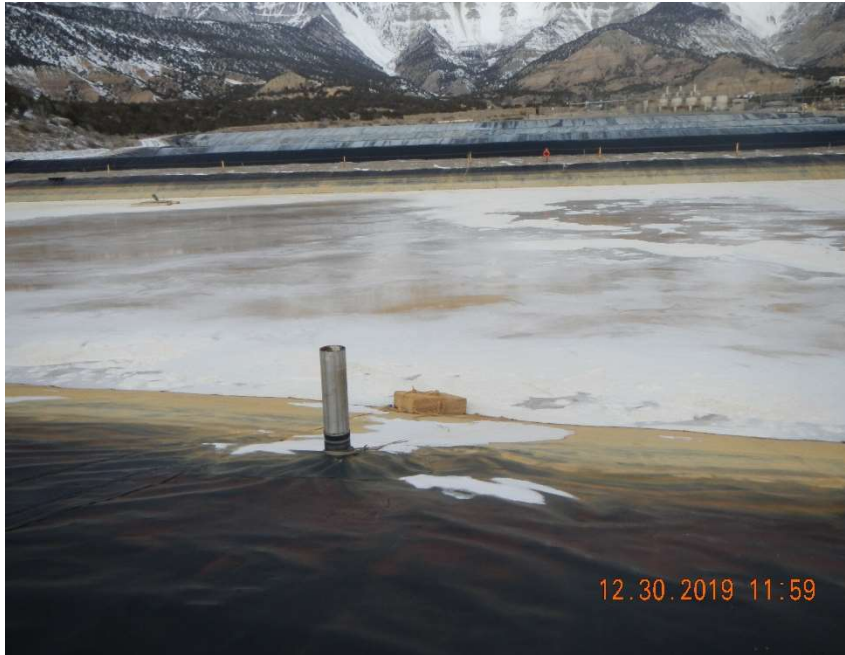
Photo #11 - Flowline penetrating the liner on the south side of the pit.

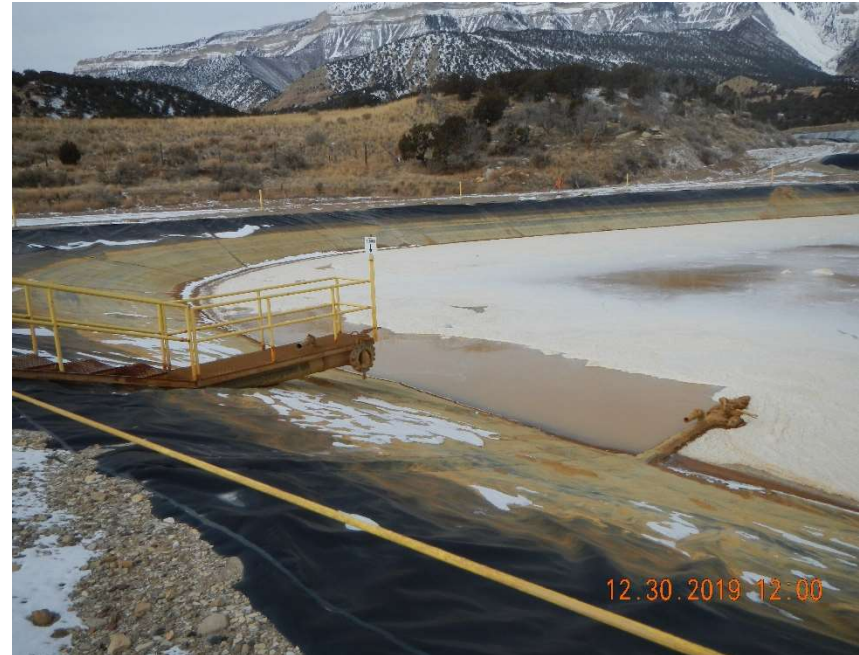
Photo #12 – Flowlines penetrating the liner on the south side of the pit.

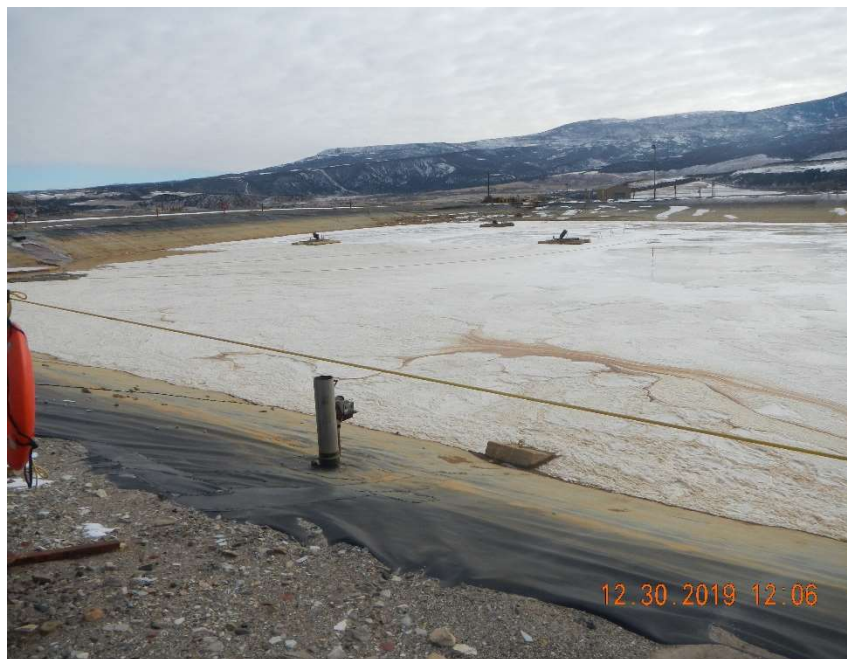
Photo #13 – Flowline penetrating the liner on the north side of the pit.

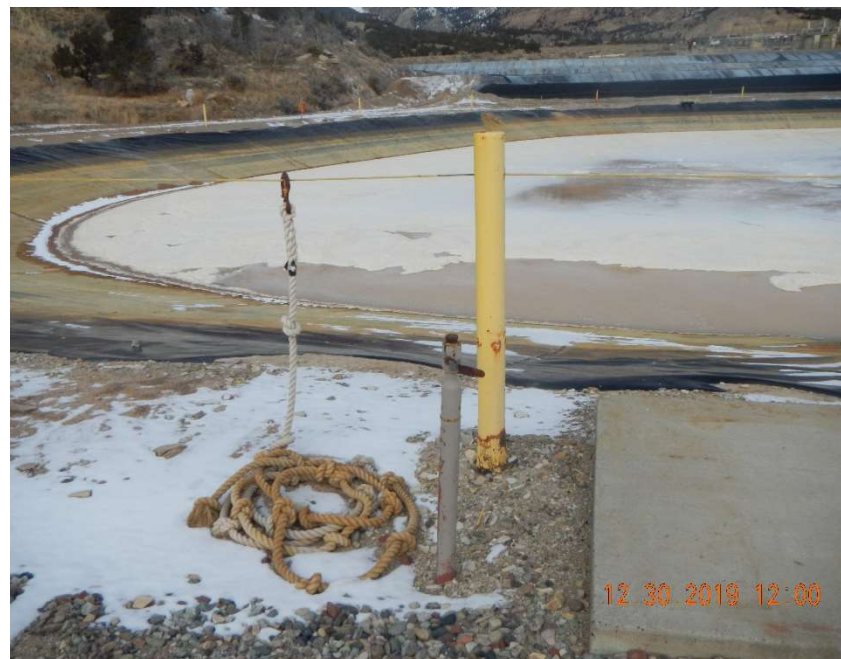
Photo #14 – Unmarked riser on the southwest corner of the pit.

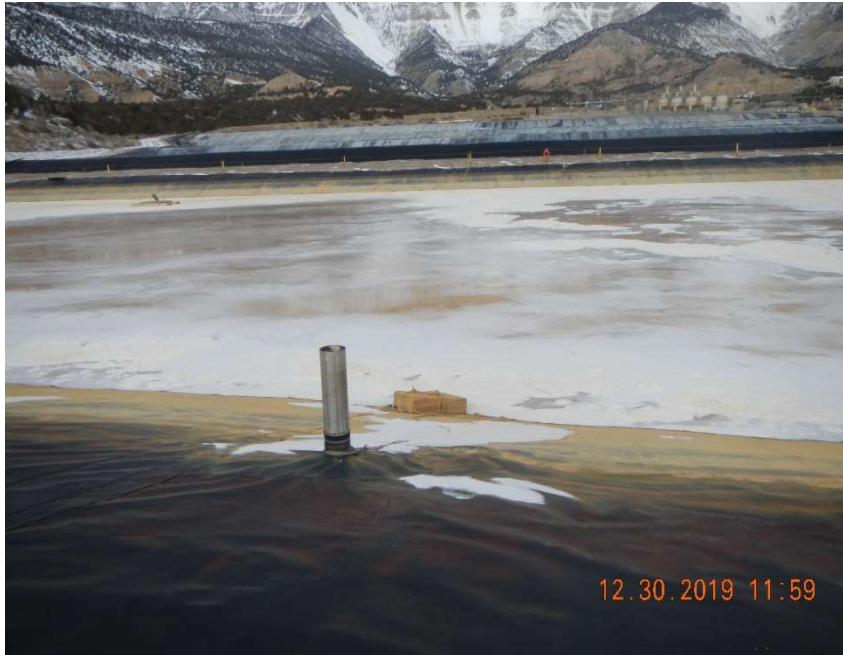
Photo #15 – Concrete anchor resting directly on the pit liner (south side).

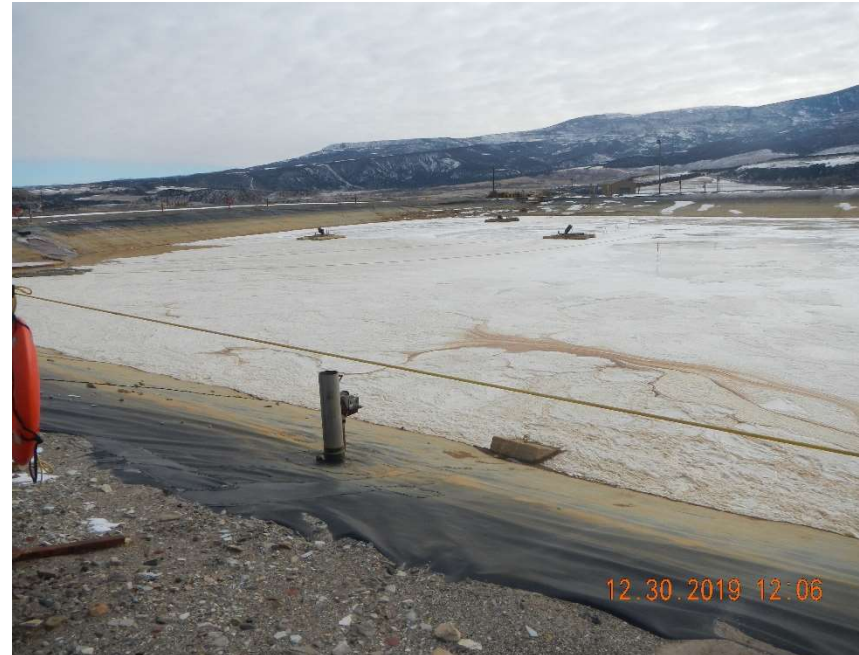
Photo #16 - Concrete anchor resting directly on the pit liner (north side).

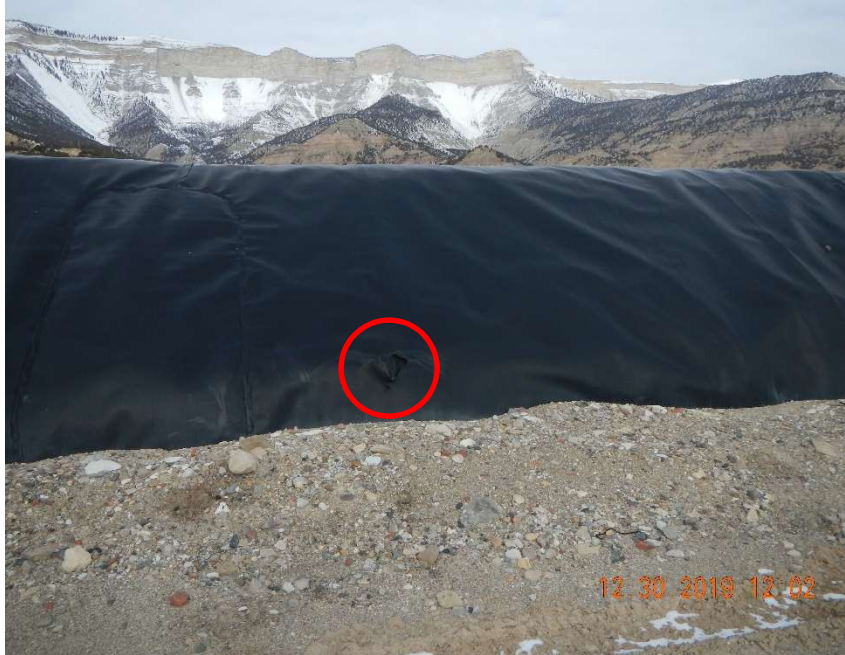
Photo #17 – 3-inch hole (Red circle) located on the southwest corner of the pit liner.

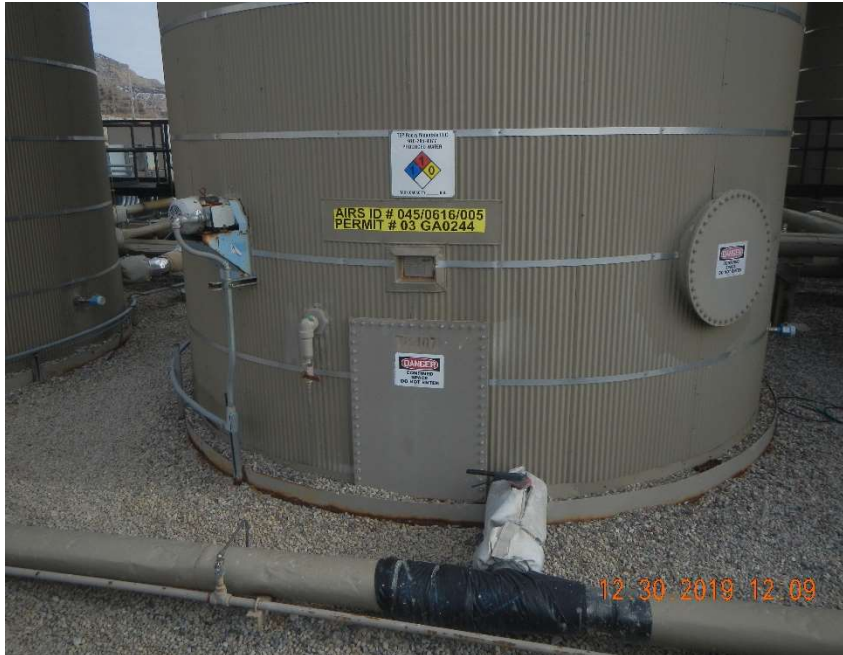
Photo #23 – One of the nine steel ASTs missing the tank capacity label.

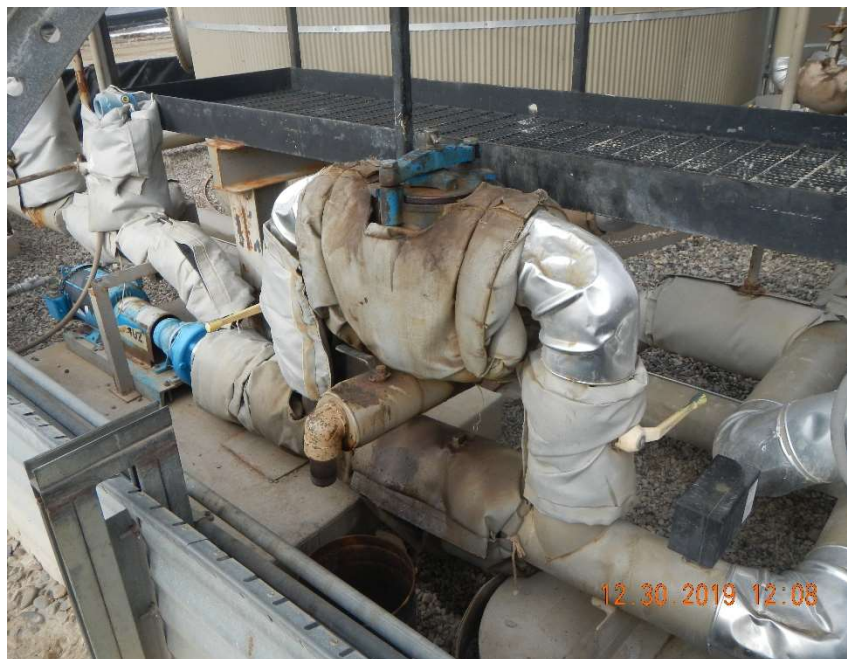
Photo #25 – Five gallon bucket containing hydrocarbons beneath a valve.

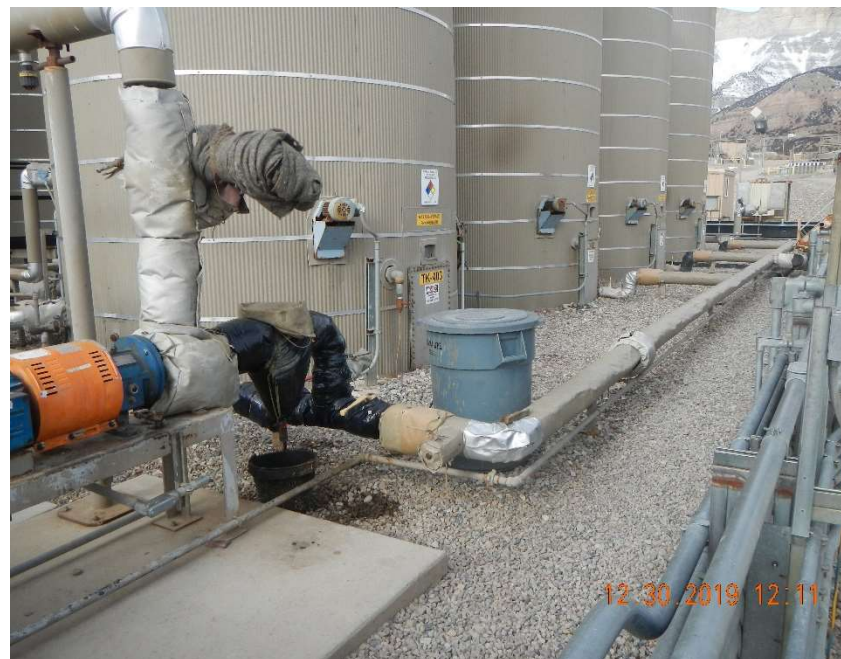
Photo #26 - Five gallon bucket containing hydrocarbons and impacted gravel beneath a valve.

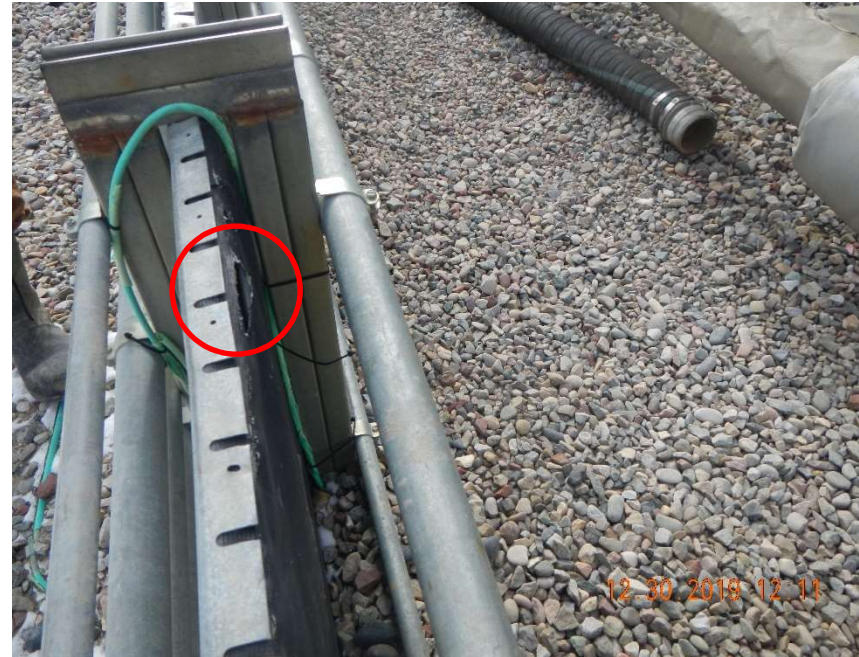
Photo #28 – 2-inch hole in the tank battery secondary containment liner (Red circle).

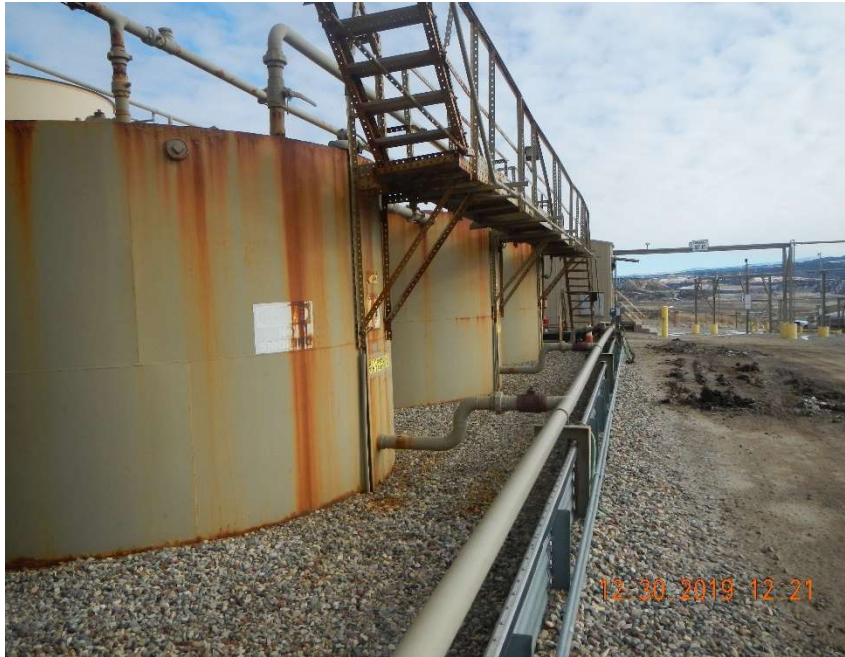
Photo #29 – Rusting three smaller steel ASTs.

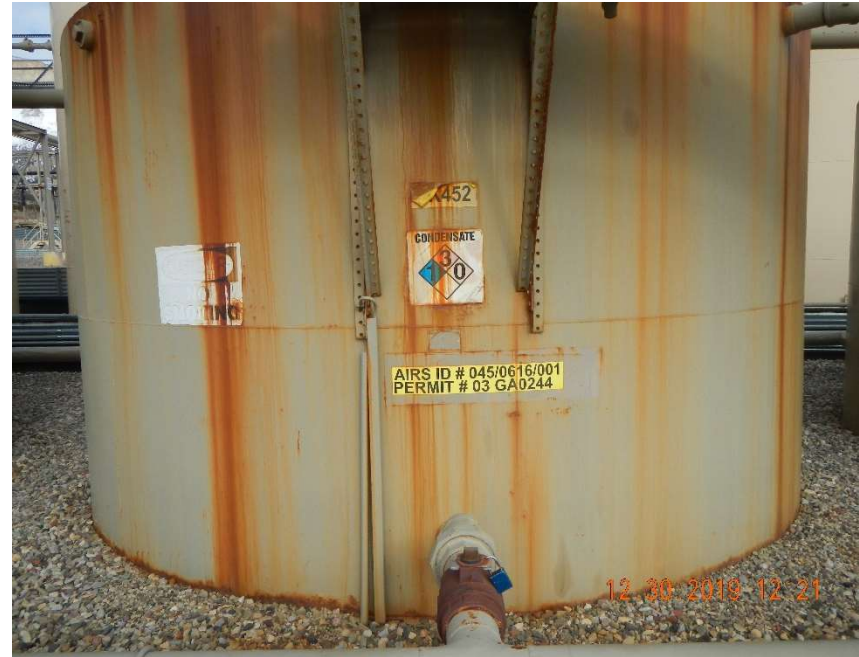
Photo #30 – One of the three rusting steel ASTs missing name of operator, operator emergency contact number and tank capacity.

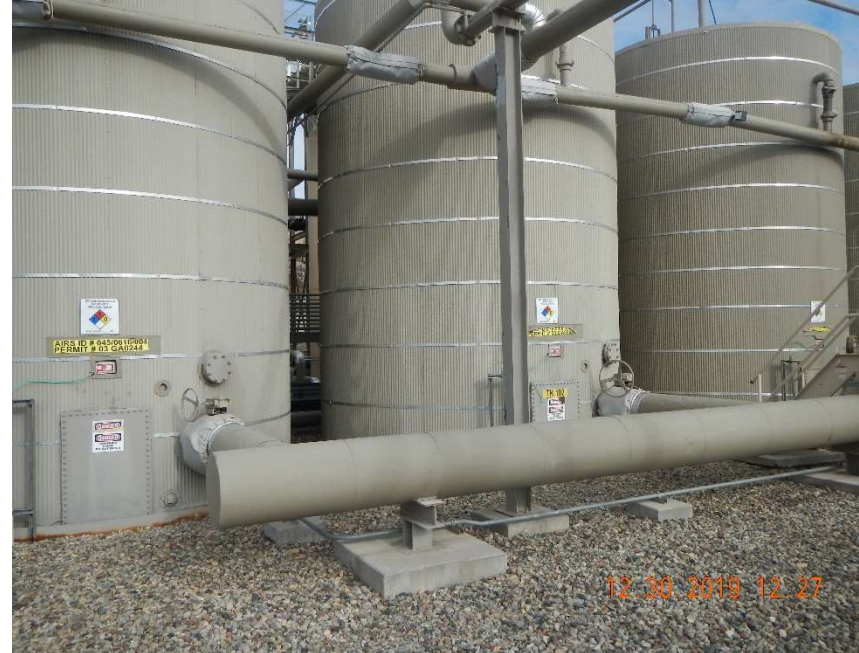
Photo #34 – Three out of the six Produced Water steel ASTs that are missing capacity labels.

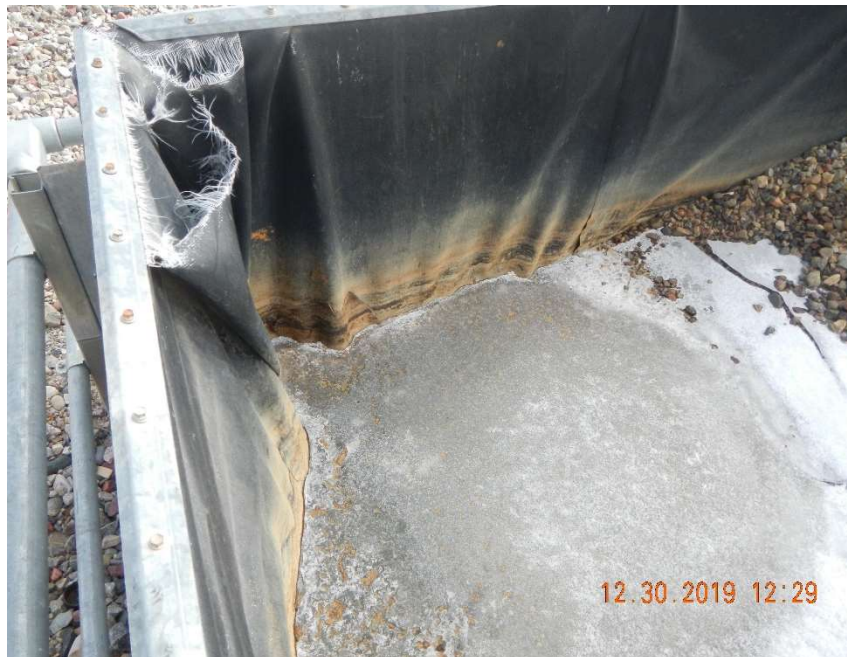
Photo #35 – Secondary containment liner in disrepair.

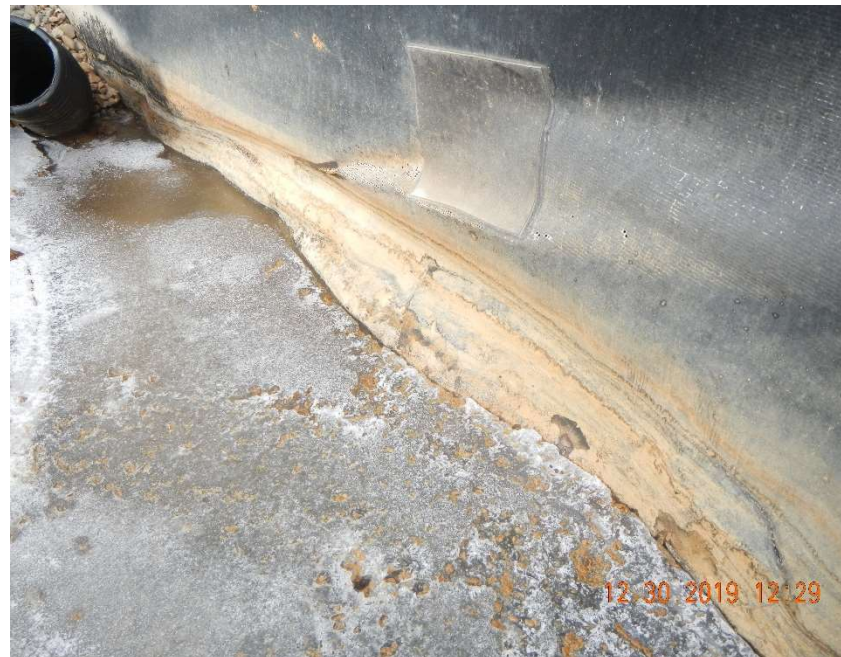
Photo #36 - Secondary containment liner in disrepair.

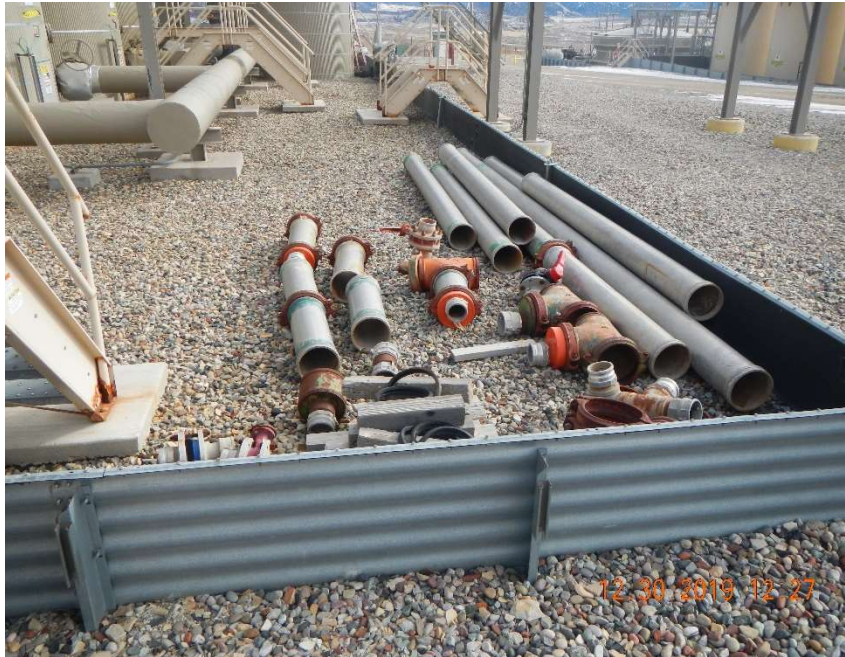
Photo #37 – Storage of pipes and fittings within the tank battery secondary containment structure.

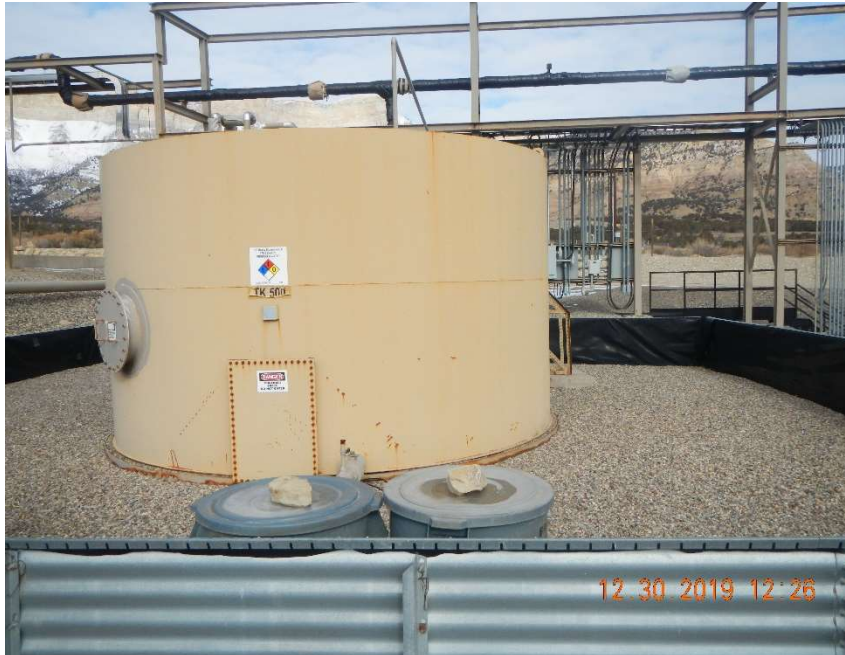
Photo #39 – TK 500 missing capacity label.

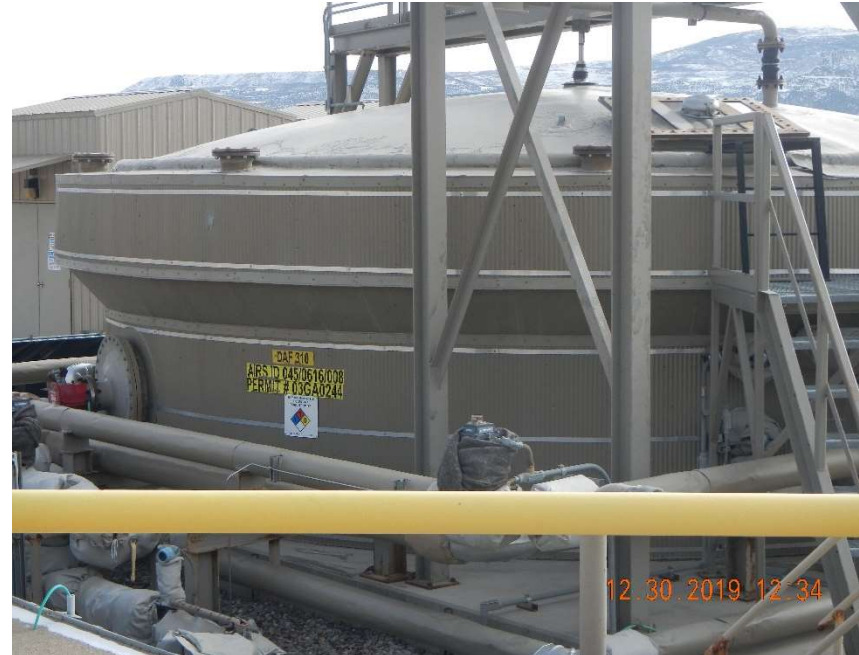
Photo #40 – DAF 310 missing capacity label.

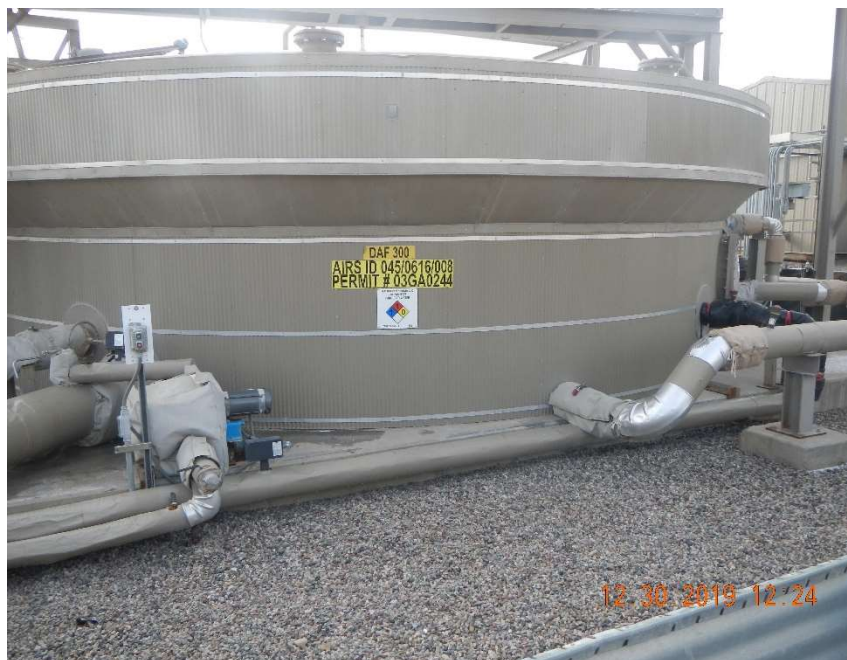
Photo #41 – DAF 300 missing capacity label.

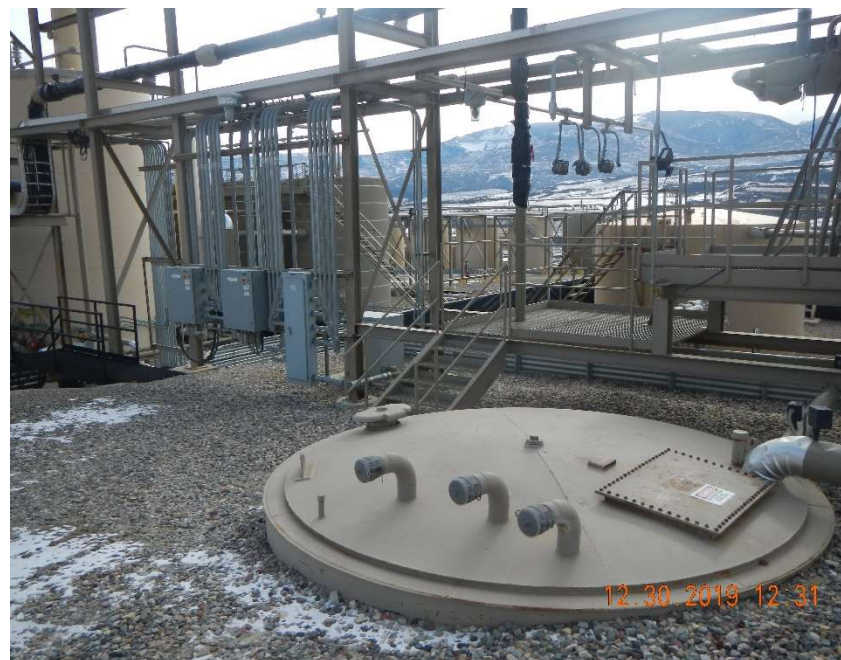
Photo #42 – Partially buried steel AST located north of TK 500.

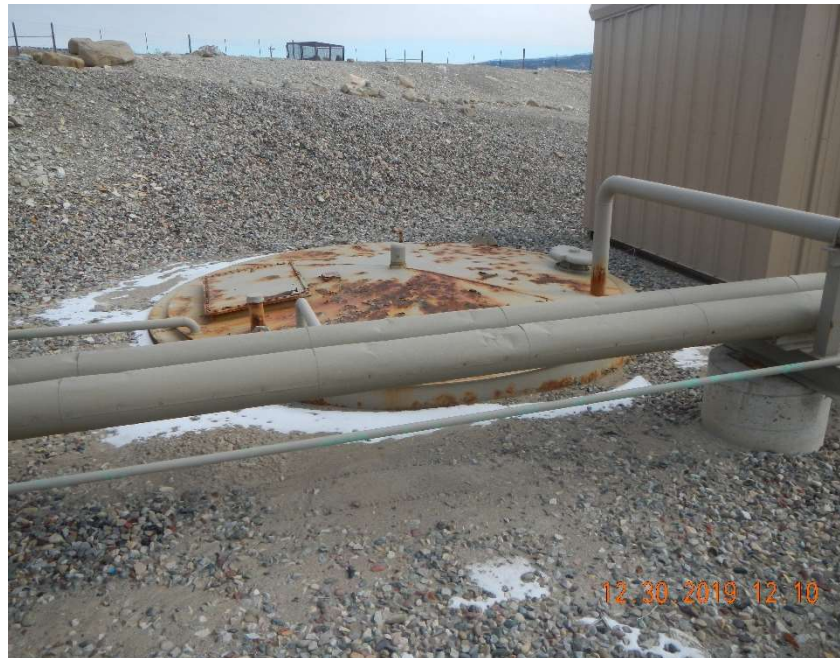
Photo #43 – Partially buried steel AST located north of the lower tank battery.
