Response to December 2, 2019 Inspection
Document Number 696501182

Name: Schaefer 13-14F

Location ID: 327830

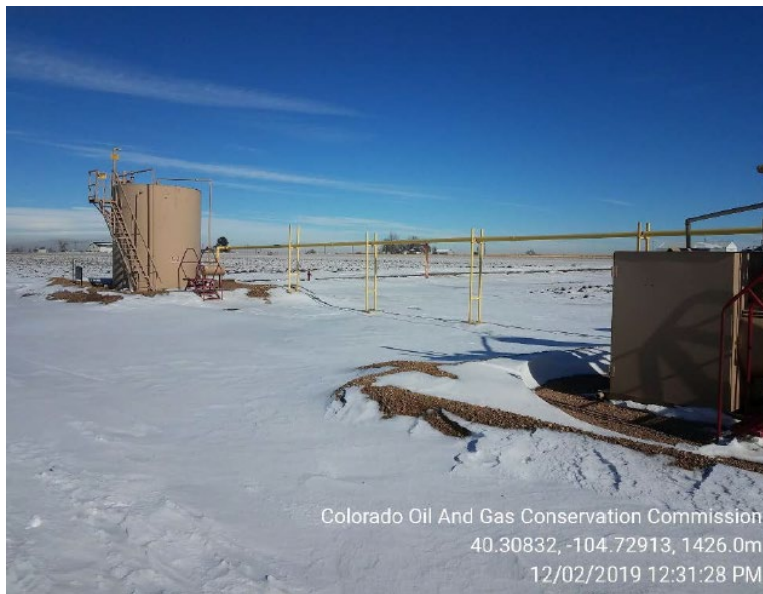
Photo 2. Production Facility

2. Tanks and Berms: Secondary containment is inadequate to contain largest single tank plus sufficient freeboard. Repair or install berms or other secondary containment devices per Rule 605.a.(4).

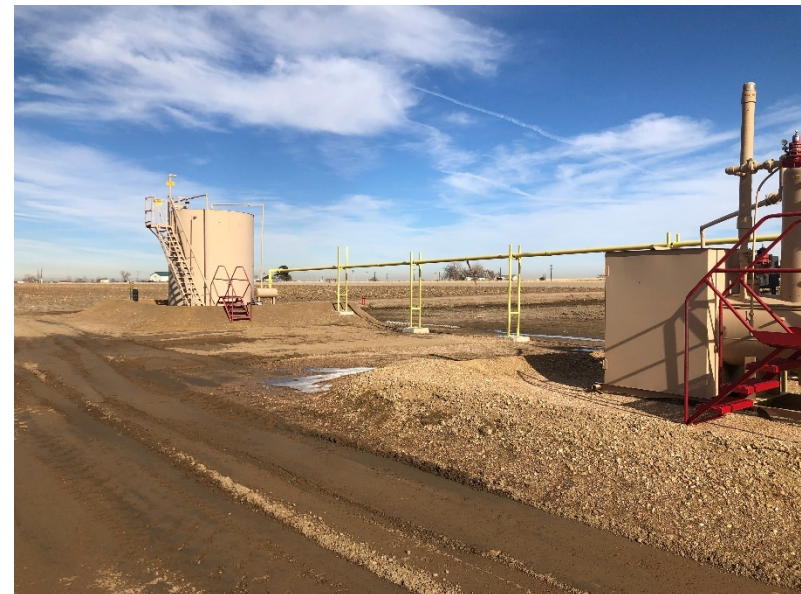
Photo NBL2. Production facility, facing northeast. Secondary containment has been repaired to provide adequate containment per 605.a.(4).

Response: Noble removed debris from the site (603.f.). The berm surrounding the crude oil tank and the produced water pit was repaired to provide adequate secondary containment [605.a.(4)]. The repaired secondary containment provides adequate storage of the largest single tank and sufficient freeboard to contain precipitation.

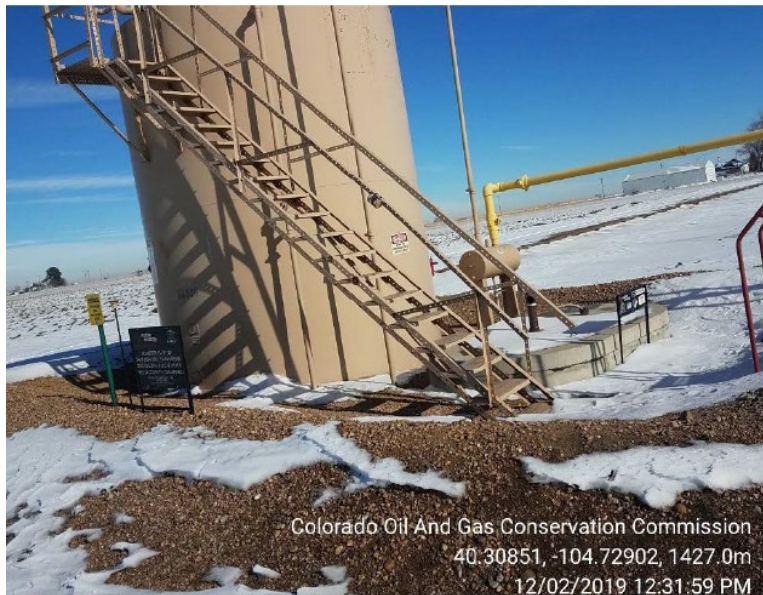
Photo 3. Crude oil tank berm

2. Tanks and Berms: Secondary containment is inadequate to contain largest single tank plus sufficient freeboard. Repair or install berms or other secondary containment devices per Rule 605.a.(4).

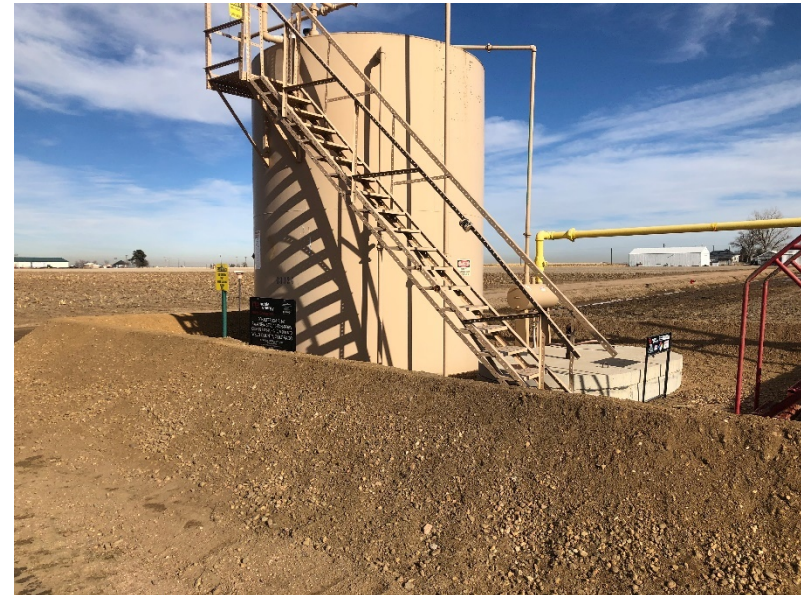
Photo NBL3. Berm surrounding crude oil tank and produced water pit, facing northeast. Secondary containment has been repaired to provide adequate containment per 605.a.(4).

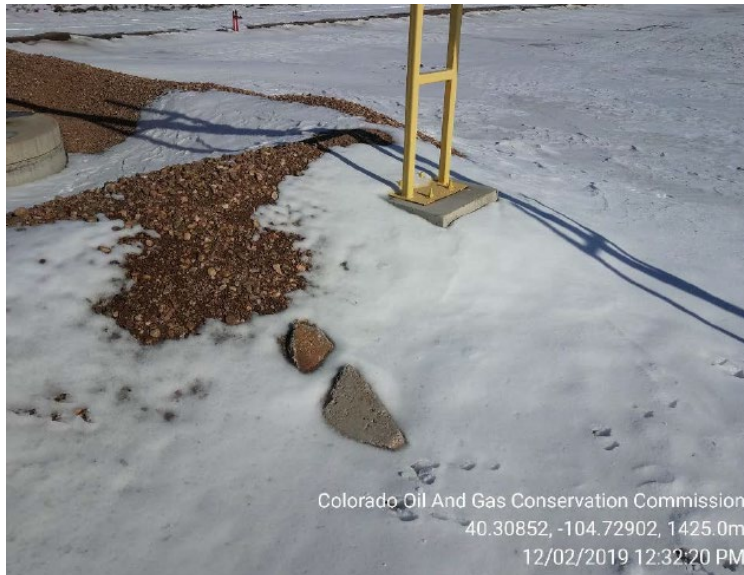
Photo 4. Trash

1. Trash: Broken concrete next to tank berm. Comply with Rule 603.f.

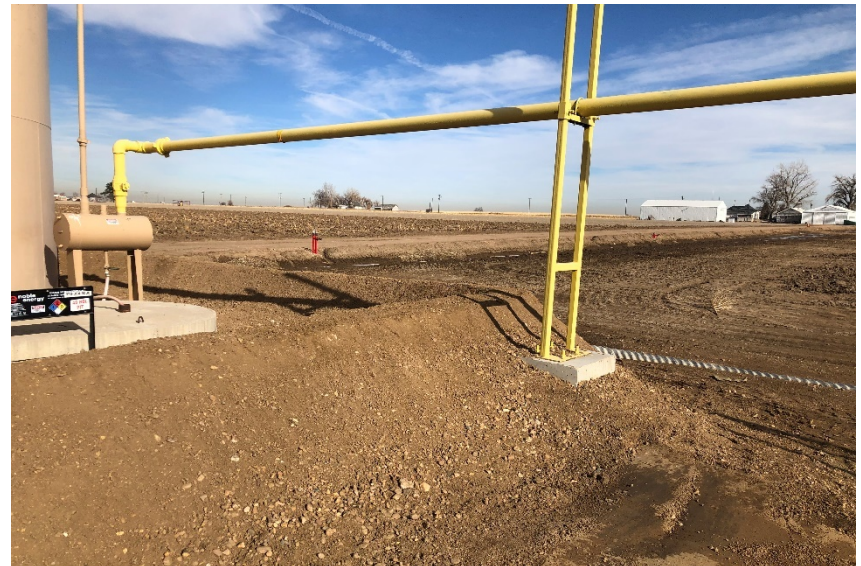
Photo NBL4. Trash has been removed from the site.
