Inspection Photos
Operator: BP America
Location/API #: 067-09471
Date: 1-15-2020

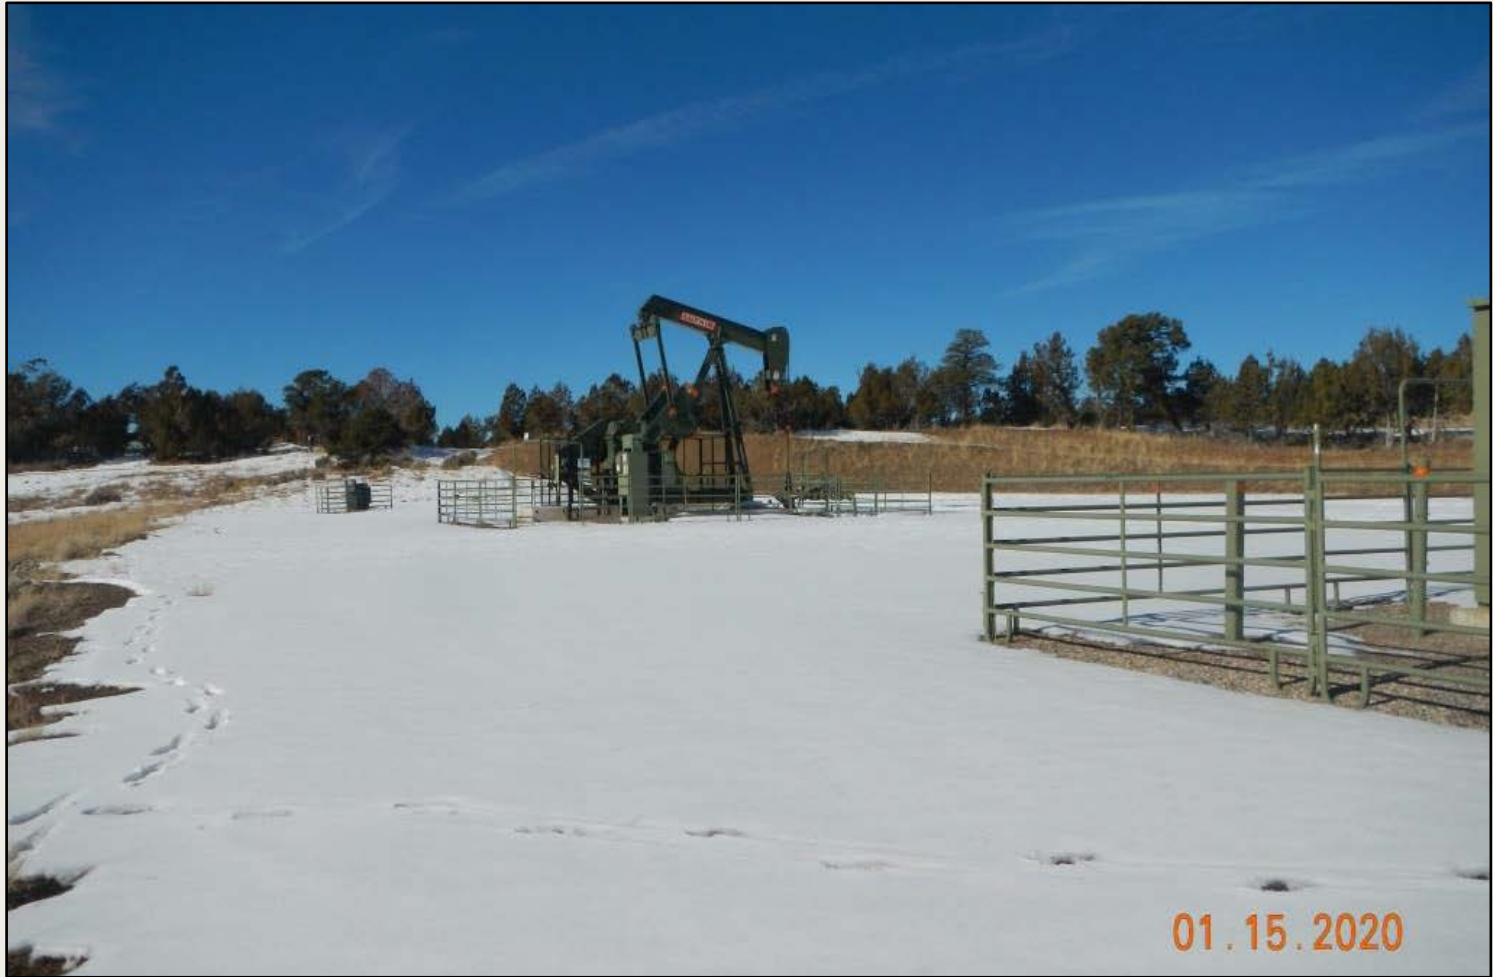
Photo 1. View of the project area from the southwestern corner facing center.

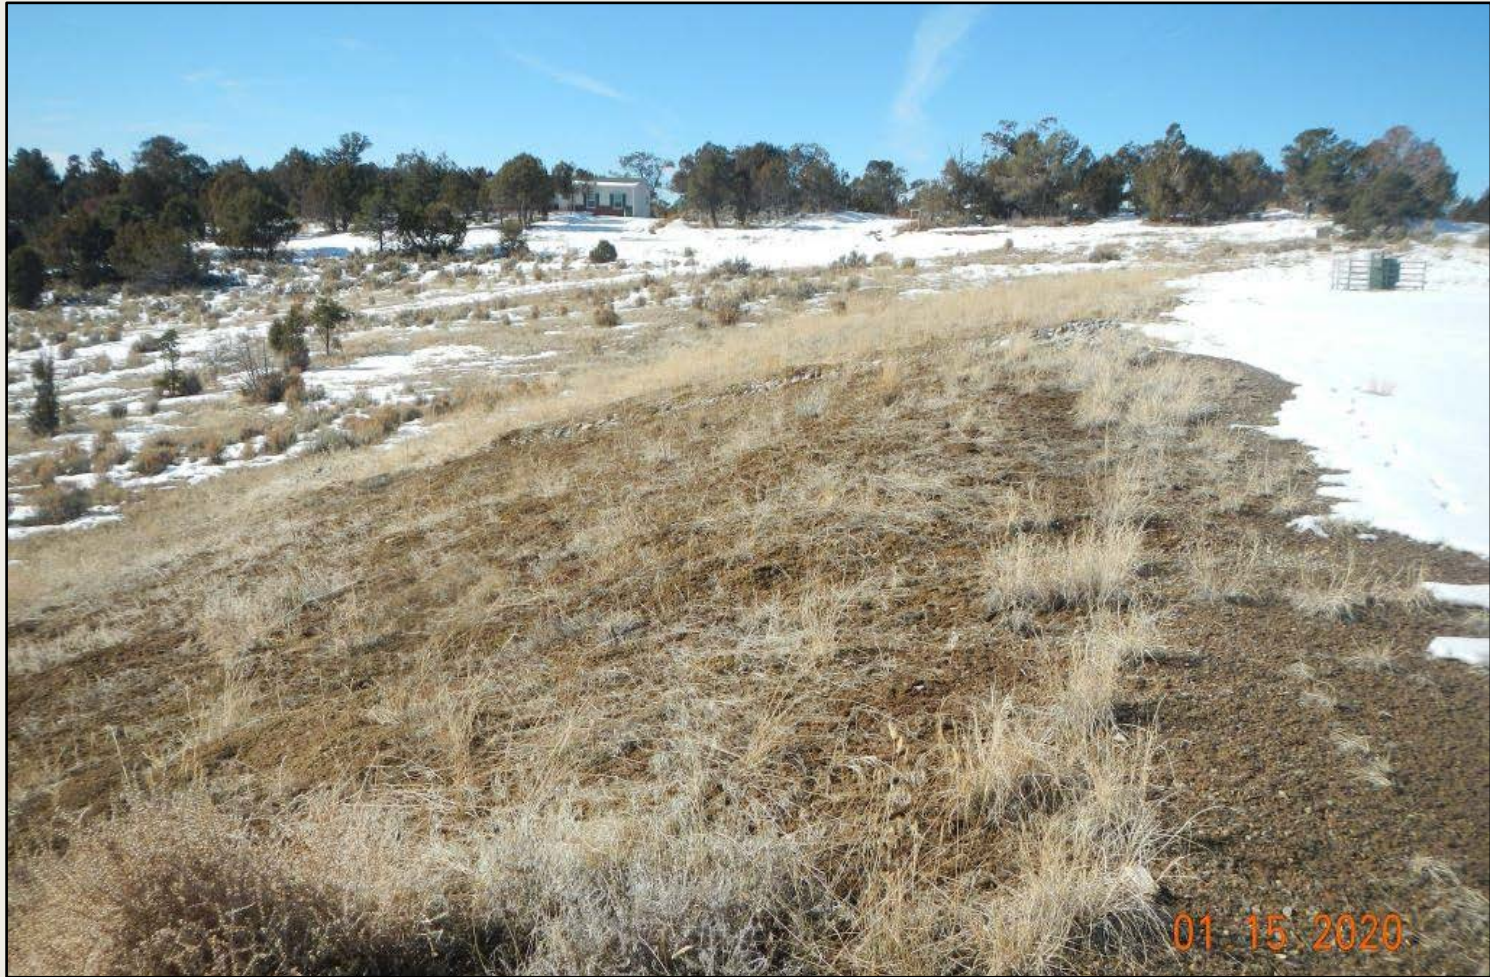
Photo 2. View of the southern fill slope from the southeastern corner facing westward. Based on operator submitted documentation, re-seeding was conducted in 2018. As vegetation is in a dormant condition, germination and revegetation success should be assessed during the active 2020 growing season.

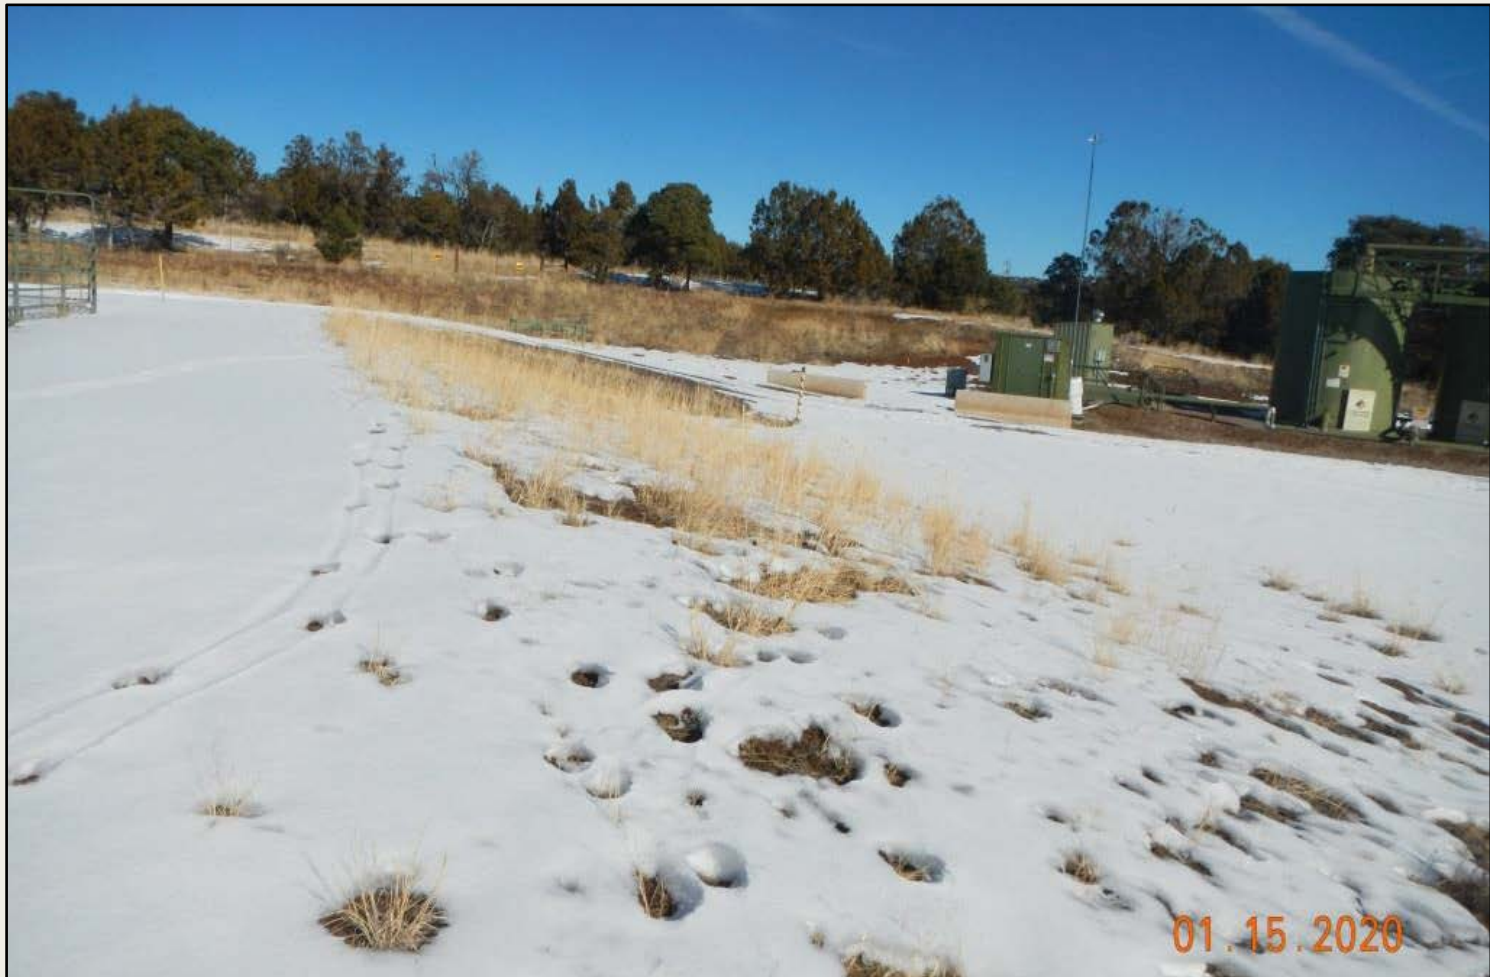
Photo 3. View of the eastern project area from the southeastern corner facing northward.

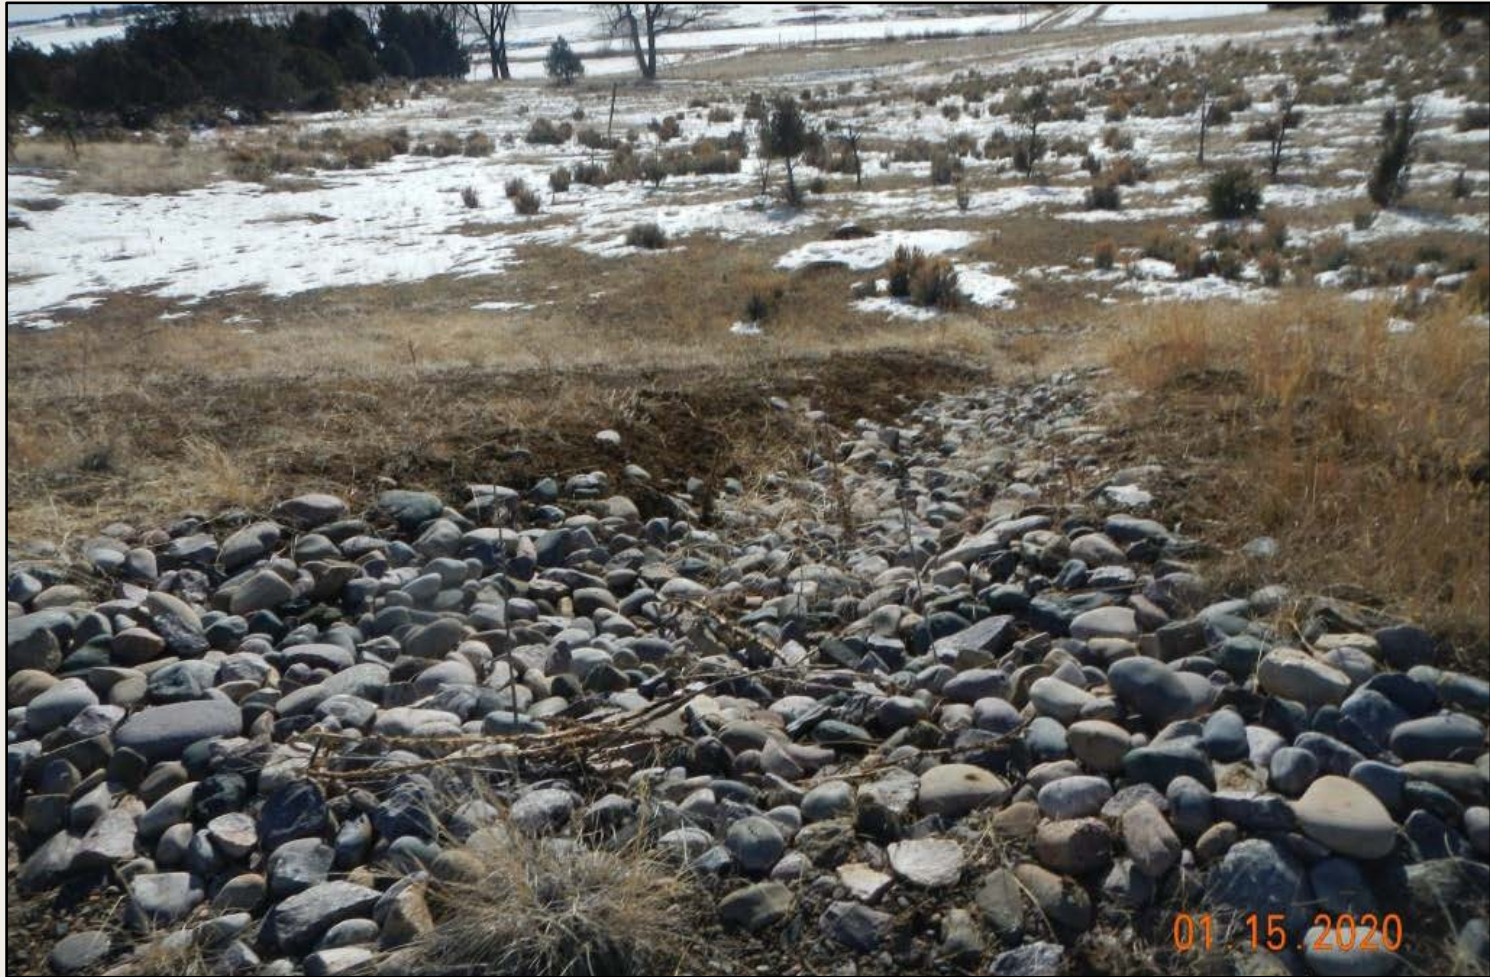
Photo 4. View of cobble run-down placed in the southern project area. Operator should note that cobble rock is not considered a BMP, as it does not effectively reduce energy of stormwater flows. Course rock is needed where rock is used as a stormwater BMP. Operator needs to continue to monitor stormwater erosion and apply BMPs according to good engineering practices when/where stabilization is needed.
