# Inspection Photos

API: 05-017-07813

Operator: MCCOY PETROLEUM CORPORATION

Inspection Date: 1/14/2020

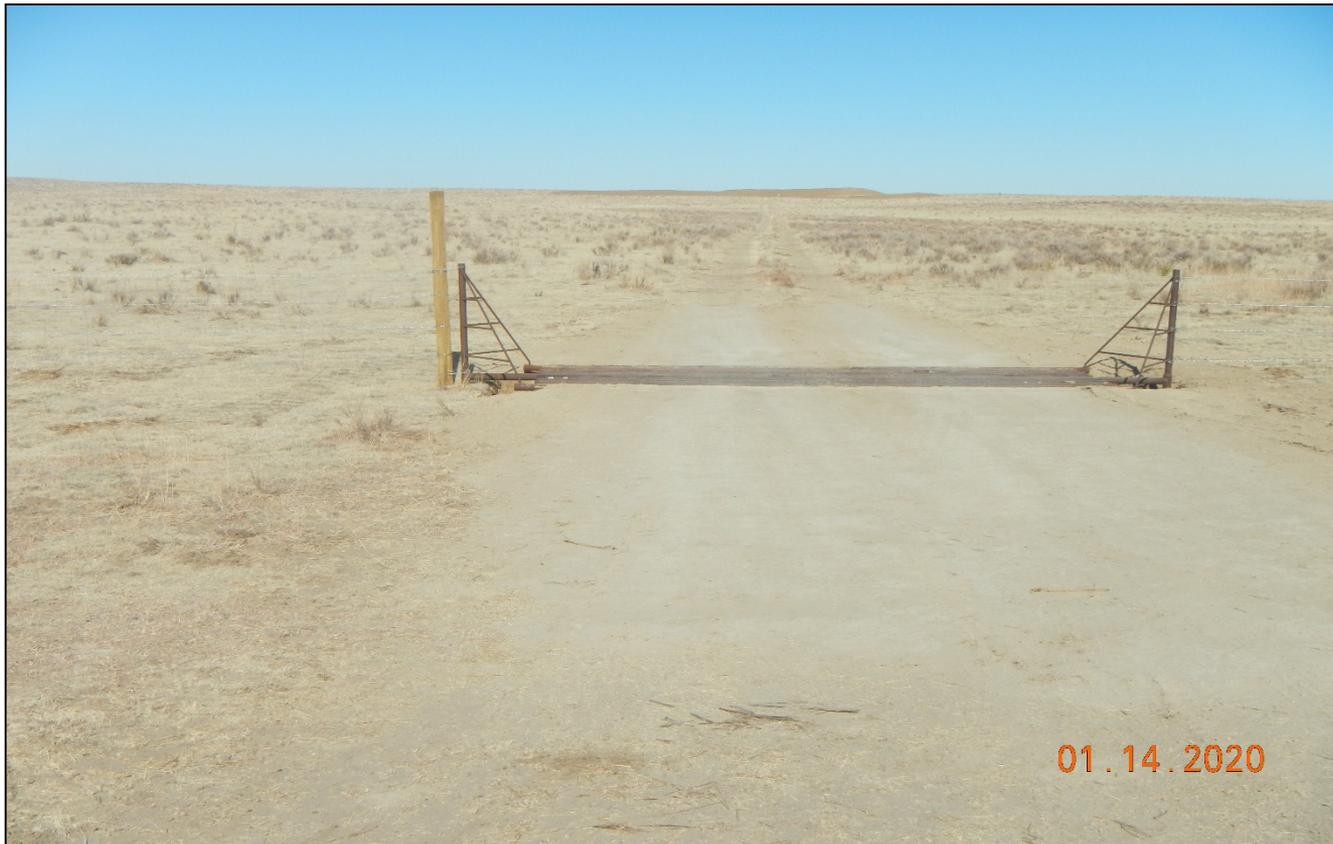
**Photo 1.** Facing north at the beginning of the access road.

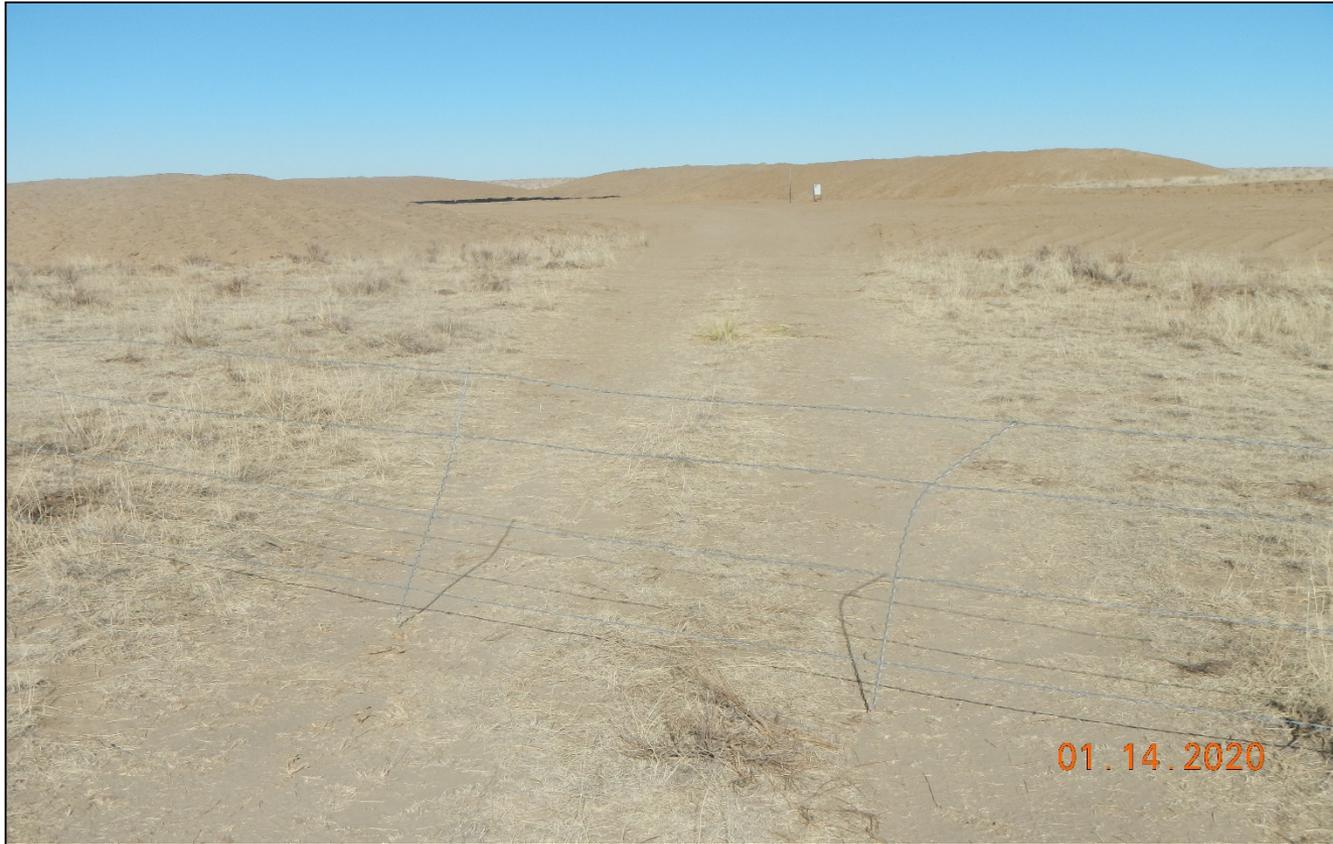
**Photo 2.** Facing north toward the location. The perimeter of the location is fenced.

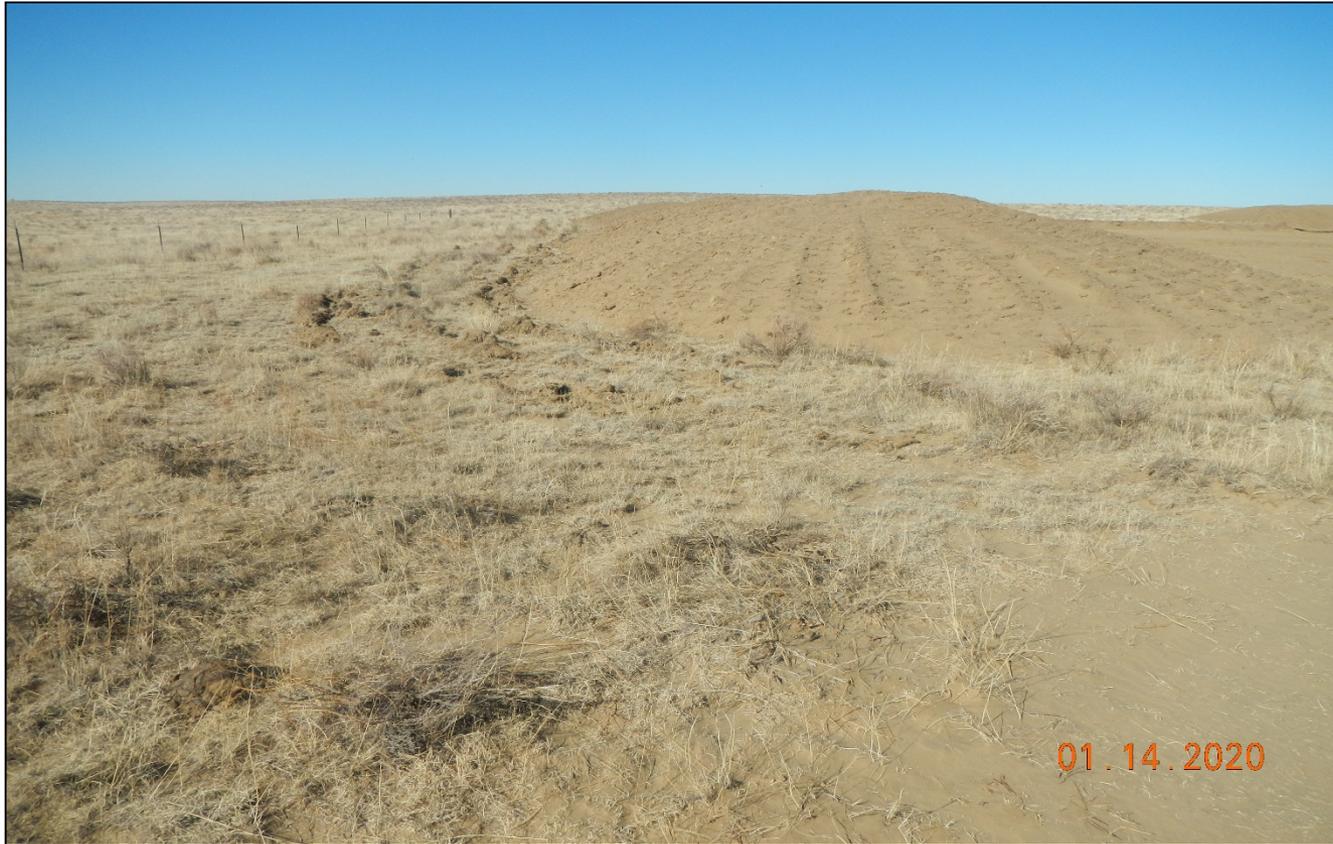
**Photo 3.** Facing toward the topsoil pile at the west side of the location. Surface roughening has occurred around the perimeter.

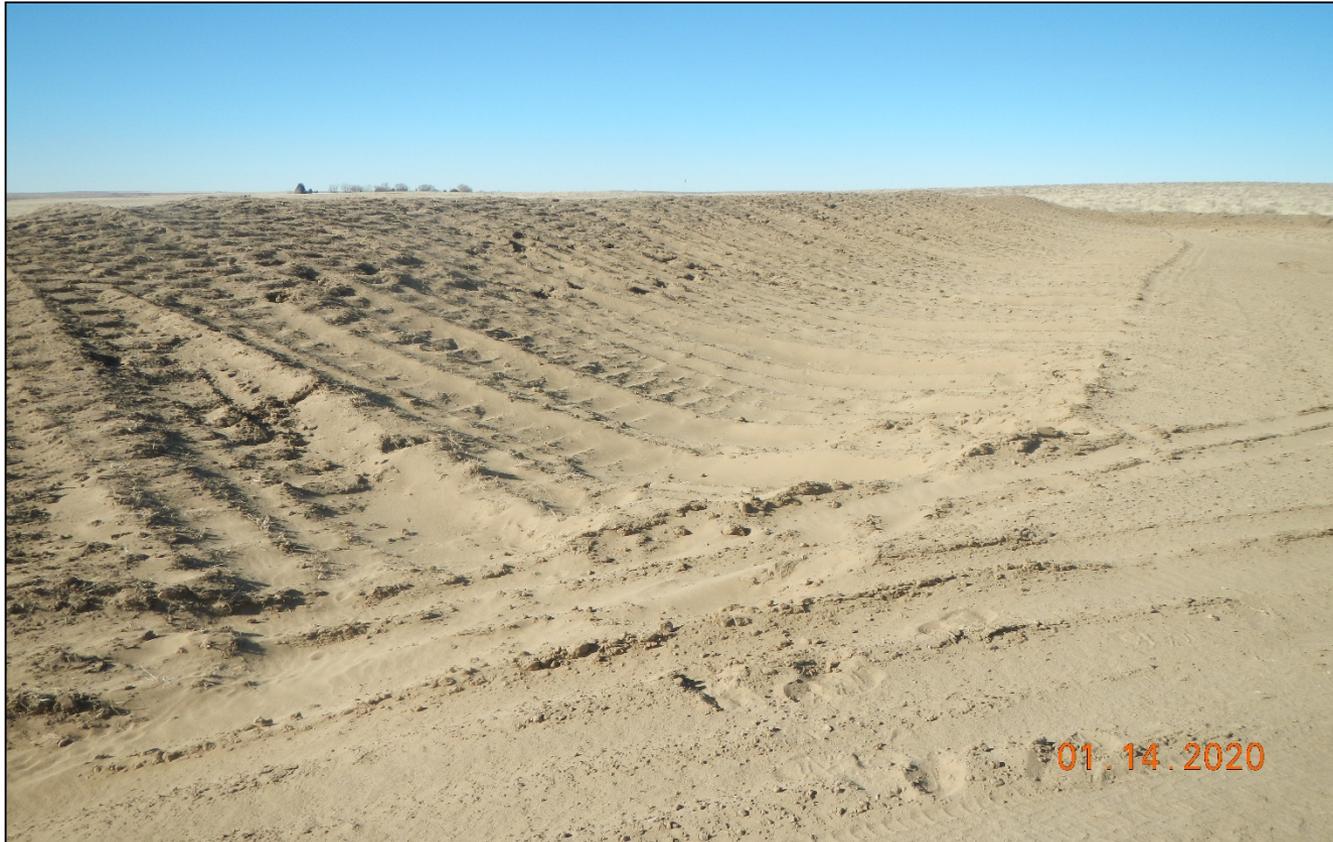
**Photo 4.** Topsoil pile at west side of the location has been tracked in. The soils are sandy and susceptible to wind erosion. Additional BMP's will be needed for stabilization.

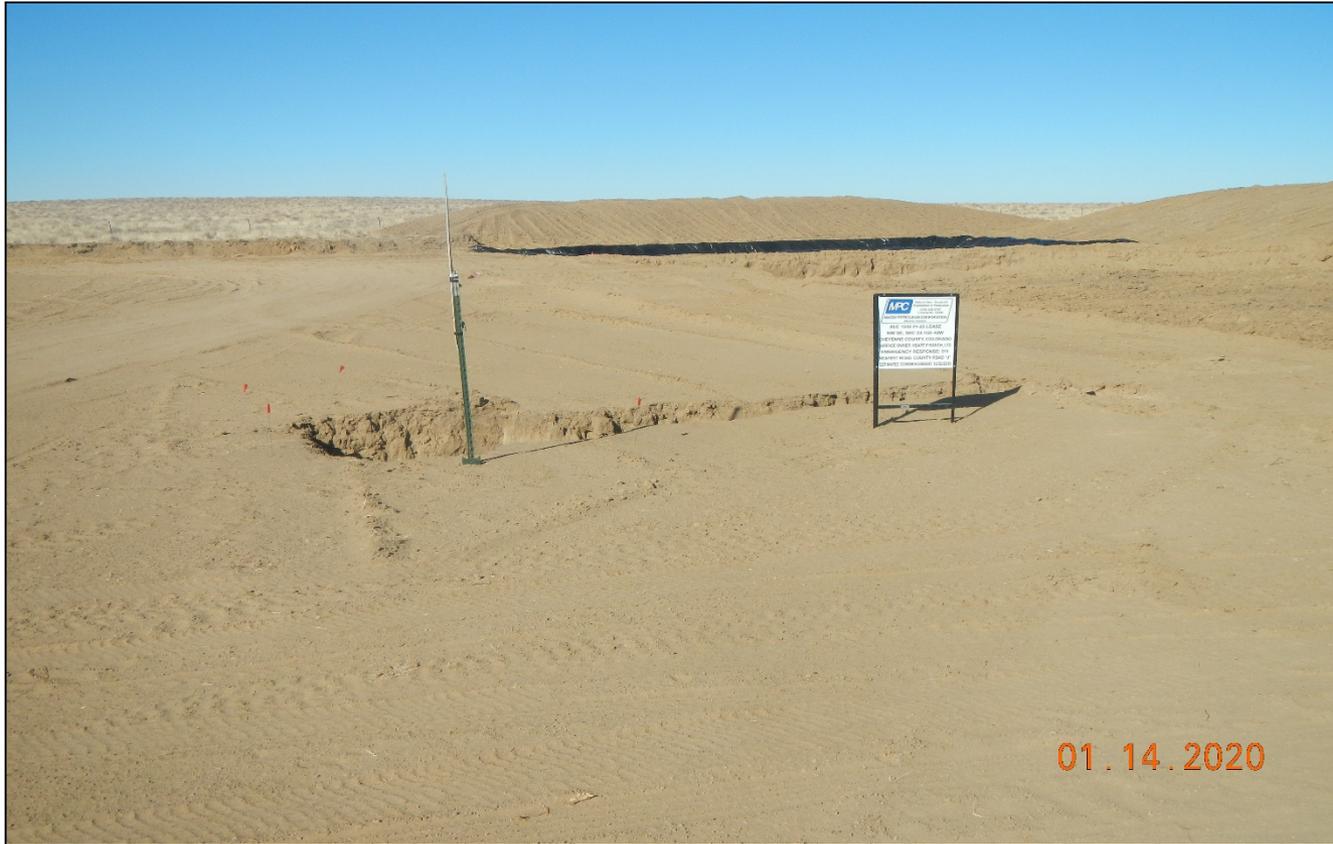
**Photo 5.** Well sign posted at the center of the location.

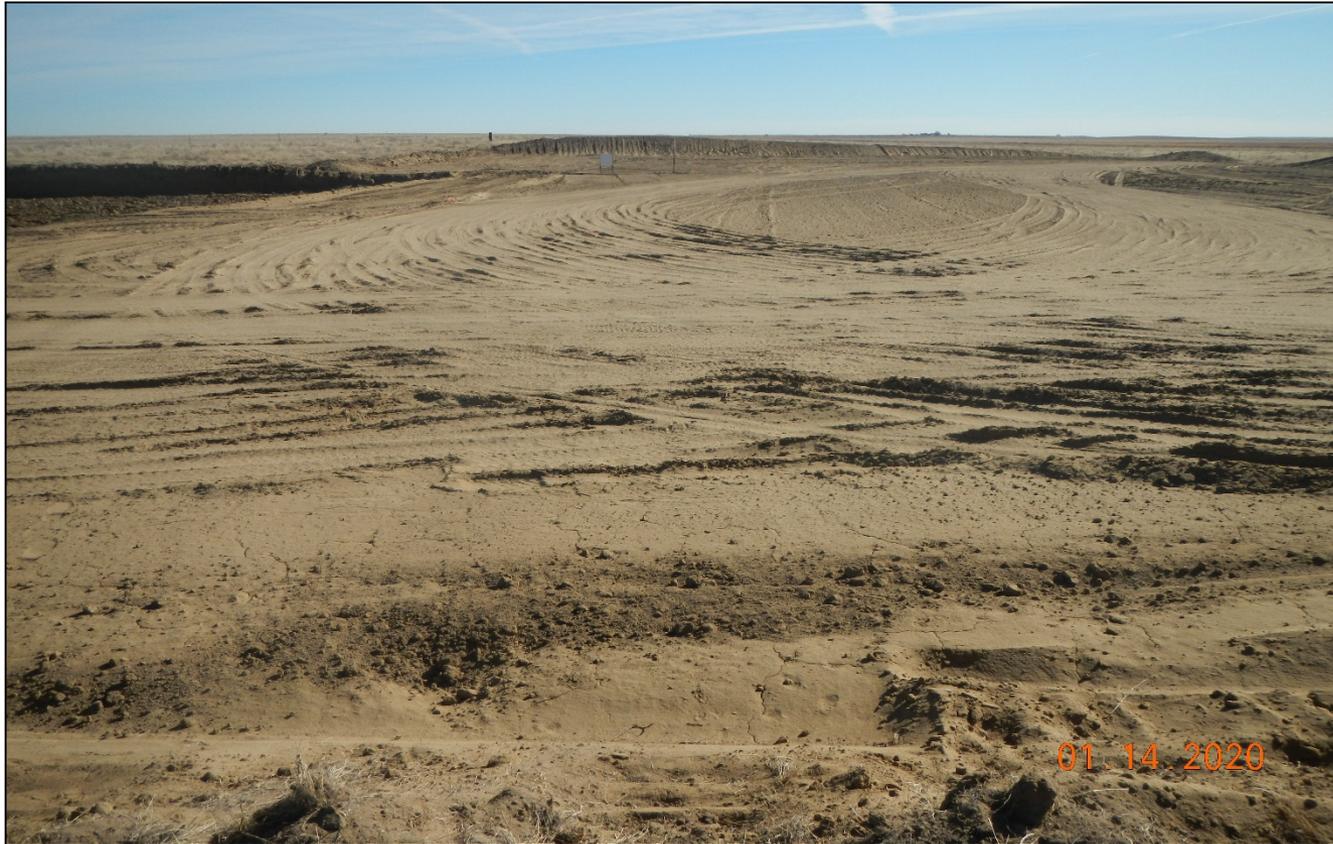
**Photo 6.** North side of the location facing south.
