Inspection Photos

API: 05-017-07718

Operator: VECTA OIL & GAS

Inspection Date: 1/14/2020

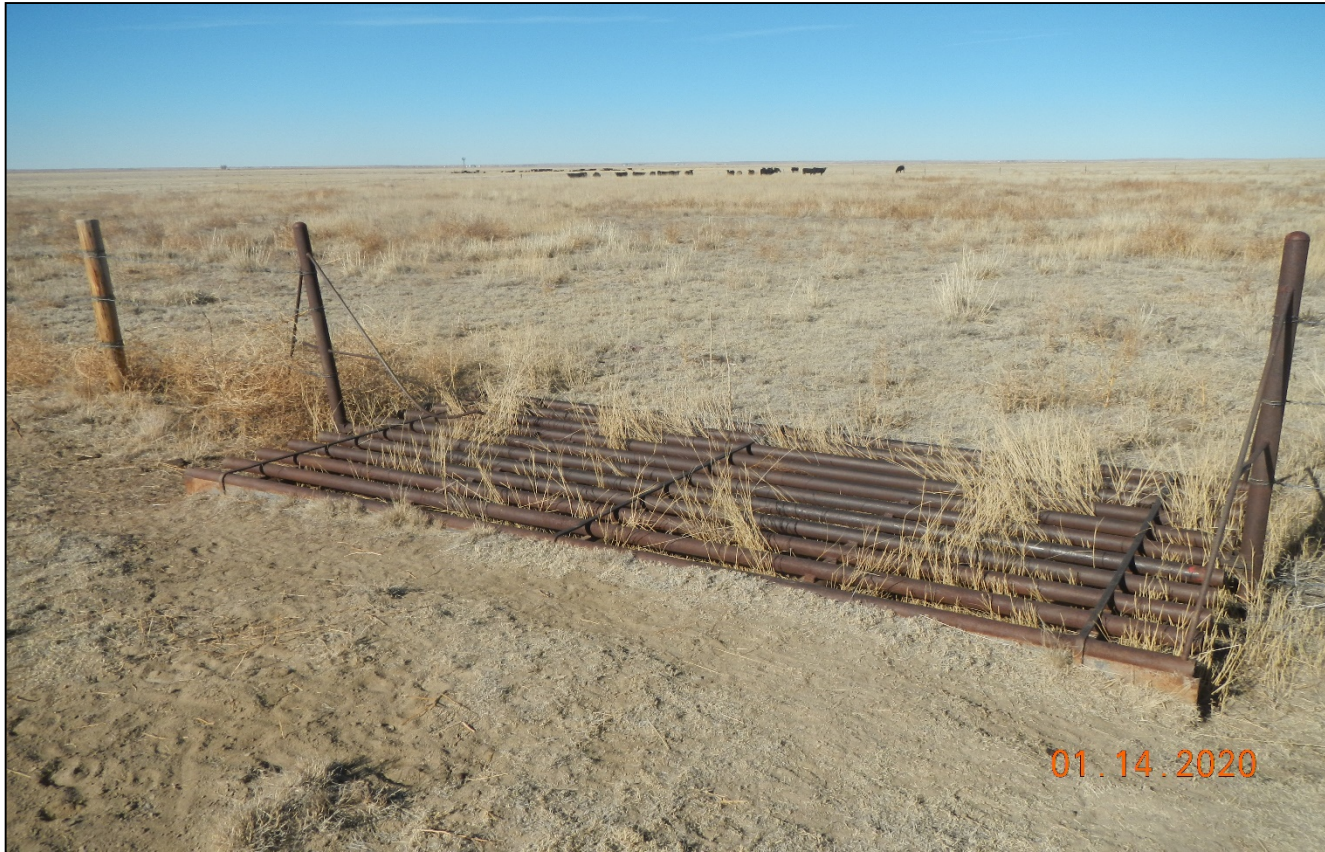
Photo 1. Facing north toward the location. The perimeter of the location is fenced and this cattle guard remains.

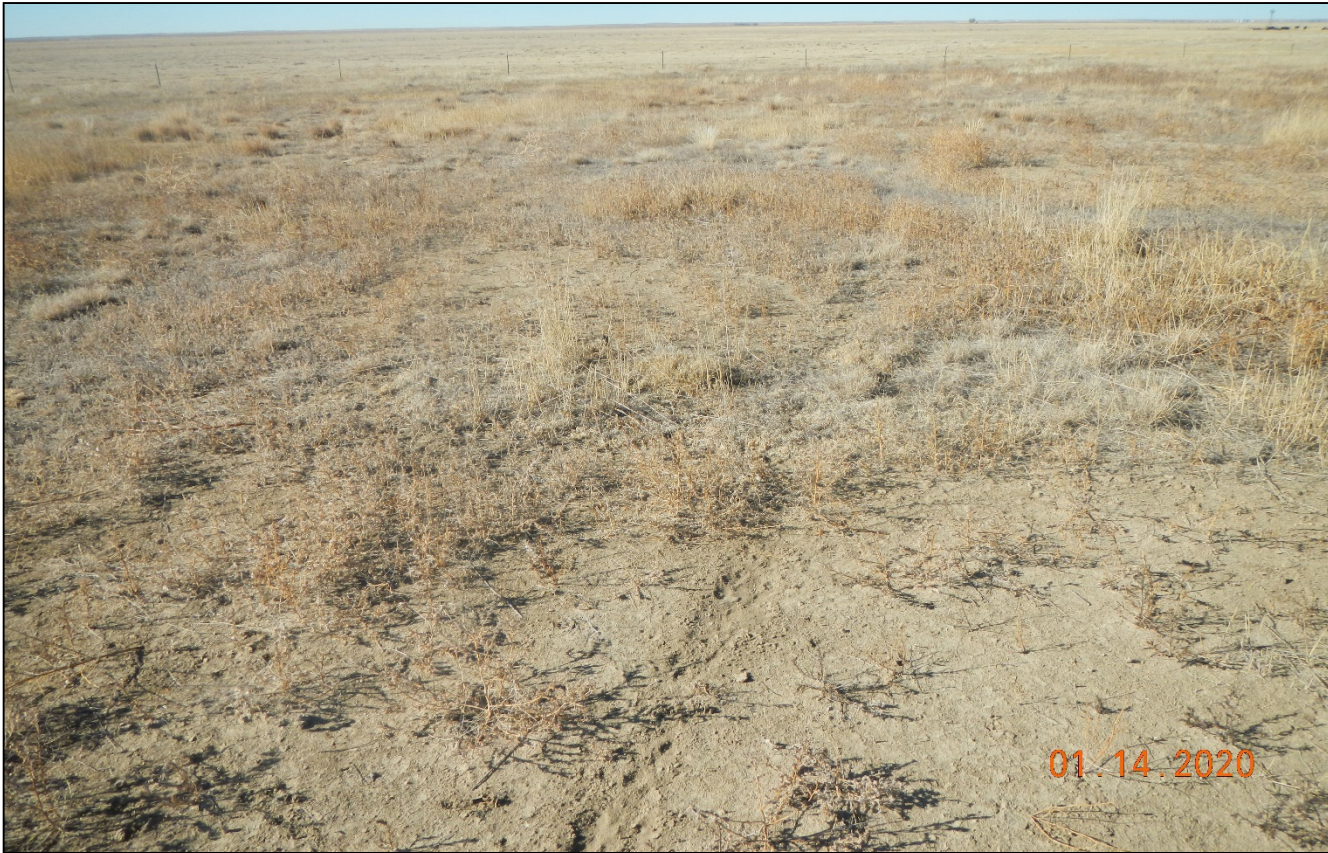
Photo 2. Center of the location facing north.

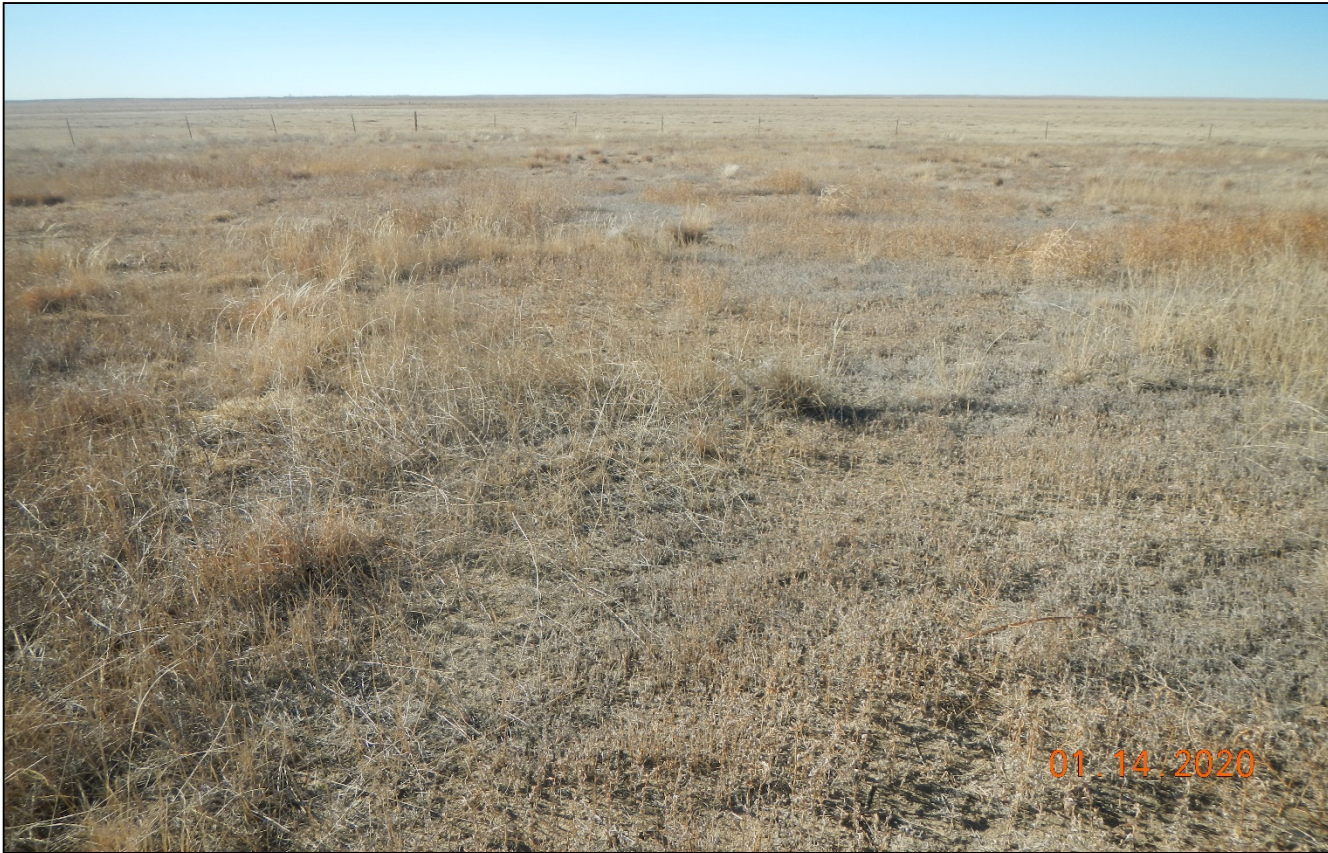
Photo 3. Center of the location facing west.

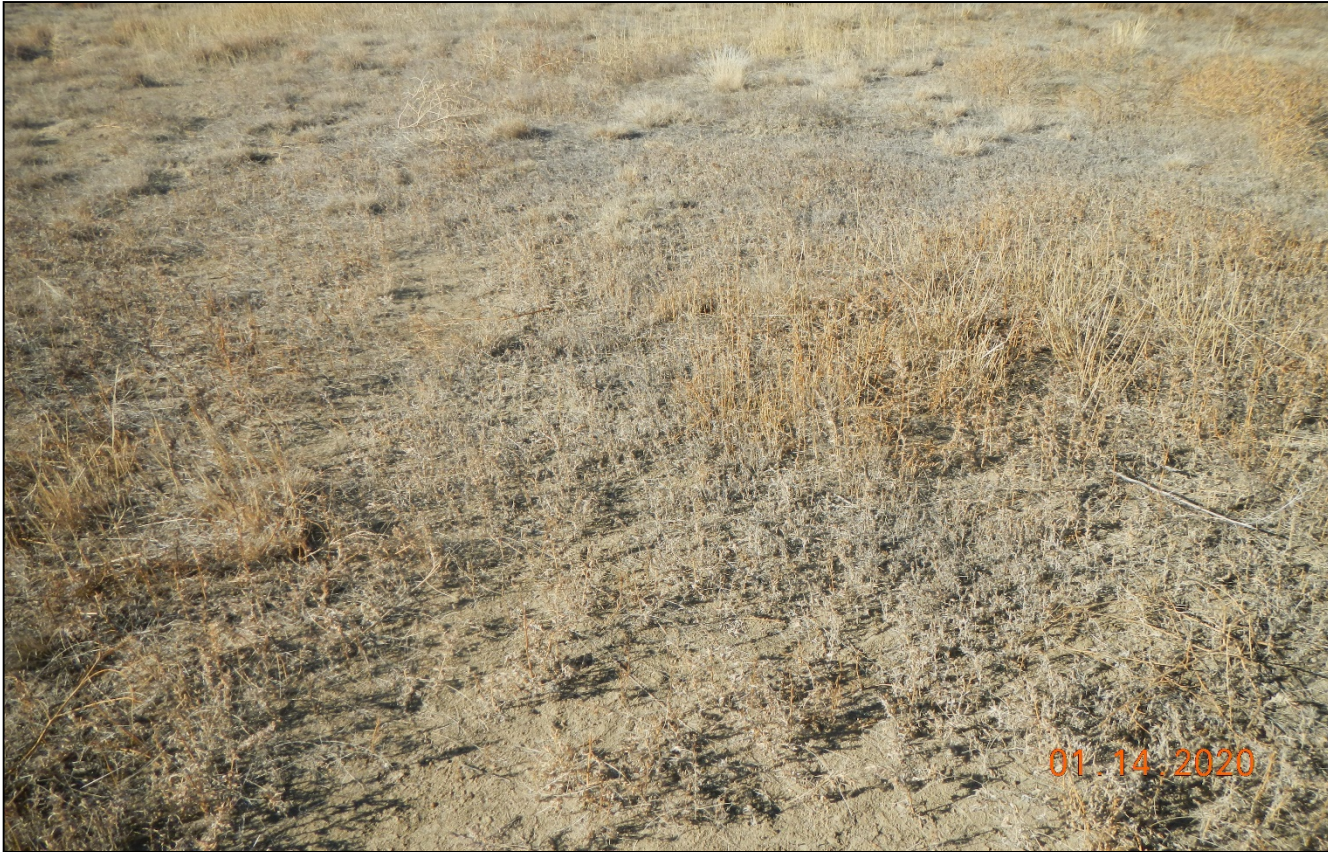
Photo 4. View of vegetation cover at the western portion of location. Photo shows predominately undesirable weeds.

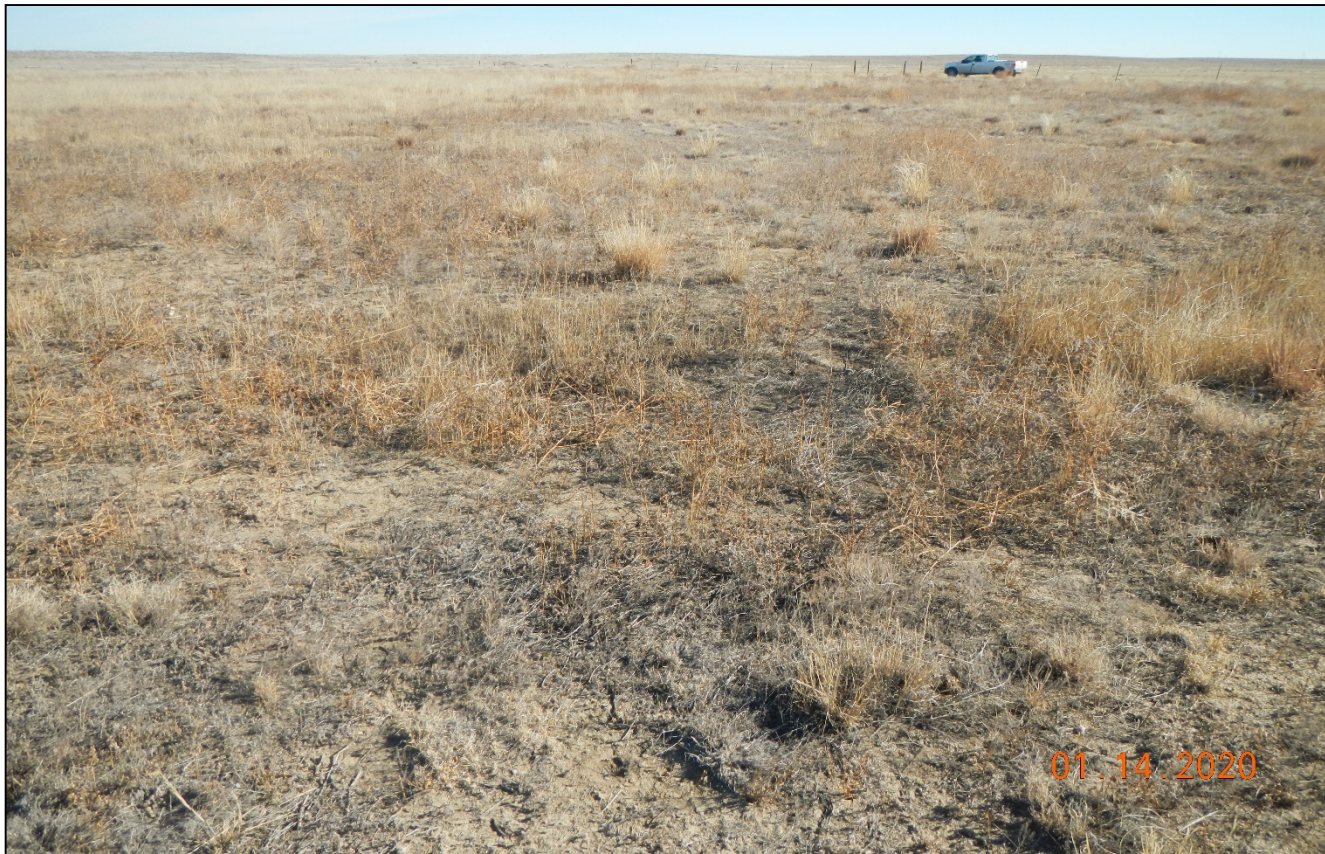
Photo 5. Center of the location facing south.

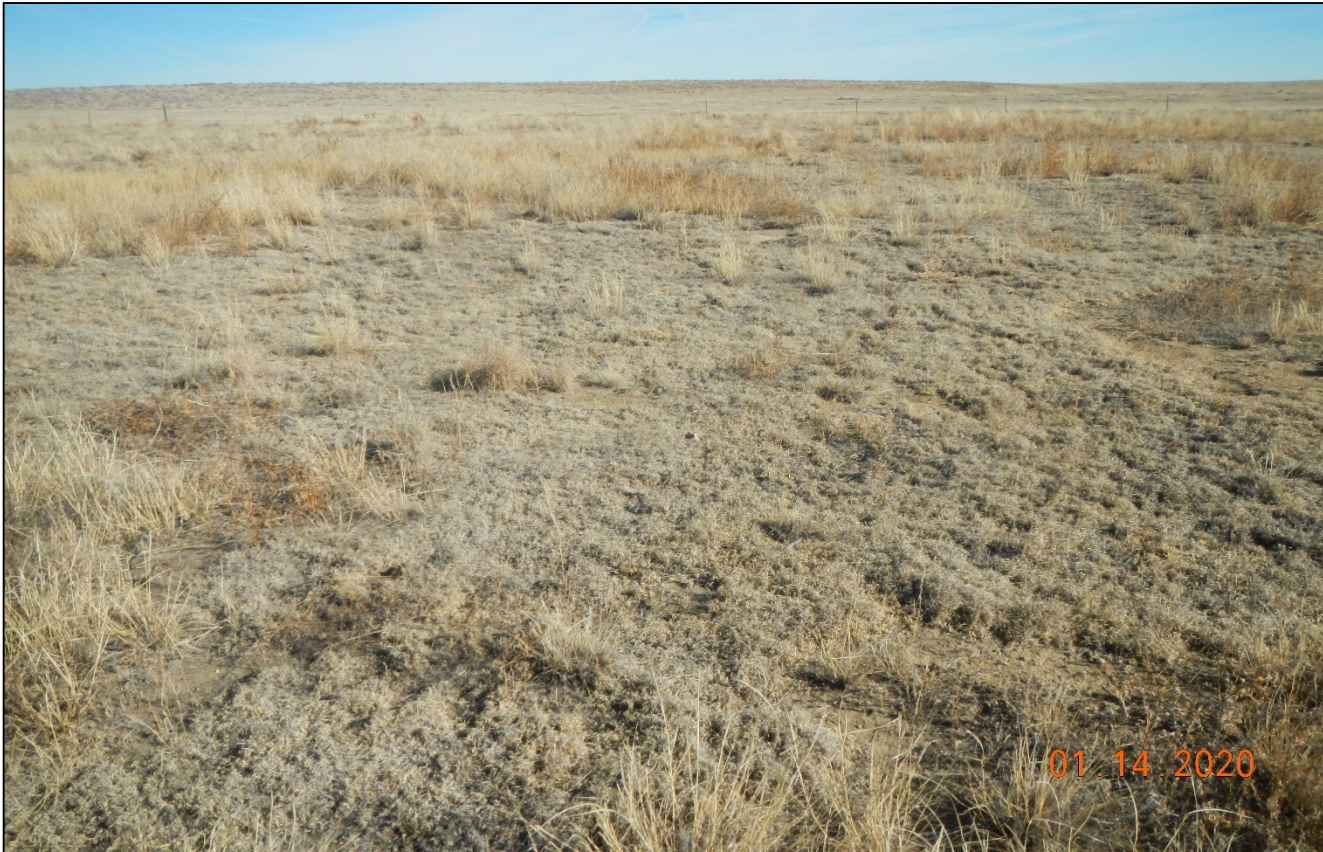
Photo 6. Center of the location facing east. Native vegetation is established well at the east portion of the location.
