Inspection Photos  
Operator: BP America  
Location/API #: 067-07686  
Date: 1-15-2020

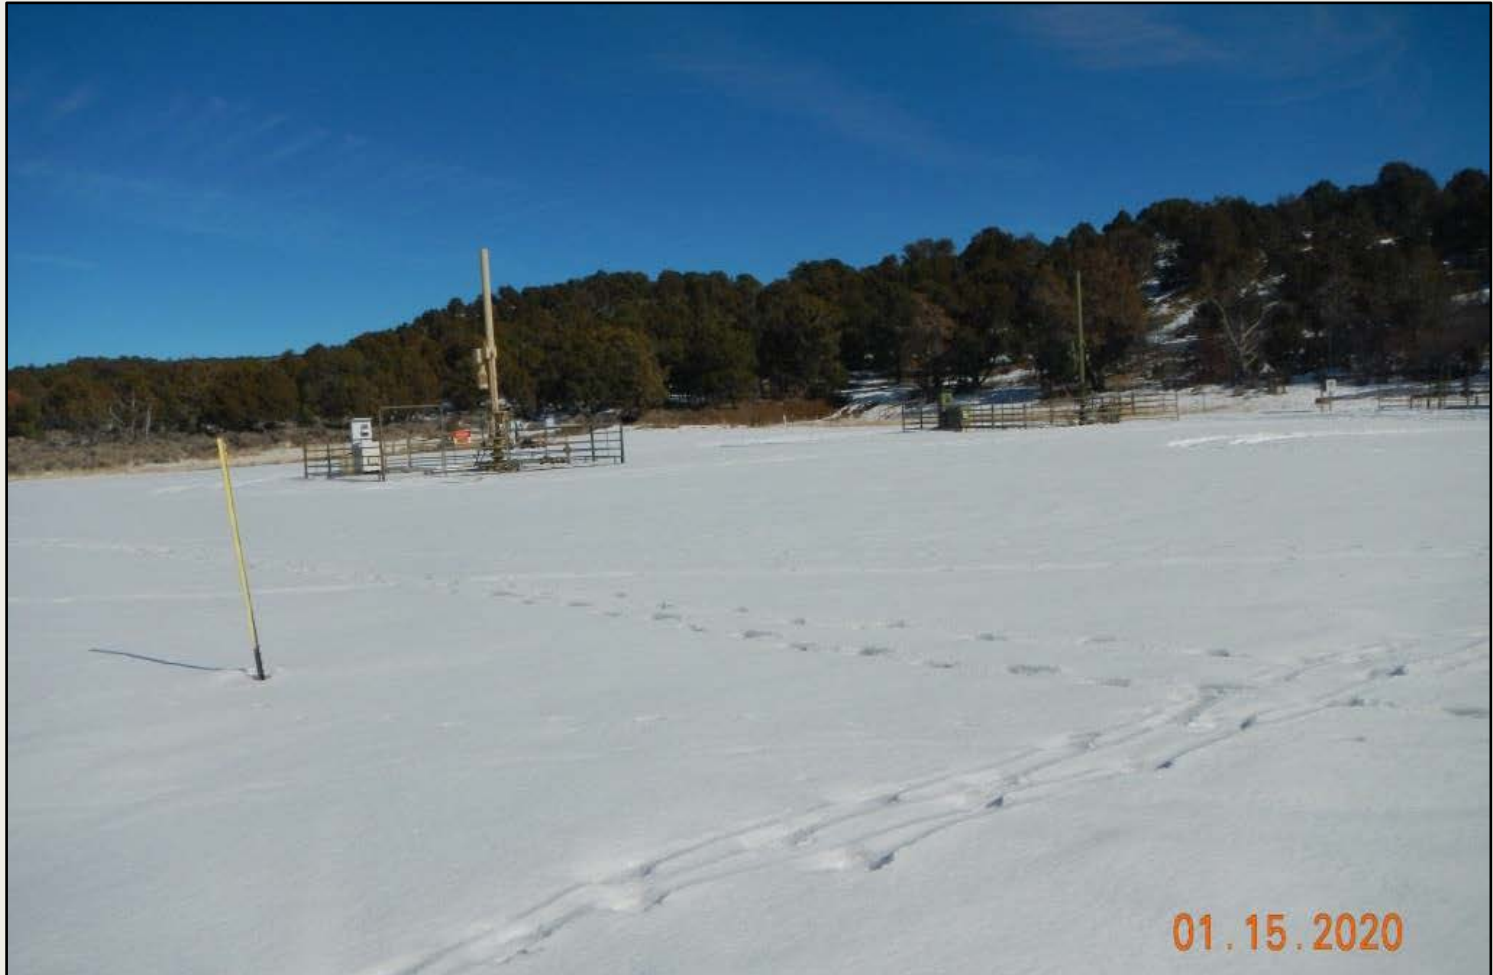
Photo 1. View of the project area from the southwestern corner facing center.

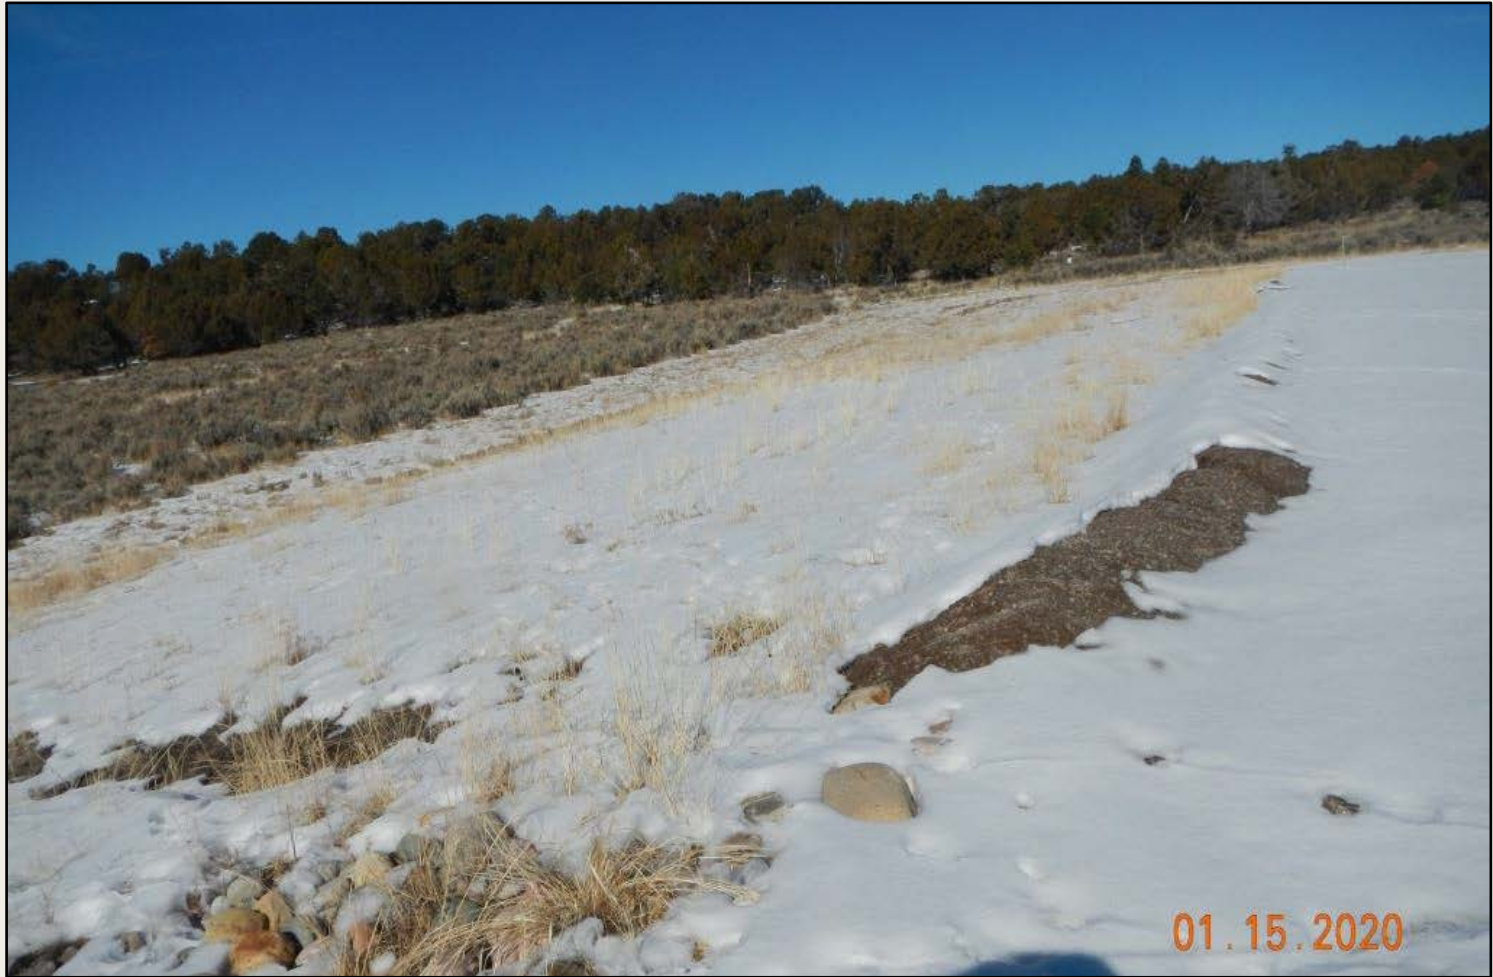
Photo 2. View of the western project area from the southwestern corner facing northward.

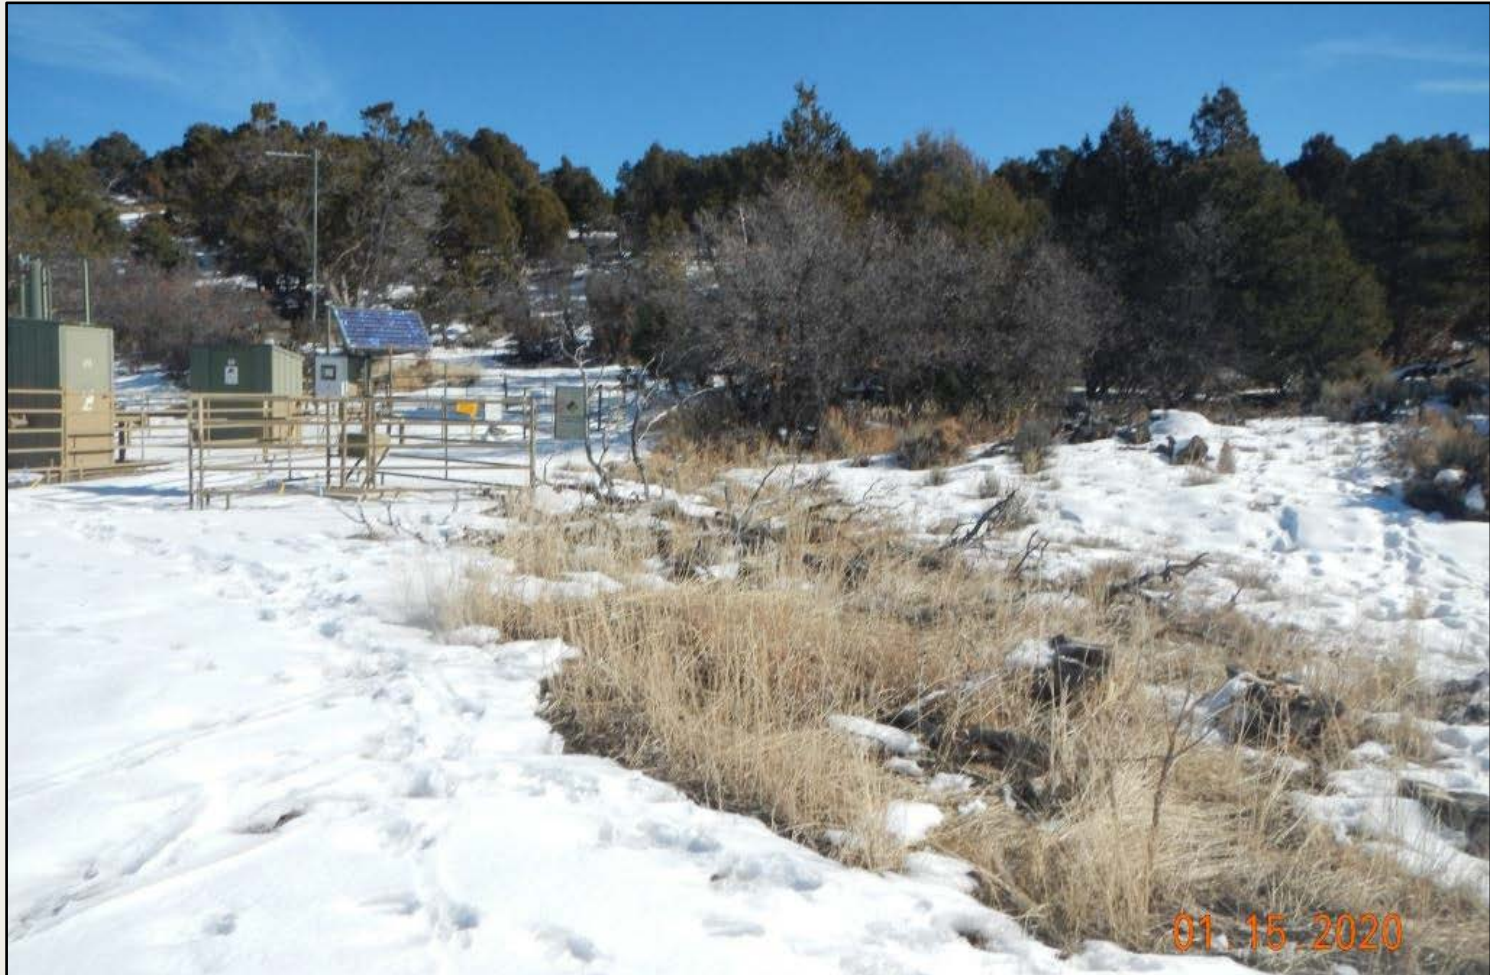
Photo 3. View of the southeastern project area from the well pad entrance facing eastward. It appears that cobble is placed in erosional channel in response to 2018 corrective action. Operator should note that cobble rock is not considered a BMP, as it does not effectively reduce energy of stormwater flows. Course rock is needed where rock is used as a stormwater BMP. Operator needs to continue to monitor stormwater erosion and apply BMPs according to good engineering practices when/where stabilization is needed.

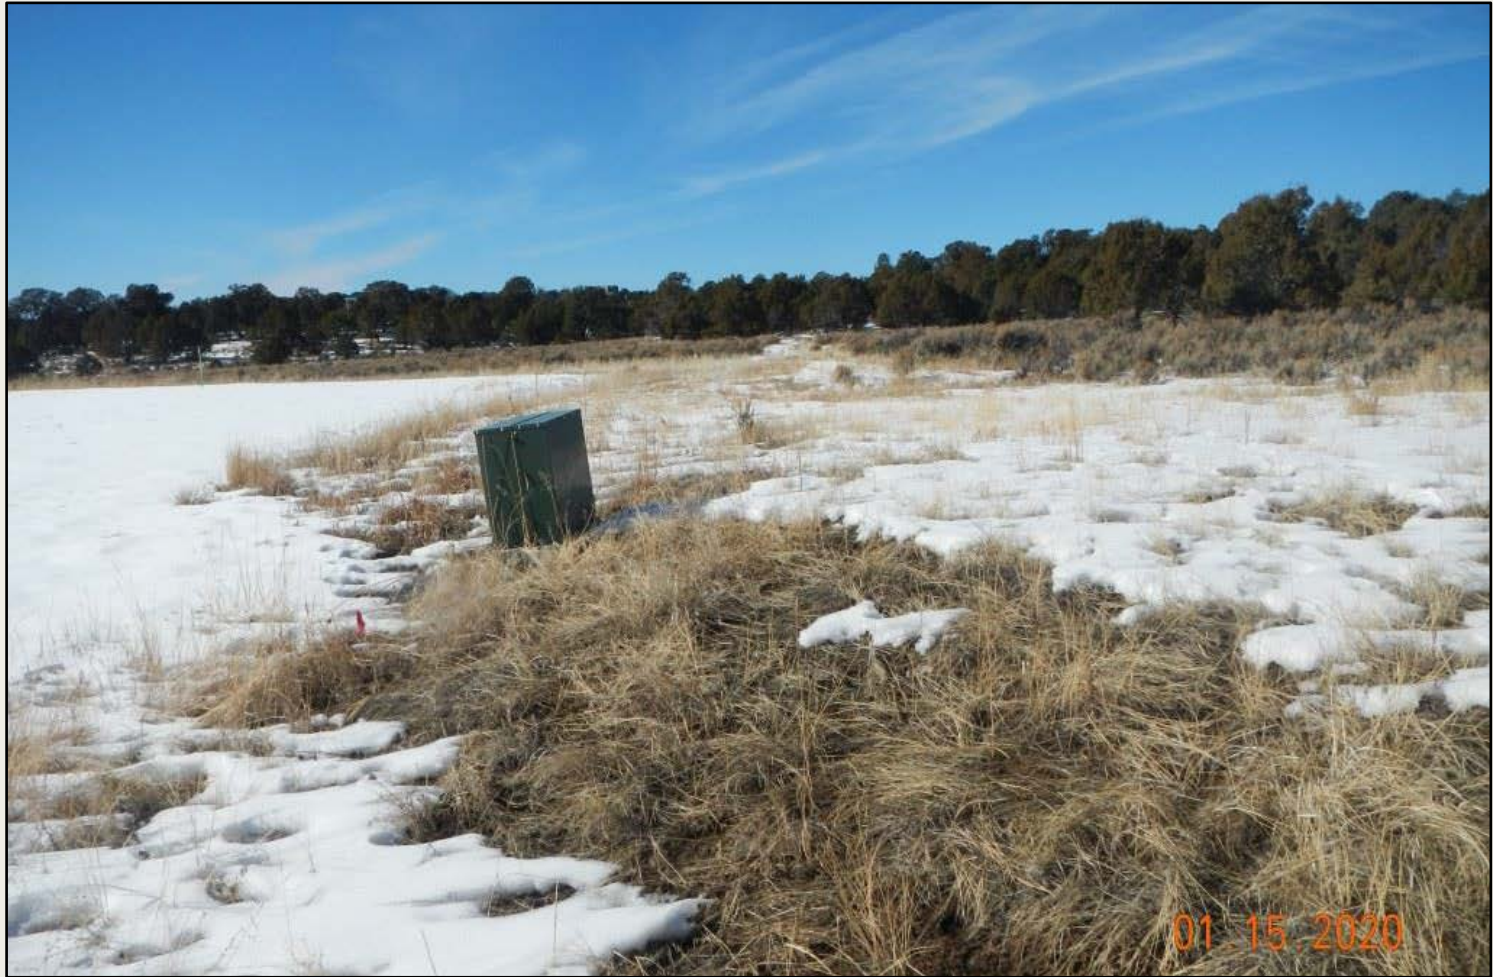
Photo 4. View of the northern project area from the northeastern corner facing westward.

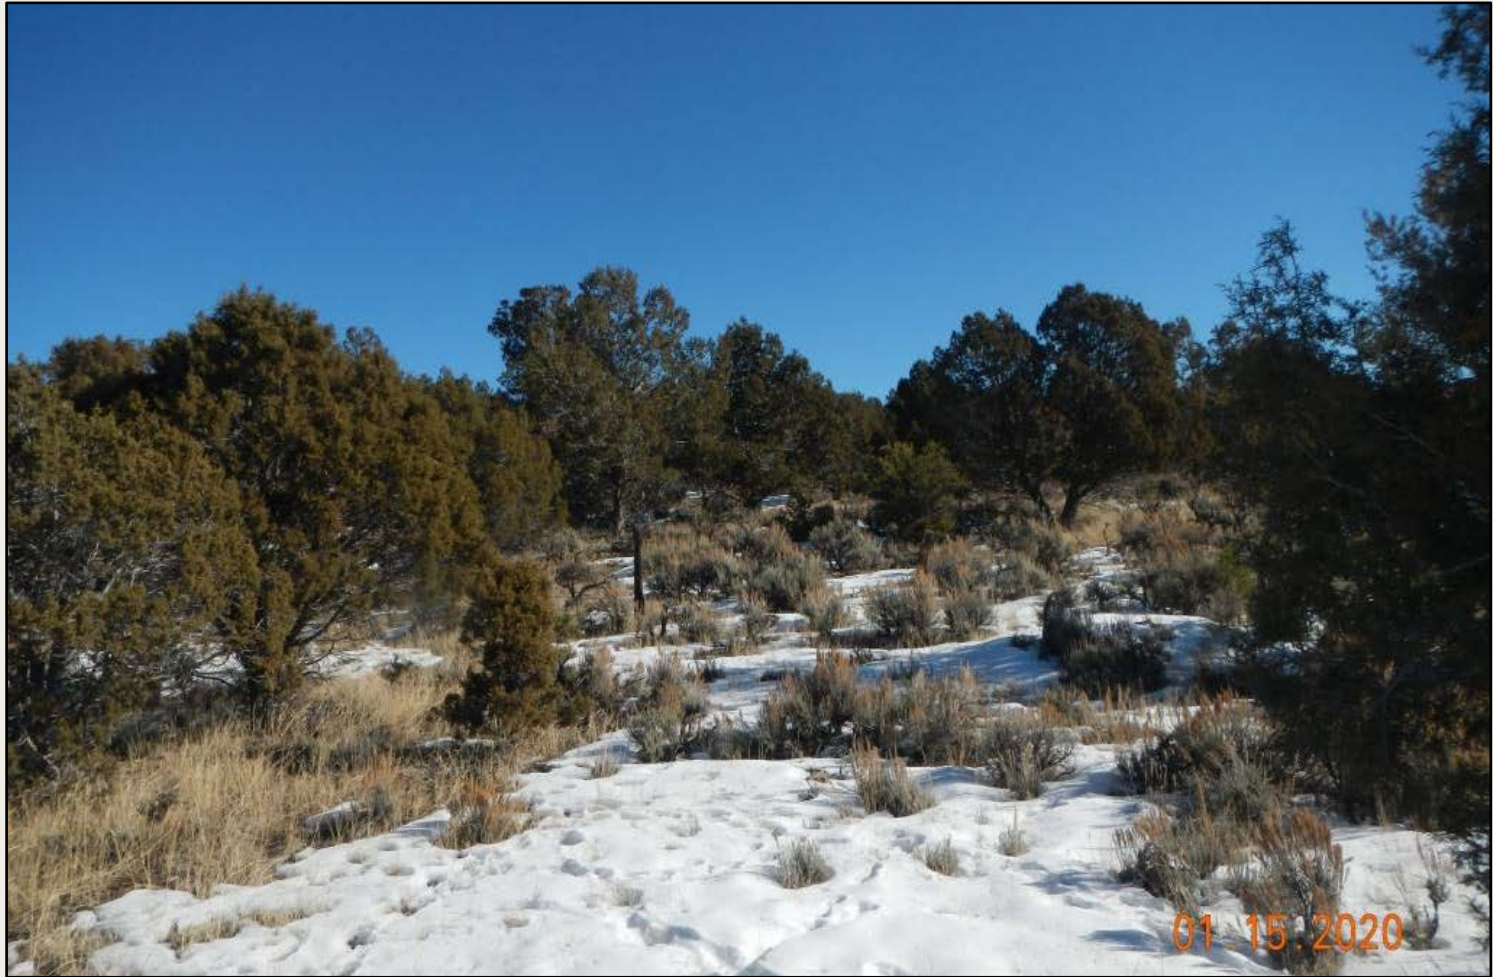
Photo 5. View of reference area, comprised of open pinyon and juniper woodland with sagebrush dominated understory.
