Construction and Stormwater Inspection

January 10 and 16, 2020

Operator: KERR MCGEE OIL & GAS ONSHORE LP #47120

Location ID: 470396

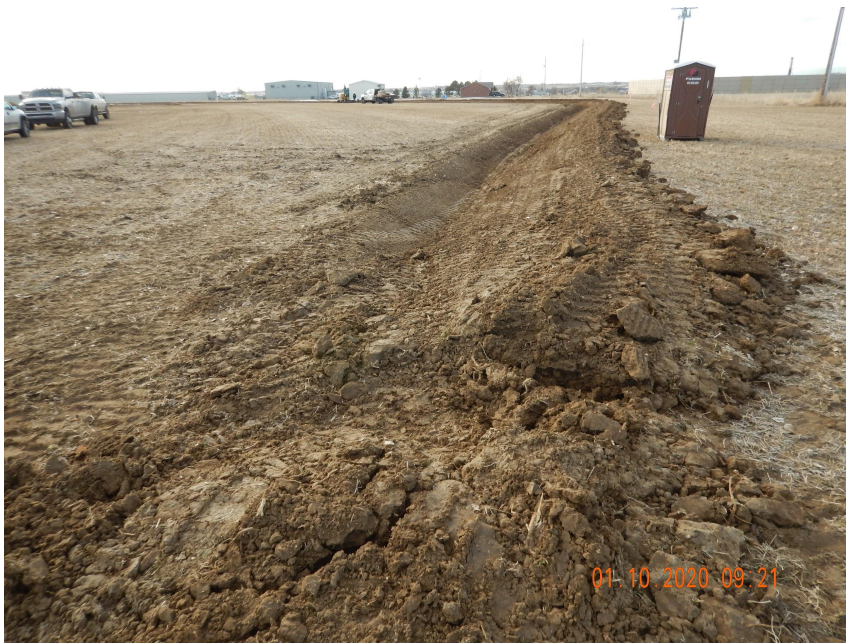
Photo 1. Photo taken from the Northern perimeter of the location on January 10, 2020, facing South. Photo illustrates the beginning of a ditch and berm BMP; however, Operator had not yet completed installing the BMP at the time of this inspection.

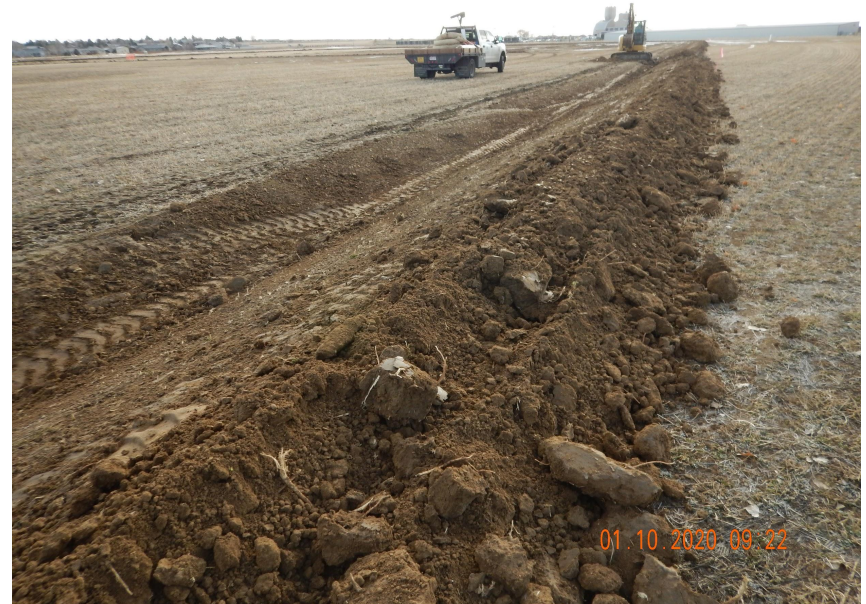
Photo 2. Photo taken from the Southwestern perimeter of location on January 10, 2020, facing East. Photo illustrates a ditch and berm BMP in the foreground. In the background sediment trap BMPs installation.

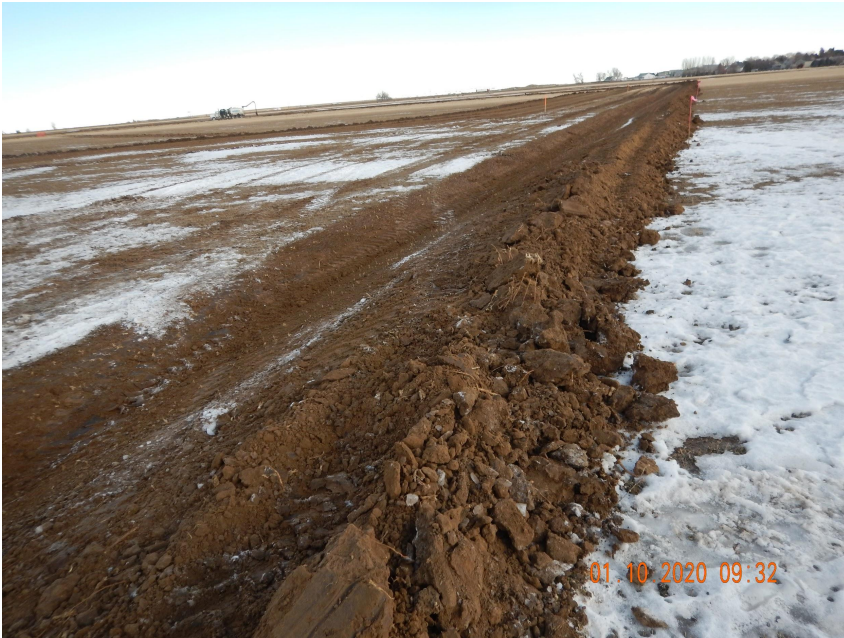
Photo 3. Photo taken from the southern location on January 10, 2020, facing Northeast. See comments under Photo 1 regarding the ditch and berm BMP.

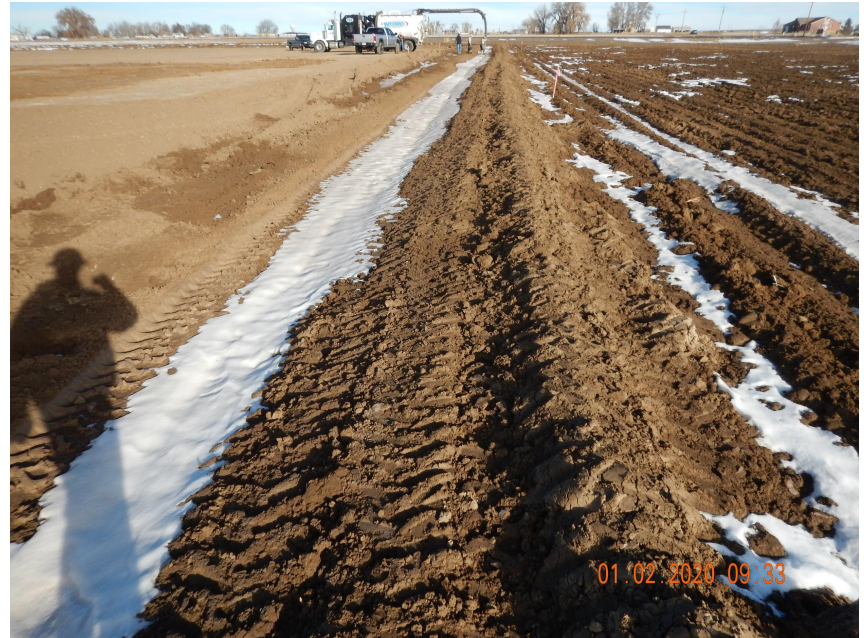
Photo 4. Photo taken from the eastern perimeter of location on January 10, 2020, facing Northwest. See comments under Photo 1 regarding the ditch and berm BMP.

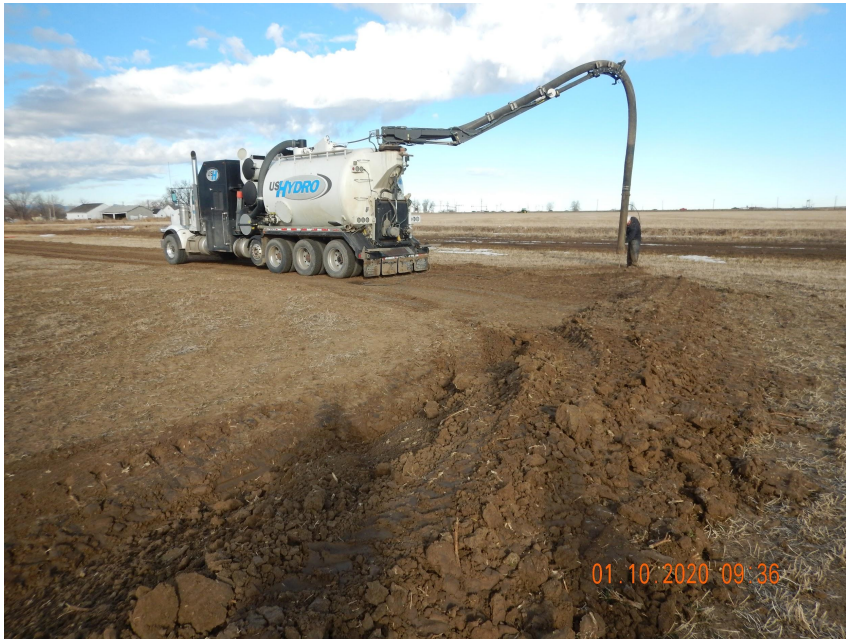
Photo 5. Photo taken from the Northeastern perimeter of location on January 10, 2020, facing North. Photo illustrates a hydro excavation operation. Operator is trying to delineate where an irrigation tile drainage is located so damage does not occur when installing the sound walls.

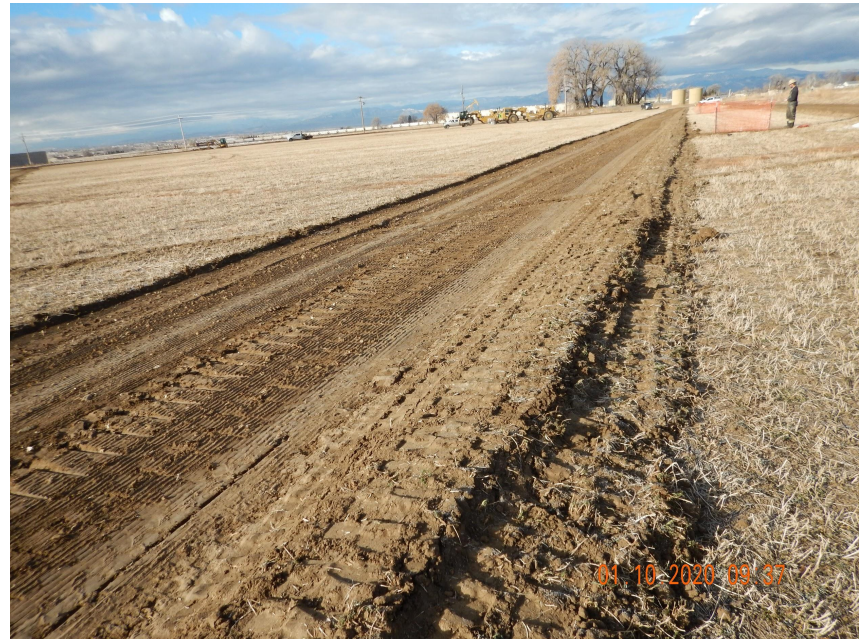
Photo 6. Photo taken from the Northeastern perimeter of location on January 10, 2020, facing West; towards Larimer County Road 1. See comments under Photo 1 regarding the ditch and berm BMP.

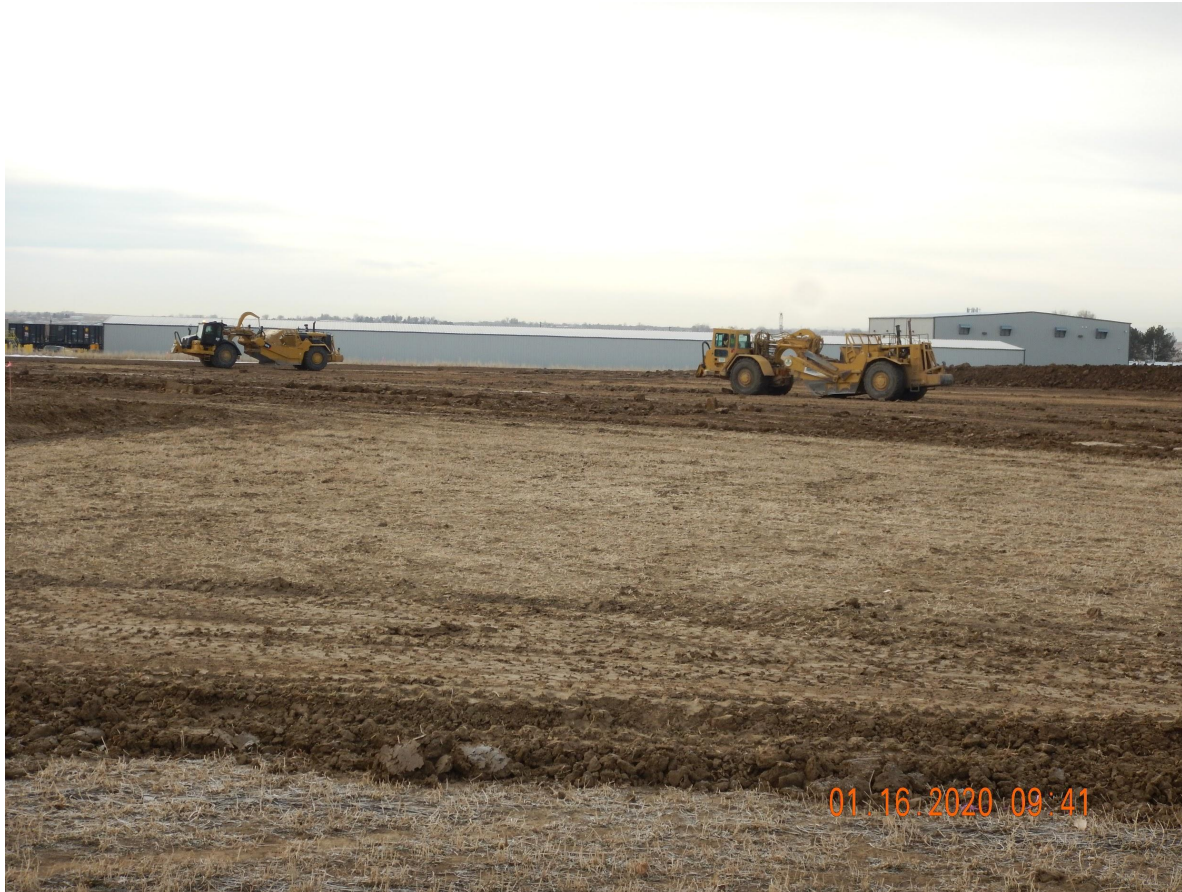
Photo 7. Photo taken from the Northern perimeter of location on January 16, 2020, facing South. Photo illustrates Operator conducting topsoil salvage operations along the eastern portion of location.

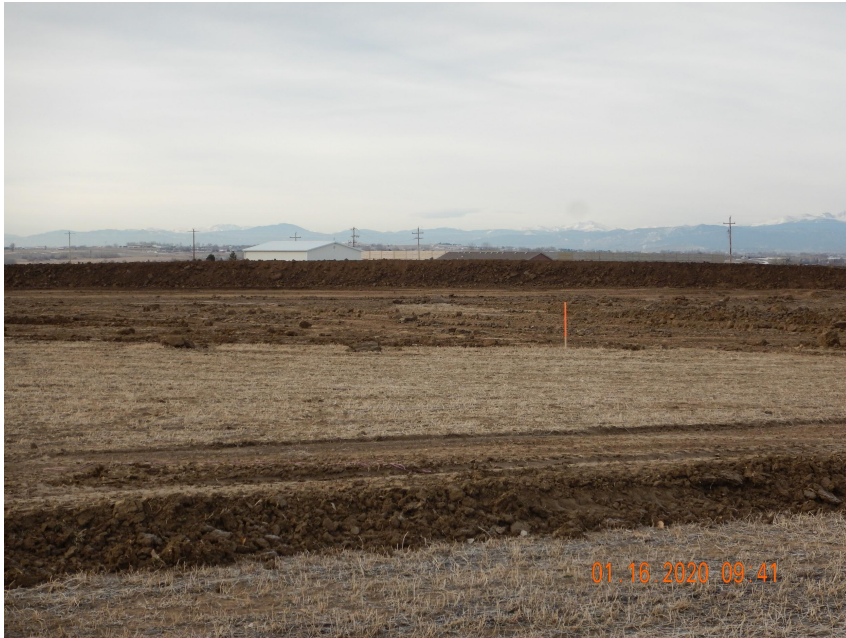
Photo 8. Photo taken from the Northern perimeter of location on January 16, 2020, facing Southwest. Photo illustrates the current topsoil stockpile located along the southern perimeter of location.

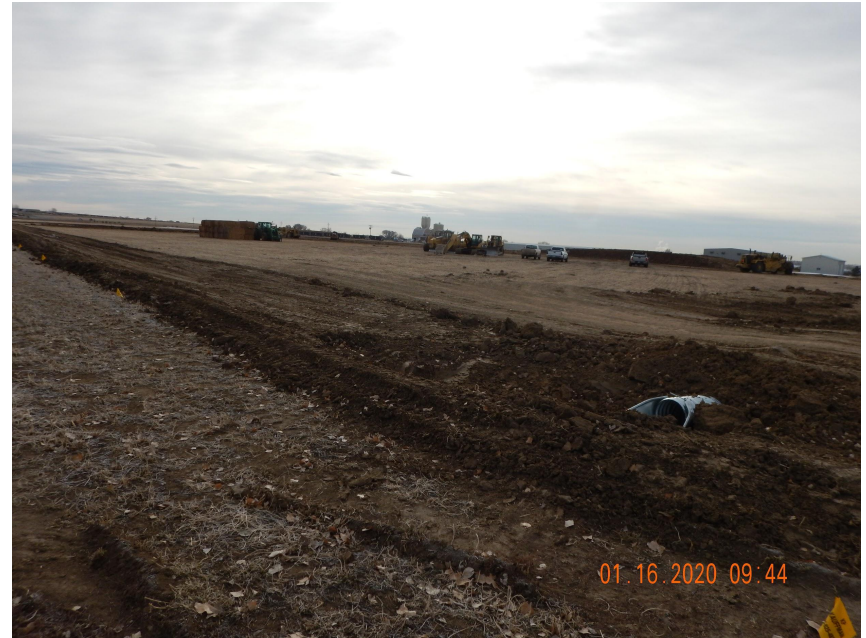
Photo 9. Photo taken from the Northwestern perimeter of location on January 16, 2020, facing Southeast. Operator has completed the installation of the ditch and berm BMP. Operator has stabilized the berm portion of the BMP with equipment tracking.

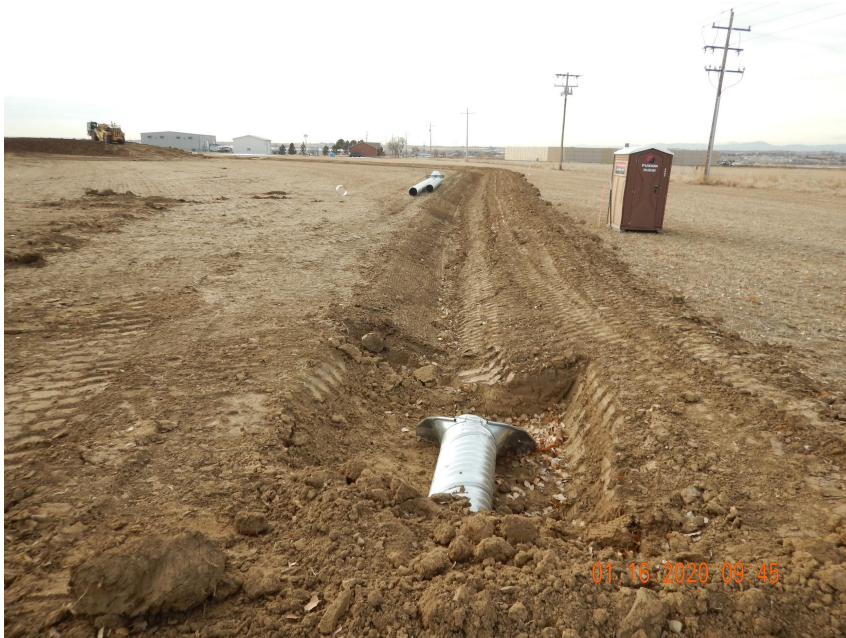
Photo 10. Photo taken from the Northwestern perimeter of location on January 16, 2020, facing South. See comments under Photo 9 regarding the ditch and berm BMP. Operator still in-process of installing inlet/outlet protection for the above culvert.

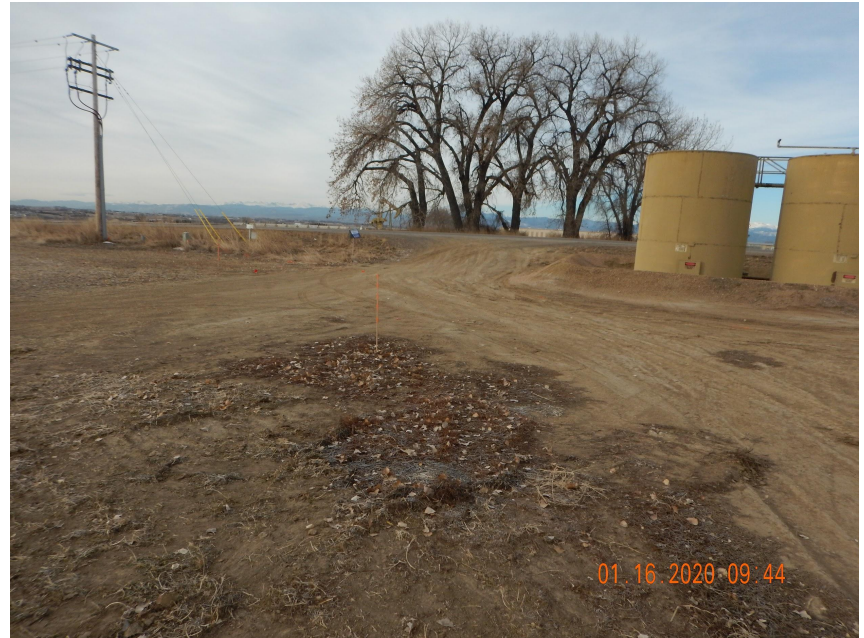
Photo 11. Photo taken from the entrance of location on January 16, 2020, facing West. Photo illustrates that entrance has pre-existing gravel. Operator will likely be required to install additional tracking device BMPs once more equipment is mobilized to location.

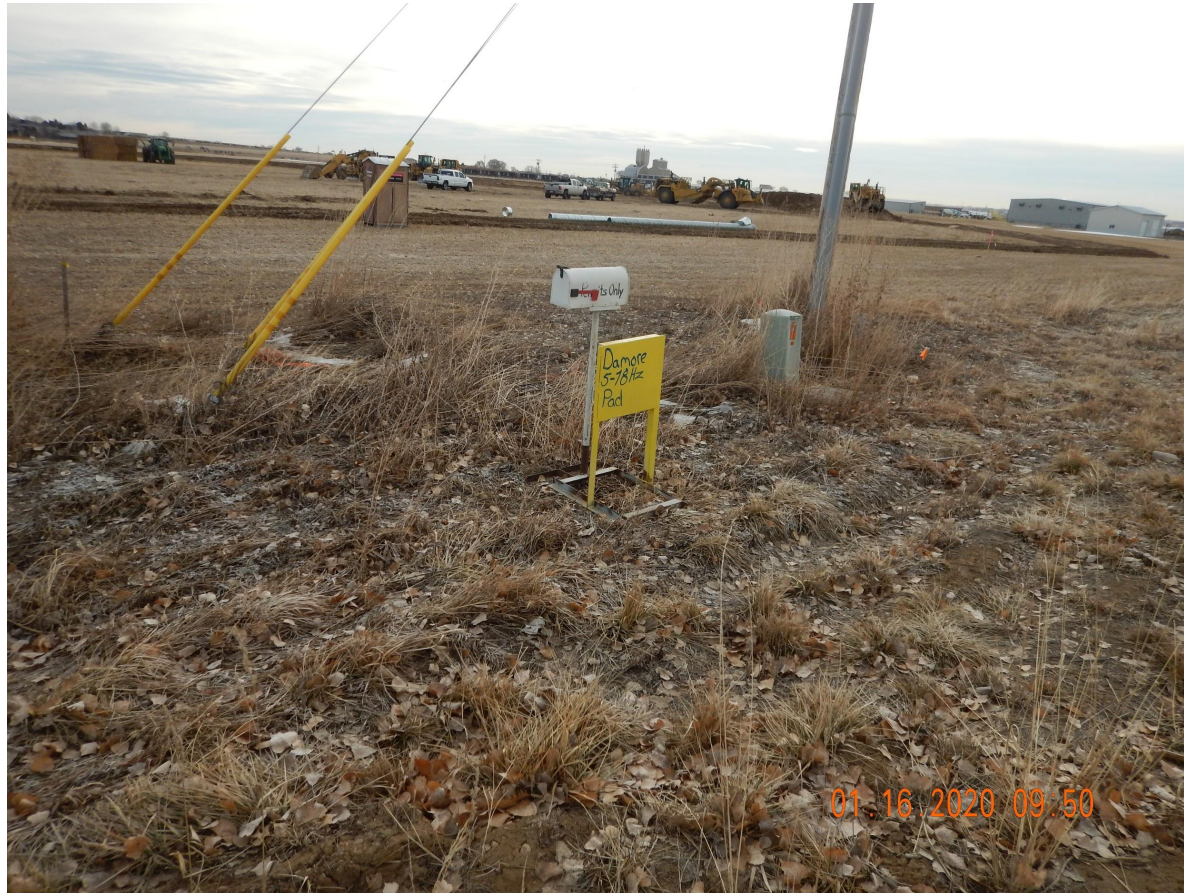
Photo 12. Photo taken from the entrance of location on January 16, 2020, facing East. Photo illustrates a temporary sign and mailbox with the approved Form 2A per the Form 2A Conditions of Approval.
