Inspection Photos

API: 05-071-09381

Operator: XTO ENERGY INC

Inspection Date: 1/22/2019

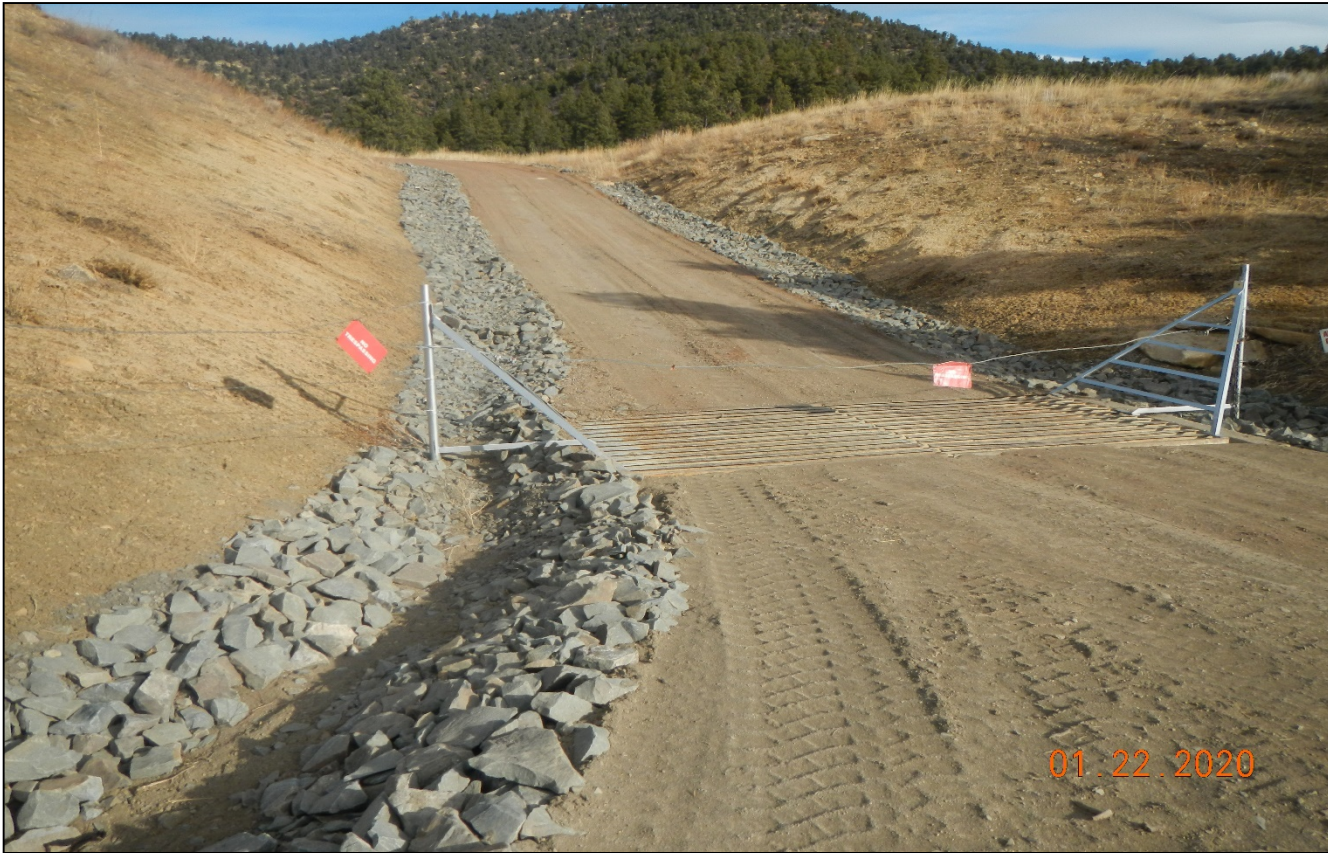
Photo 1. Facing north at the beginning of the access road. Additional rock rip/rap has been installed along the side of the road to prevent erosion.

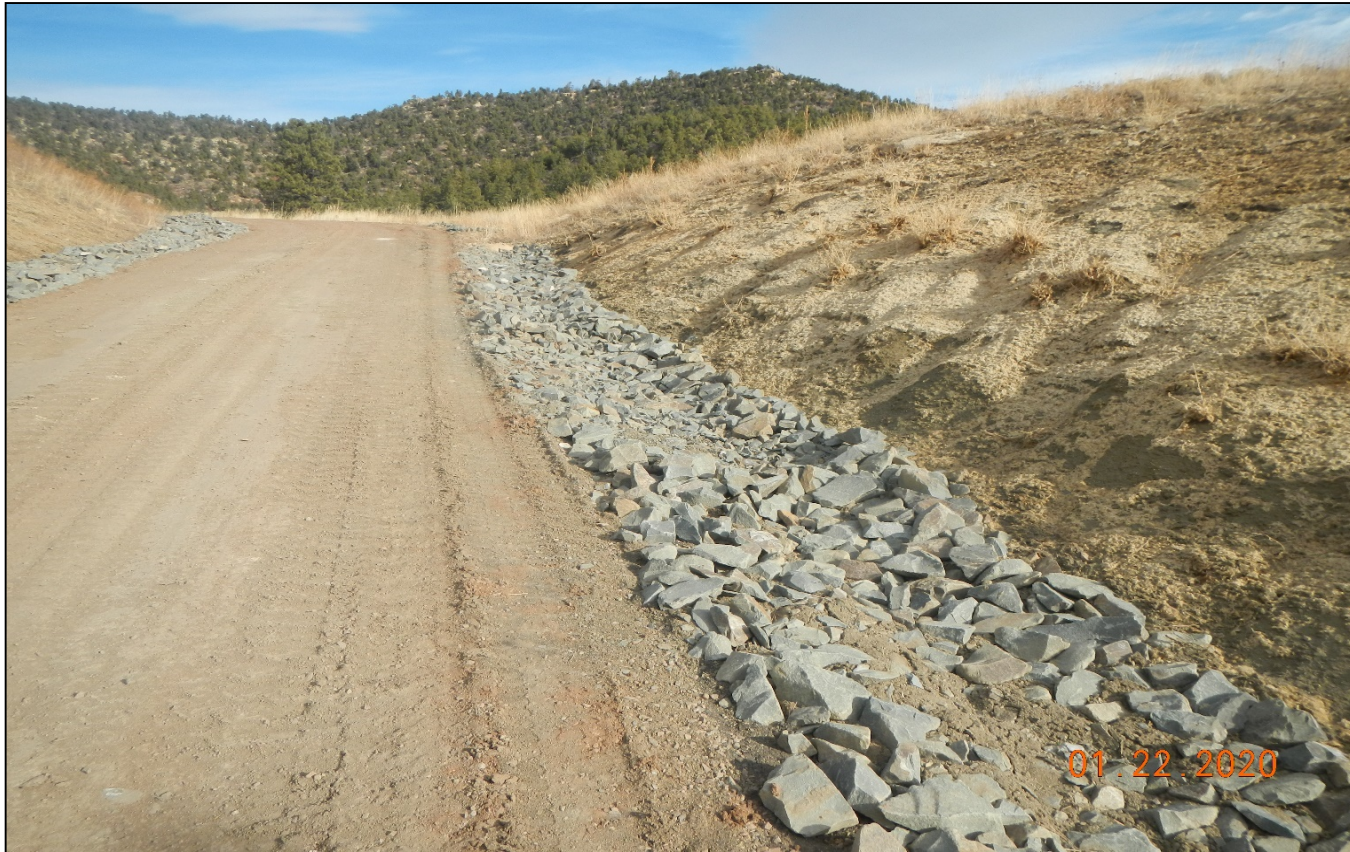
Photo 2. Facing toward the side of the access road as it ascends up the steep grade. Rock rip/rap and check dams have been installed along the road. The sides of the slope have been seeded and hydro mulched.

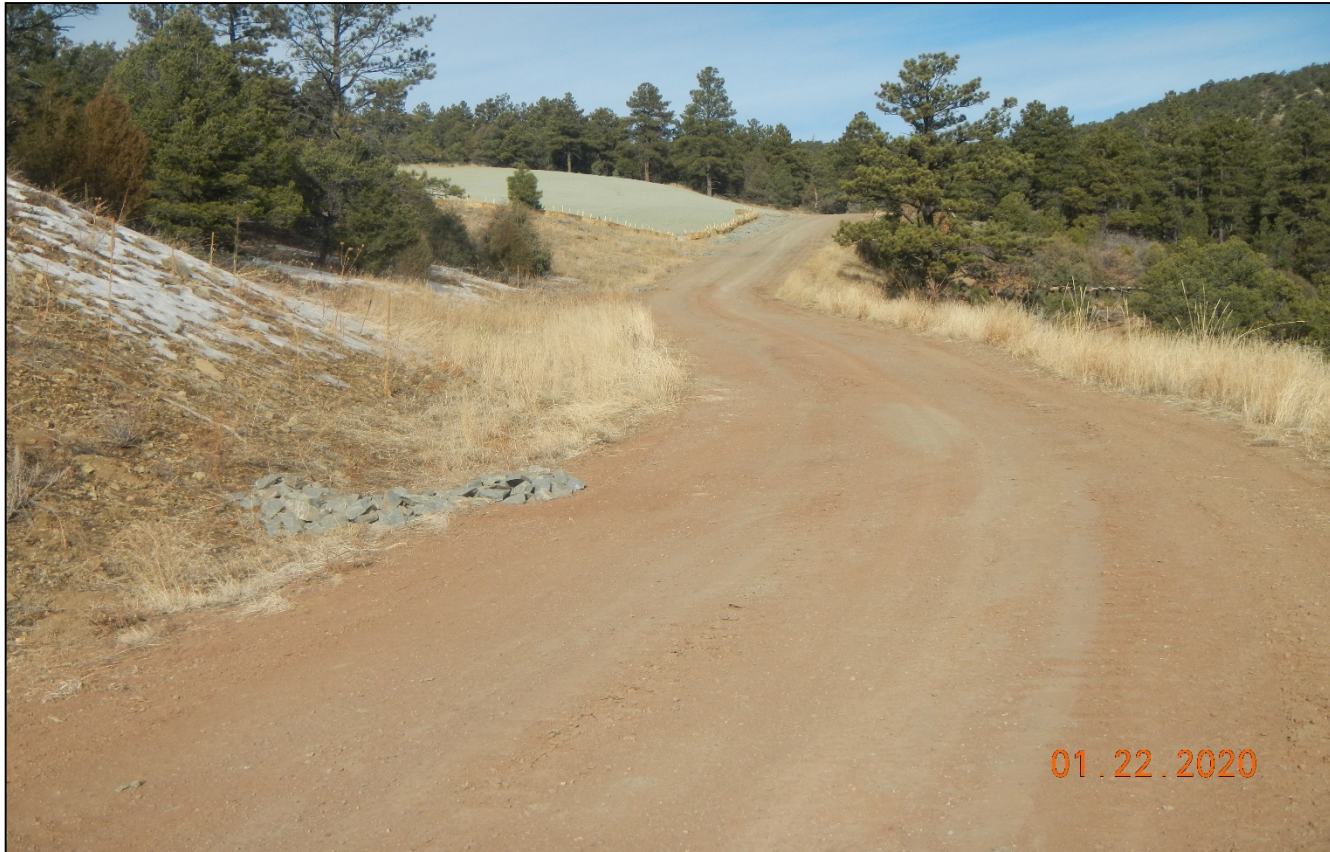
Photo 3. Facing northwest along the access road toward the location. The access will remain per the approved variance request.

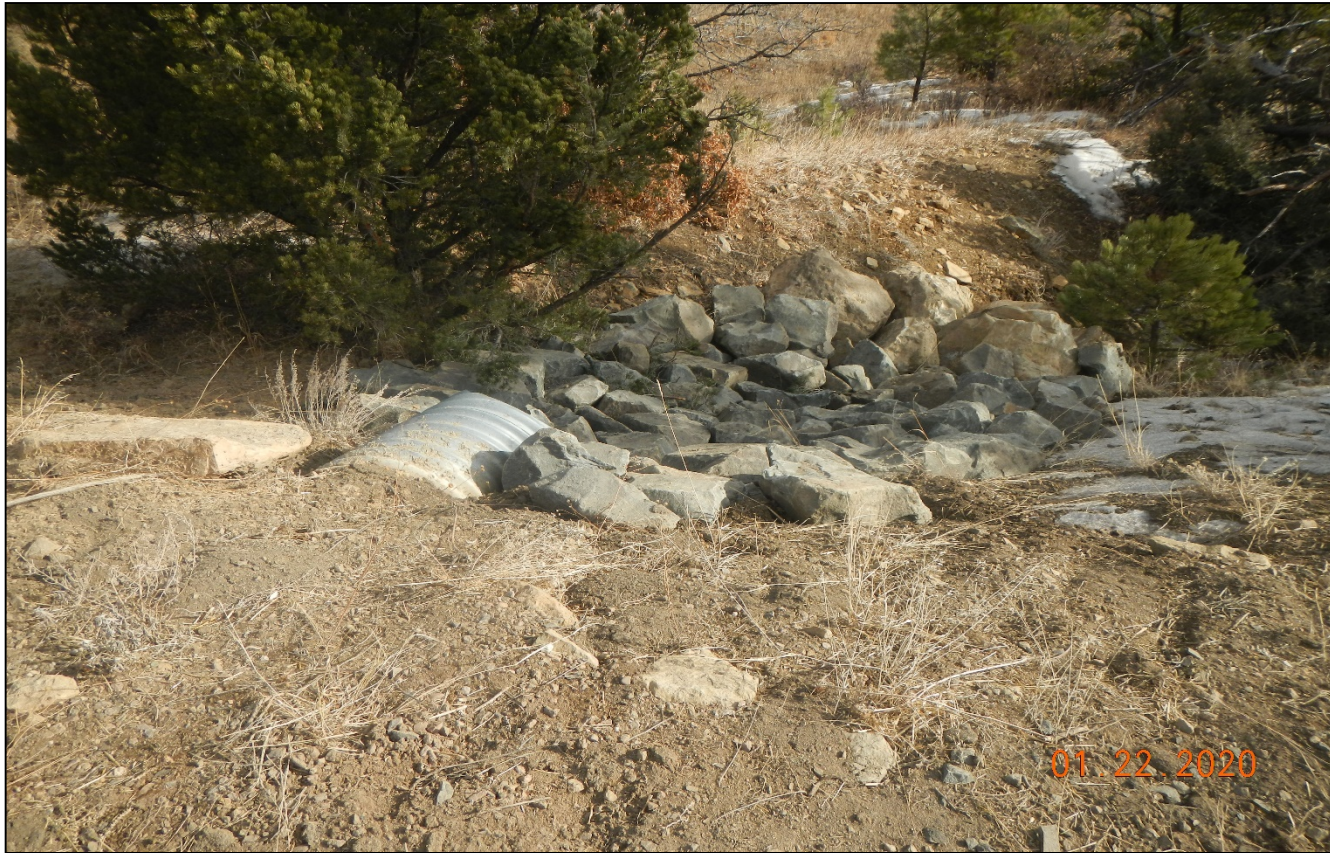
Photo 4. The culvert outlet has been cut closer to the surface and rock rip/rap outlet protection has been installed.

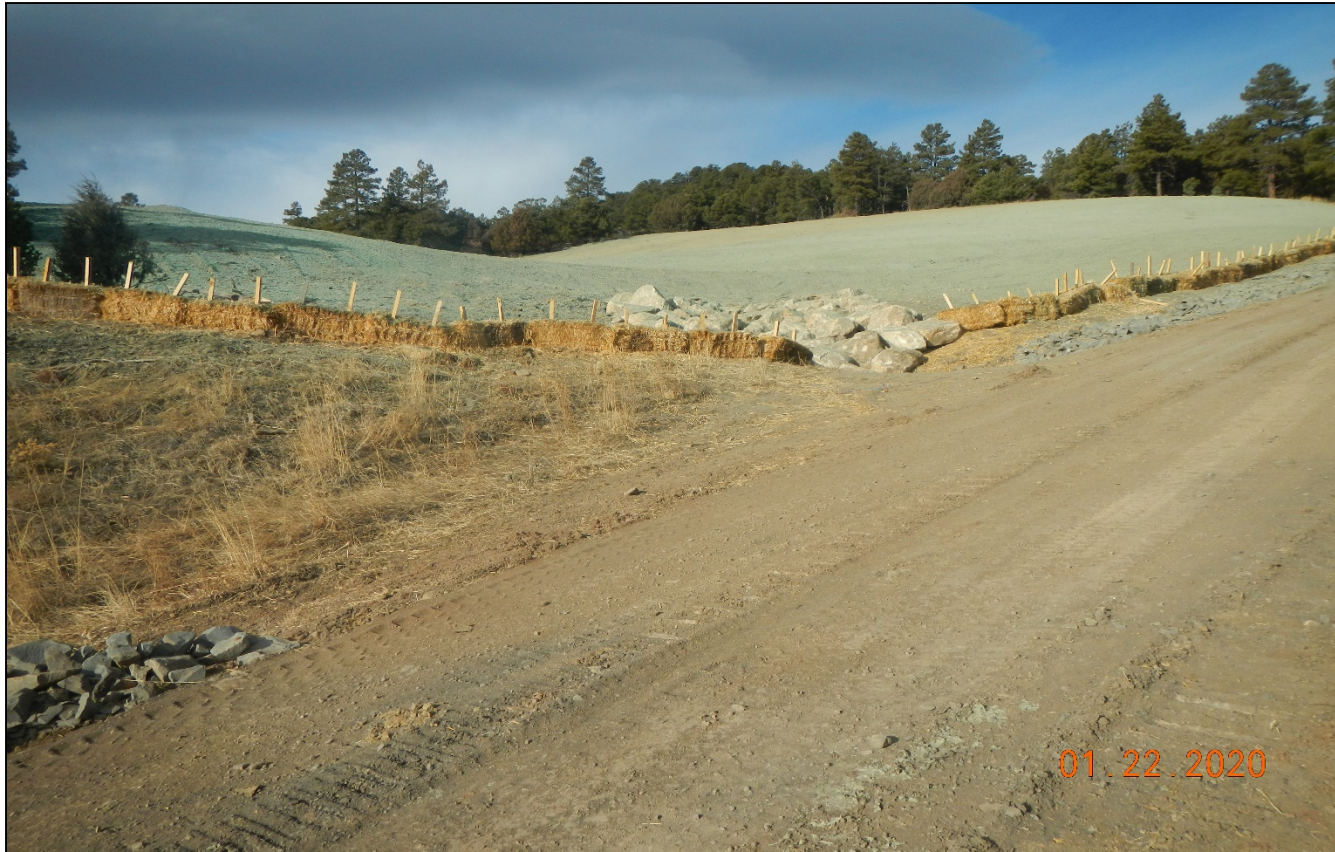
Photo 5. Facing northwest toward the location which has been recontoured and reclaimed. The location has been hydromulched and stormwater controls are installed around the perimeter and drainage areas.

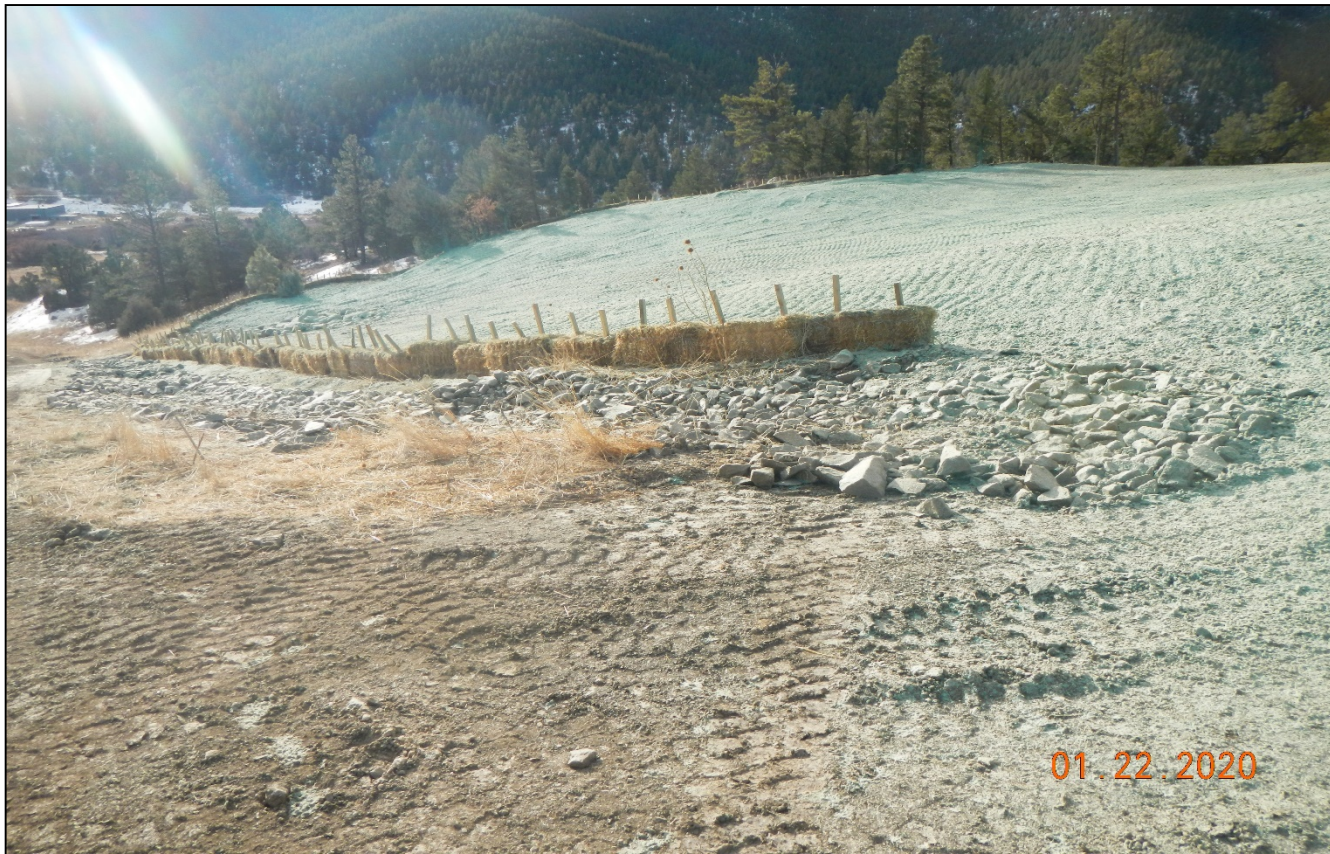
Photo 6. Facing south down the hillside toward the location.

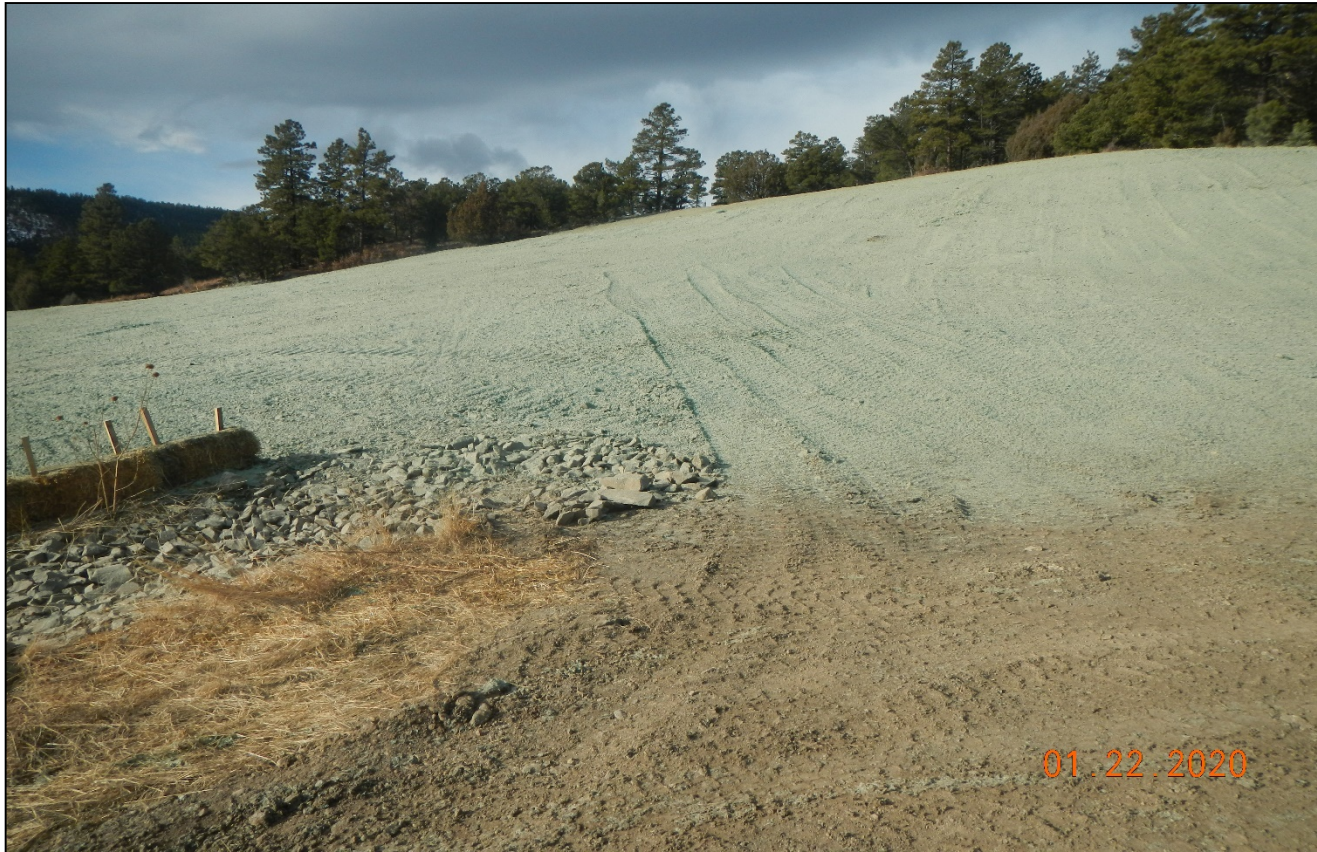
Photo 7. Facing southwest toward the top portion of the location where the cut slope was previously located. The location is recontoured and matches the surrounding contour of the terrain.

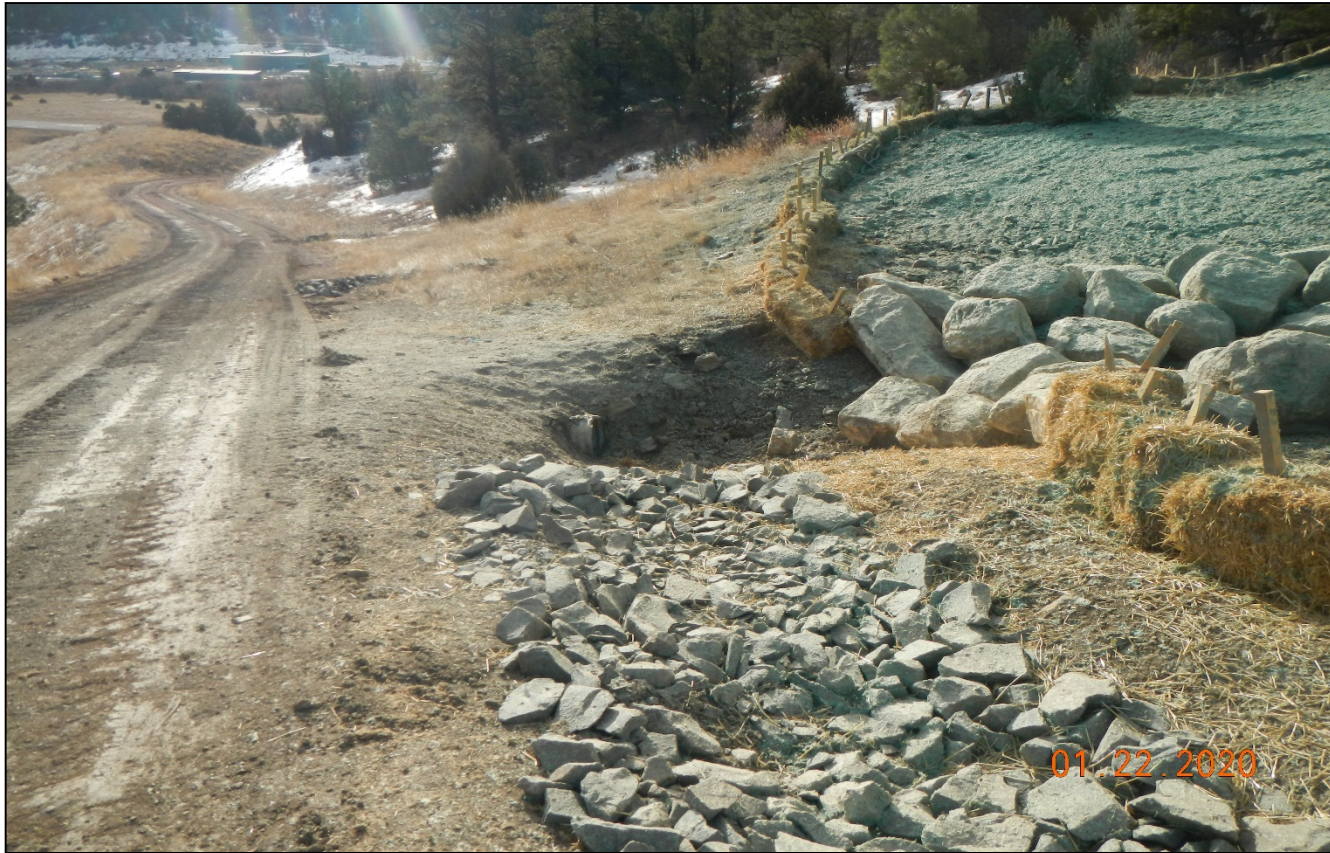
Photo 8. Facing southeast near the bottom of the location. Stormwater controls are installed along the side of the road and perimeter of the location Stormwater is directed toward the culvert at this point.

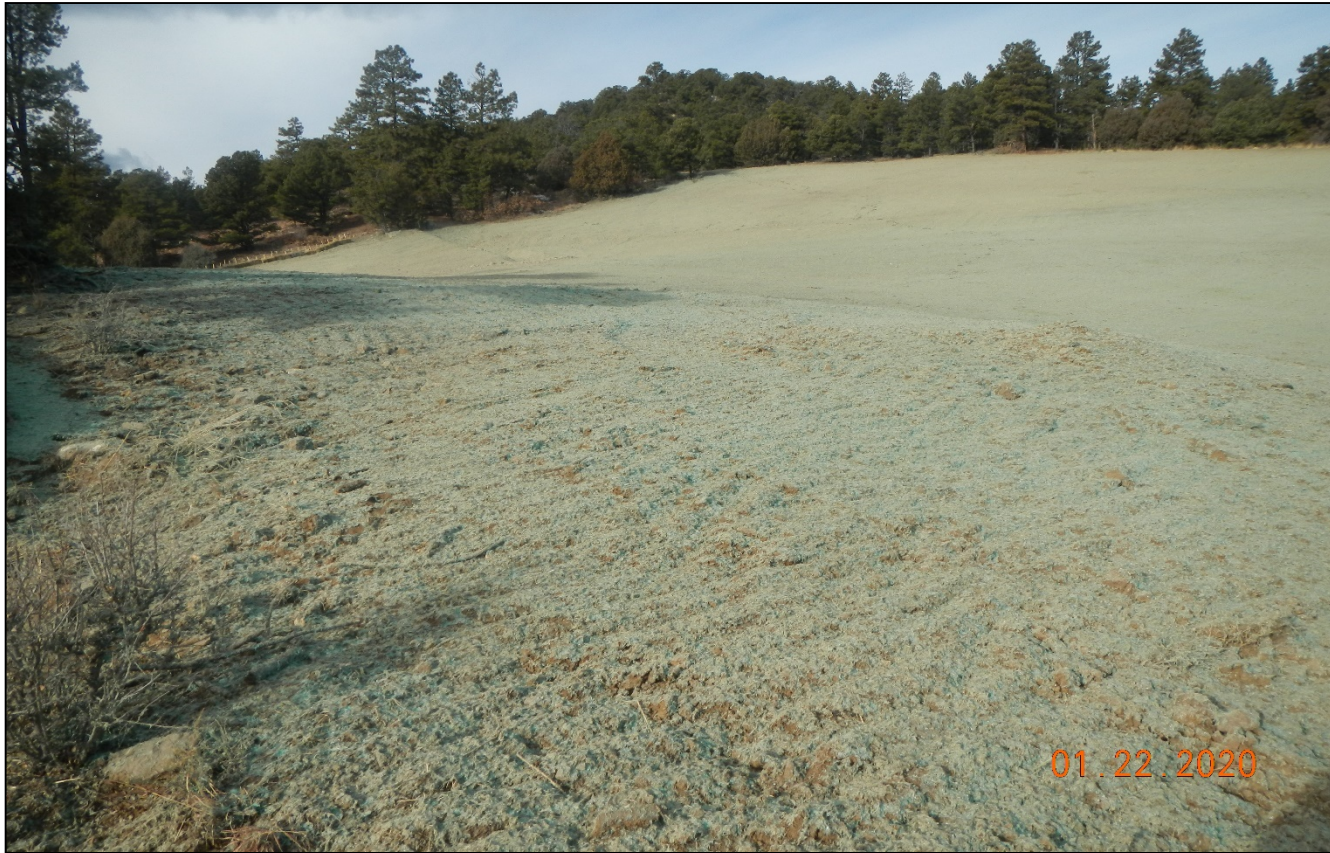
Photo 9. Standing at the bottom of the location facing northwest.

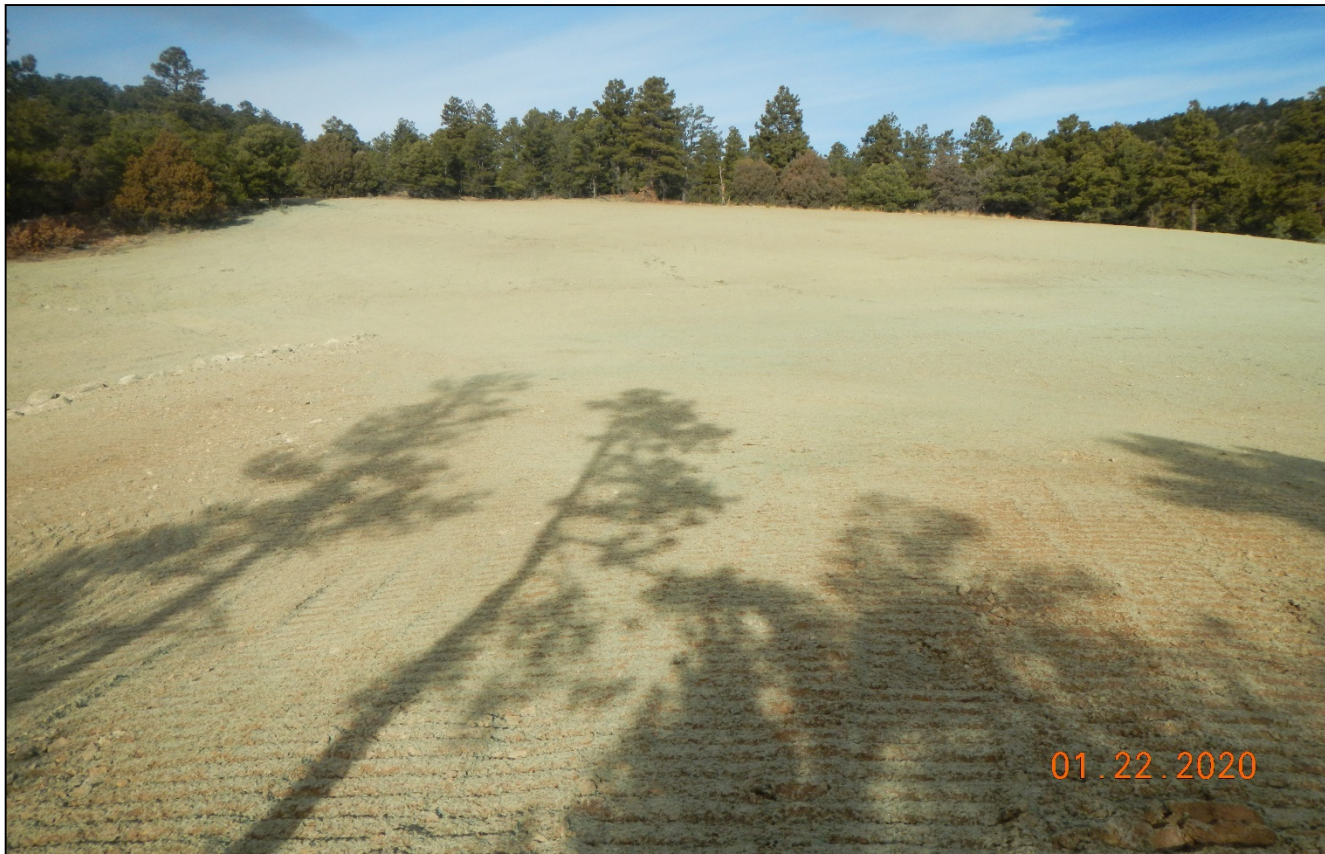
Photo 10. Standing at the bottom of the location facing north. The soils were properly tracked and hydromulched.

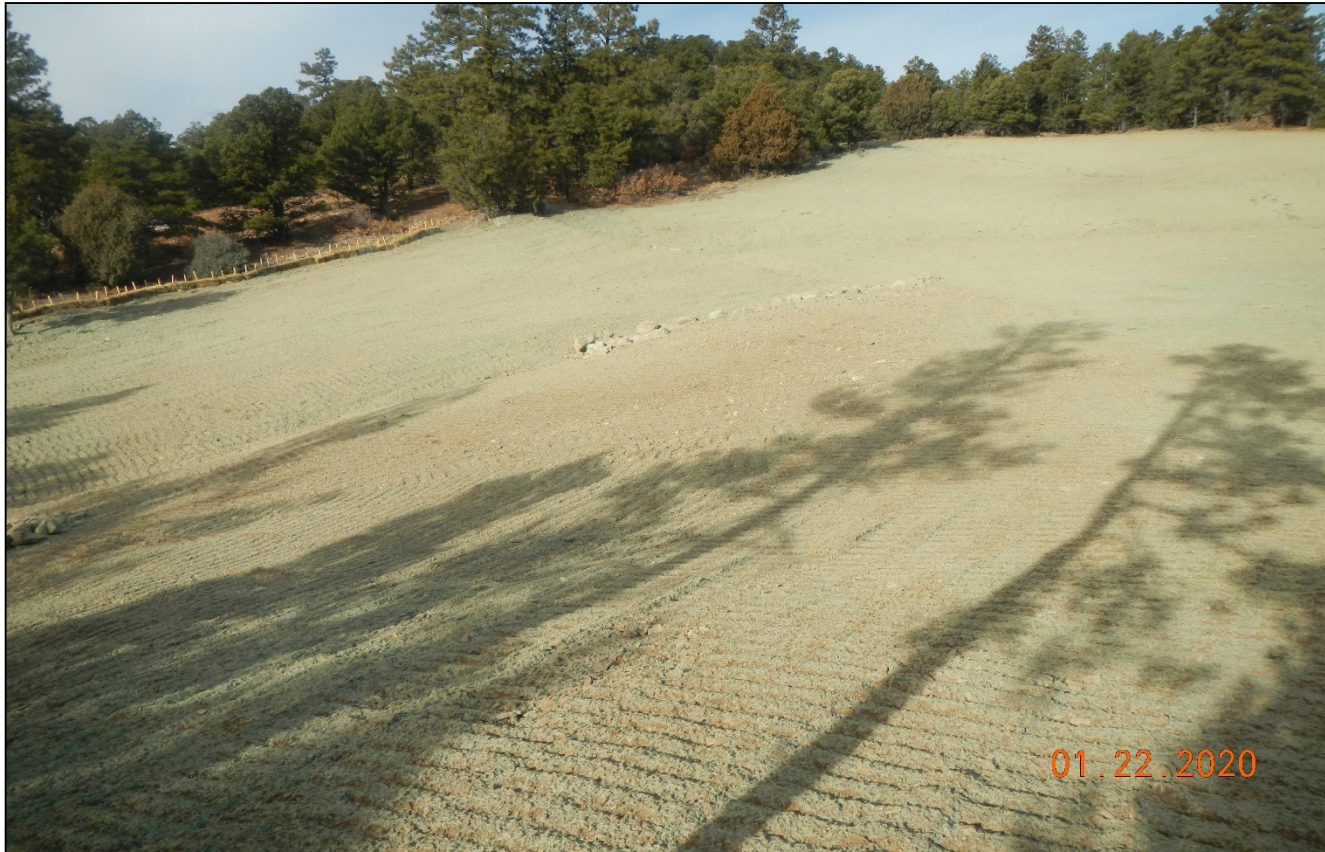
Photo 11. Standing at the bottom of the location facing northwest.
