McLaughlin 72
API: 05-103-01143
Inspection: 679707043

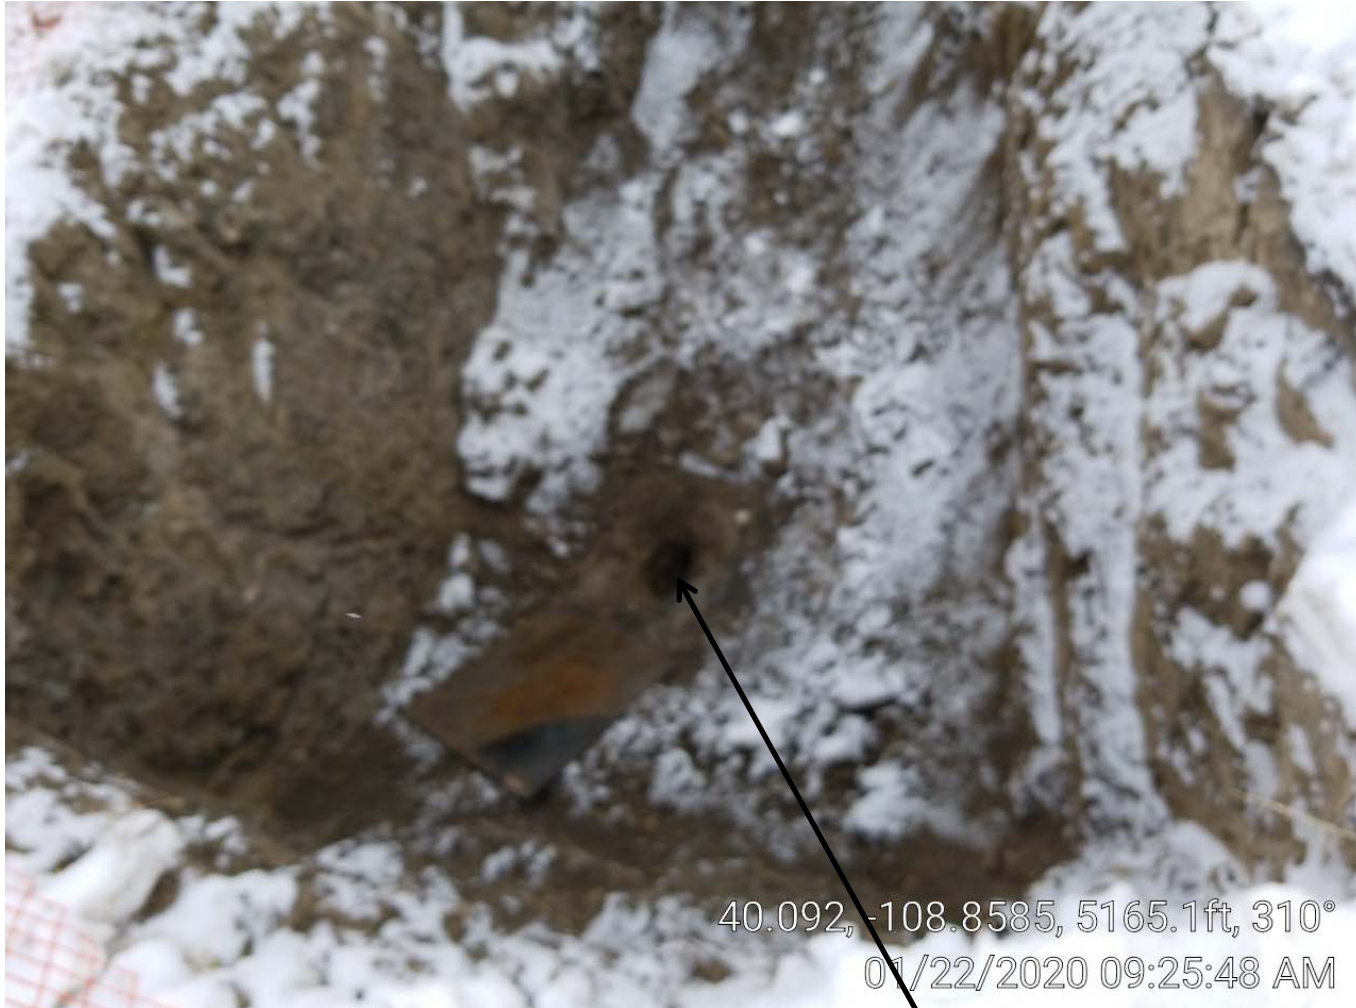
Photo 1. Excavated Location.

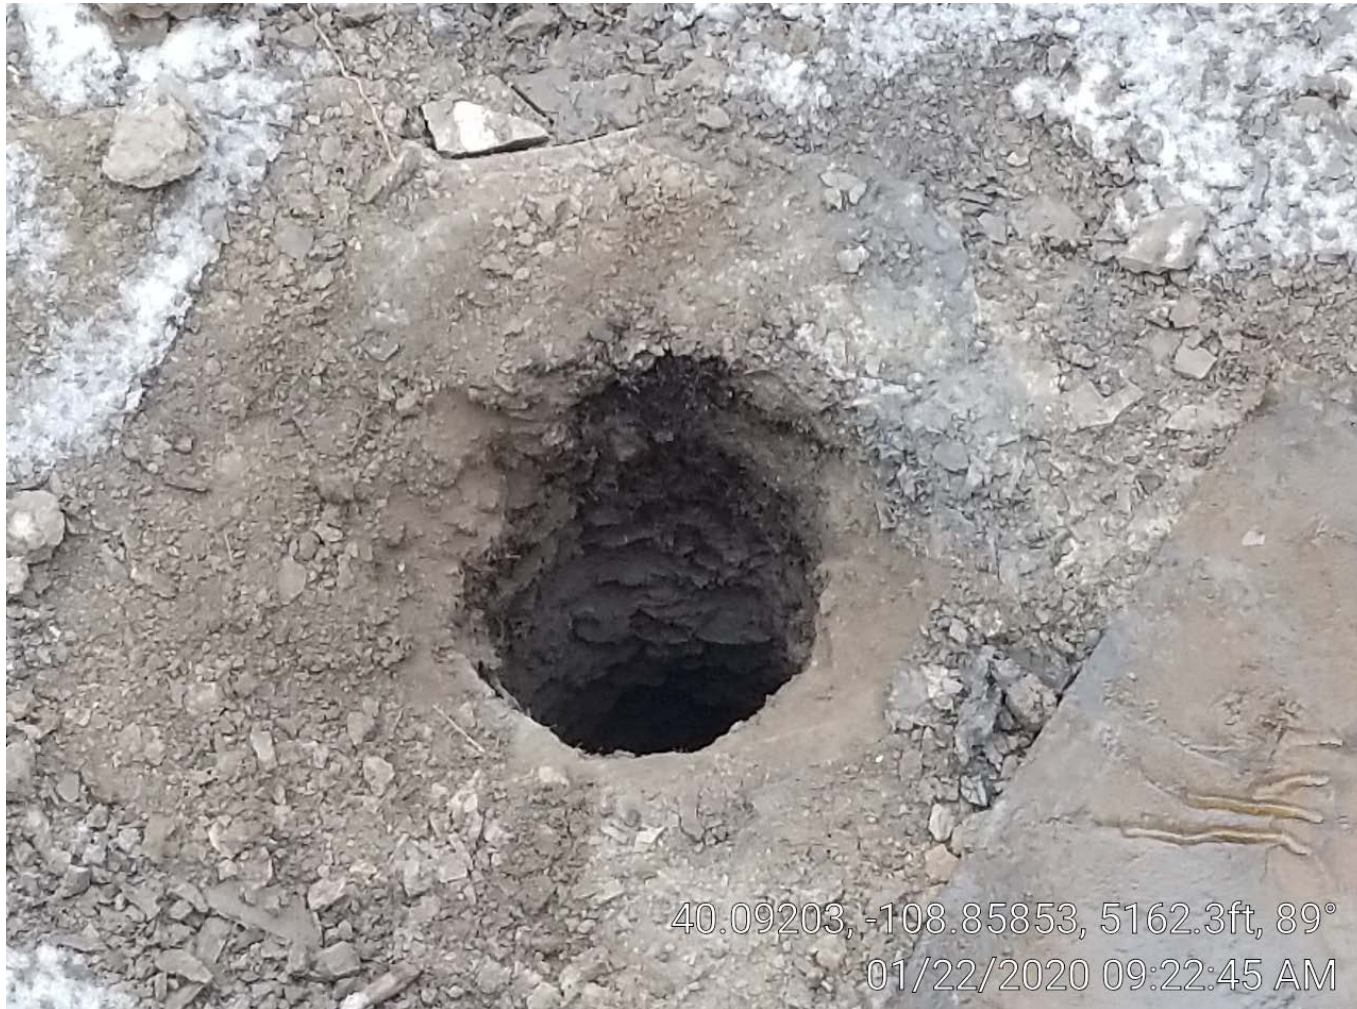
Photo 2. Well bore.

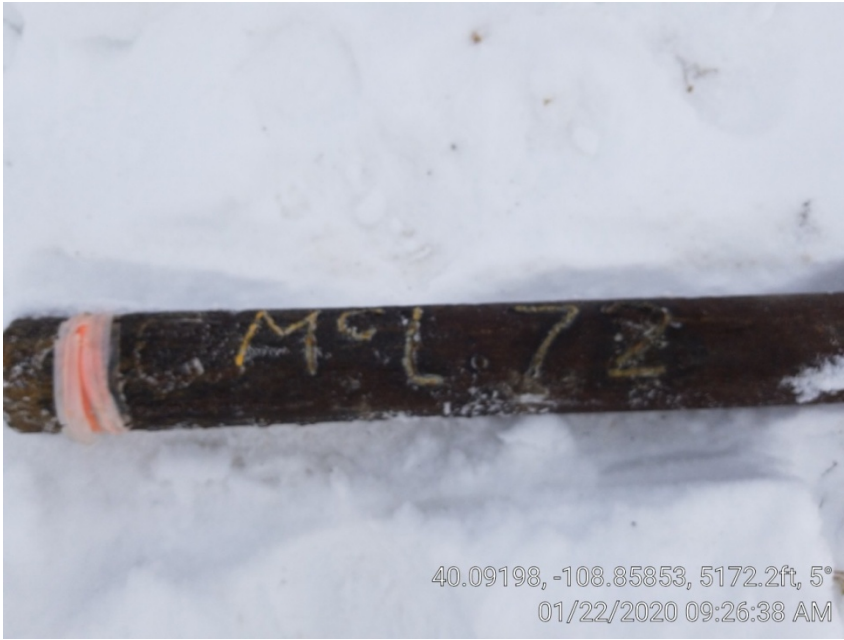
Photo 3. Well marker.

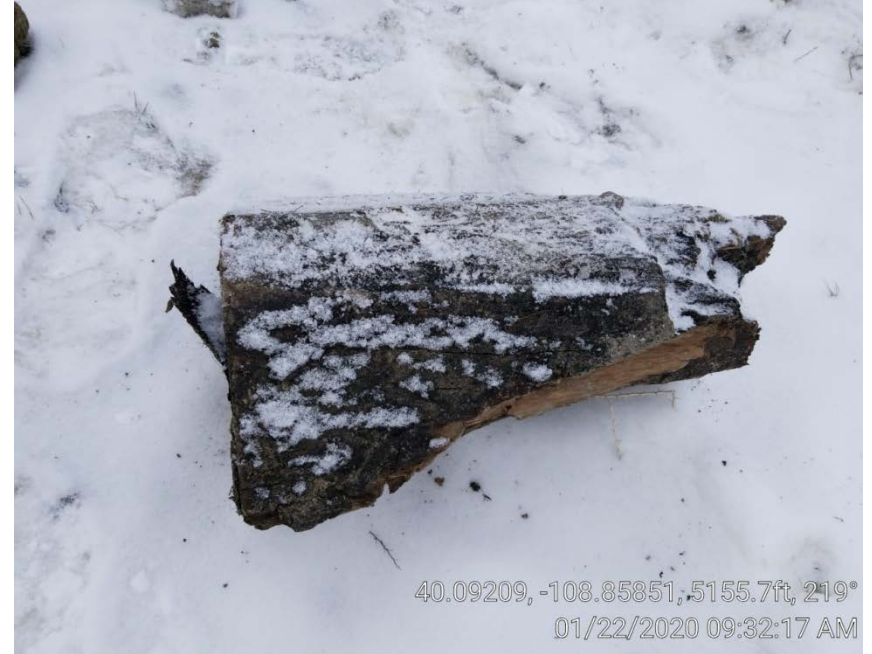
Photo 4. Wood used to plug well bore in ~1953.

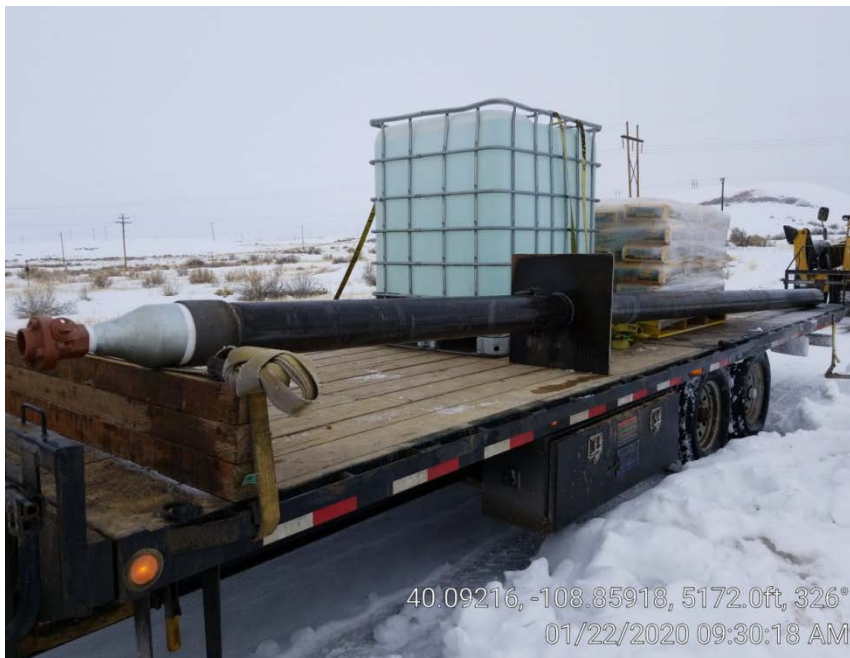
Photo 5. Surface casing installed 1-22-2020 to plug well.

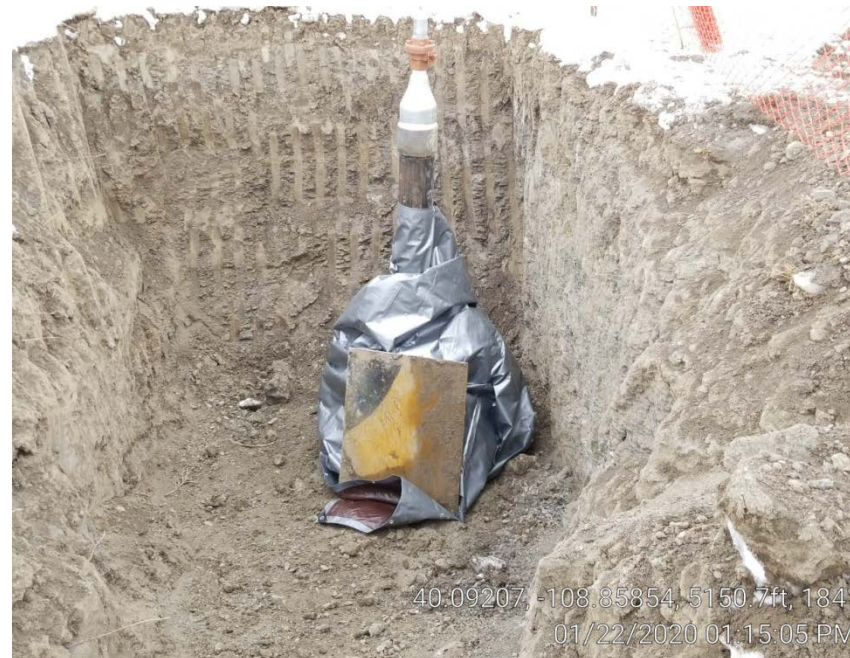
Photo 6. New surface casing installed.
