## Inspection Photos

Location Name: CAERUS PICEANCE LLC LINDAUER-68S96W /3SWSE

Location ID: 334105

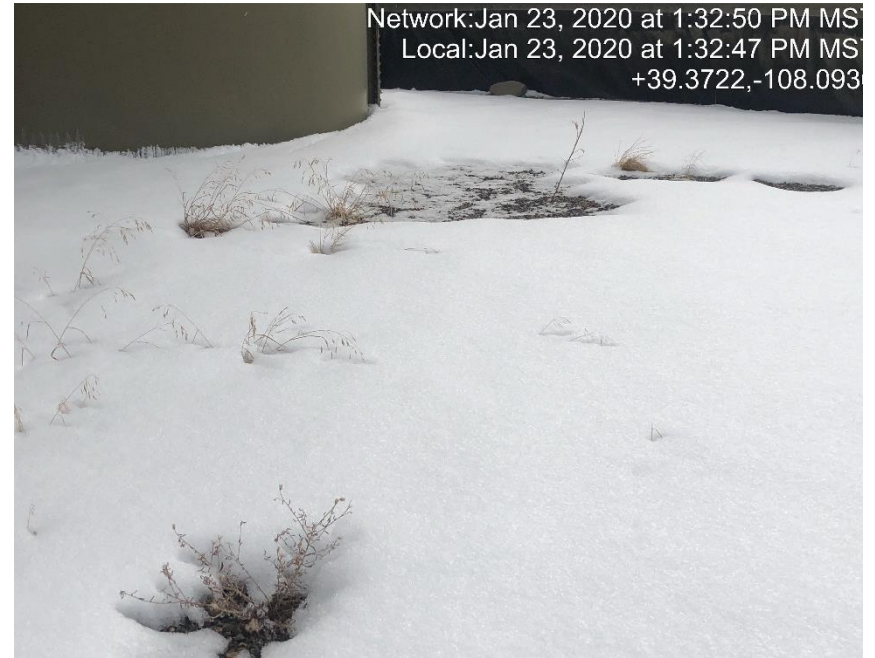
**Photo #0458 Debris in tank containment.**

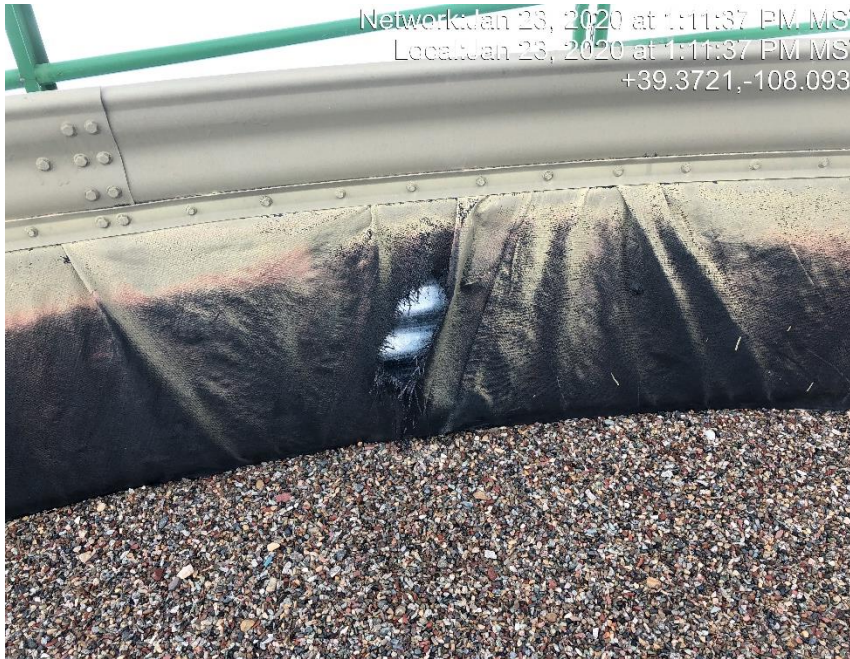
**Photo #0454 Multiple holes in tank containment liner.**

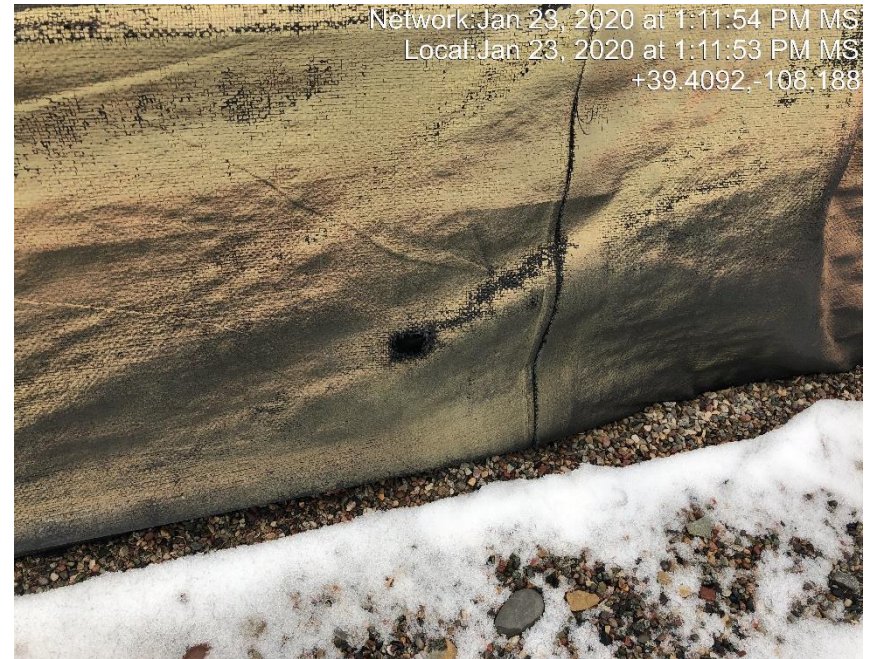
**Photo #0455 Multiple holes in tank containment liner.**

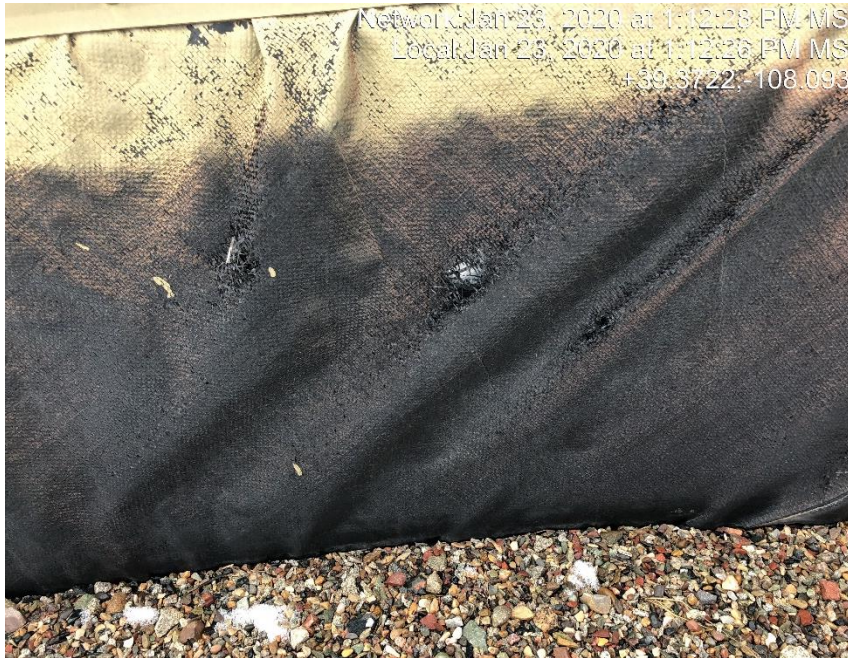
**Photo #0457 Multiple holes in tank containment liner.**
