Inspection Photos

API: 05-043-40006

Operator: JAVERNICK OIL

Inspection Date: 1/23/2020

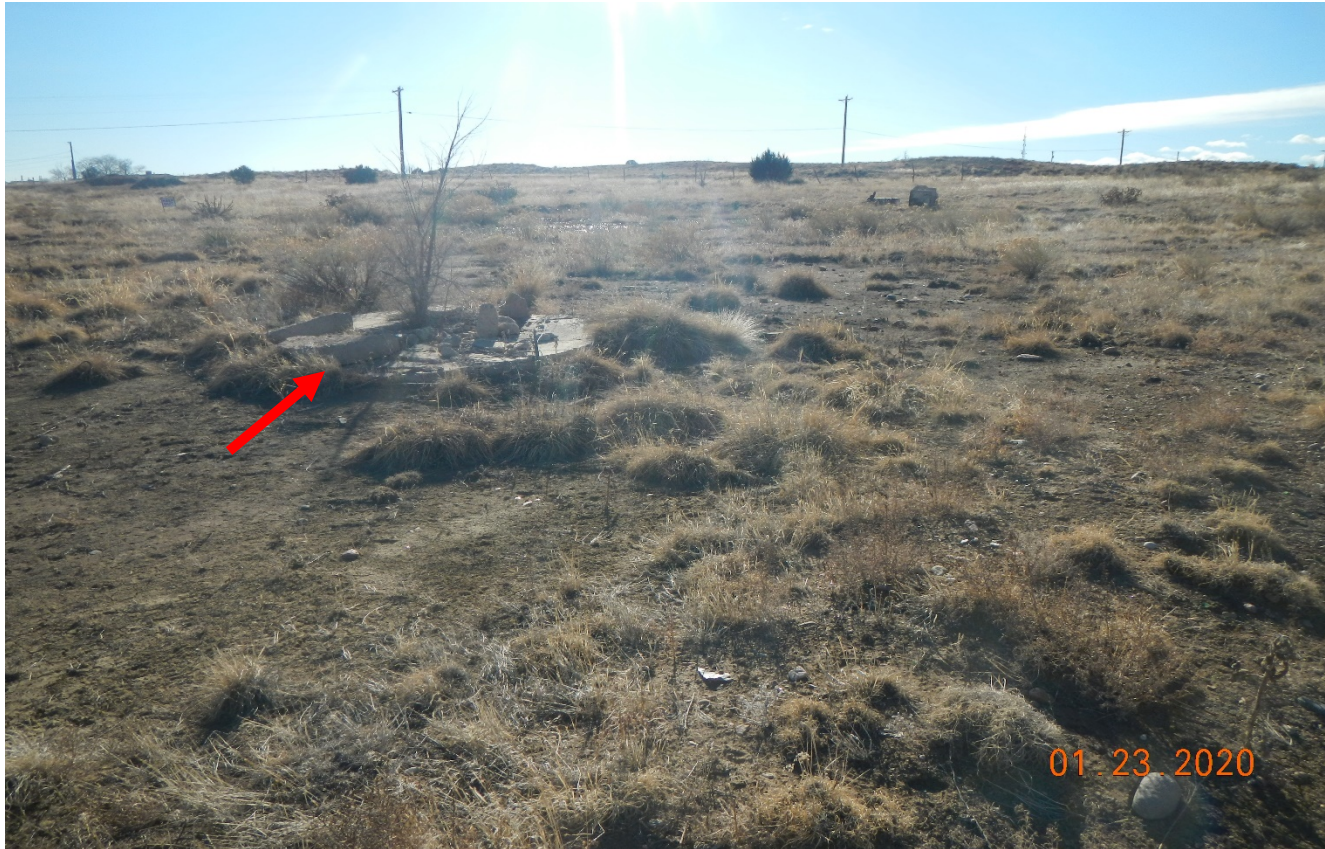
Photo 1. Facing southeast toward the location. There is cement debris that remains shown by red arrow.

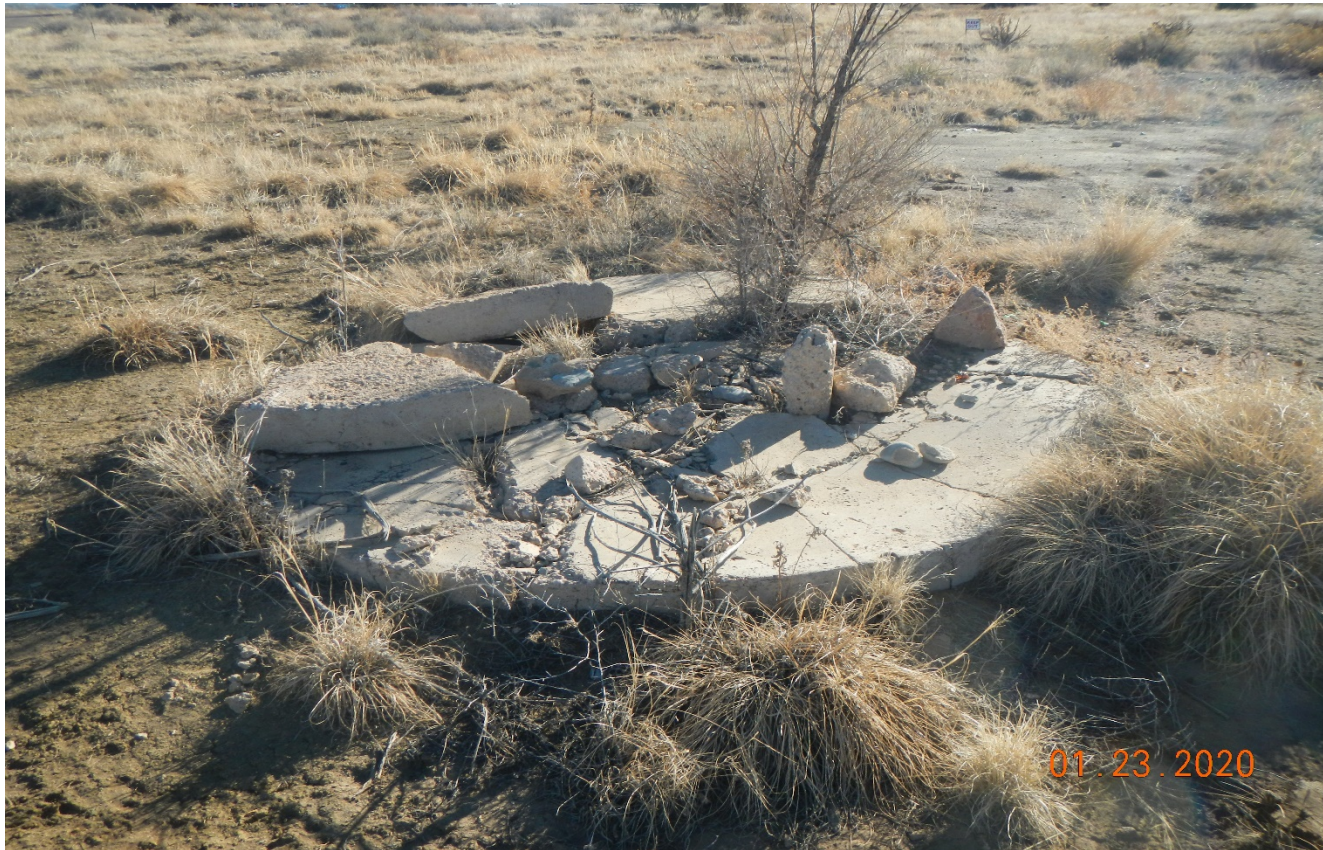
Photo 2. Close up view of the cement debris found at the location.

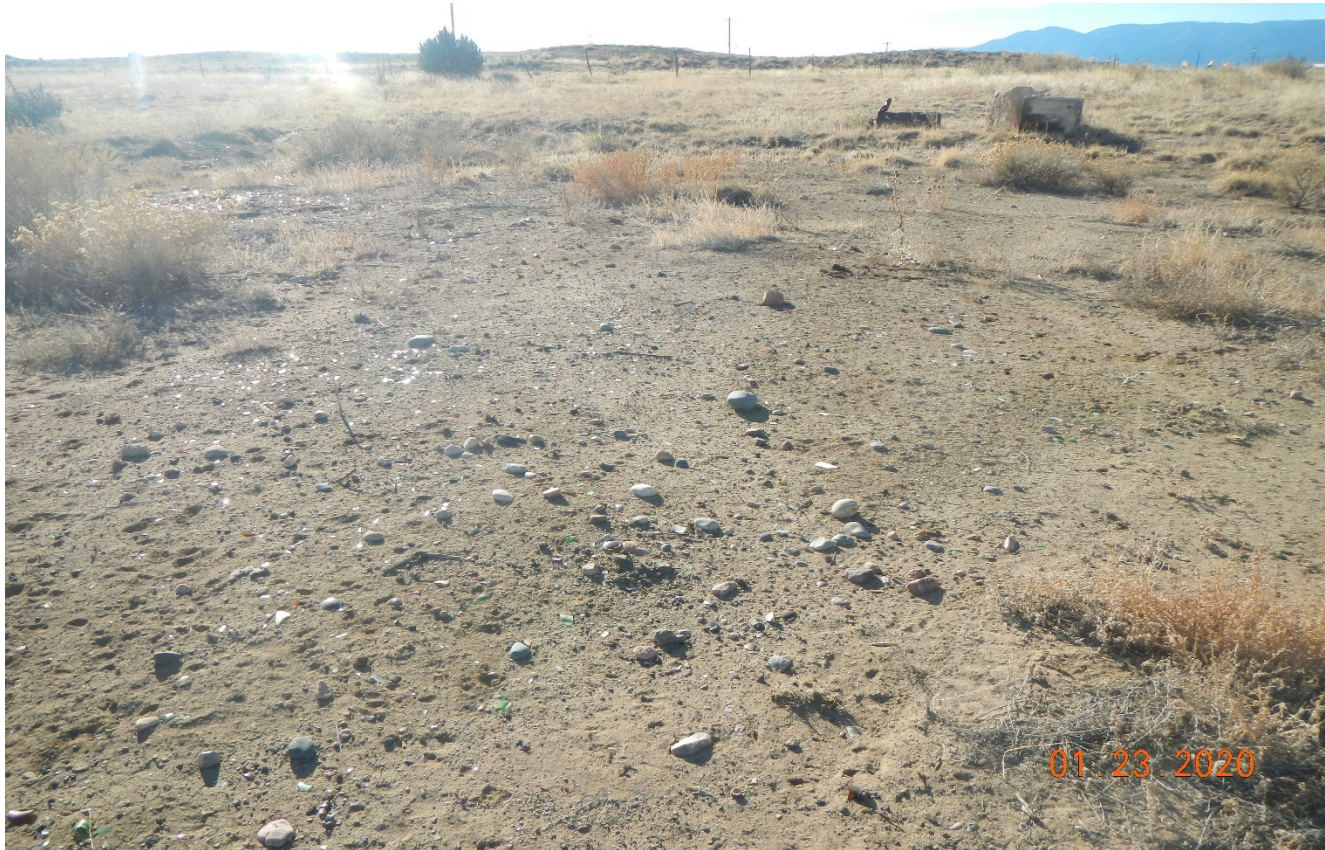
Photo 3. Facing south where well was located. This area is bare of vegetation and must be reclaimed.

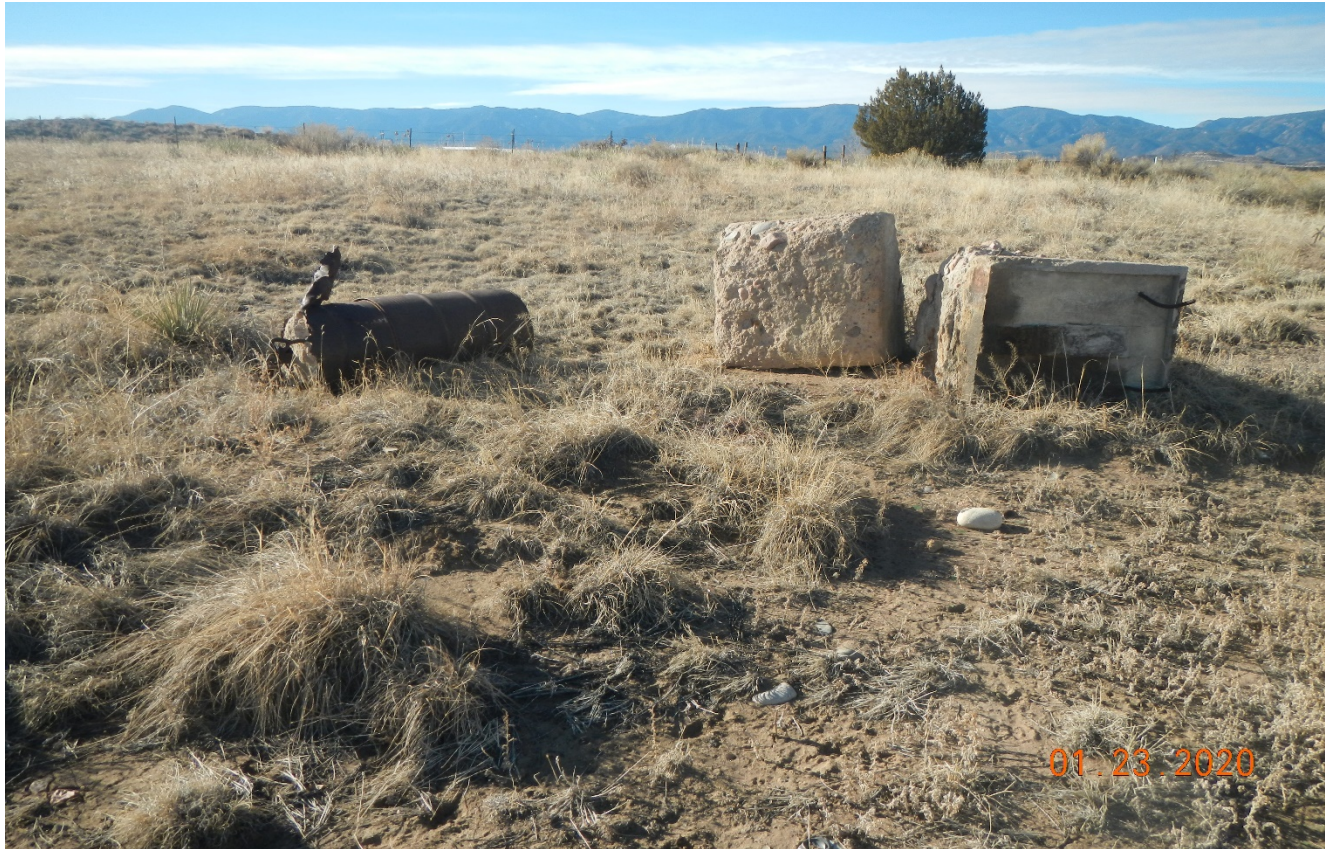
Photo 4. There are cement block and cemented anchor that remain at the south side of the location.

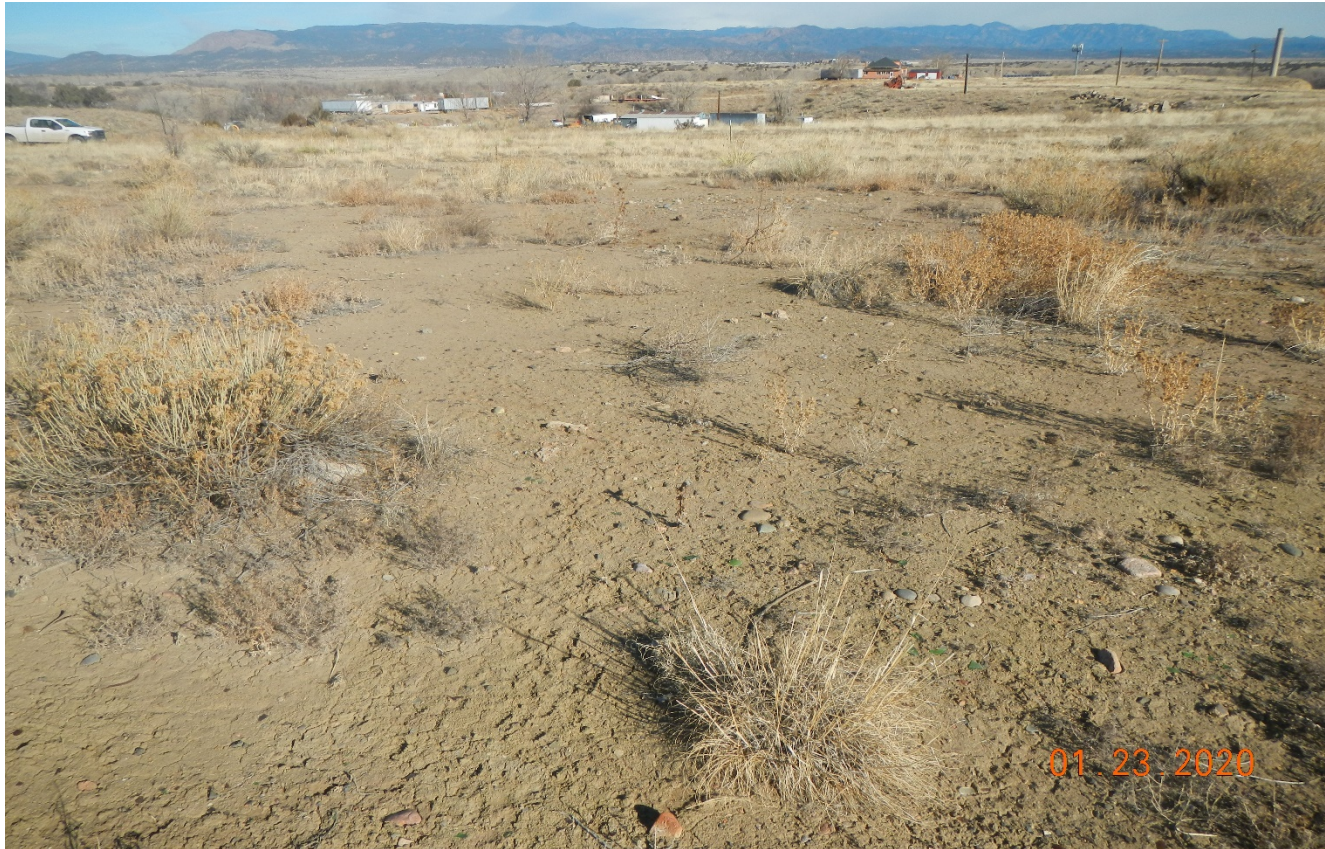
Photo 5. Facing north where well was located. This area is bare of vegetation and must be reclaimed.

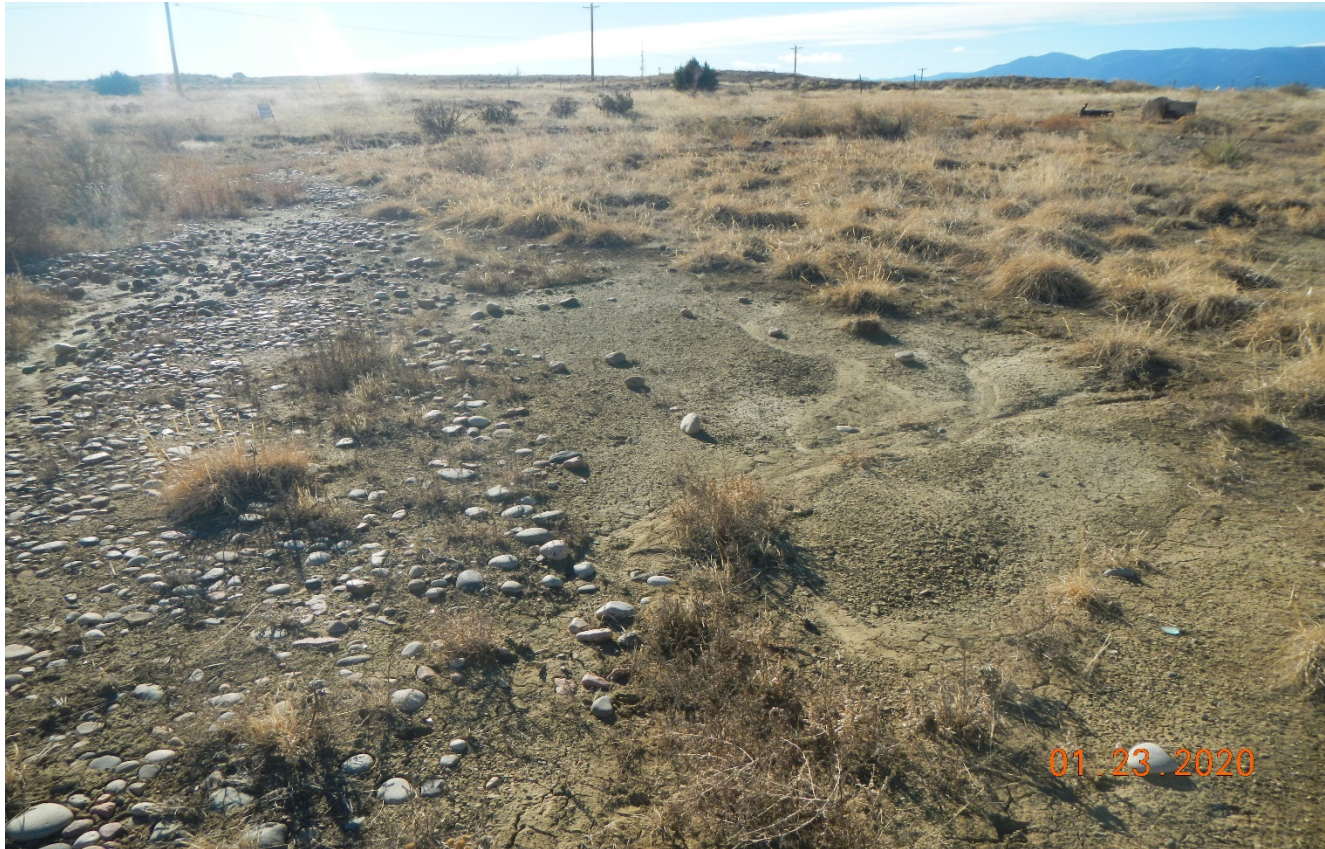
Photo 6. The access road made a circle around the well site. There is still gravel that remains and areas bare of vegetation along the former access road.
