Inspection Photos

API: 05-043-06059

Operator: JAVERNICK OIL

Inspection Date: 1/23/2020

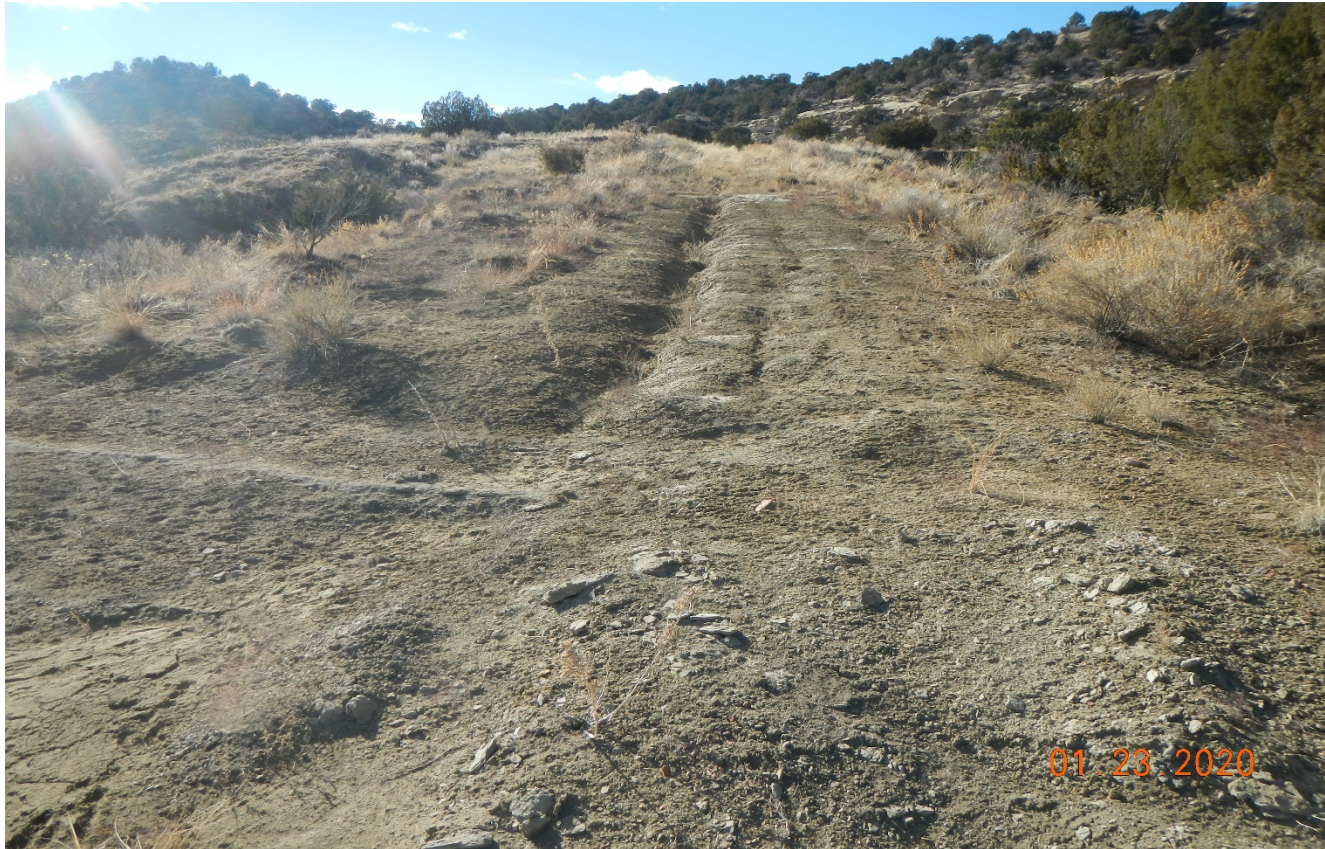
Photo 1. Facing southeast toward the access road. This area of the former road is bare of vegetation and there are signs of erosion.

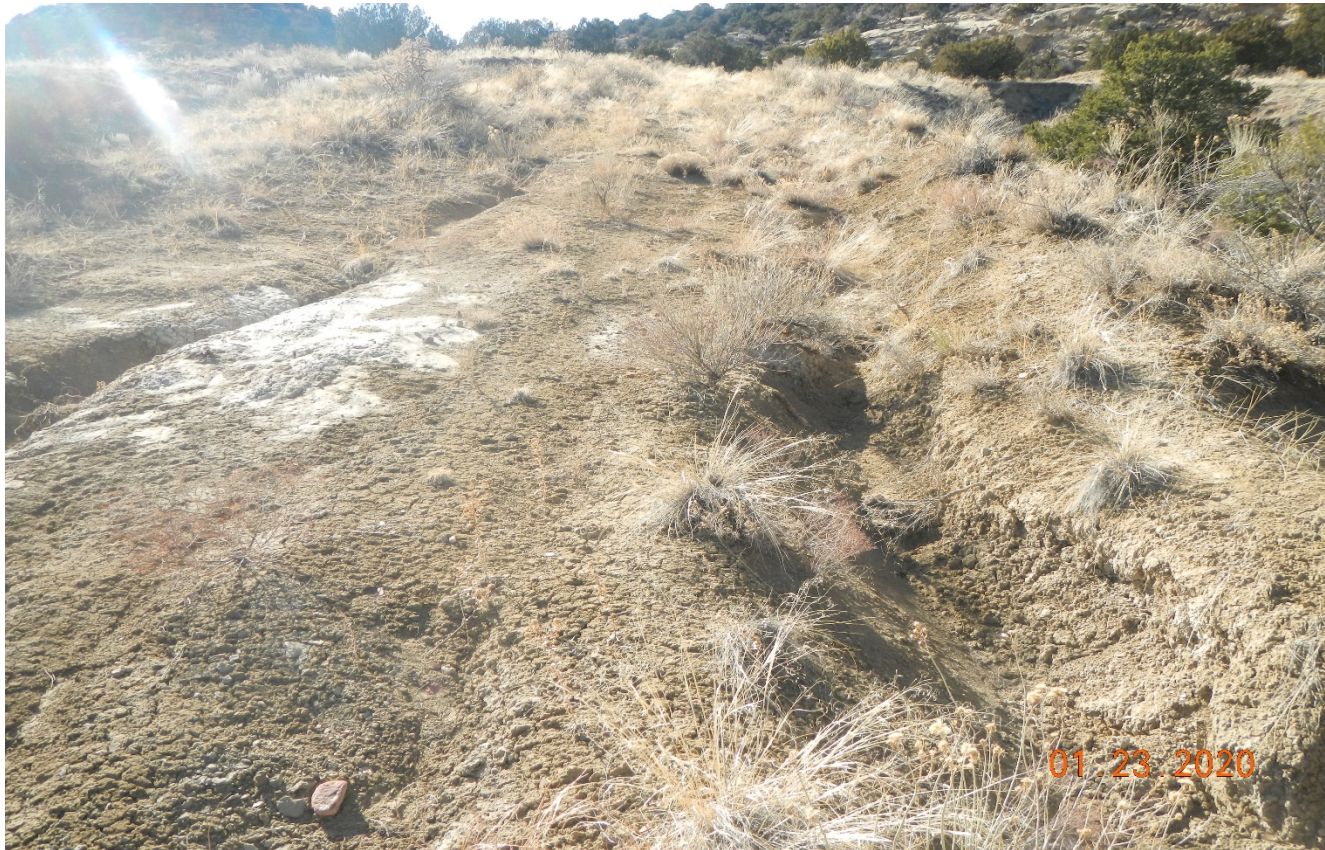
Photo 2. There is erosion occurring down the former road. The erosion channels need to be repaired and stabilized.

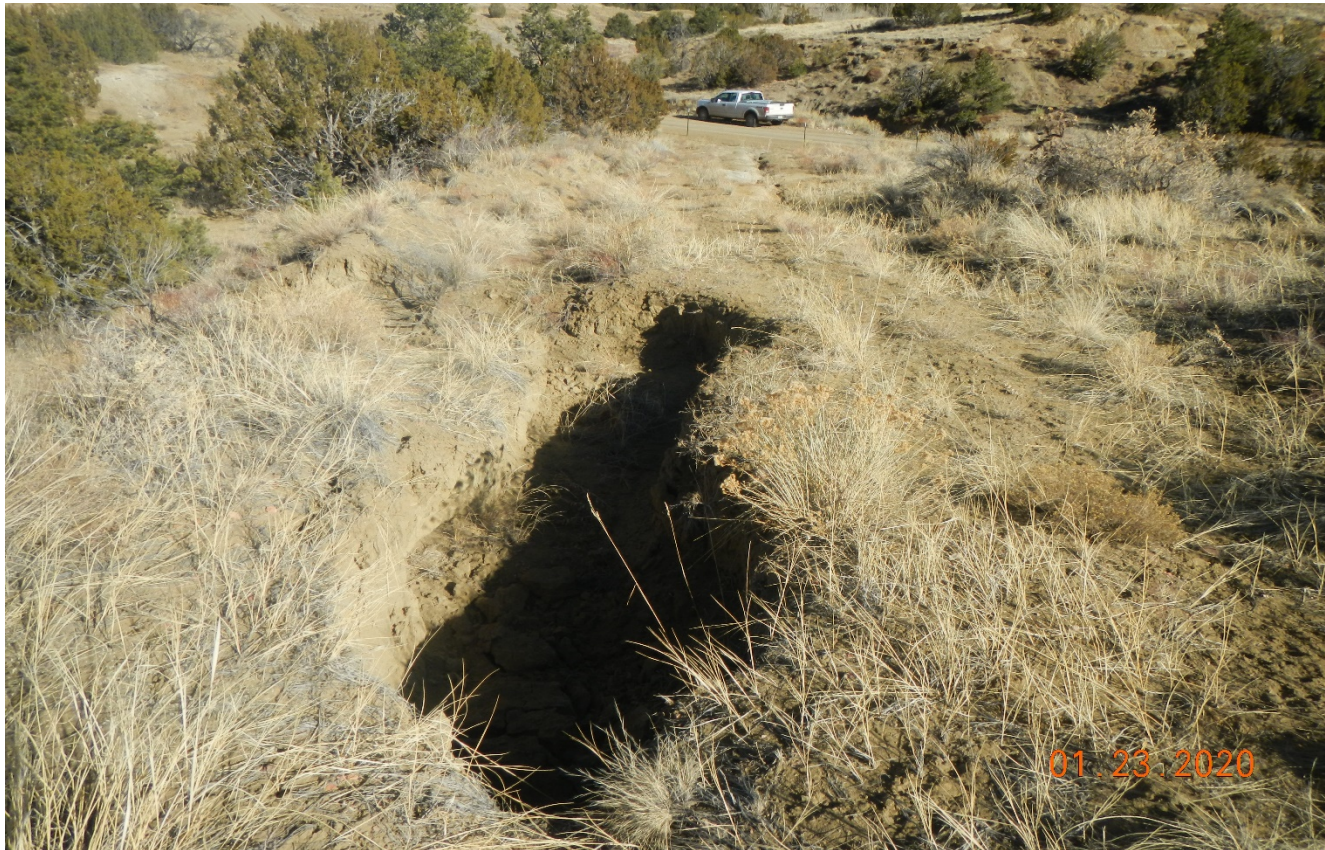
Photo 3. There is an erosion gully along the road that is approximately 2-3 ft. deep.

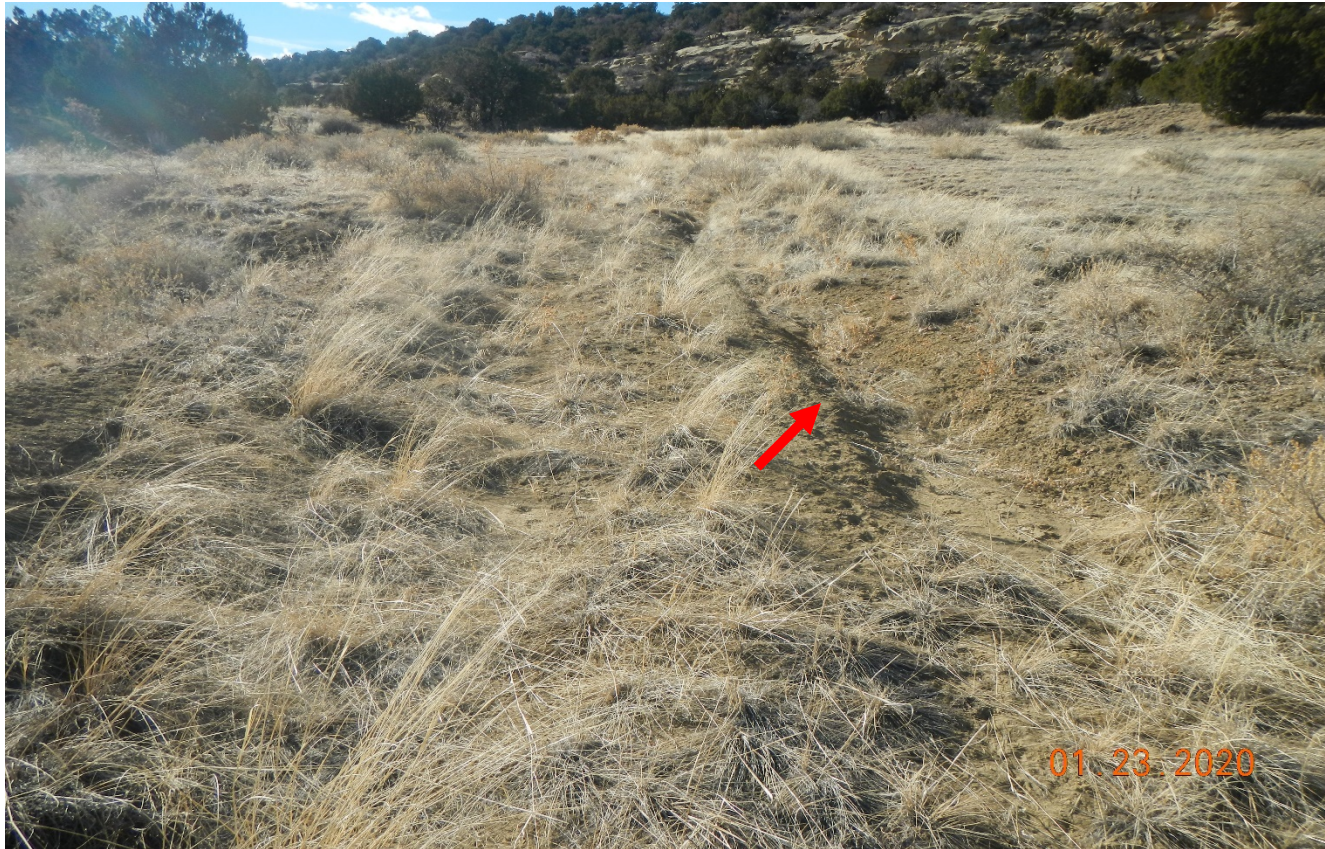
Photo 4. Vegetation is establishing along the remainder of the road to the location. Arrow points to area that may need erosion control.

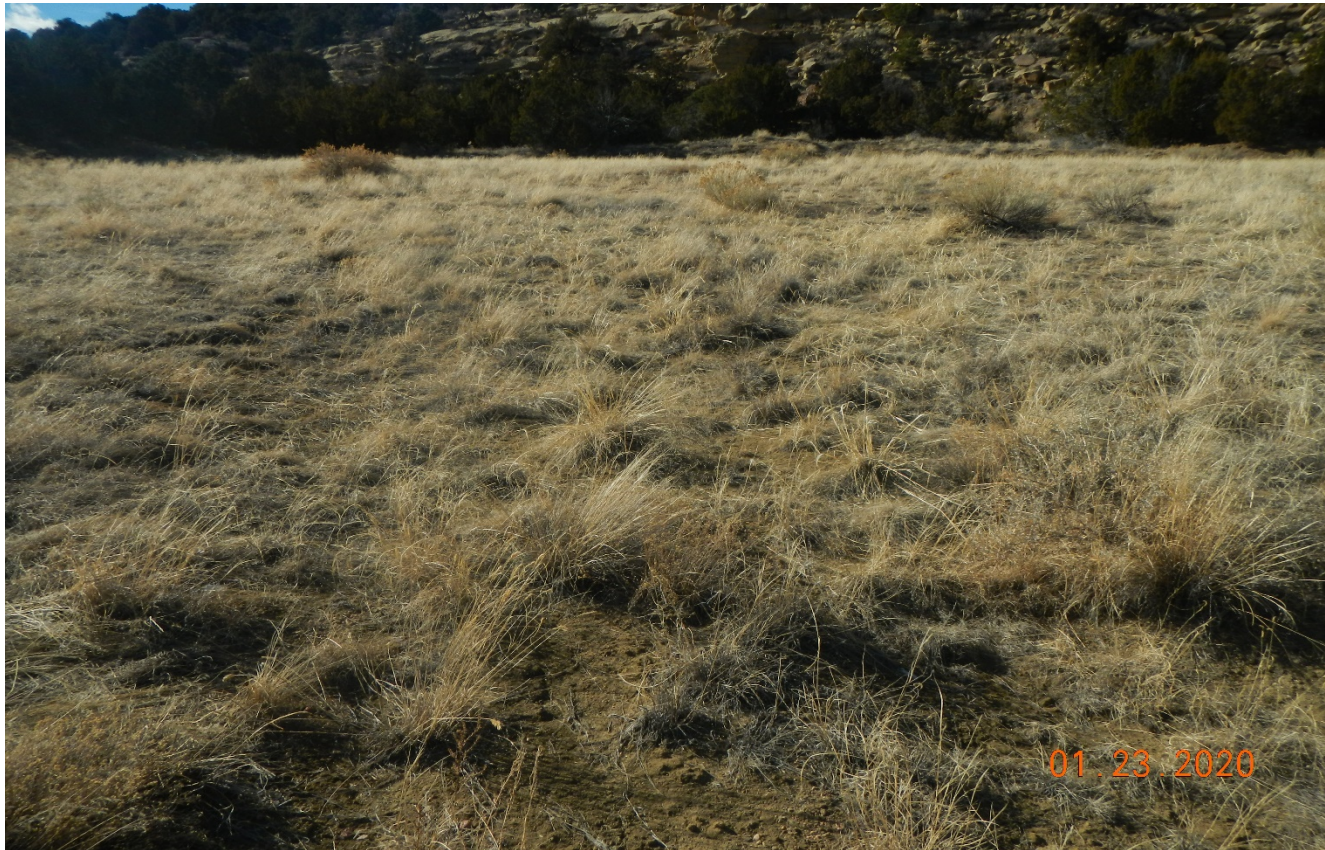
Photo 5. Facing west toward the location. Vegetation is well established at the location and consist of Indian rice grass and Sand dropseed.

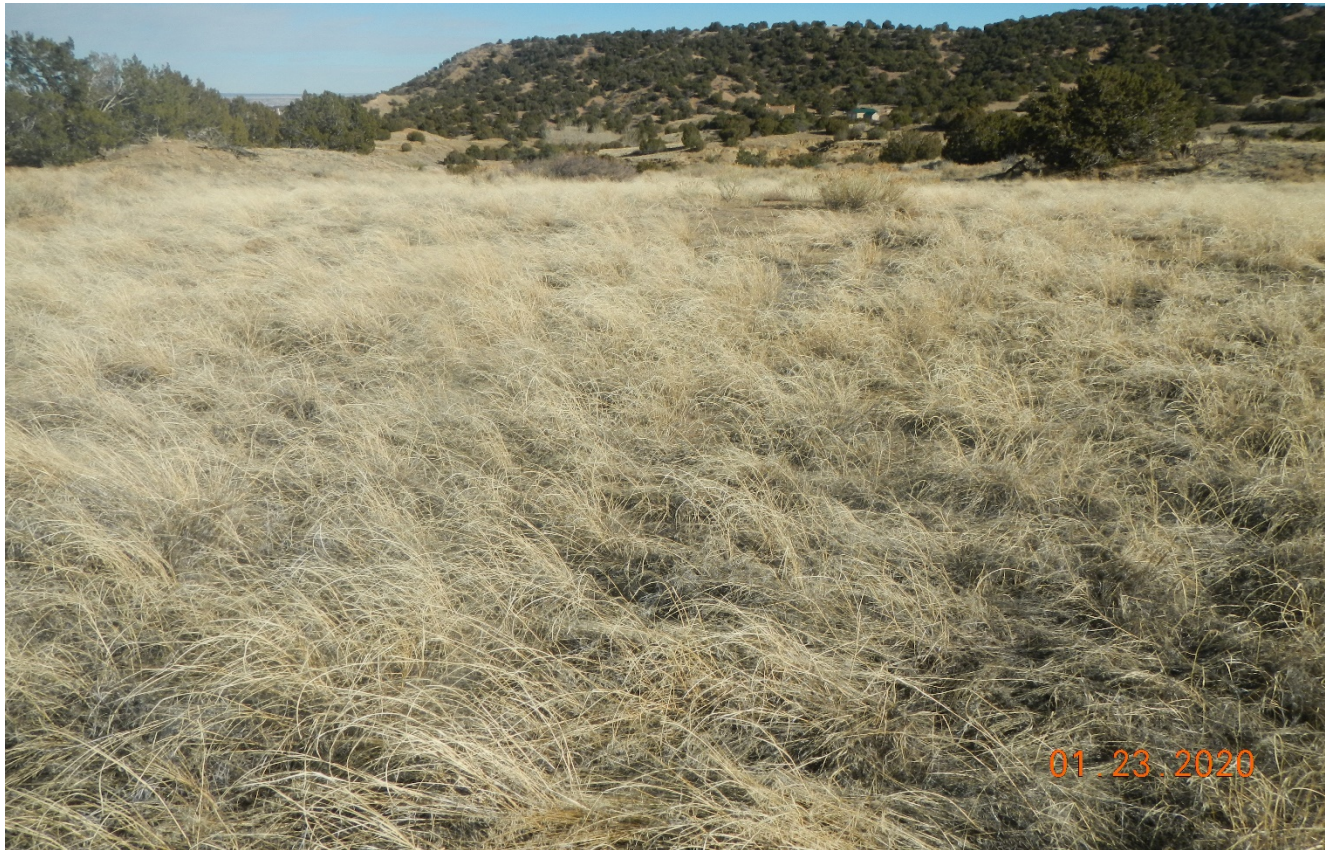
Photo 6. Facing east toward the location. Vegetation is well established at the location and consist of Indian rice grass and Sand dropseed.
