# Inspection Photos

Operator: Catamount Energy  
Location/API #: 067-05279  
Date: 1-22-2020

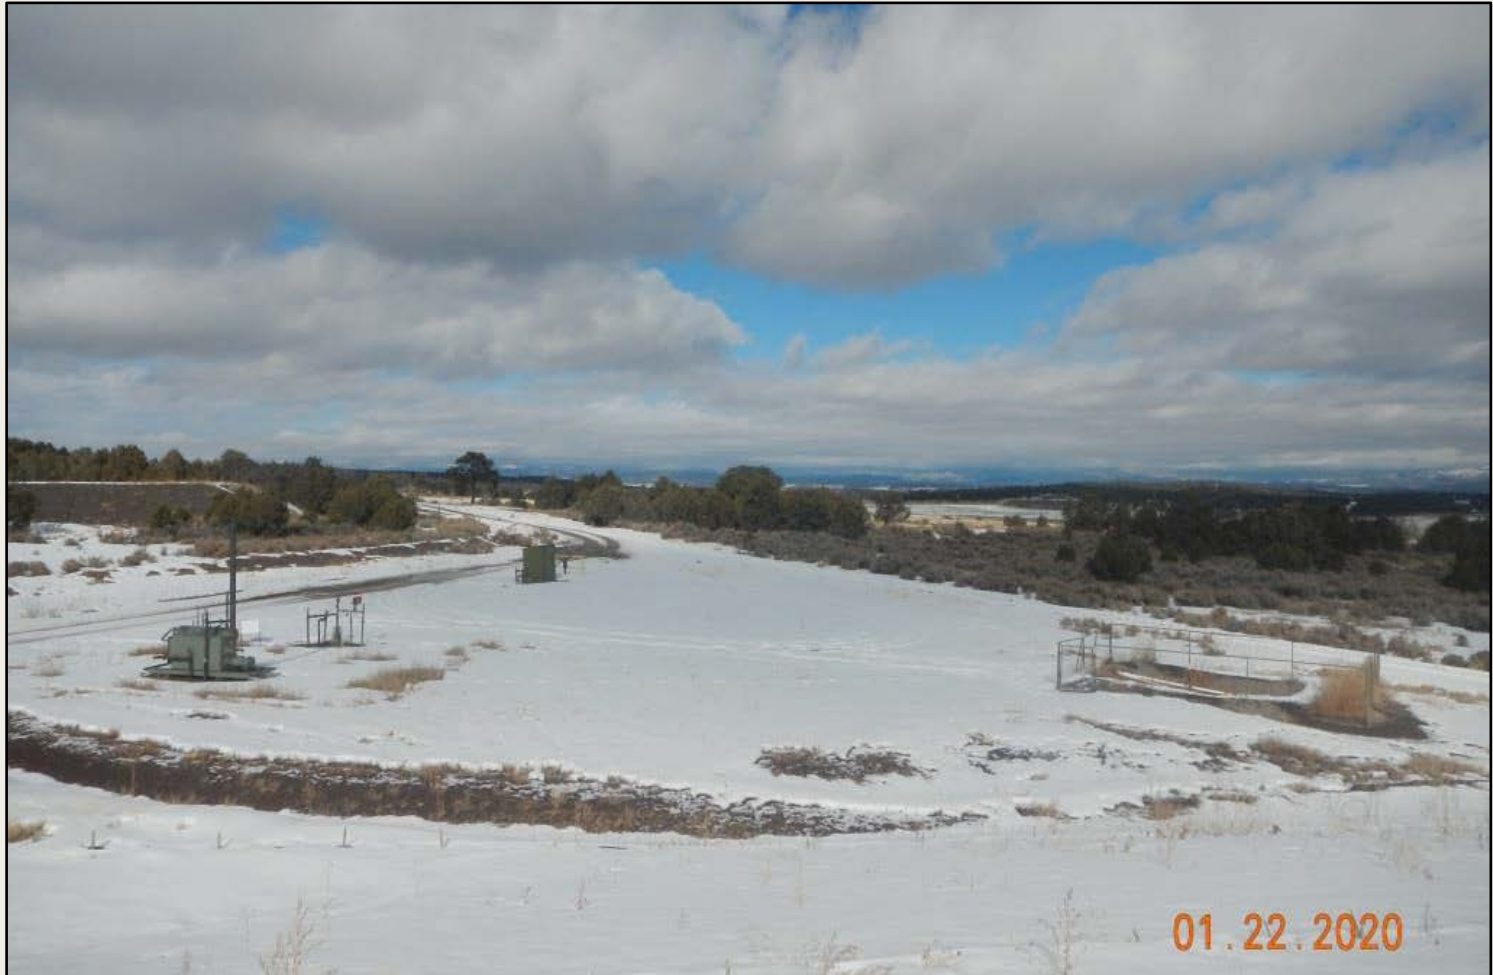
Photo 1. View of the project area from the northern edge of the adjacent well pad, facing center.

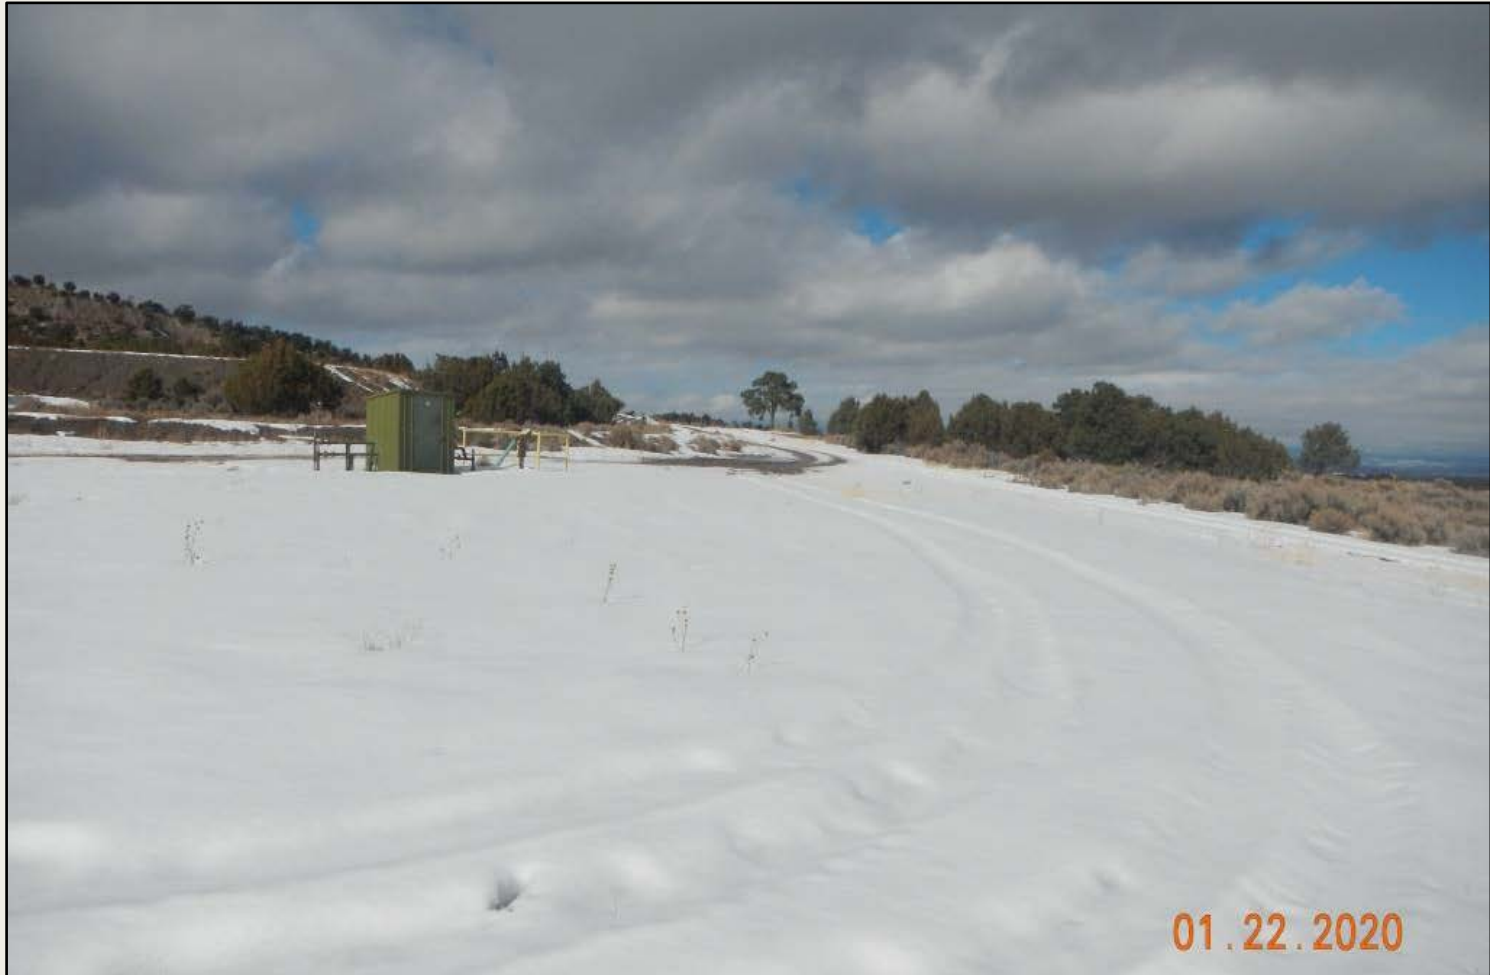
Photo 2. View of the eastern project area from the southeastern portion facing northward. Although snow covered, it is apparent that revegetation is not conducted and erosion/stormwater controls are not installed.
