Inspection Photos
Operator: BP America
Location/API #: 067-05796
Date: 1-22-2020

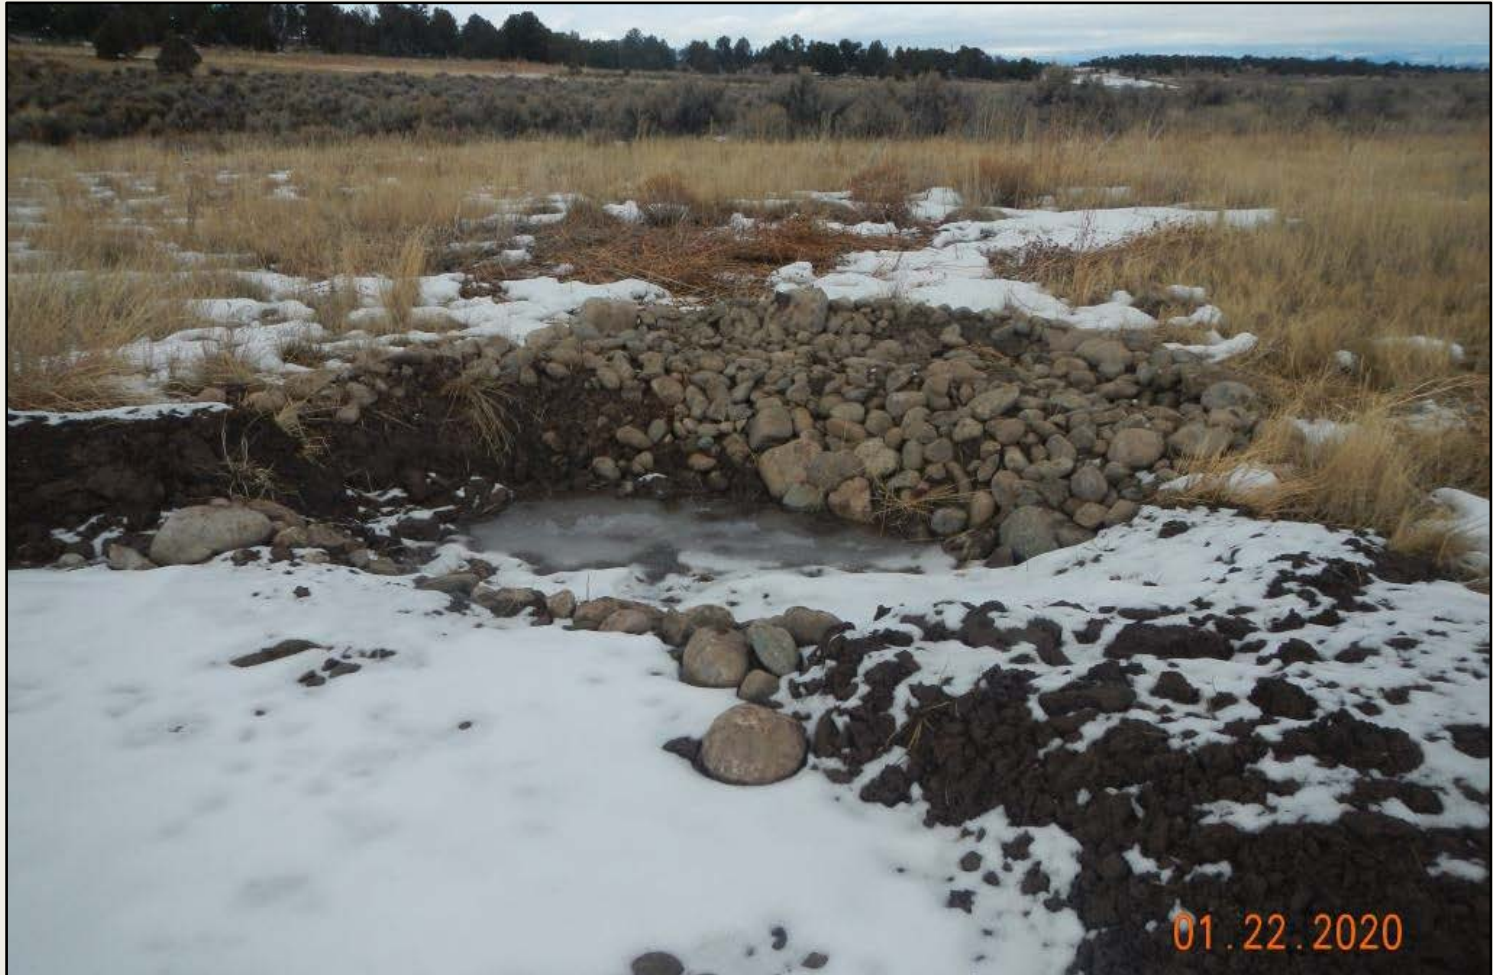
Photo 1. View of stormwater controls installed within the northern project area. Cobble rock at outlet is not adequate outlet structure. Bare soils are not stabilized.

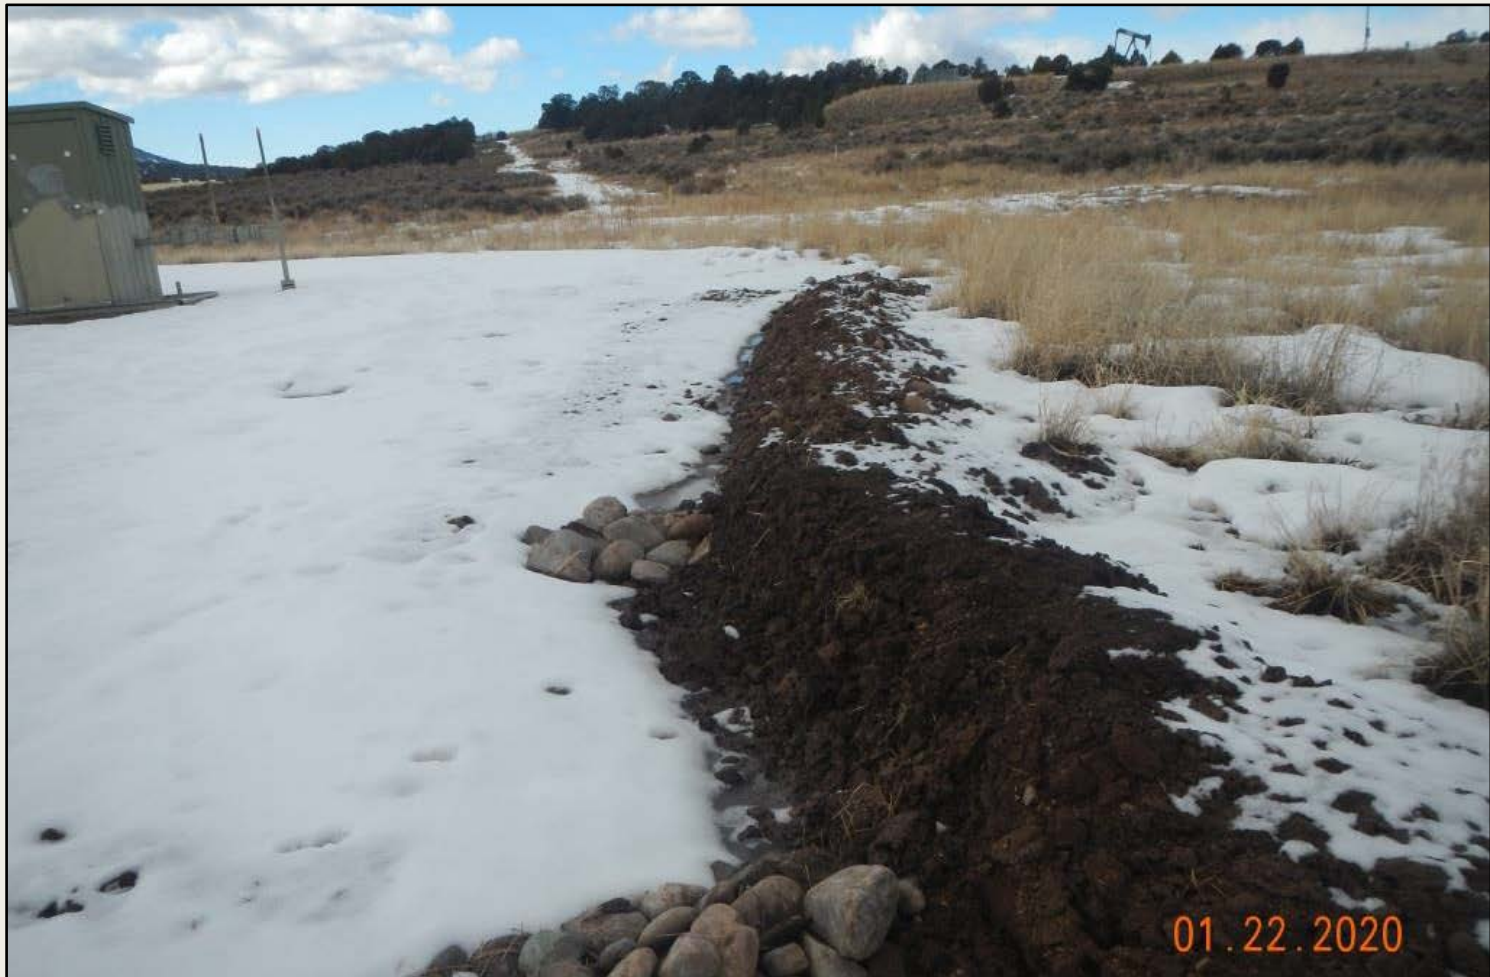
Photo 2. View of berm installed within the northern project area. Berm is not stabilized.

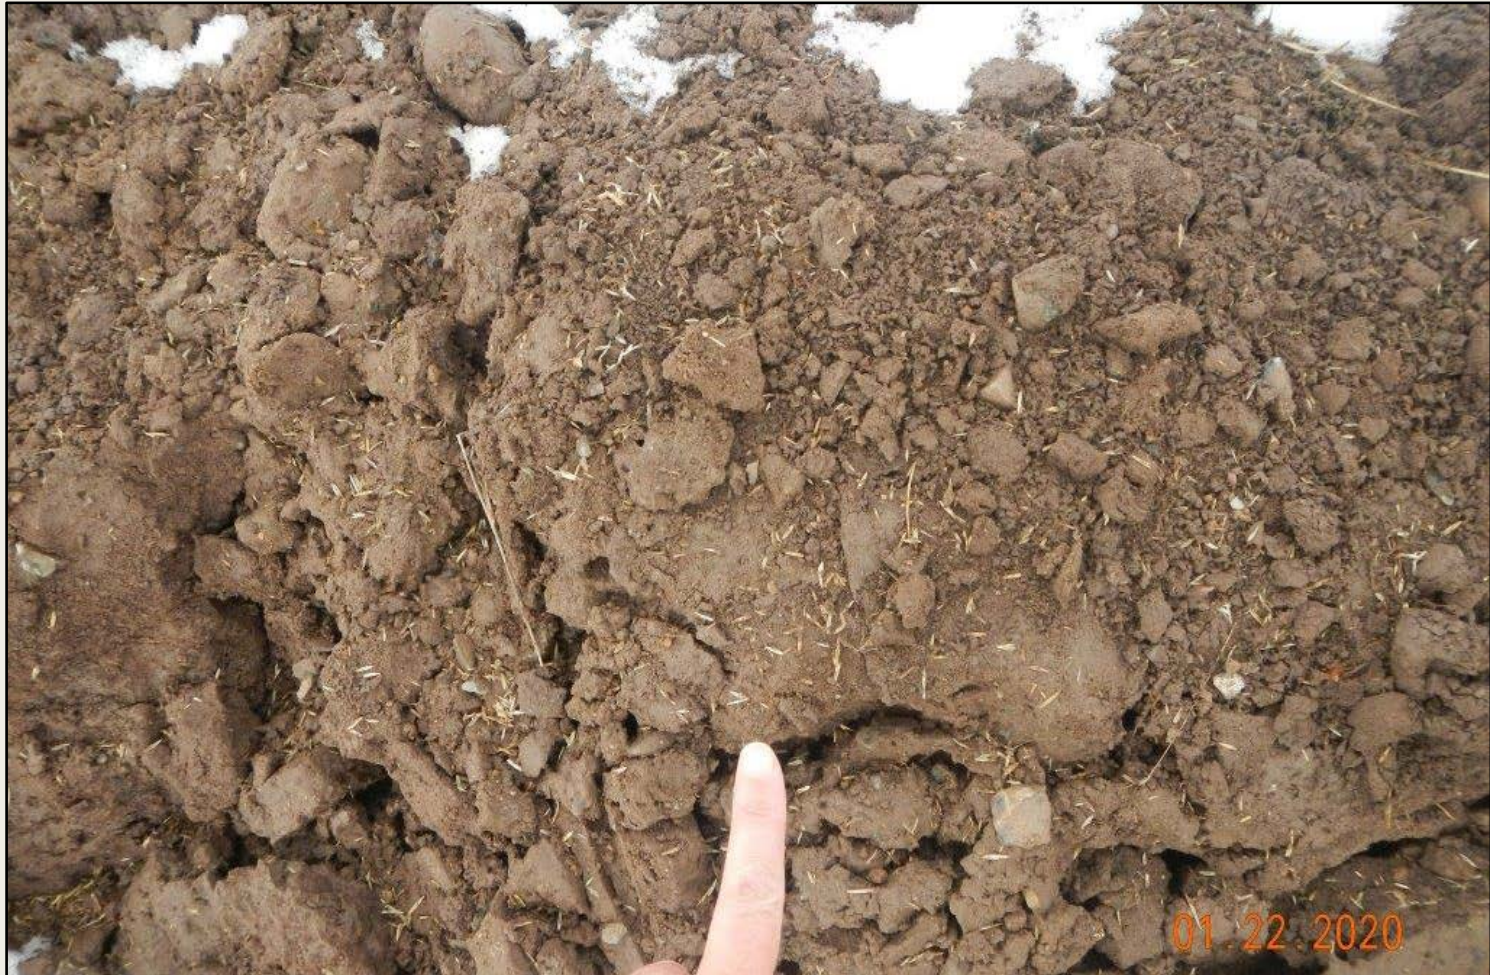
Photo 3. View of seed placed on soil surface, although seedbed is not prepared and seed is not incorporated into soil. Stabilizing measures such as hydromulch or straw mulch are needed until stabilized with perennial vegetation.

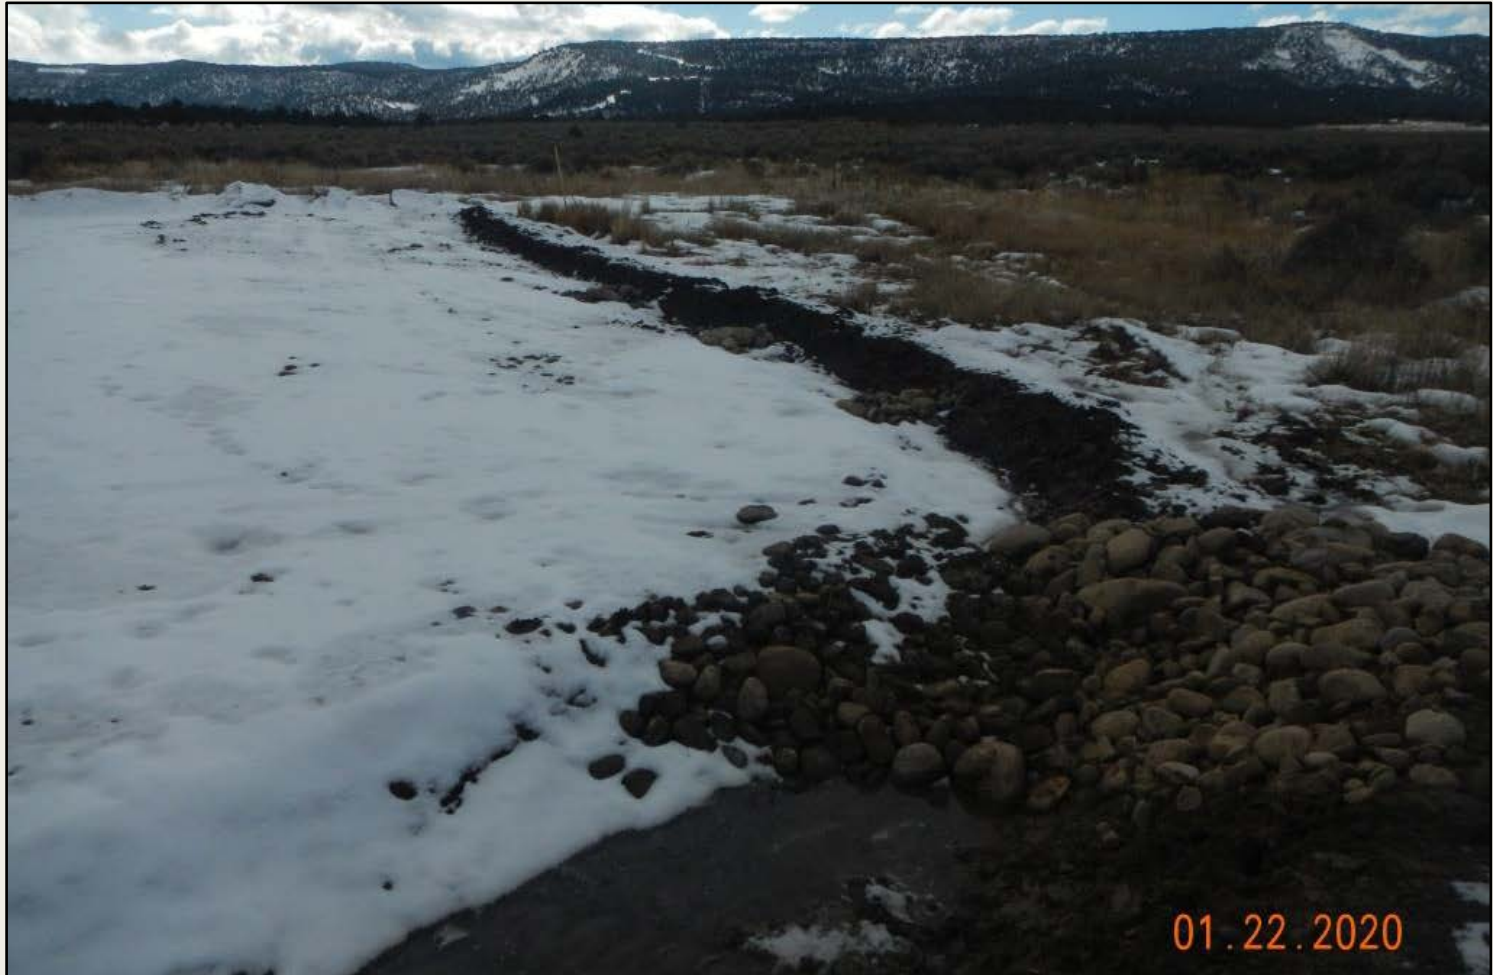
Photo 4. View of berm installed within the southwestern project area. Bare soils not stabilized, seed bed not prepared and seed not incorporated.

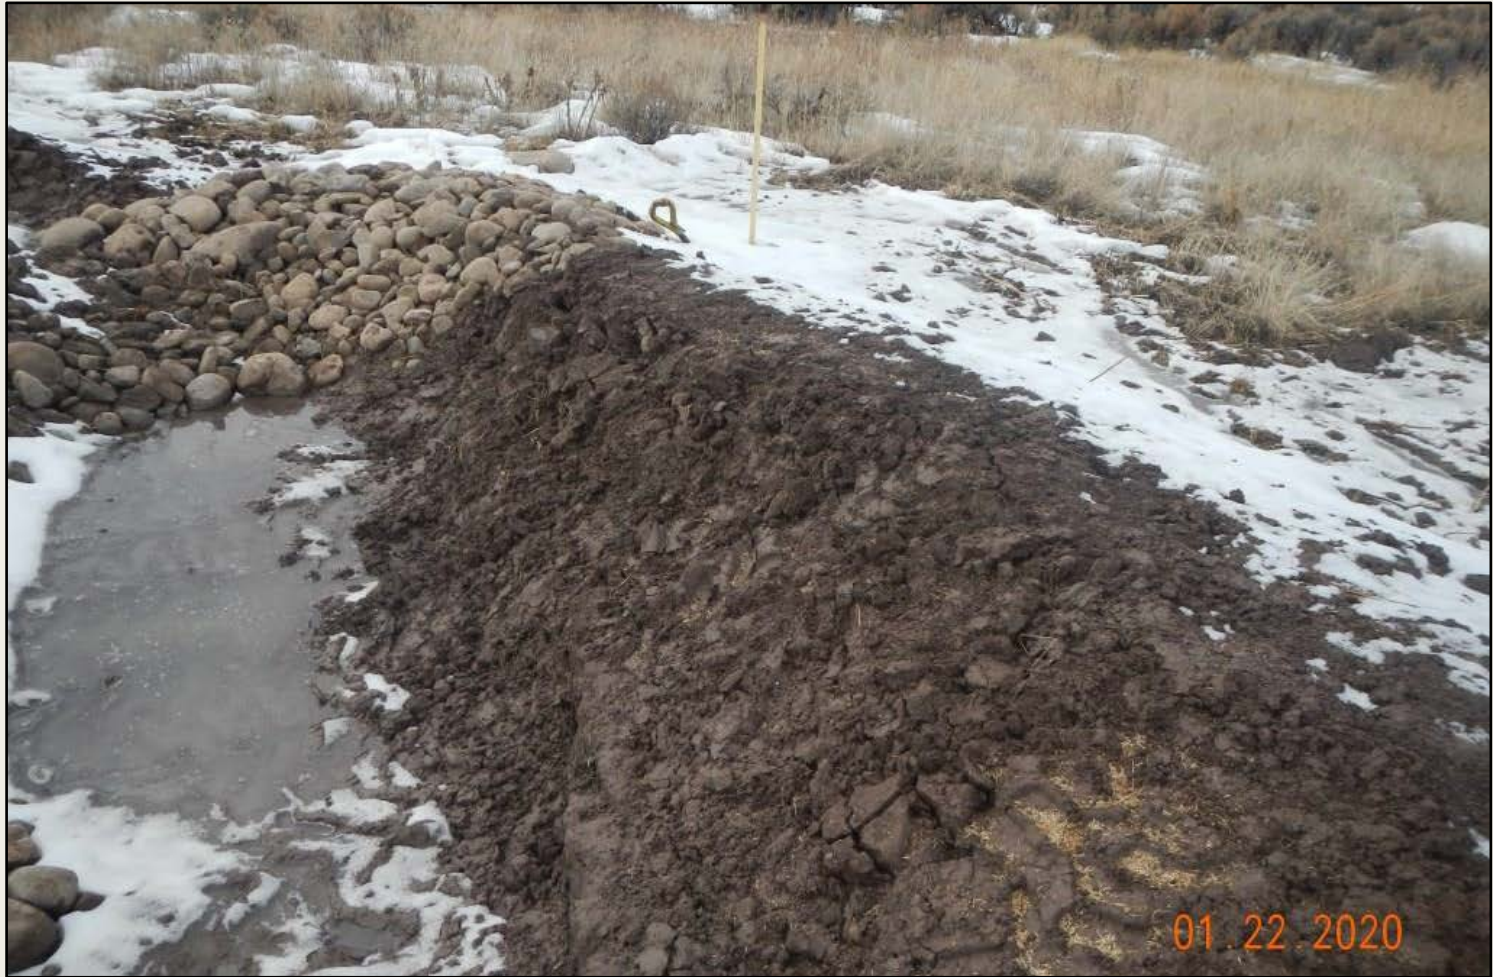
Photo 5. View of silt trap installed within the western project area. Geotextile fabric not in place. Insufficient rock armoring.
