Inspection Photos

API: 05-043-06182

Operator: INCREMENTAL OIL & GAS (FLORENCE) LLC

Inspection Date: 1/23/2020

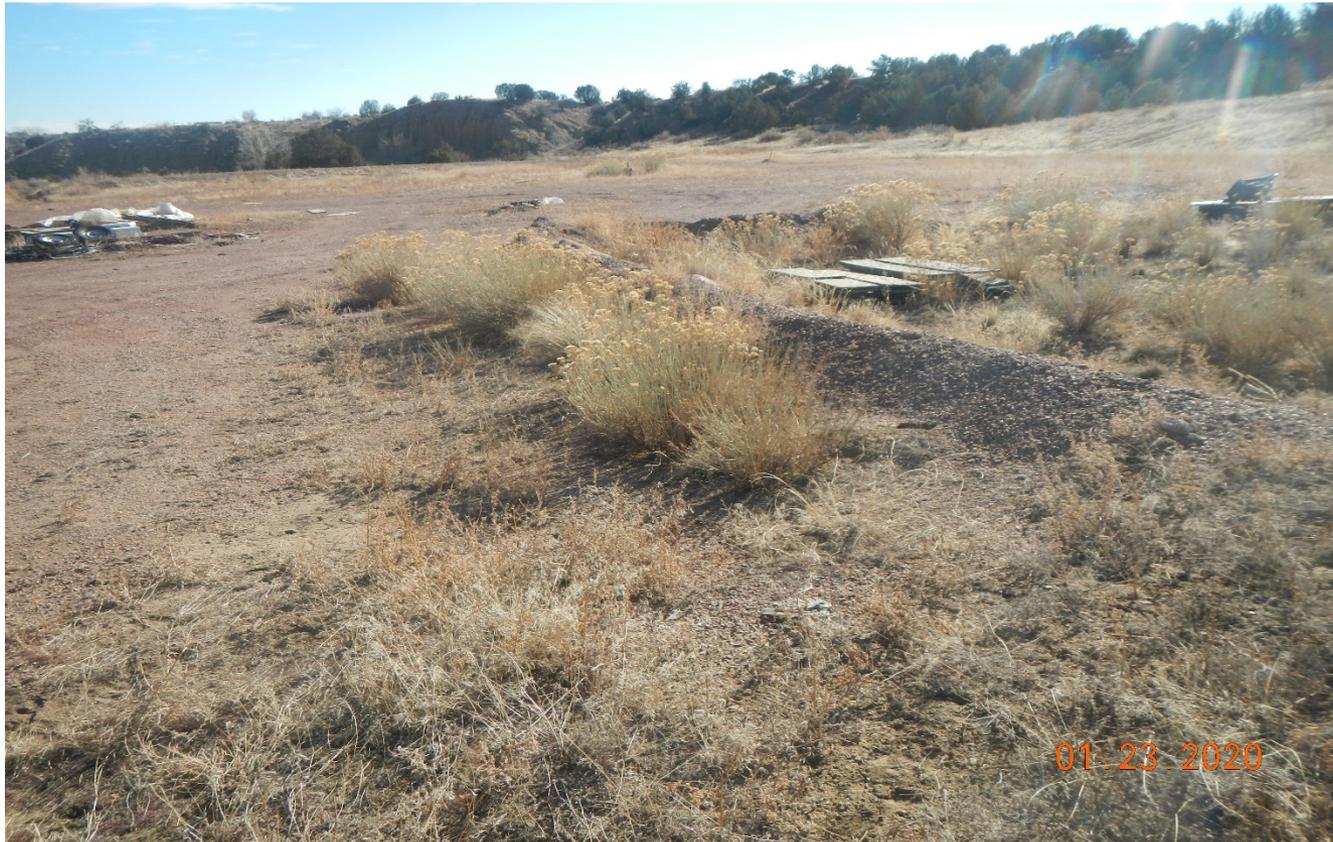
Photo 1. Facing southeast toward the location. There is debris and supplies being stored at the location.

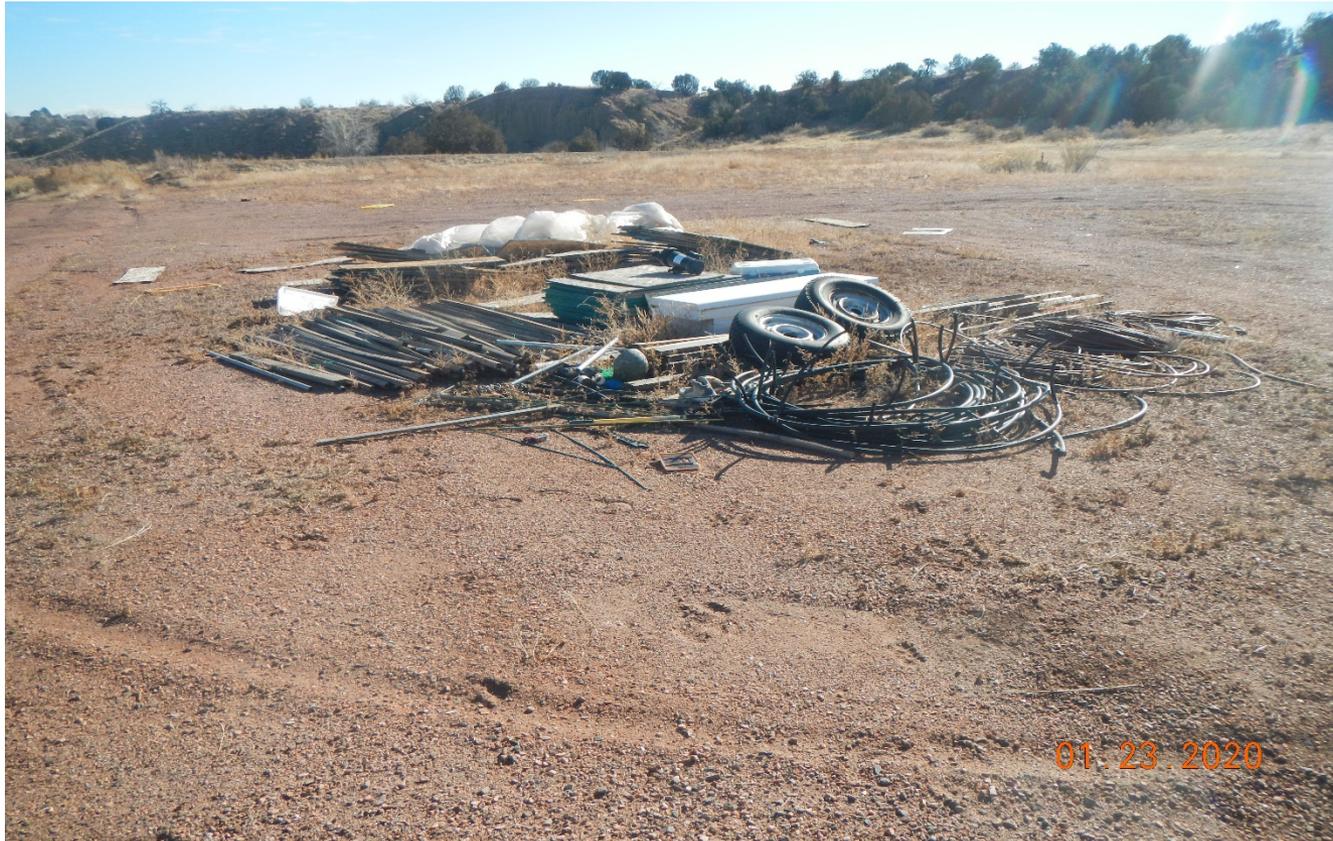
Photo 2. There is various debris and supplies being stored at the location. The location needs to be maintained and site controlled of storage.

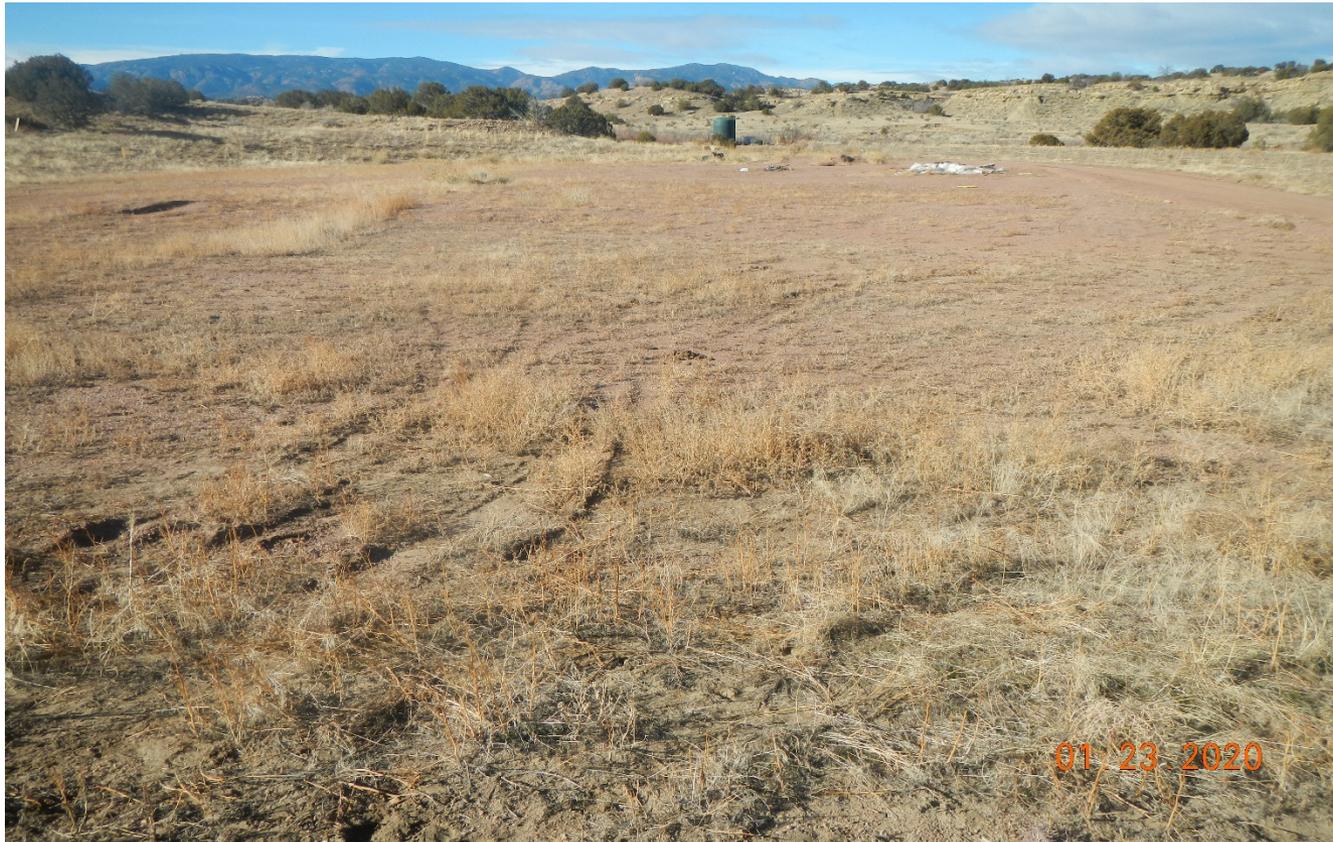
Photo 4. Facing west toward the location.

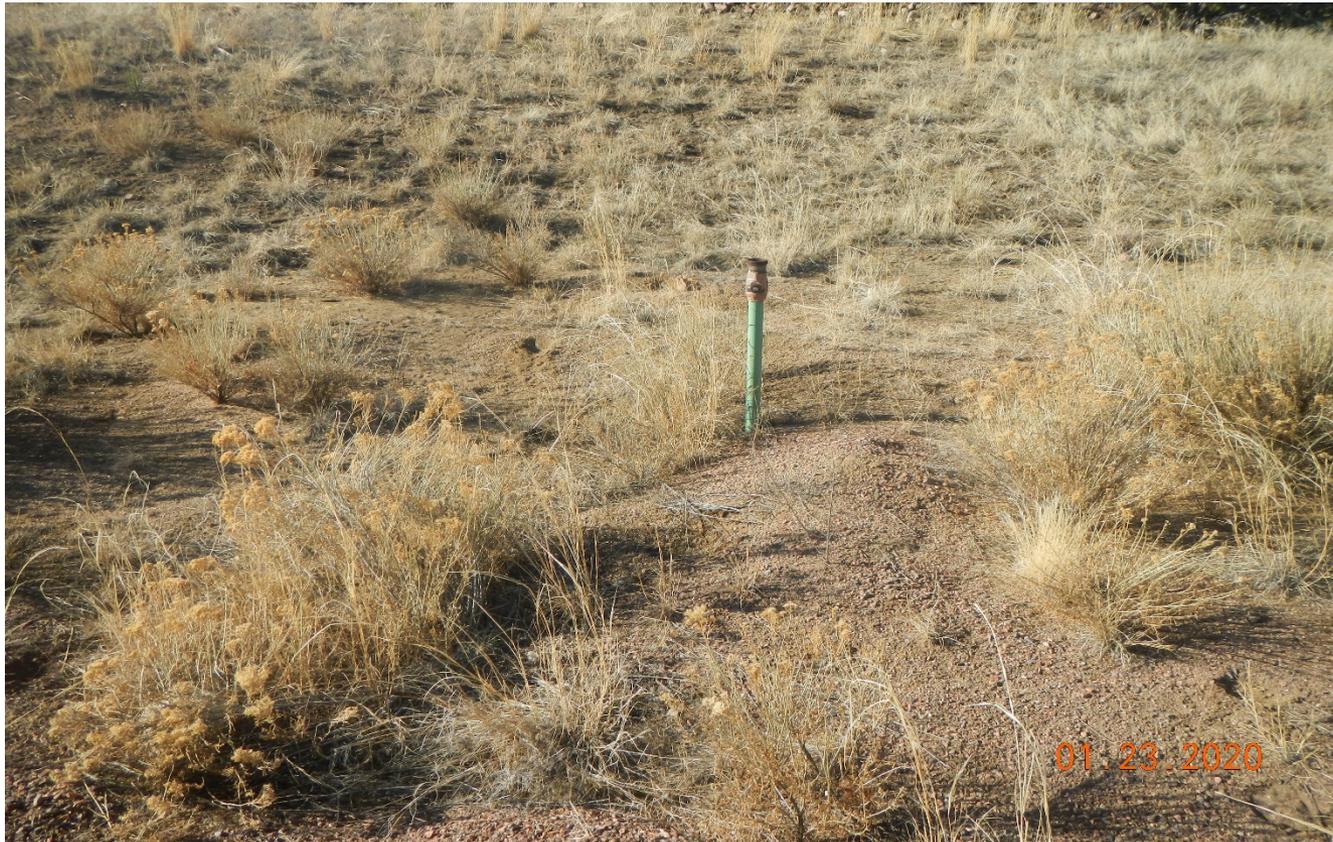
Photo 5. The pipe riser at the west side of the location has no LO/TO.

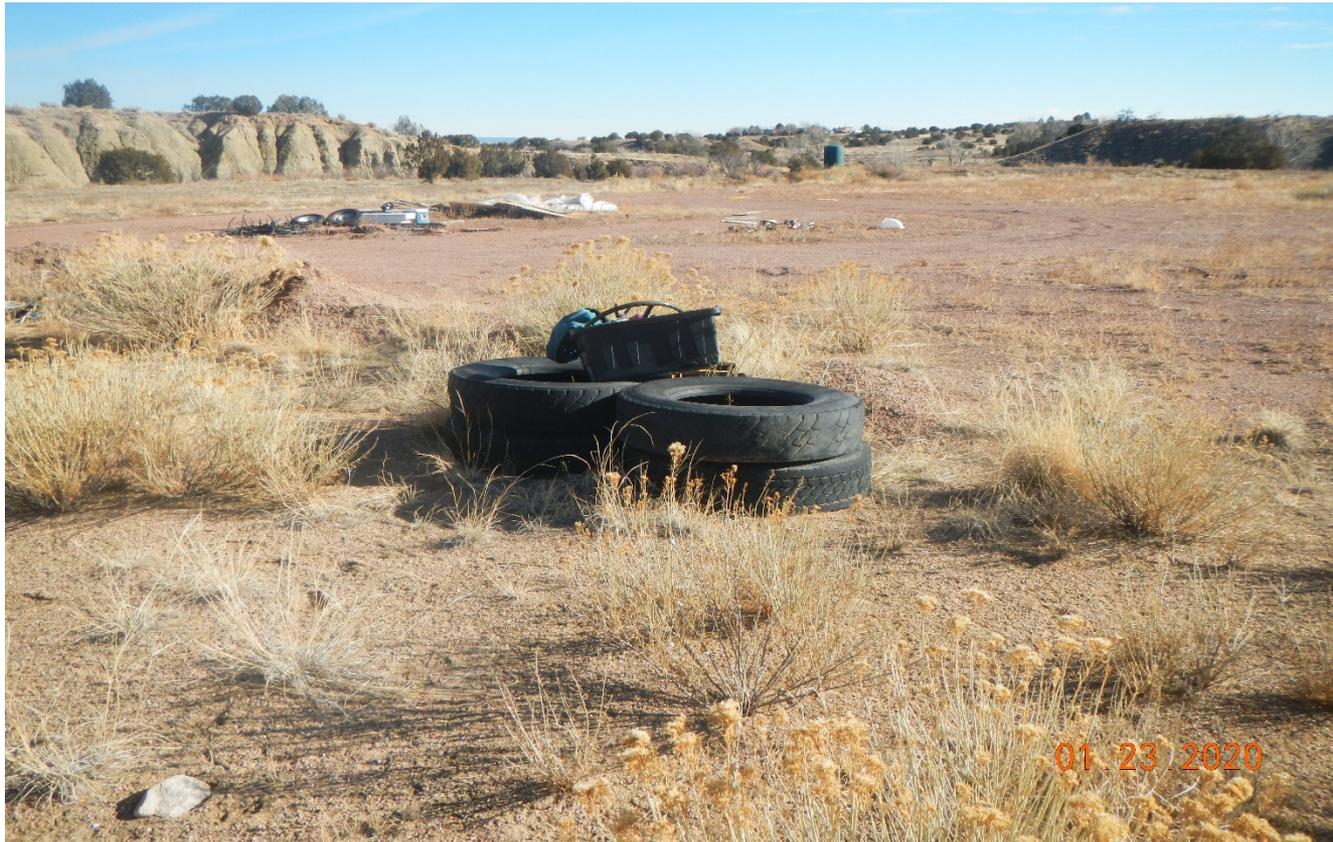
Photo 6. Facing northeast at the location. There are tires and various supplies stored at the location.
