Inspection Photos
Operator: BP America
Location/API #: 067-06982
Date: 1-28-2020

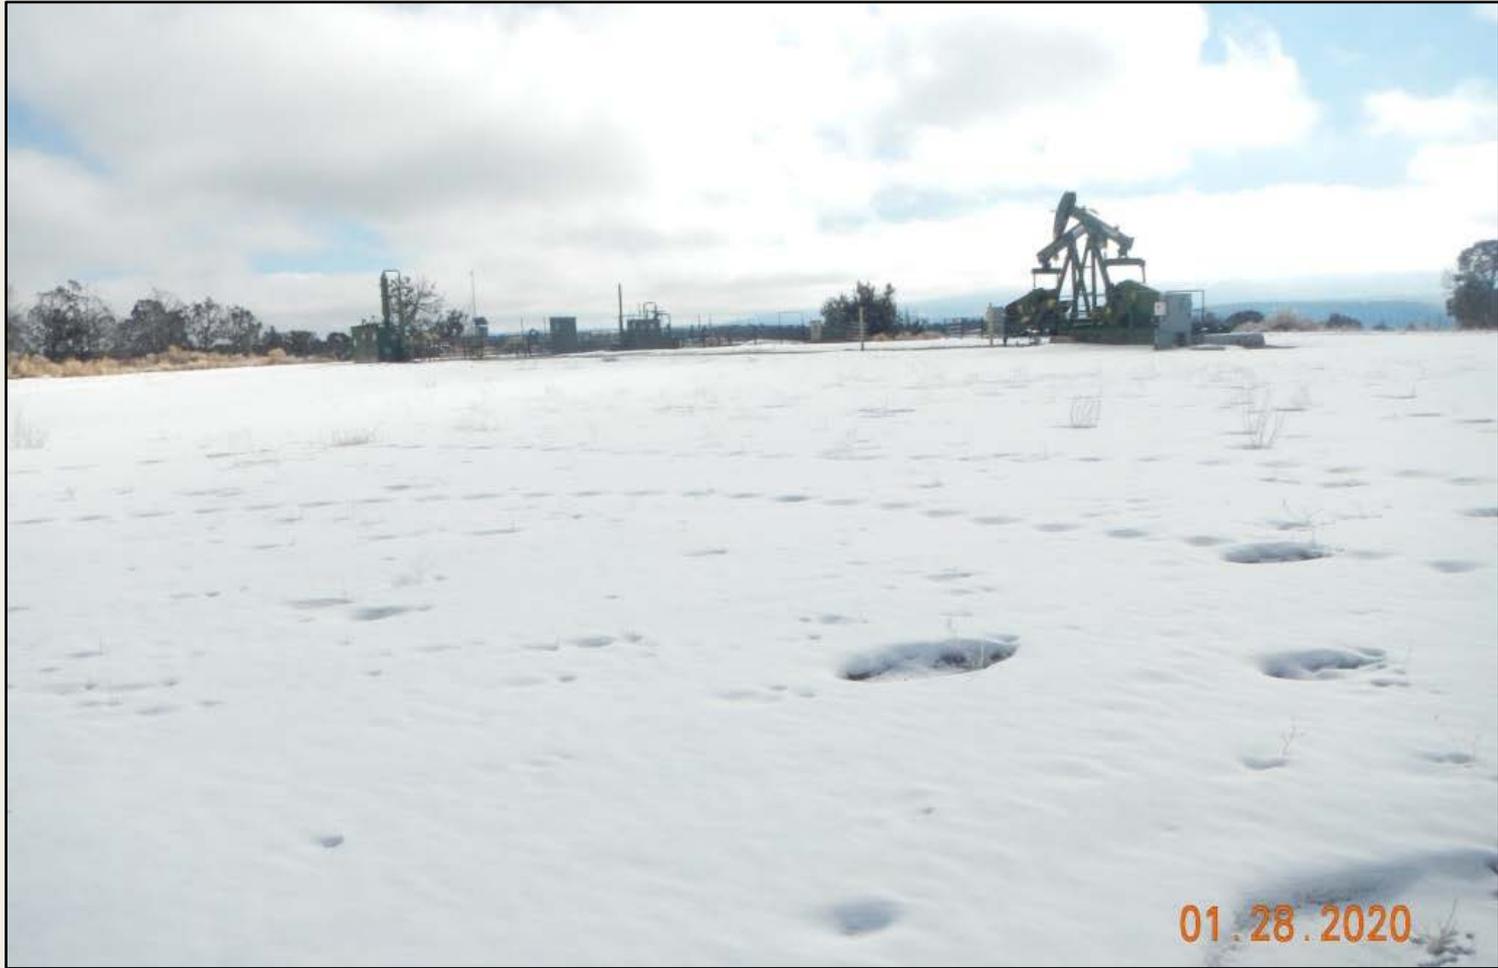
Photo 1. View of the project area from the southwestern corner facing center.

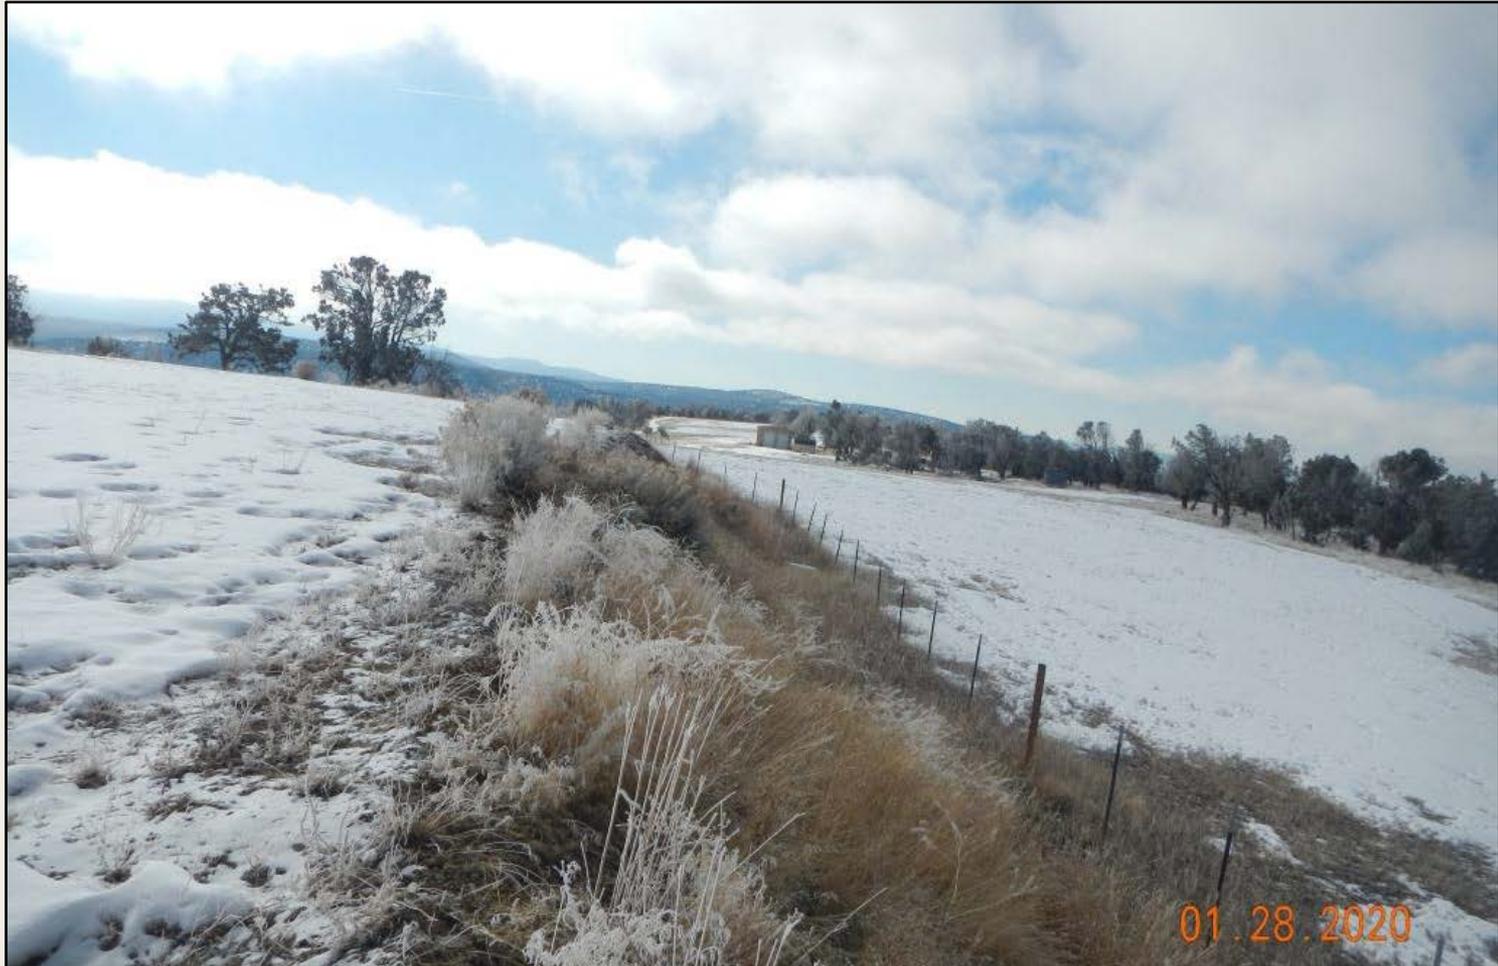
Photo 2. View of western project area from the northwestern corner facing southward. Revegetation is largely dormant but appears to be comprised of grasses such as western wheatgrass, smooth brome, and crested wheatgrass.

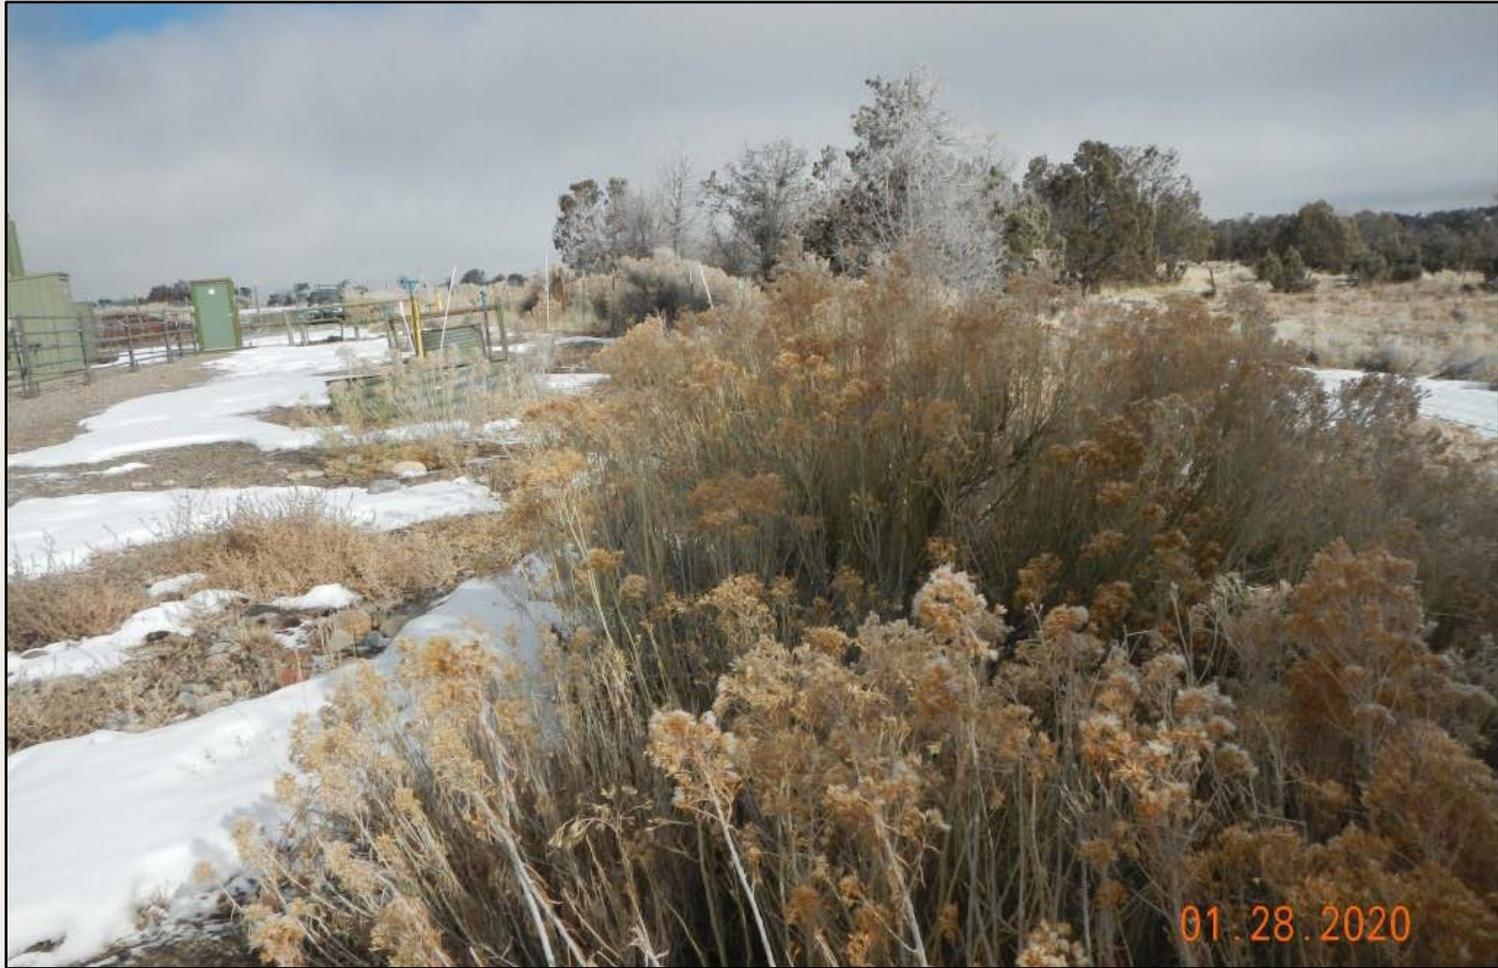
Photo 3. View of revegetation within the eastern project area comprised of dense rubber rabbitbrush.

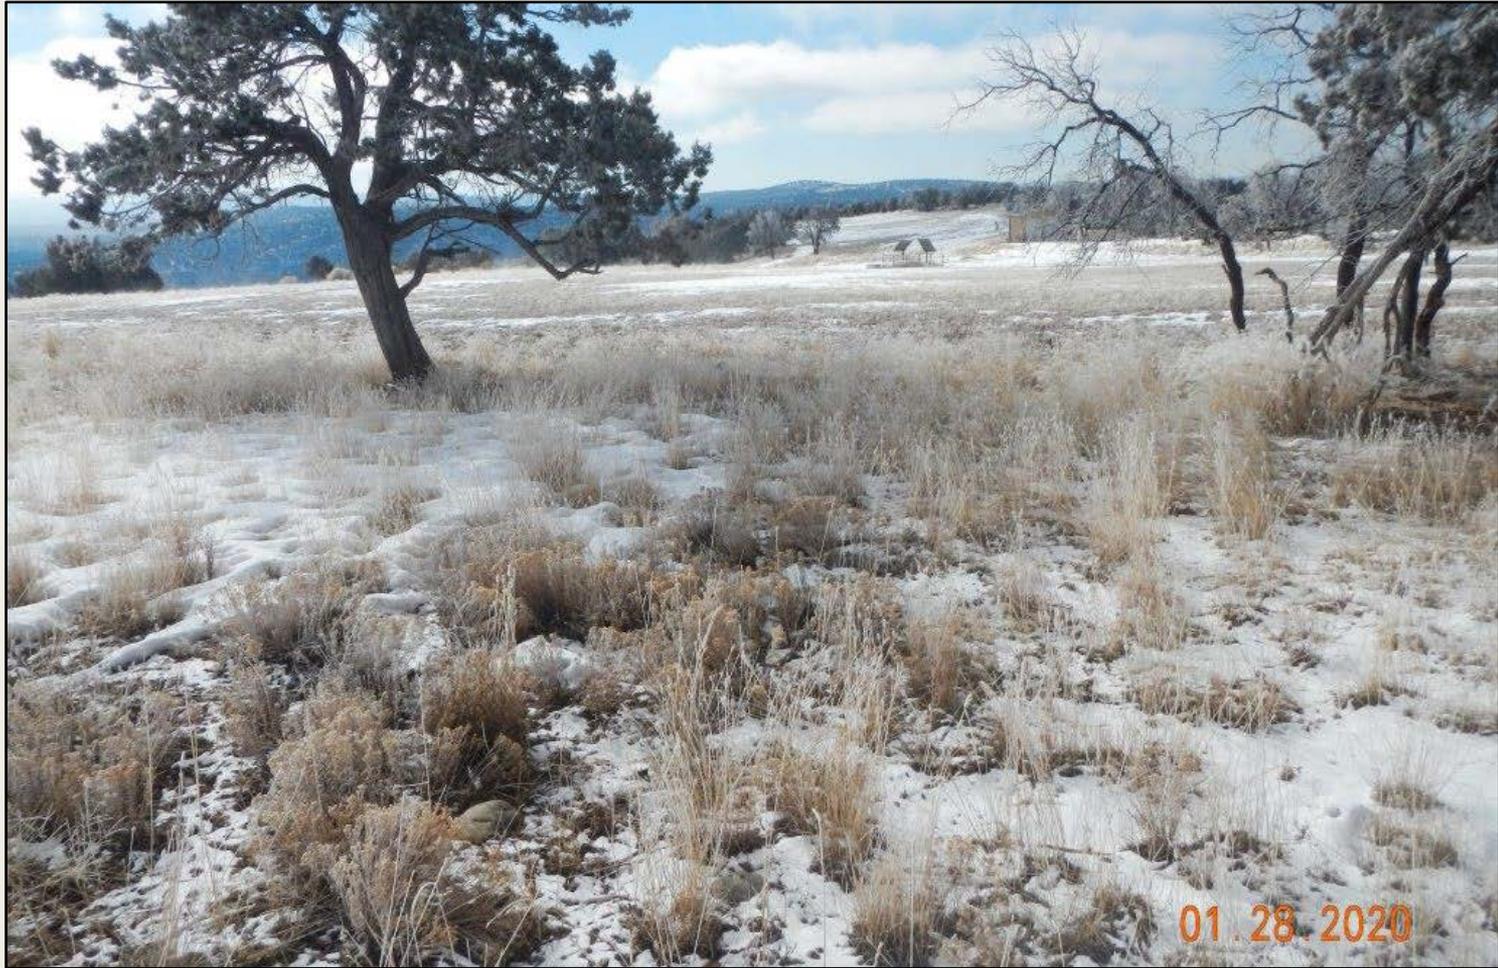
Photo 4. View of the reference area in background comprised of open grass field with scattered pinyon and juniper trees.
