Inspection Photos
Operator: BP America
Location/API #: 067-09610
Date: 1-28-2020

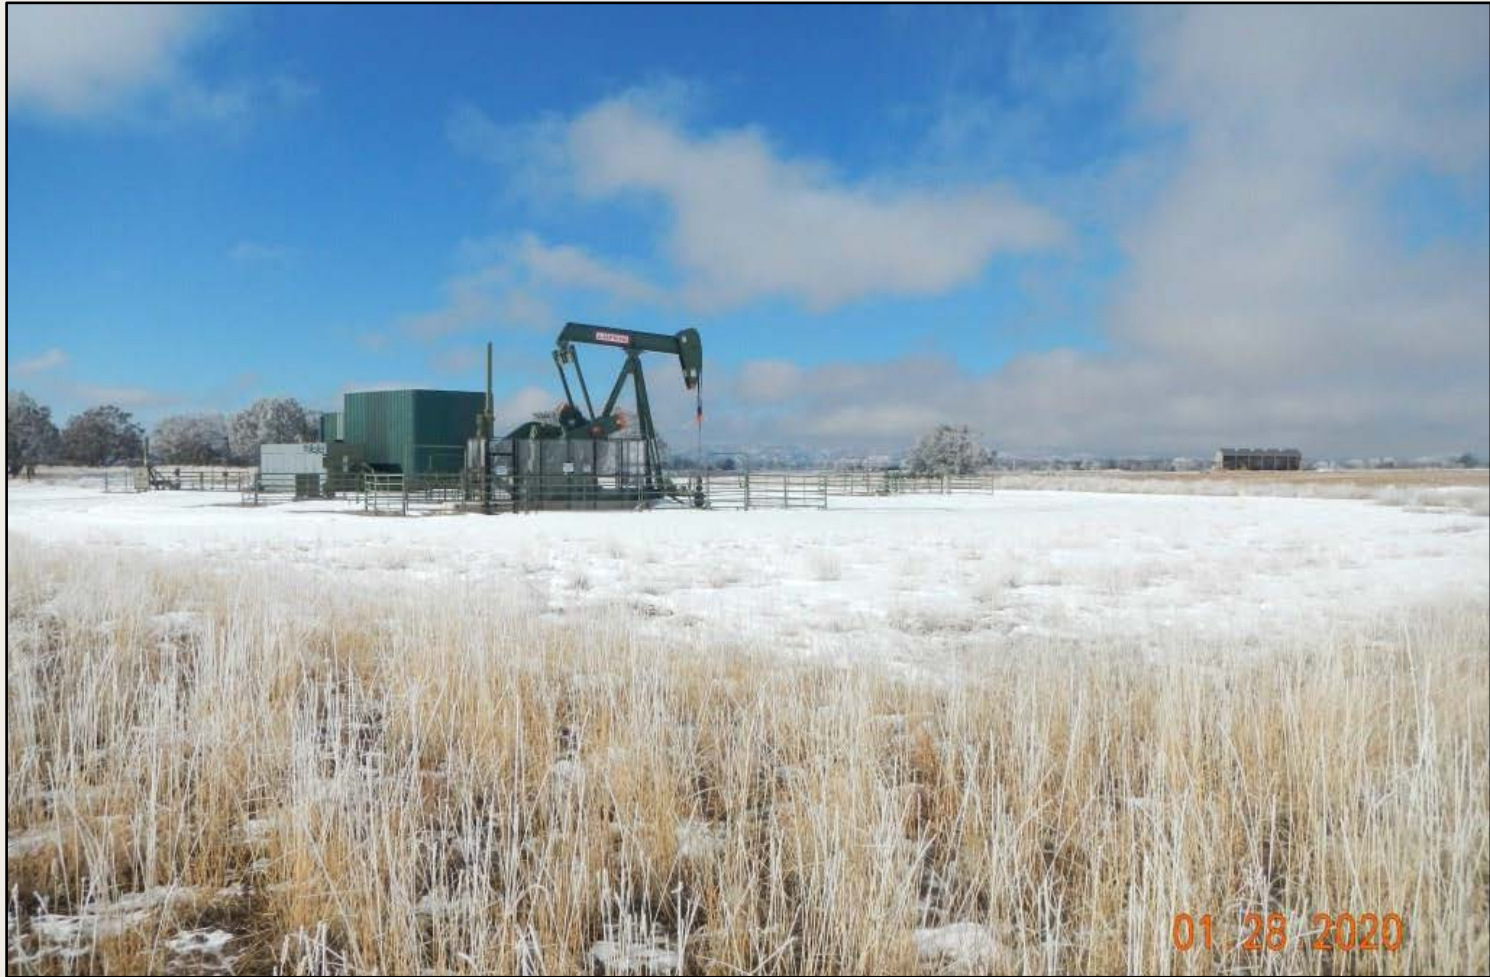
Photo 1. View of the project area from the northeastern corner facing center.

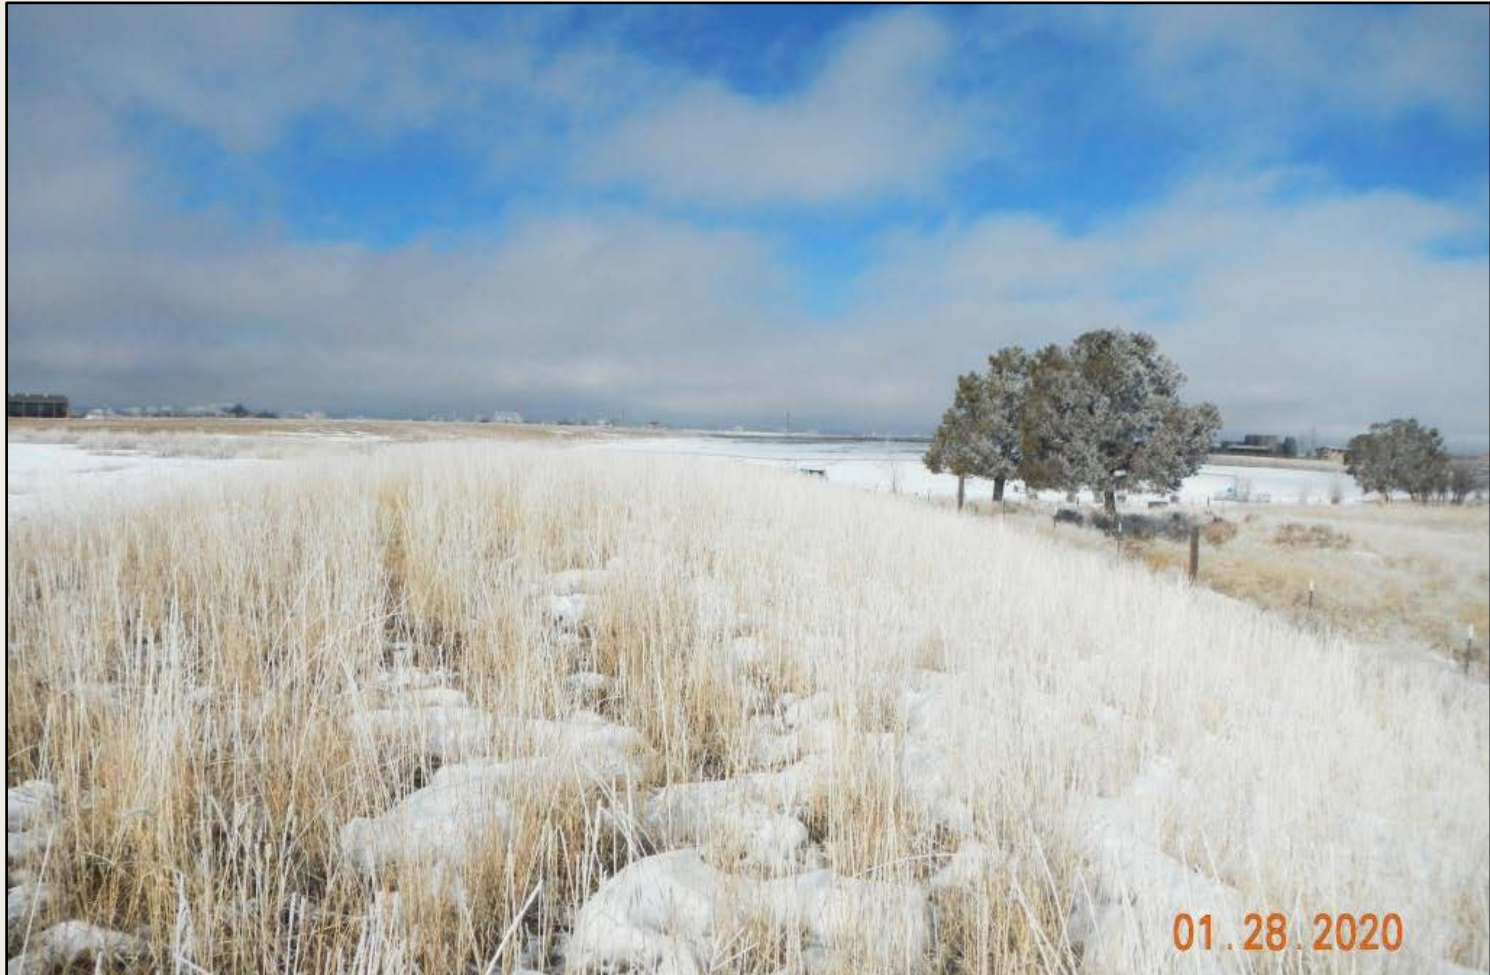
Photo 2. View of the northern project area from the northeastern corner facing southward. Revegetation is largely dormant but appears to be comprised of grasses such as intermediate wheatgrass, smooth brome, and crested wheatgrass.

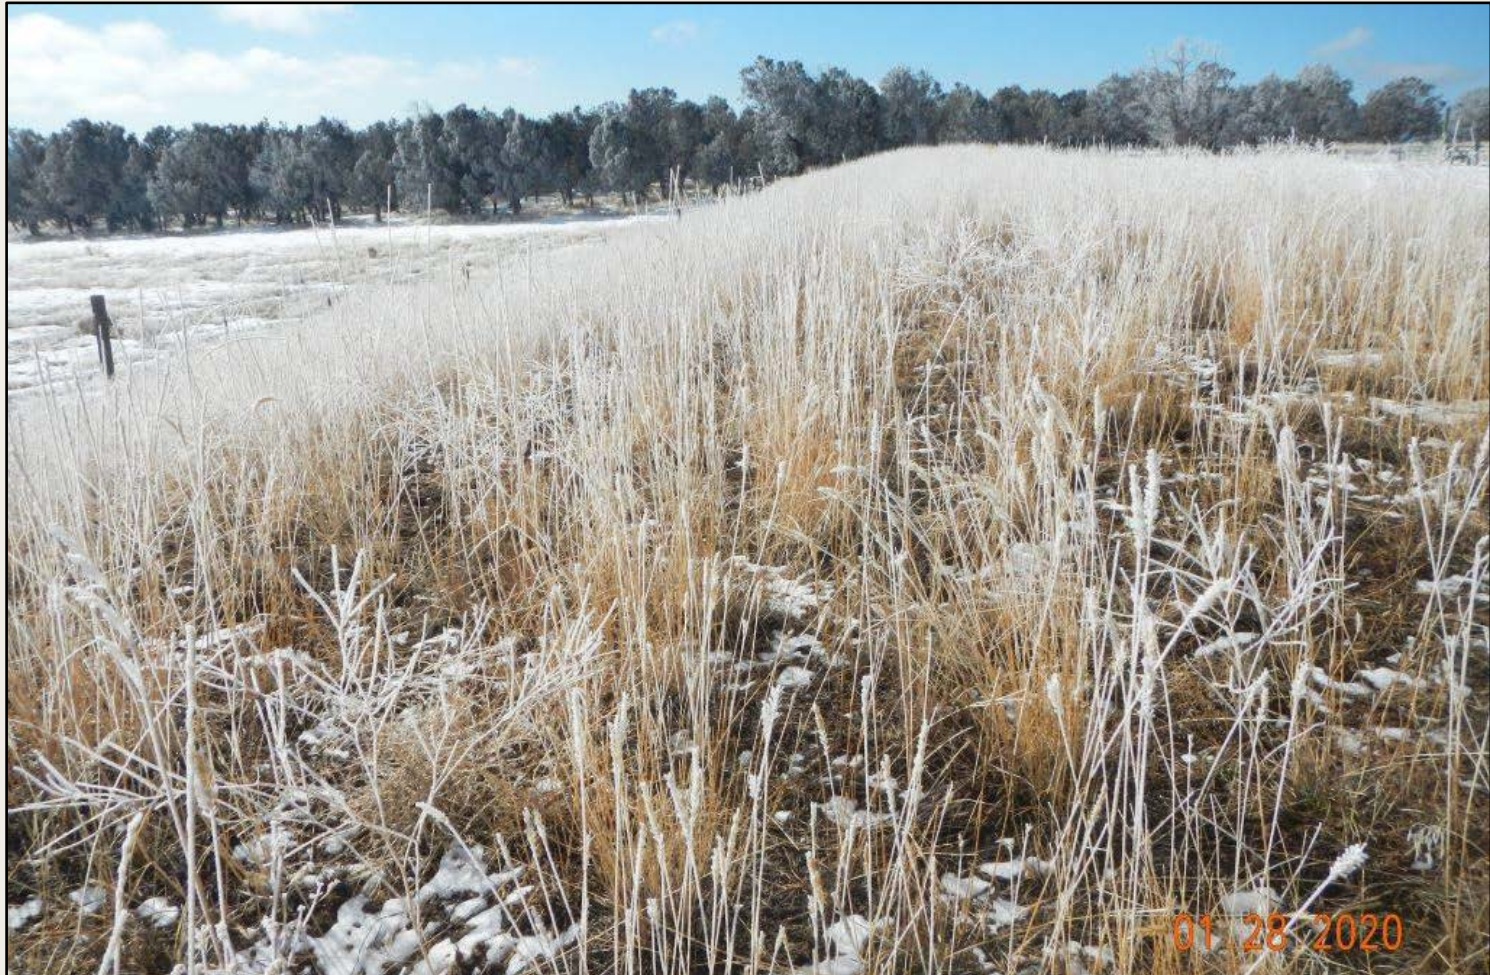
Photo 3. View of the eastern project area from the northeastern corner facing southward.

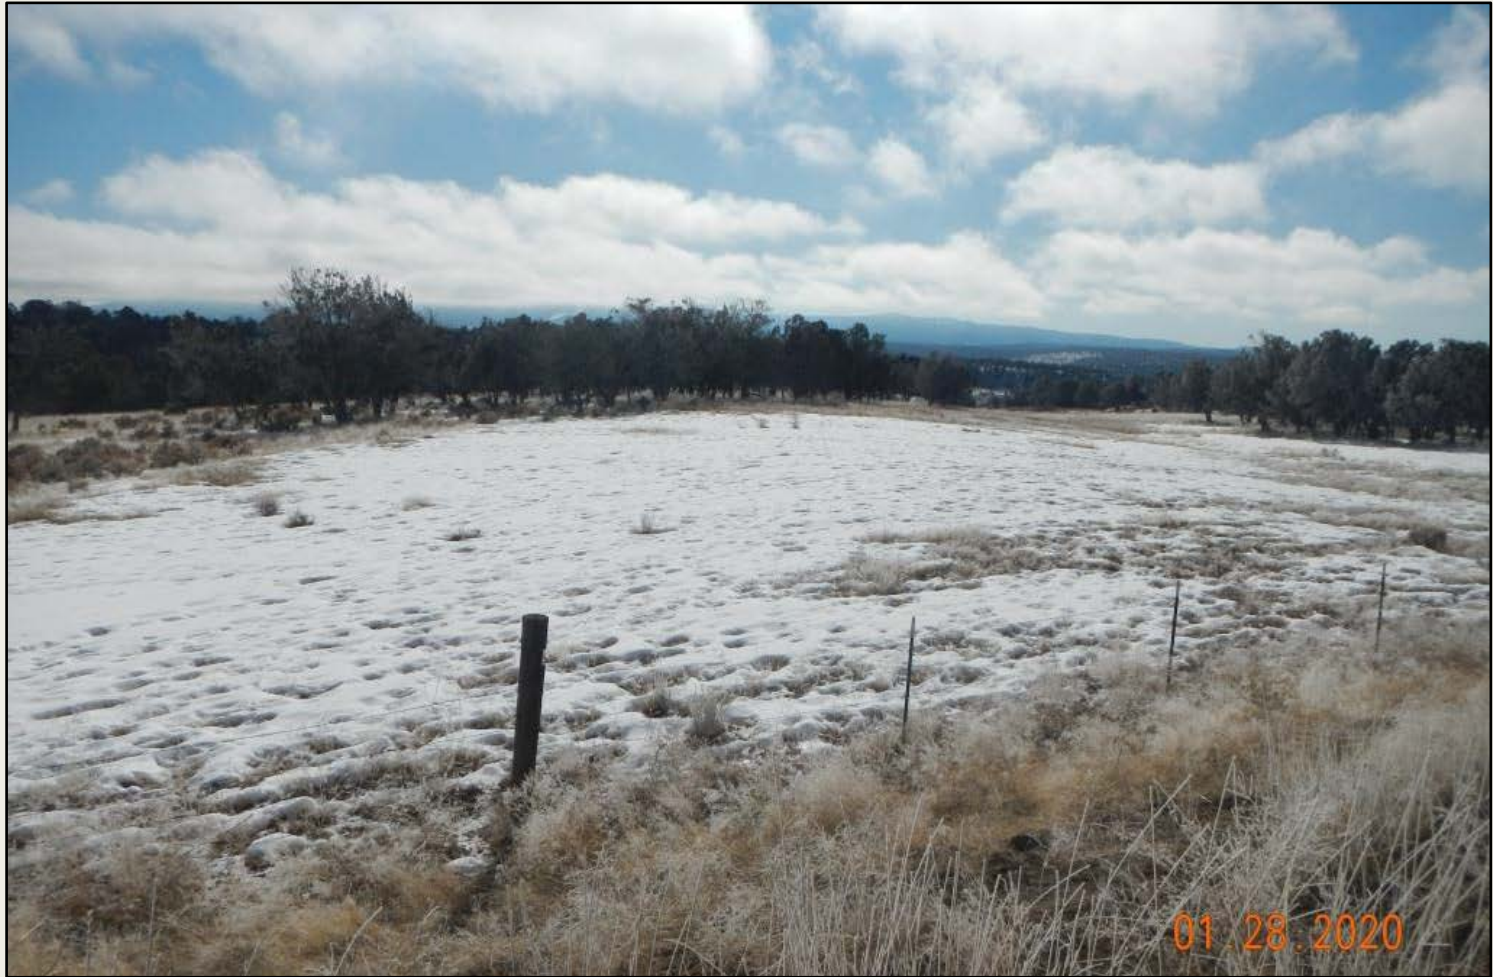
Photo 4. View of the reference area in background comprised of open grass field with scattered pinyon and juniper trees, largely snow covered at this time.
