Inspection Photos

1/28/2020

Operator: CHEVRON USA INC # 16700

Location ID: 398839

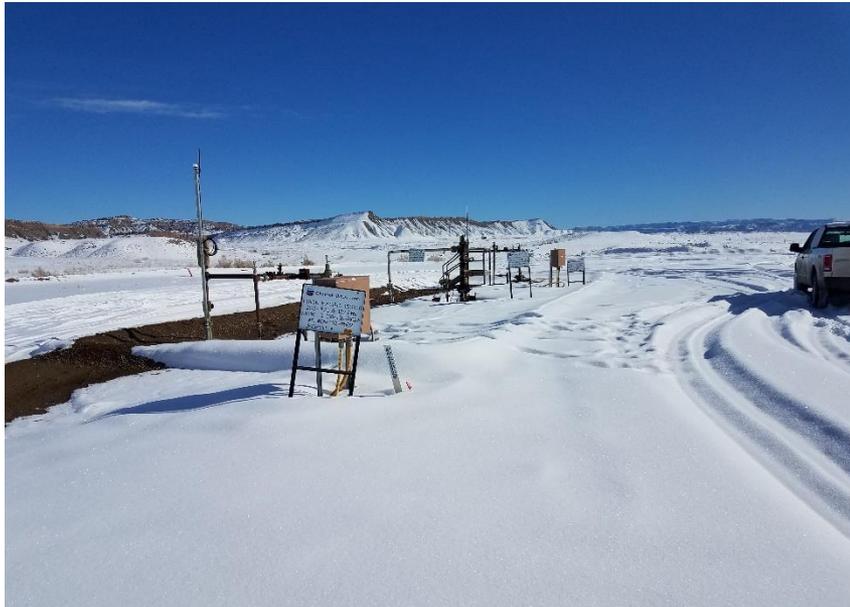
Photo 1: Photo taken from the west end of the active wells, facing east. Photo shows all 3 of the active wells have been drilled in proximity of one another. 4th well on location "AL"; unable to find evidence that well was drilled.

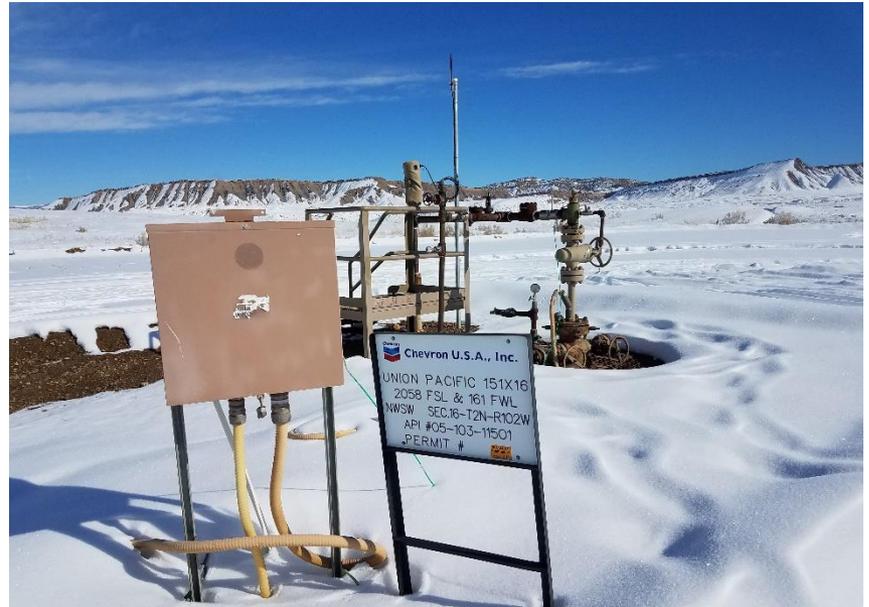
Photo 2: Photo of well API 103-11501. Form 5(F) No. 400310065 shows "as drilled" records to be "40.141068/-108.857048", or the southeast corner of the pad; See comments under photo 11. "As drilled" records in correct, well located within central area of the Location. Updated "as drilled" records will need to be submitted.

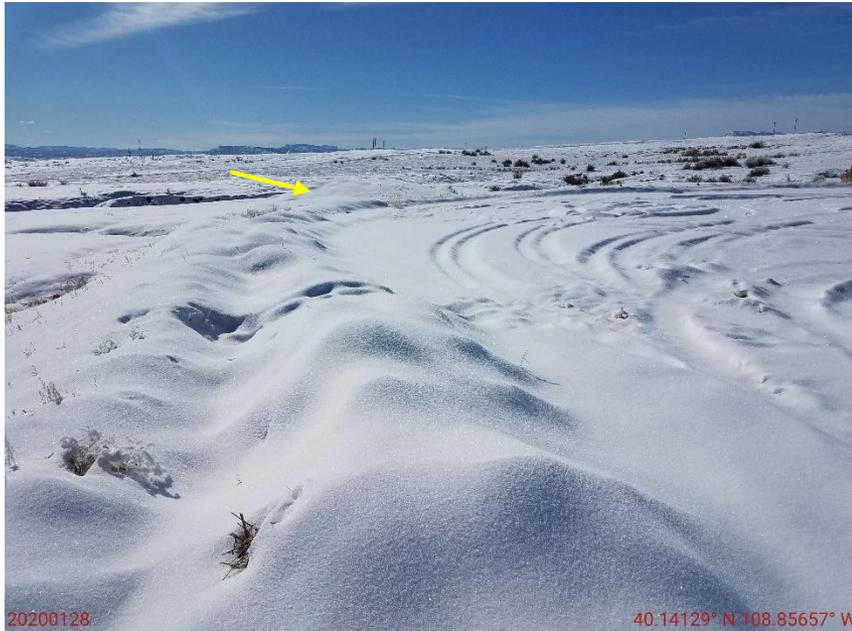
Photo 3: Photo taken from the east end of the location, facing south. Photos 3-6 provide an overview of the Location from south, southwest, northwest to north. Photos also show areas of the production area beyond the anchors that do not appear to be reasonably needed for production activities, and needs to be reclaimed in accordance with Rule 1003.b. Photo also shows soil stockpile on the southeast corner of the Location.

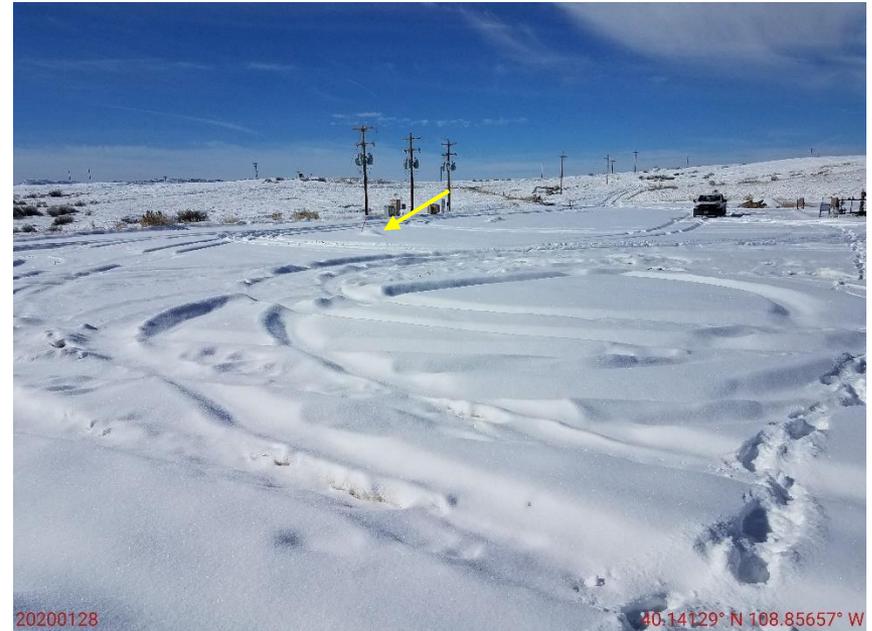
Photo 4: See comments under photo 3. Arrow shows easternmost anchor.

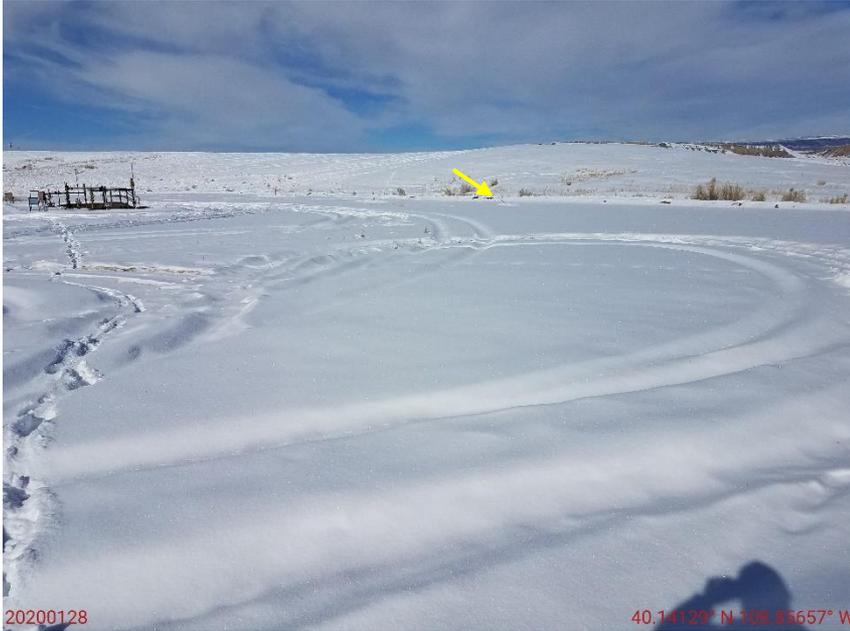
Photo 5: See comments under photo 3. Arrow shows easternmost anchor

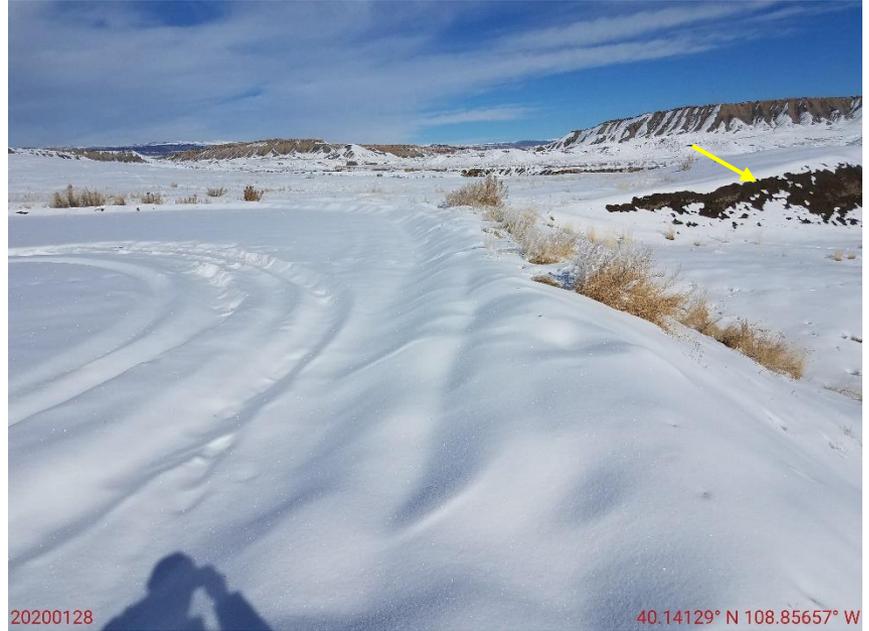
Photo 6: See comments under photo 3. Photo also shows soil stockpile on the northeast end of the Location. Soil stockpile appears exposed and unstabilized on the visible slopes.

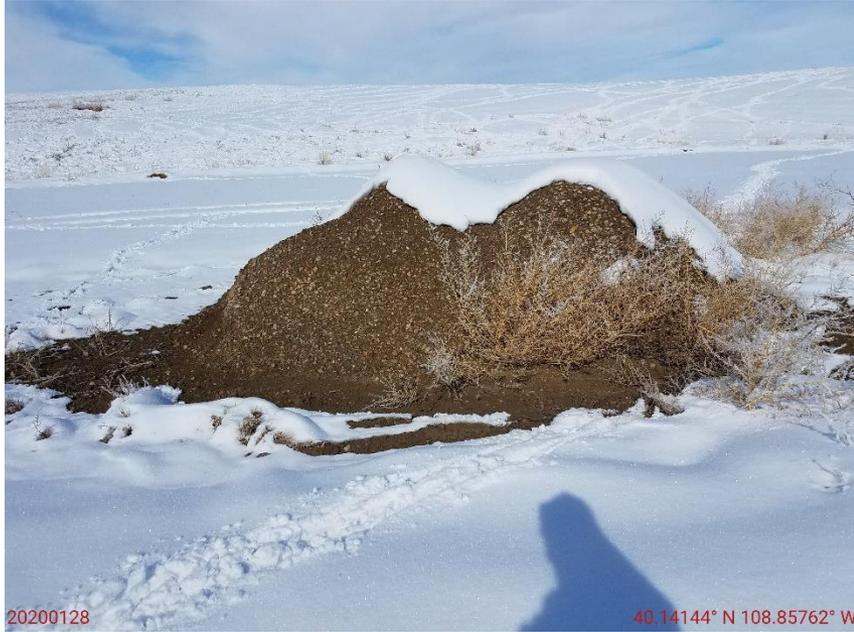
Photo 7: Photo of gravel pile stored on Location west of the wells.

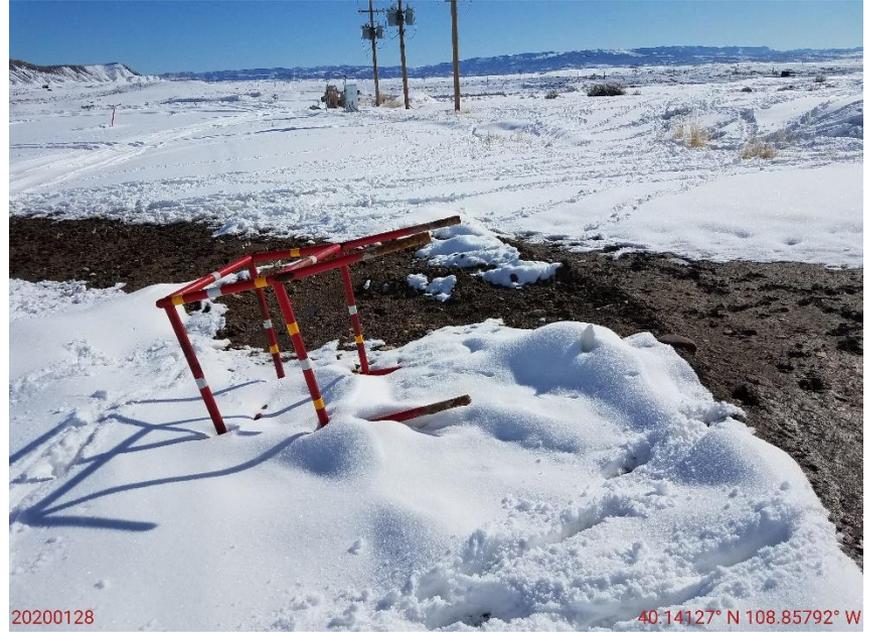
Photo 8: Photo of barrier in disrepair on the northwest end of the location.

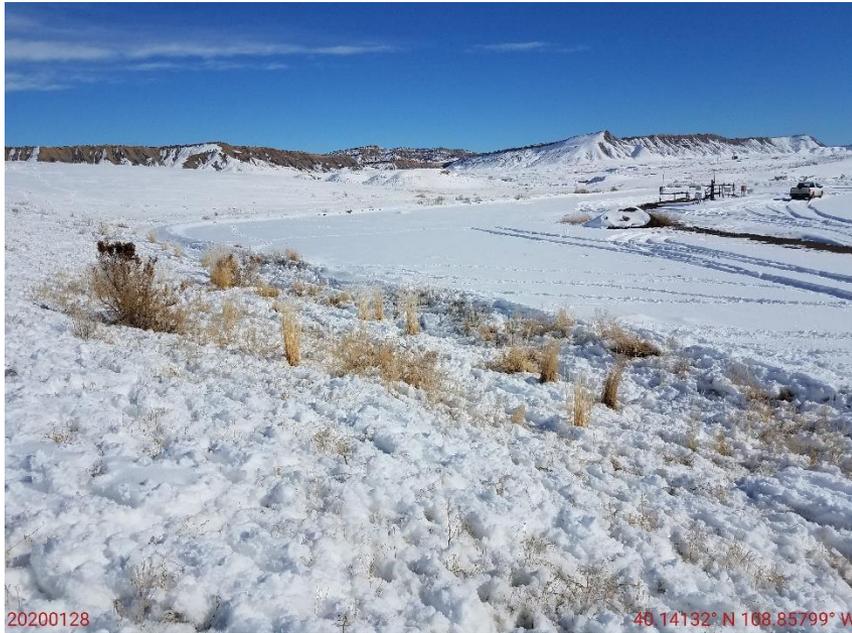
Photo 9: Photo taken from the west end of the location, facing northeast. Photo 9-10 provide an overview of the location from northeast, to southeast.

Photo shows areas of the production area beyond the anchors that do not appear to be reasonably needed for production activities, and needs to be reclaimed in accordance with Rule 1003.b.

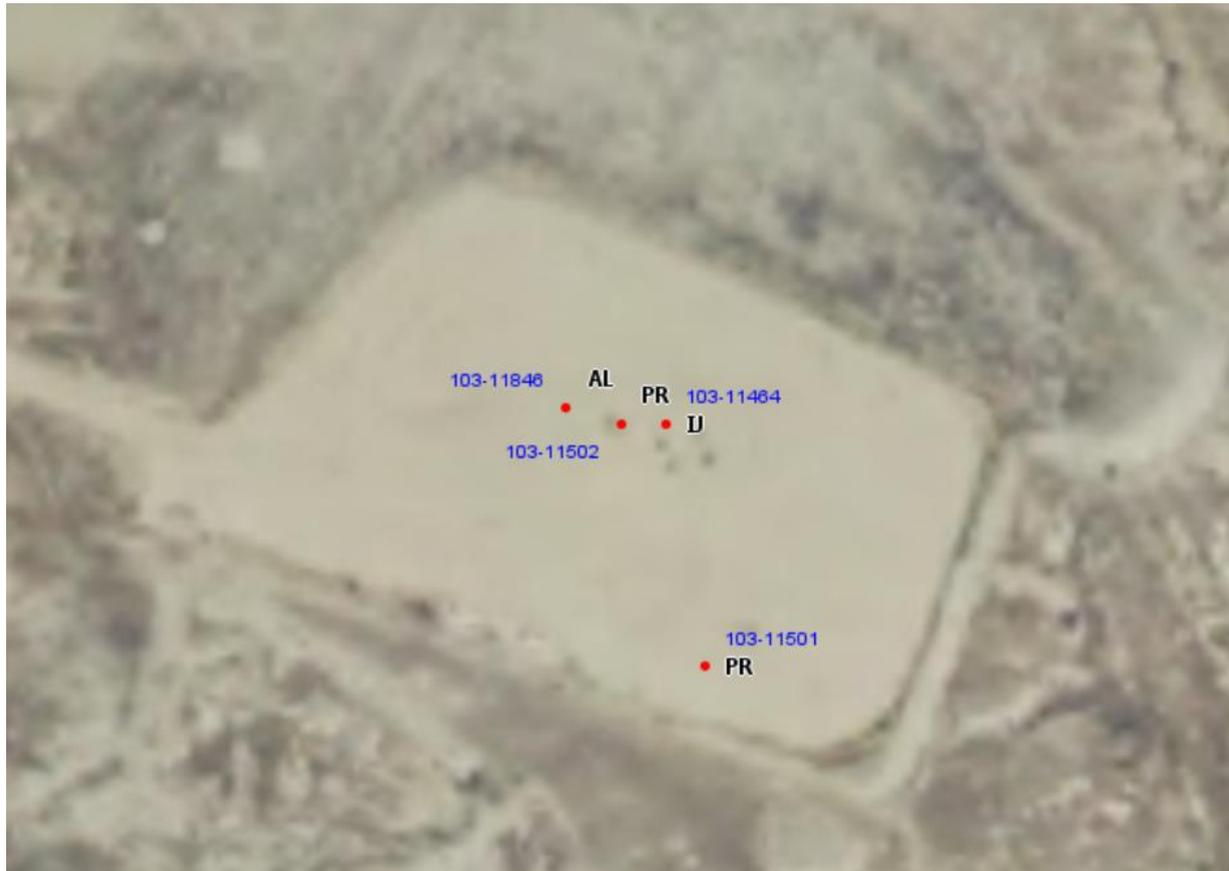
Photo 11: COGIS aerial imagery of wells on Location. Photo shows “As drilled” location for API 103-11501 is incorrect.

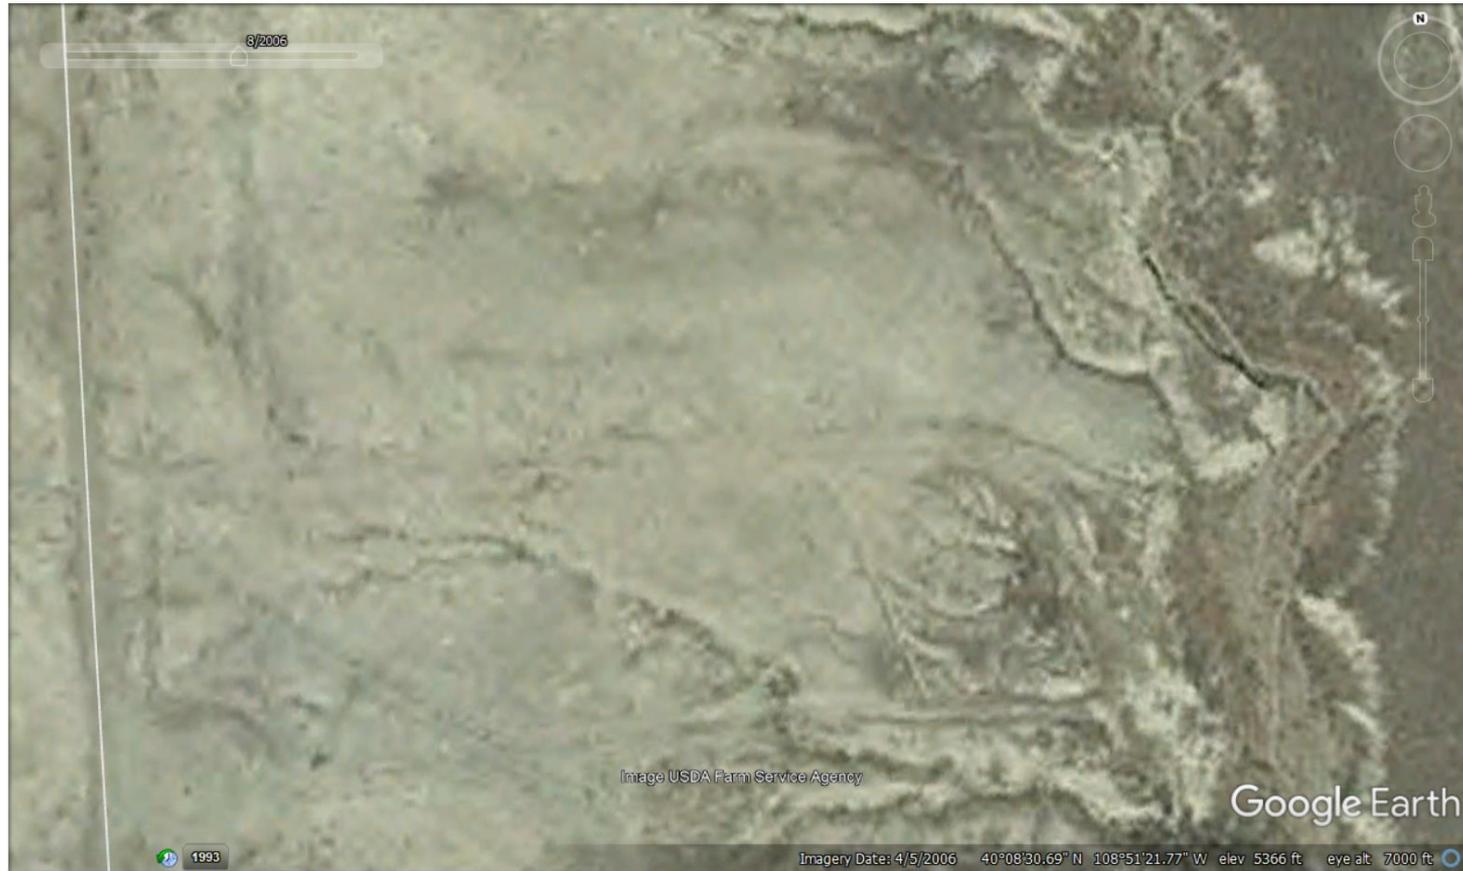
Photo 12: 2006 Google Earth aerial imagery. Photo shows Location prior to the Location's O&G disturbance.

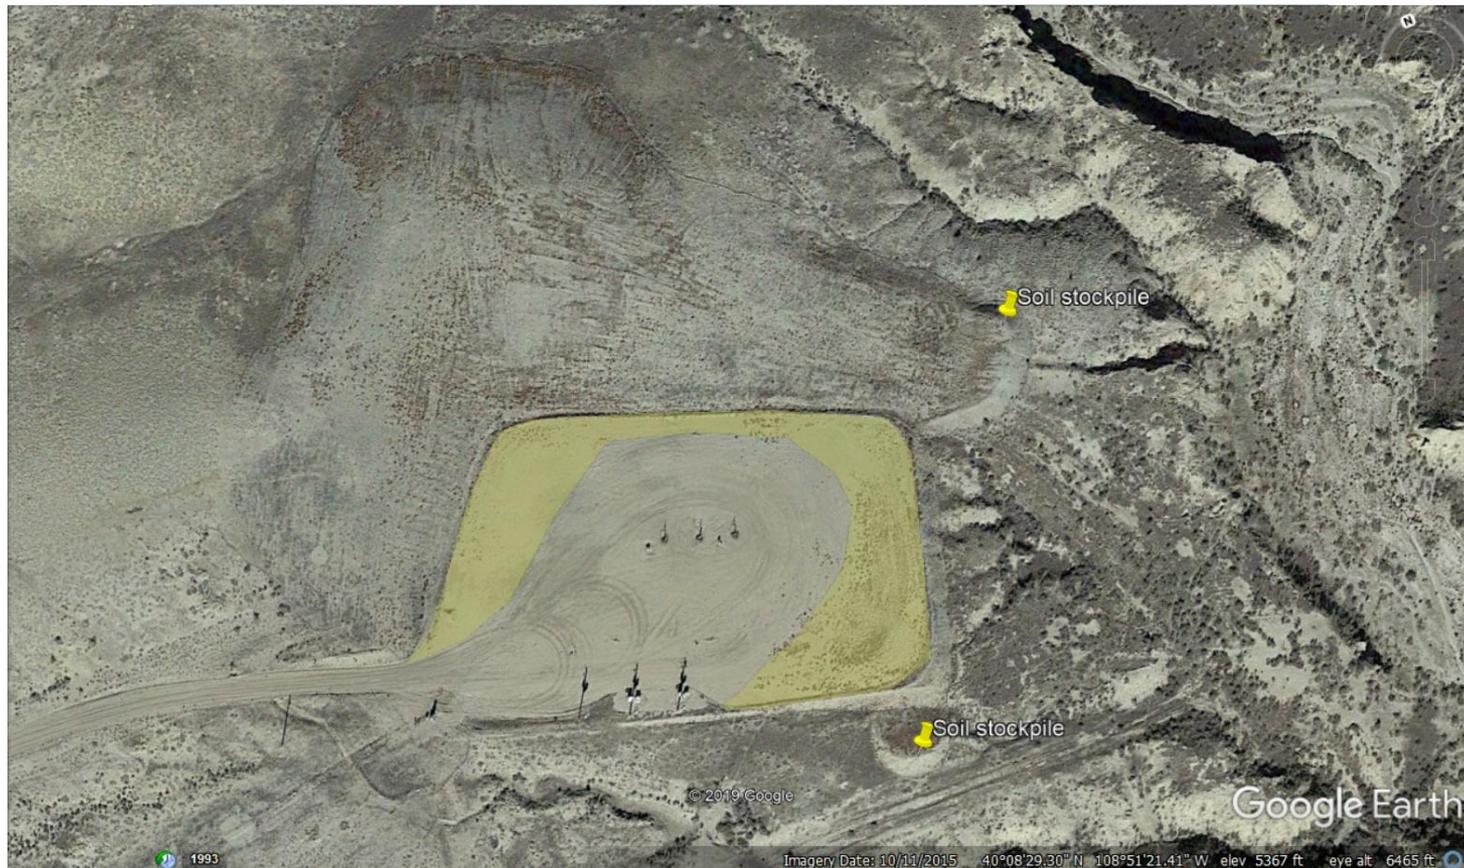
Photo 13: 2015 Google Earth aerial imagery; most current google imagery. Photo shows the soil stockpile on the northeast and southeast ends of the Location. Photo also shows approximate areas of the current production area beyond the anchors that do not appear to be reasonably needed for production activities
