# Interim Reclamation and Stormwater Inspection

Operator: HIGHPOINT OPERATING CORPORATION- 10071

Location ID: 416448

Inspection Document #: 697501075

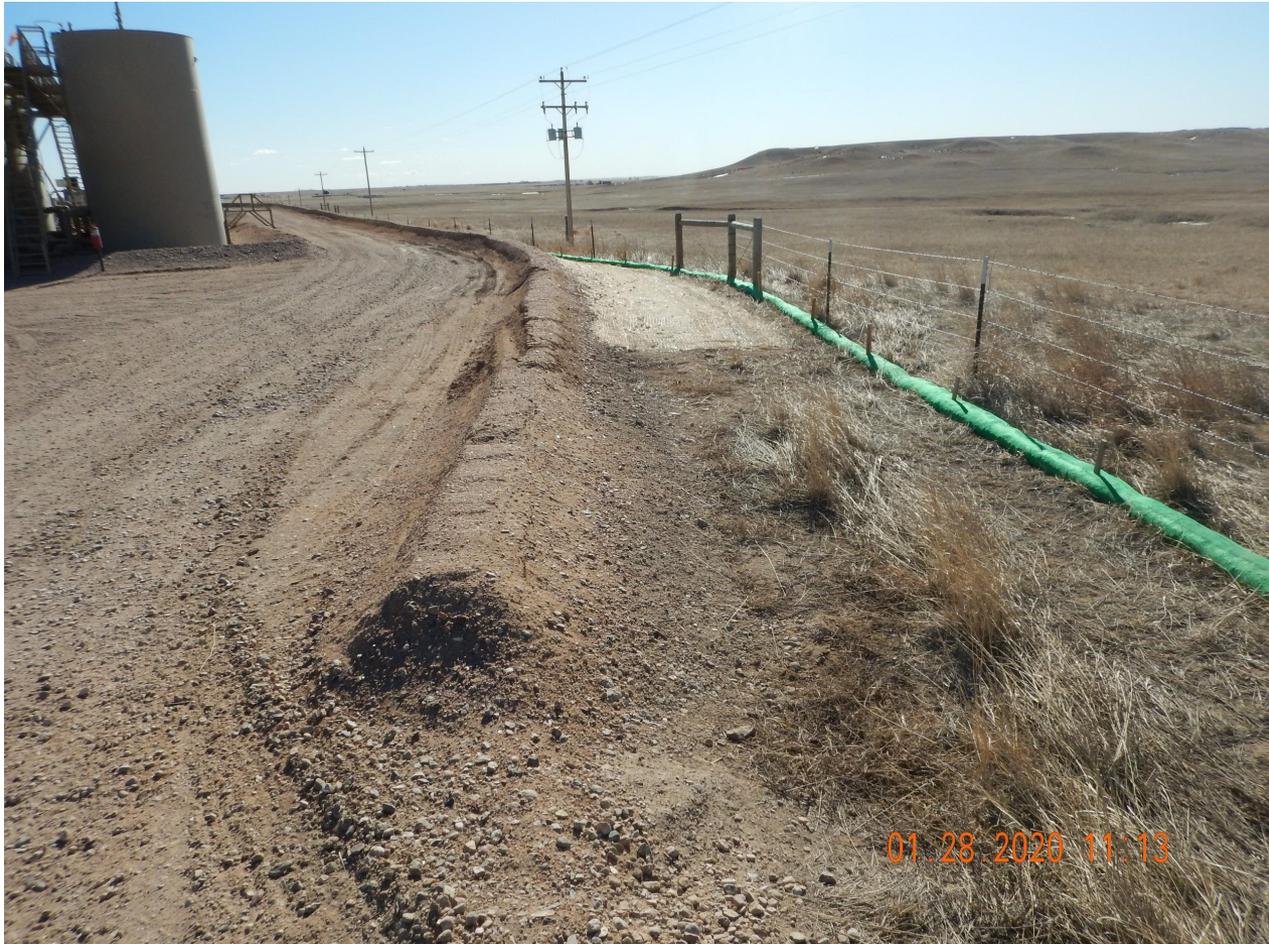
**Photo 1.** Photo taken from the northwestern location, facing Southeast. Photo illustrates Operator has installed additional BMPs (stabilized berm, erosion control blankets and wattles) along the western perimeter of the location in response to the previous corrective action inspection.

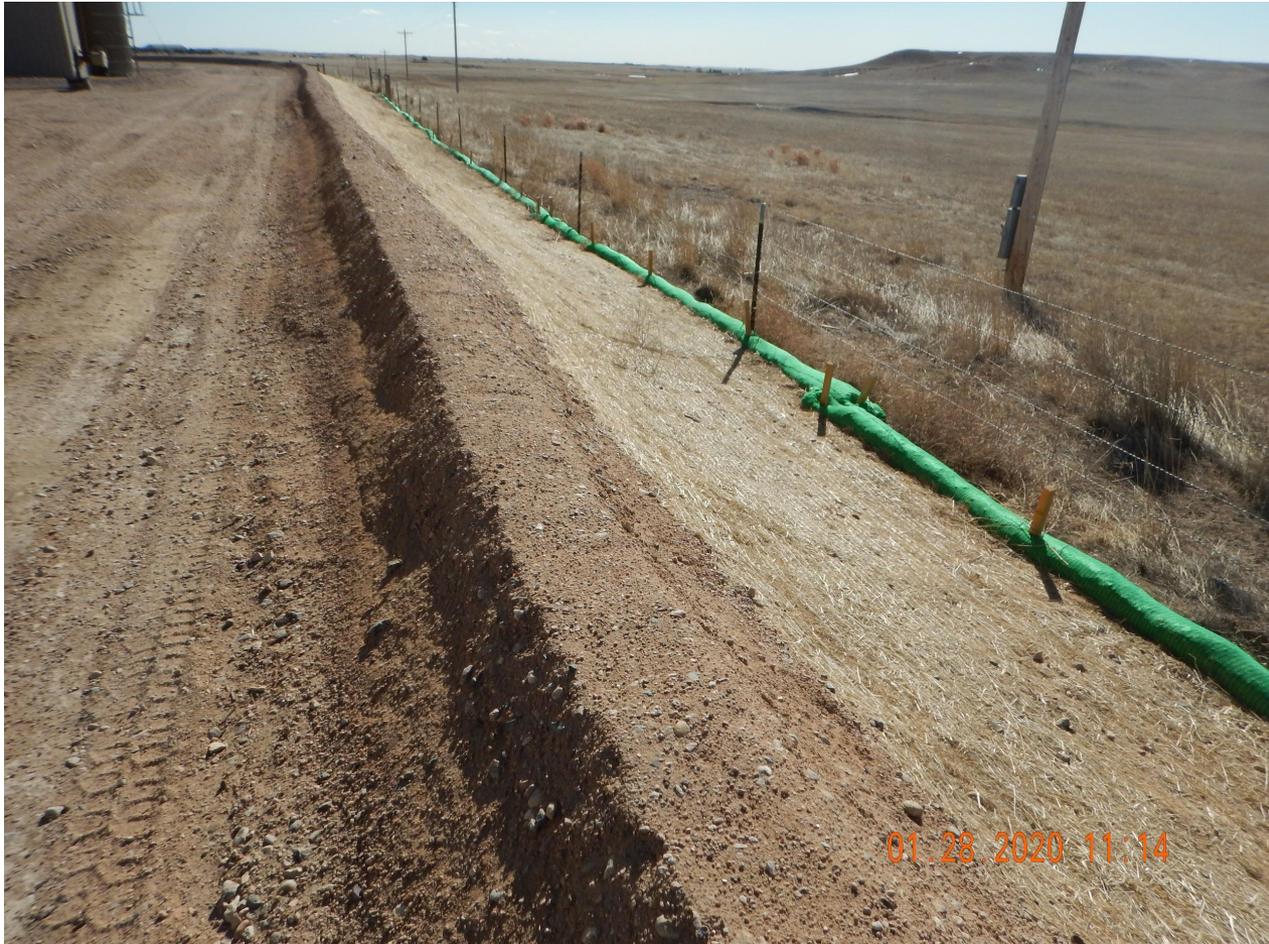
**Photo 2.** Photo taken from the western location, facing Southeast. See comments under Photo 1.

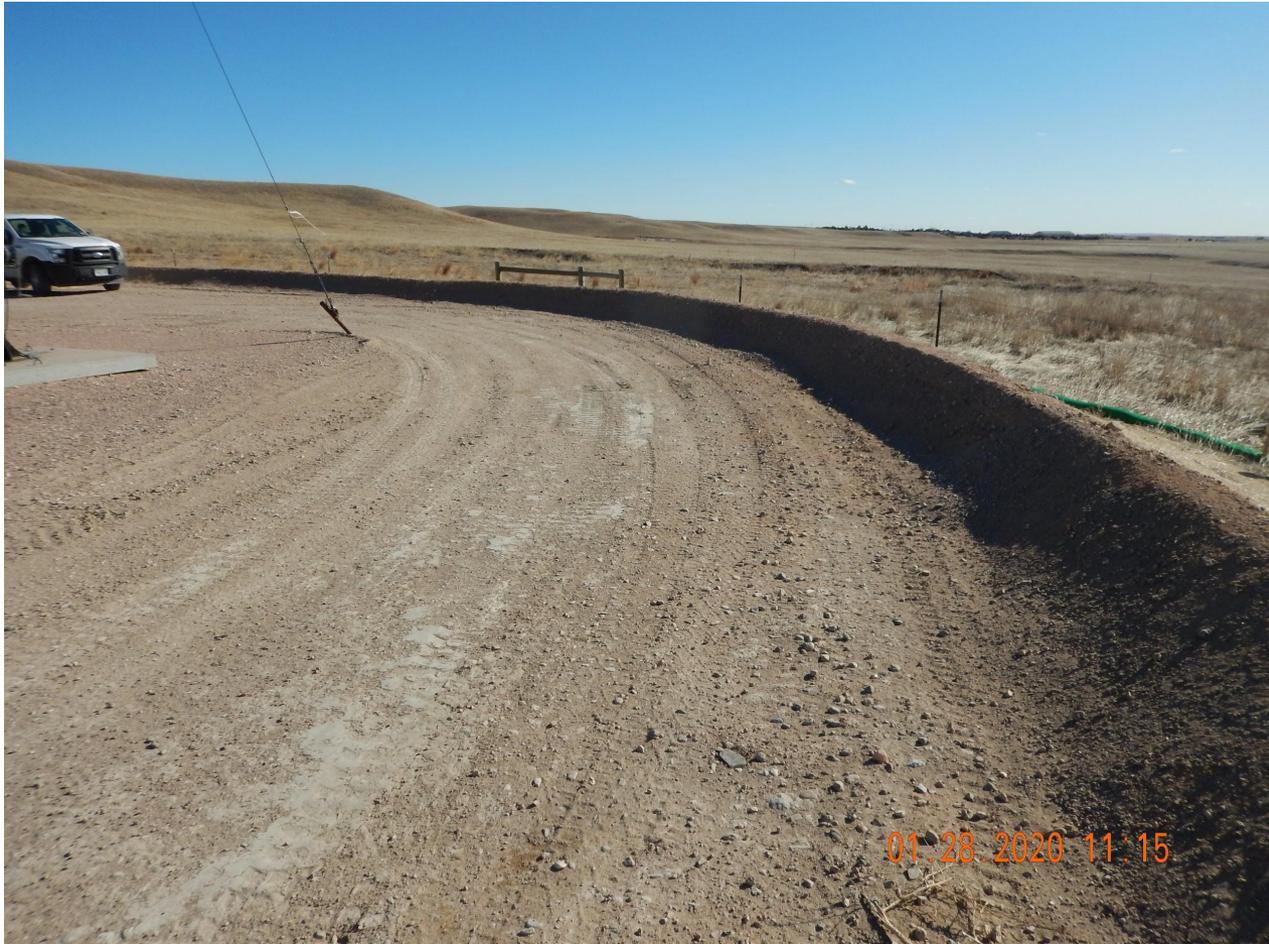
**Photo 3.** Photo taken from the southwestern location, facing Southeast. See comments under Photo 1.

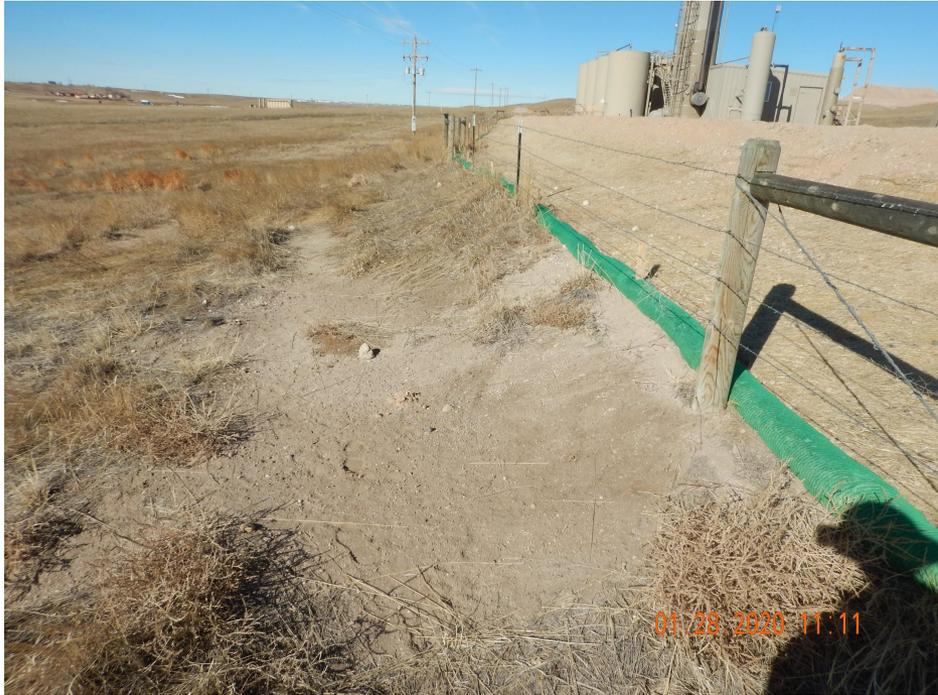
**Photo 4.** Photo taken from the southwestern perimeter of location, facing Northwest. Photo illustrates Operator has not yet performed reclamation activities associated with stormwater erosion degrading vegetation off location. Operator will be responsible for reclaiming this disturbance and should further reclamation activities the next available seeding opportunity.

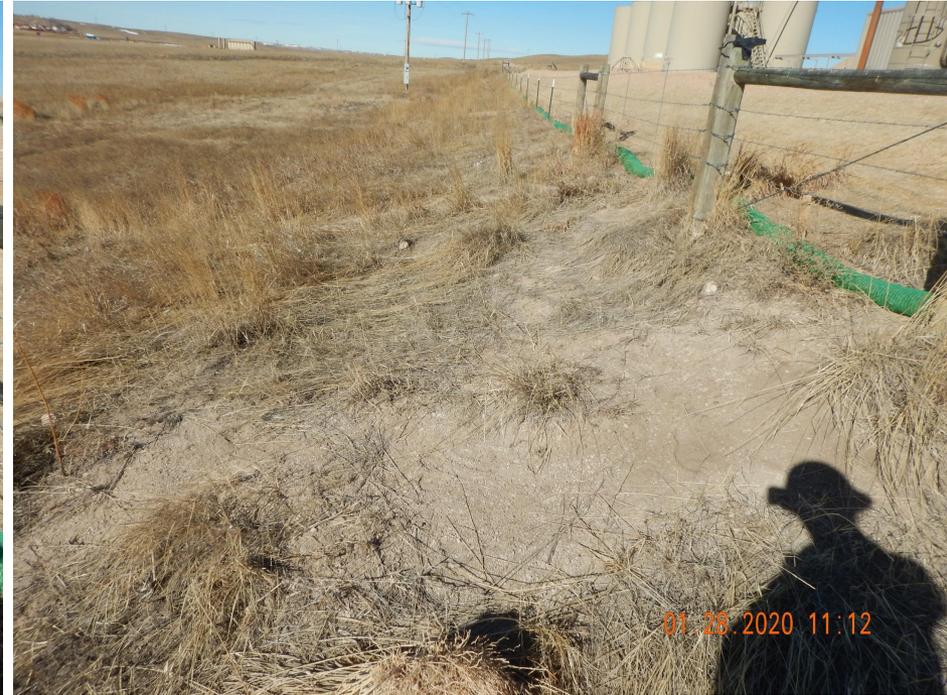
**Photo 5.** Photo taken from the southwestern perimeter of location, facing Northwest. See comments under Photo 4.

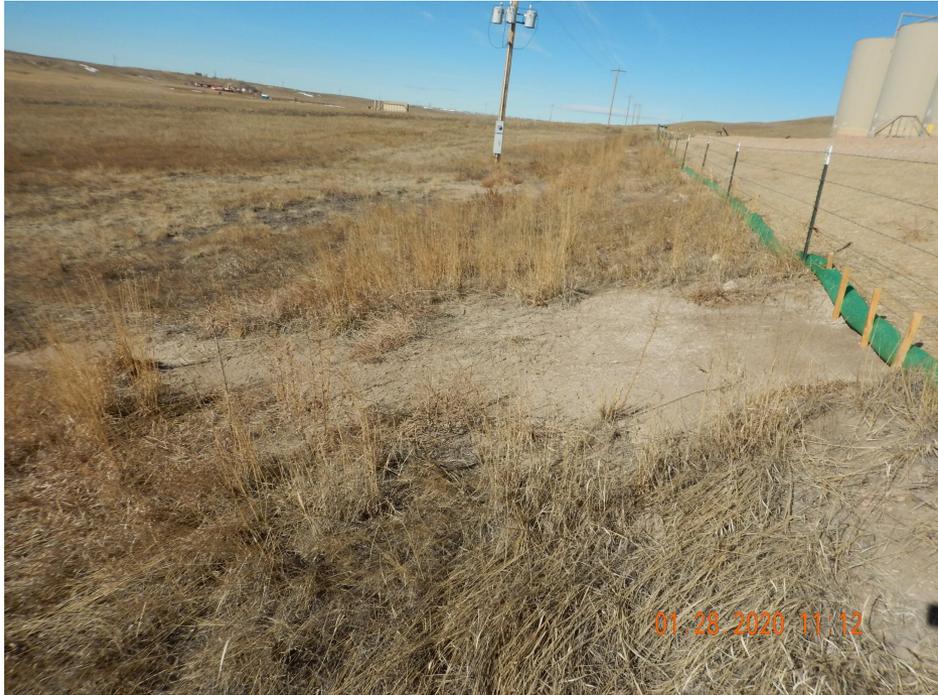
**Photo 6.** Photo taken along the western perimeter of location, facing Northwest. See comments under Photo 4.

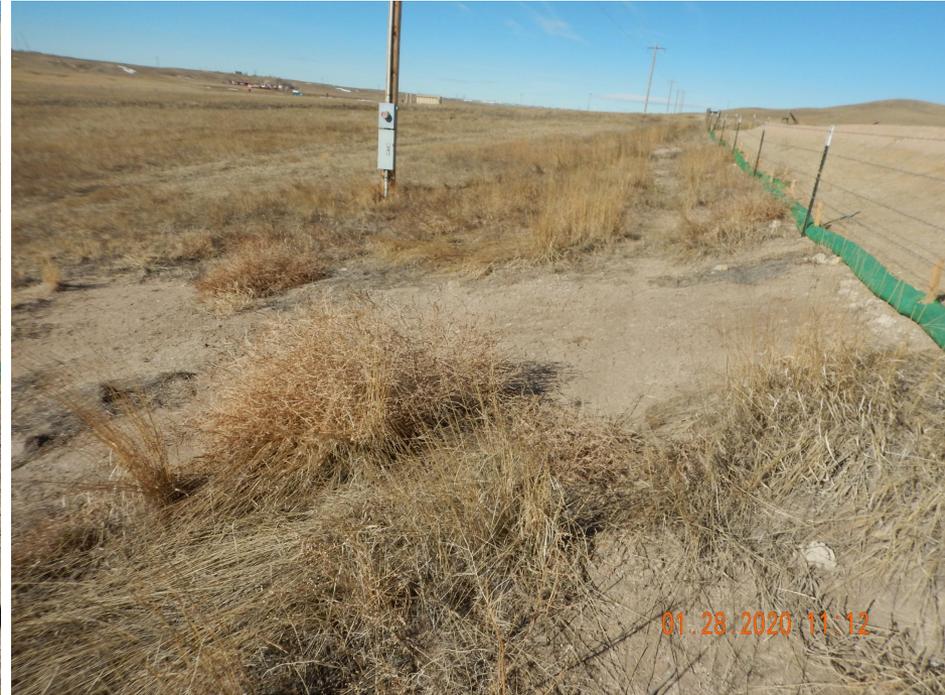
**Photo 7.** Photo taken along the western perimeter of location, facing Northwest. See comments under Photo 4.

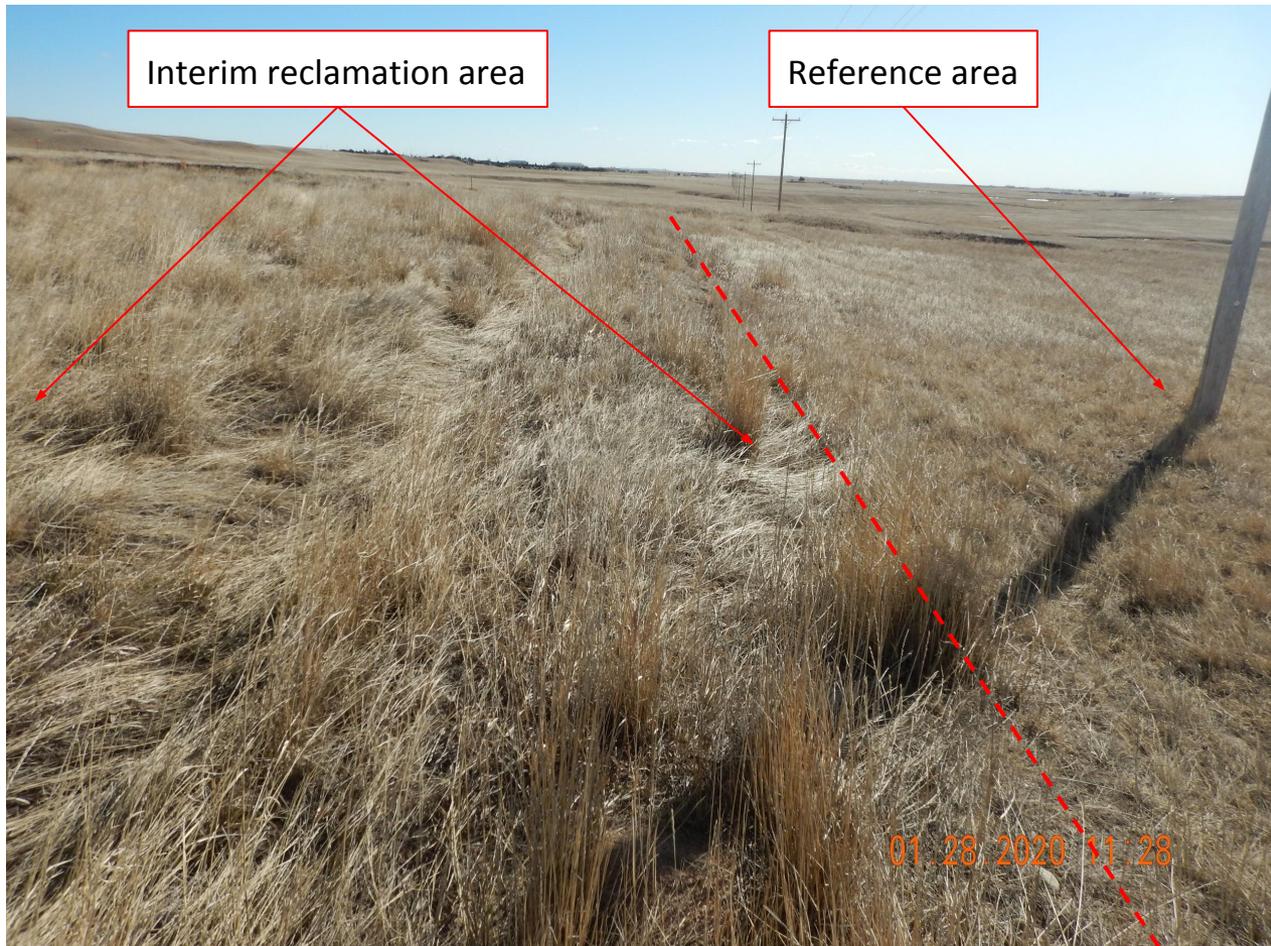
**Photo 8.** Photo taken from the southwestern interim reclamation area, facing Southeast. Photo illustrates vegetative growth within the interim reclamation area (intermediate wheatgrass and smooth brome) is not reflective of reference area vegetation (blue gramma and sand dropseed).

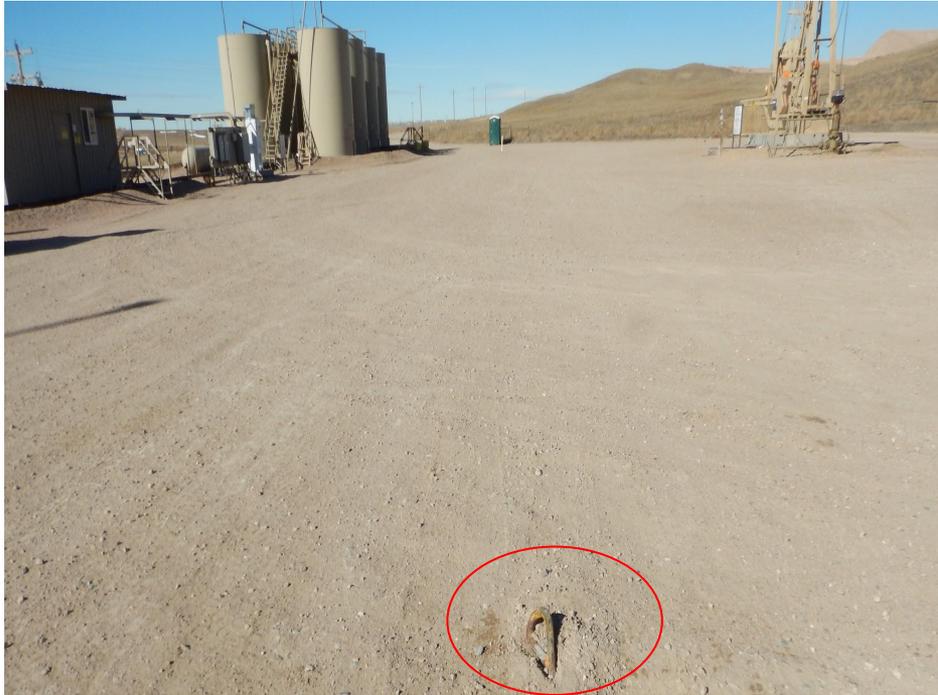
**Photo 9.** Photo taken from the southwestern guy line anchor, facing North. Operator shall properly mark anchor per Rule 1003.a.

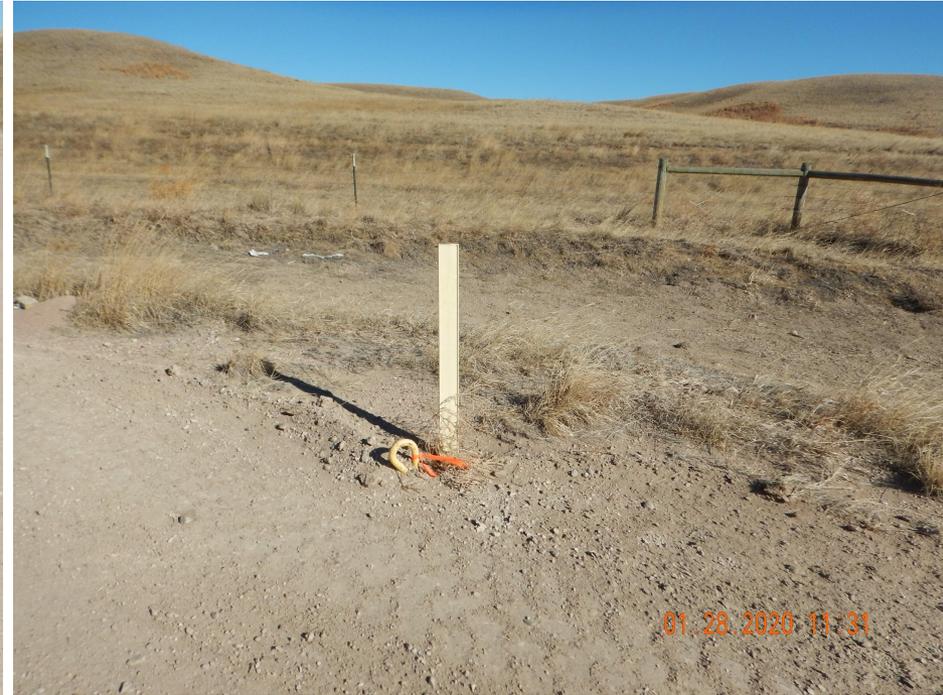
**Photo 10.** Photo taken from the southeastern guy line anchor, facing Northeast. Photo illustrates this guy line anchor is sufficiently marked per Rule 1003.a.
