Inspection Photos  
Operator: BP America  
Location/API #: 067-06651  
Date: 1-28-2020

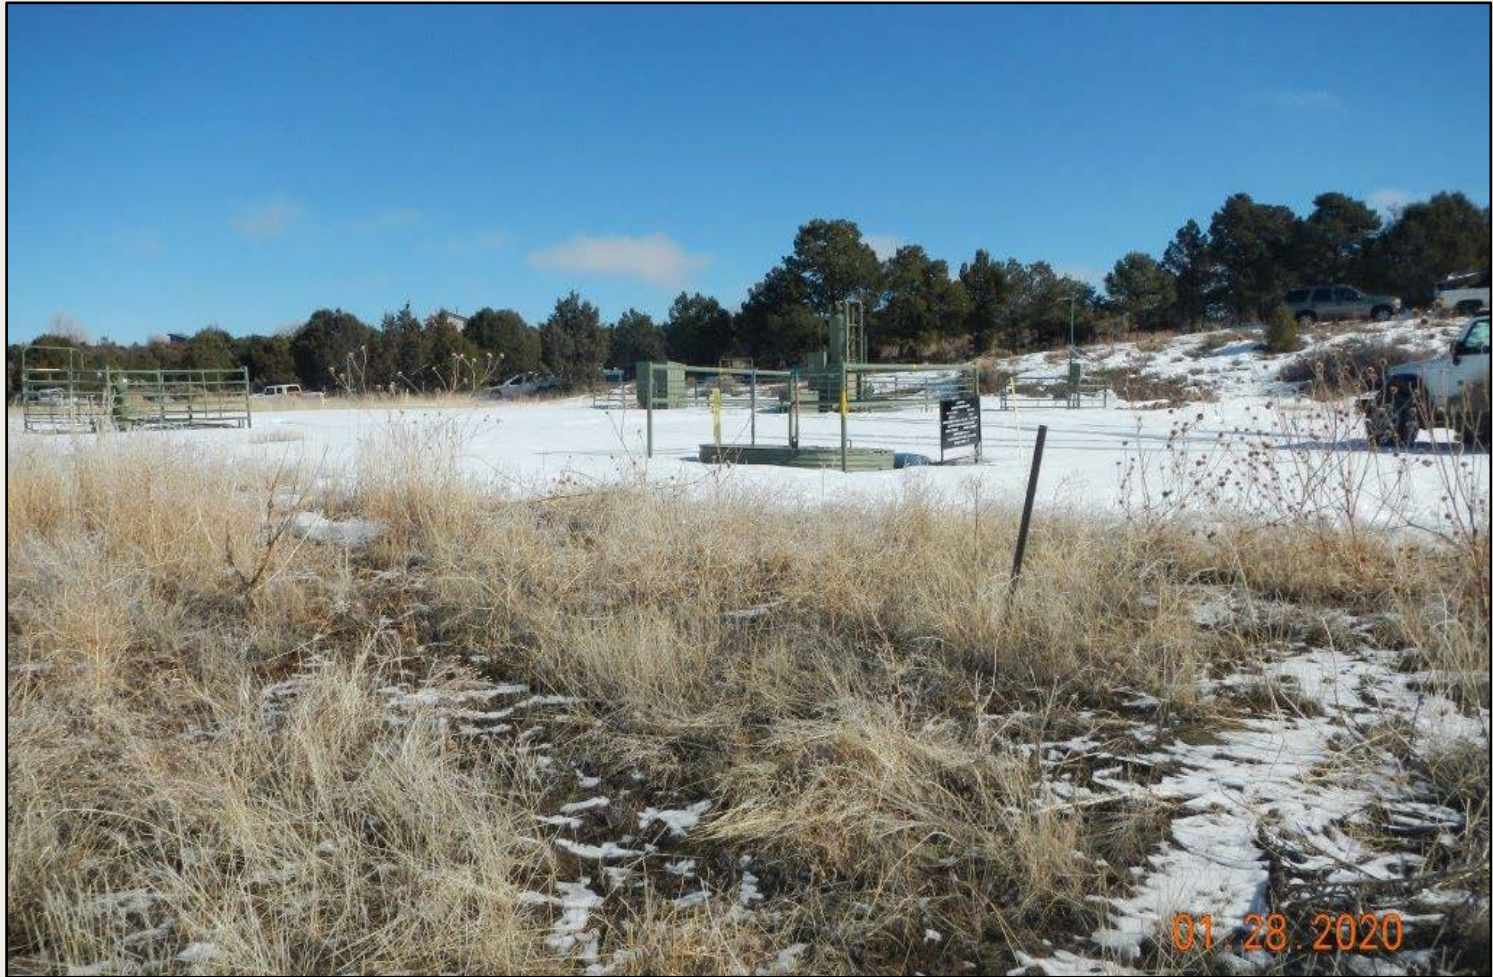
Photo 1. View of the project area from the southwestern corner facing center.

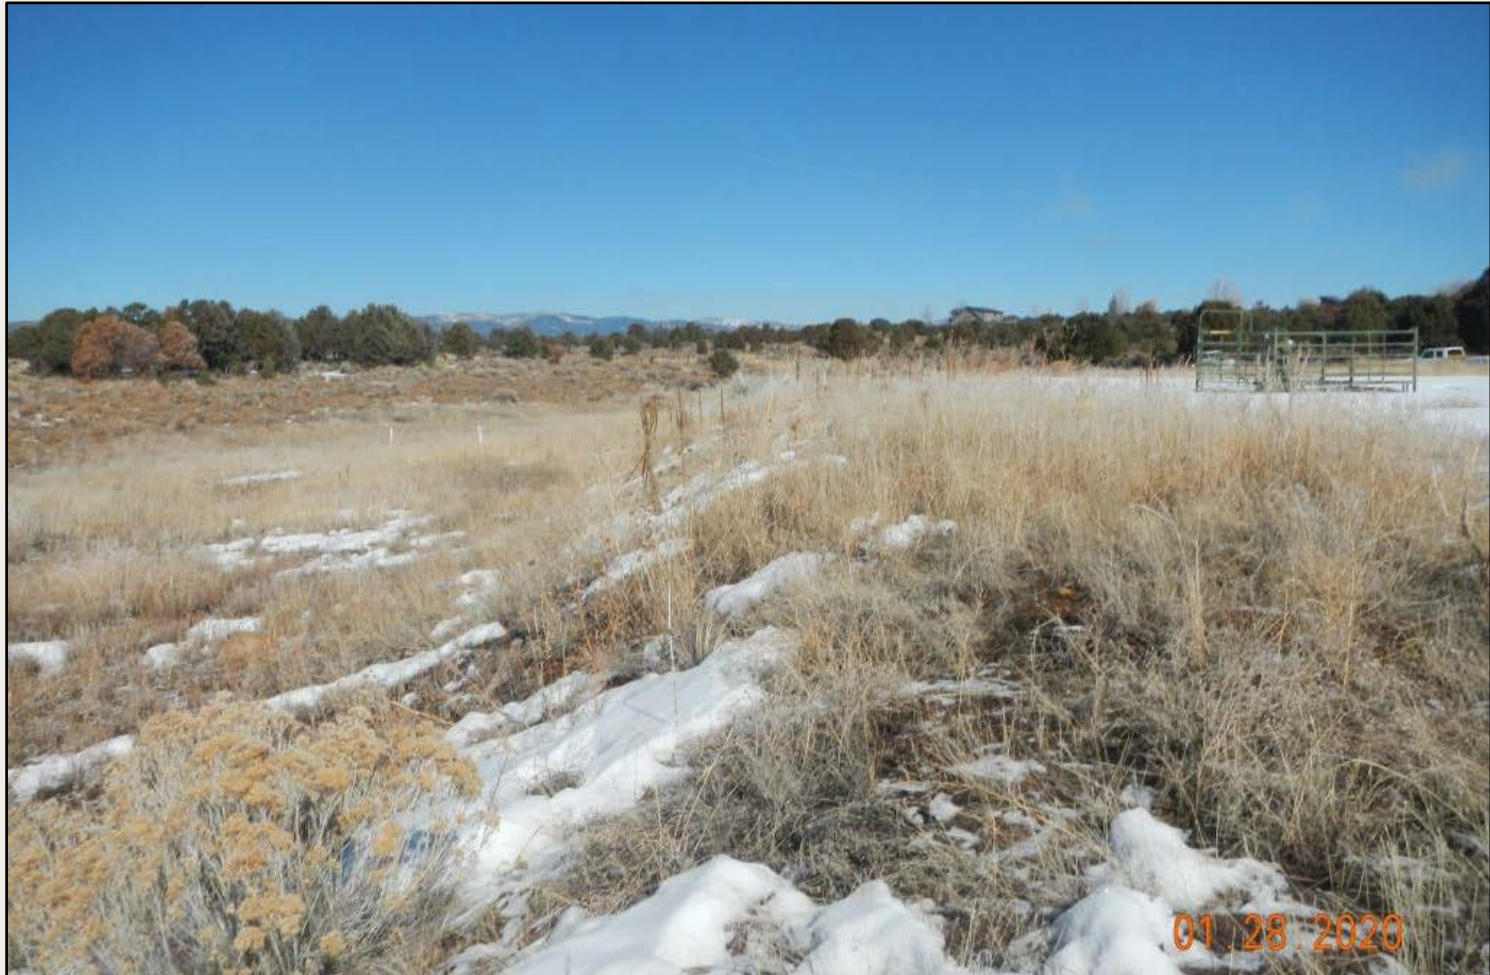
Photo 2. View of the western portion of the project area from the southwestern corner facing northward. Revegetation is progressing within areas that are not weed infested (see below), with grasses such as sand dropseed and smooth brome.

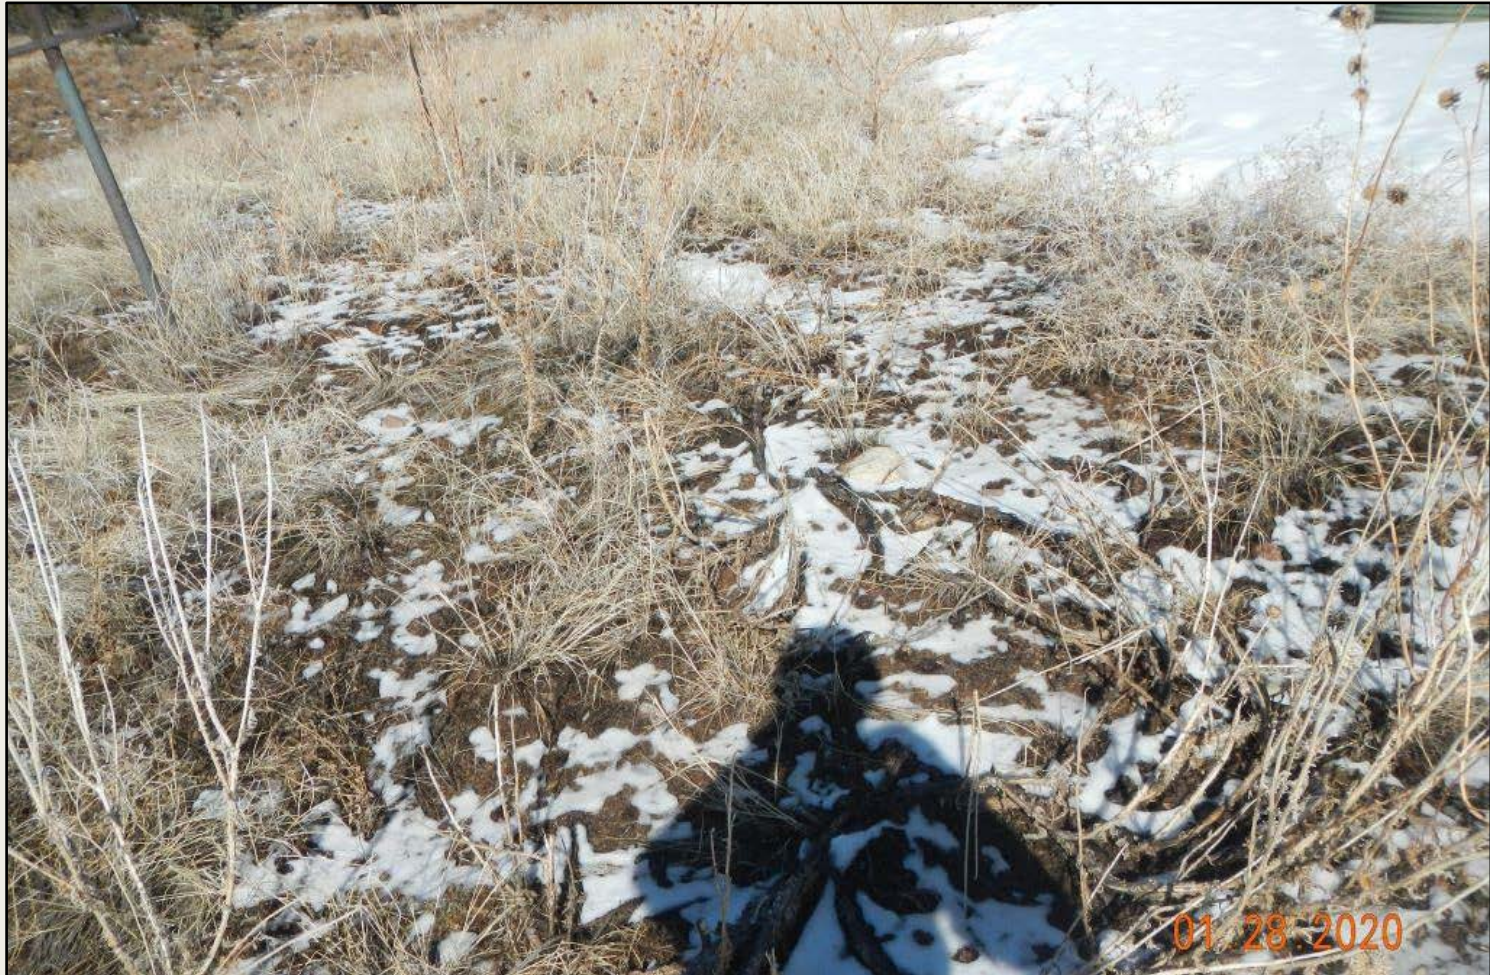
Photo 3. View of dense musk thistle debris within the southwestern project area. Weeds are not controlled.

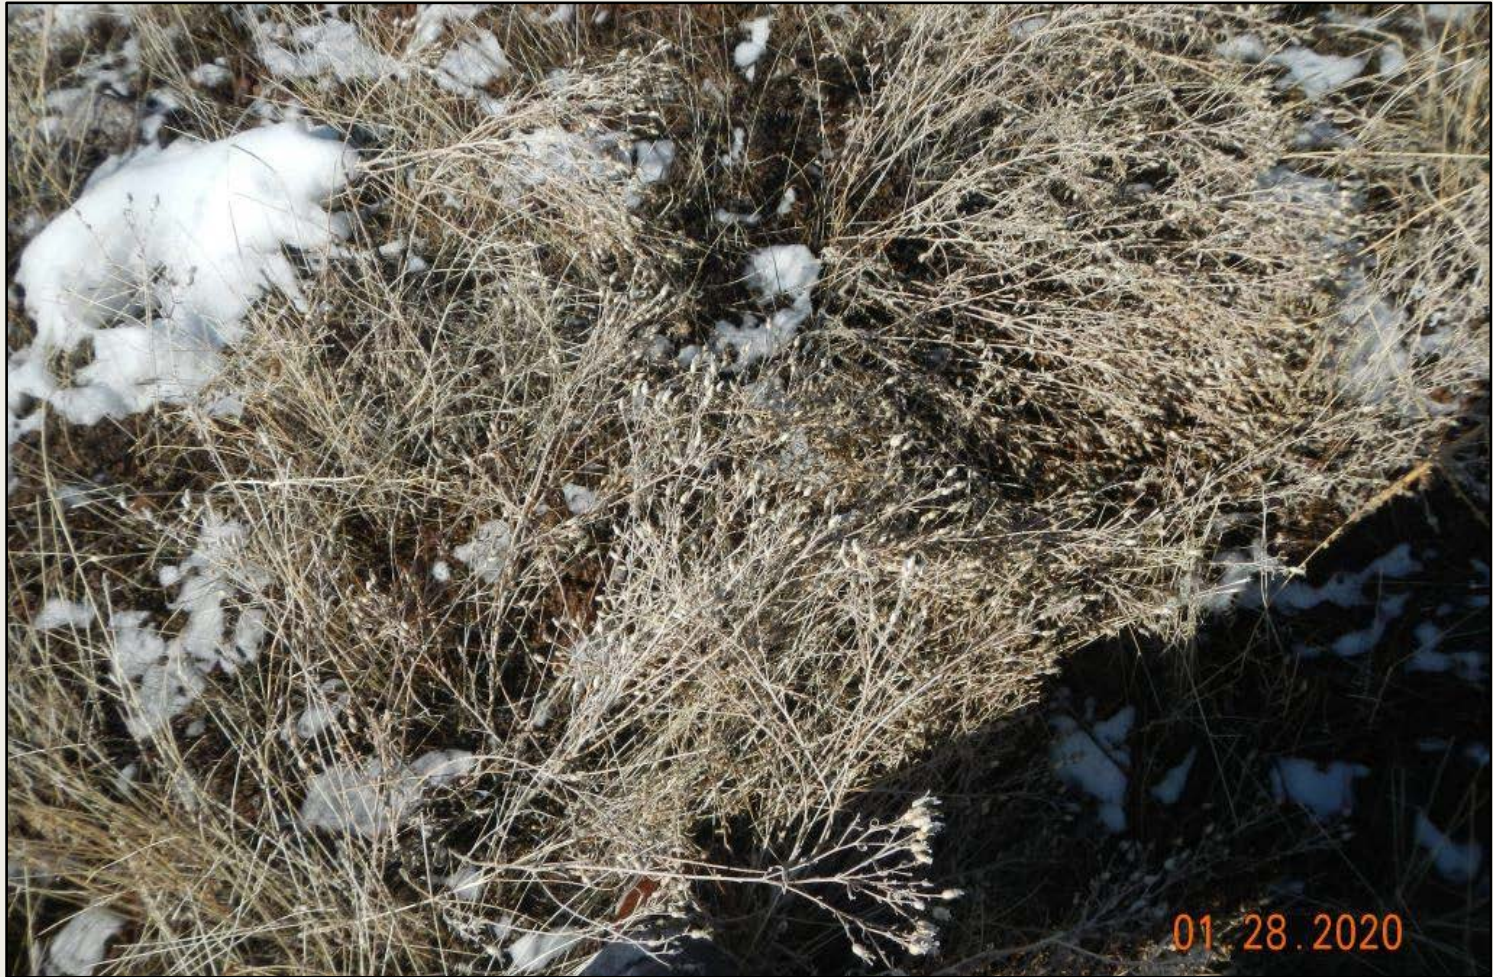
Photo 4. View of Russian knapweeds within the western project area.

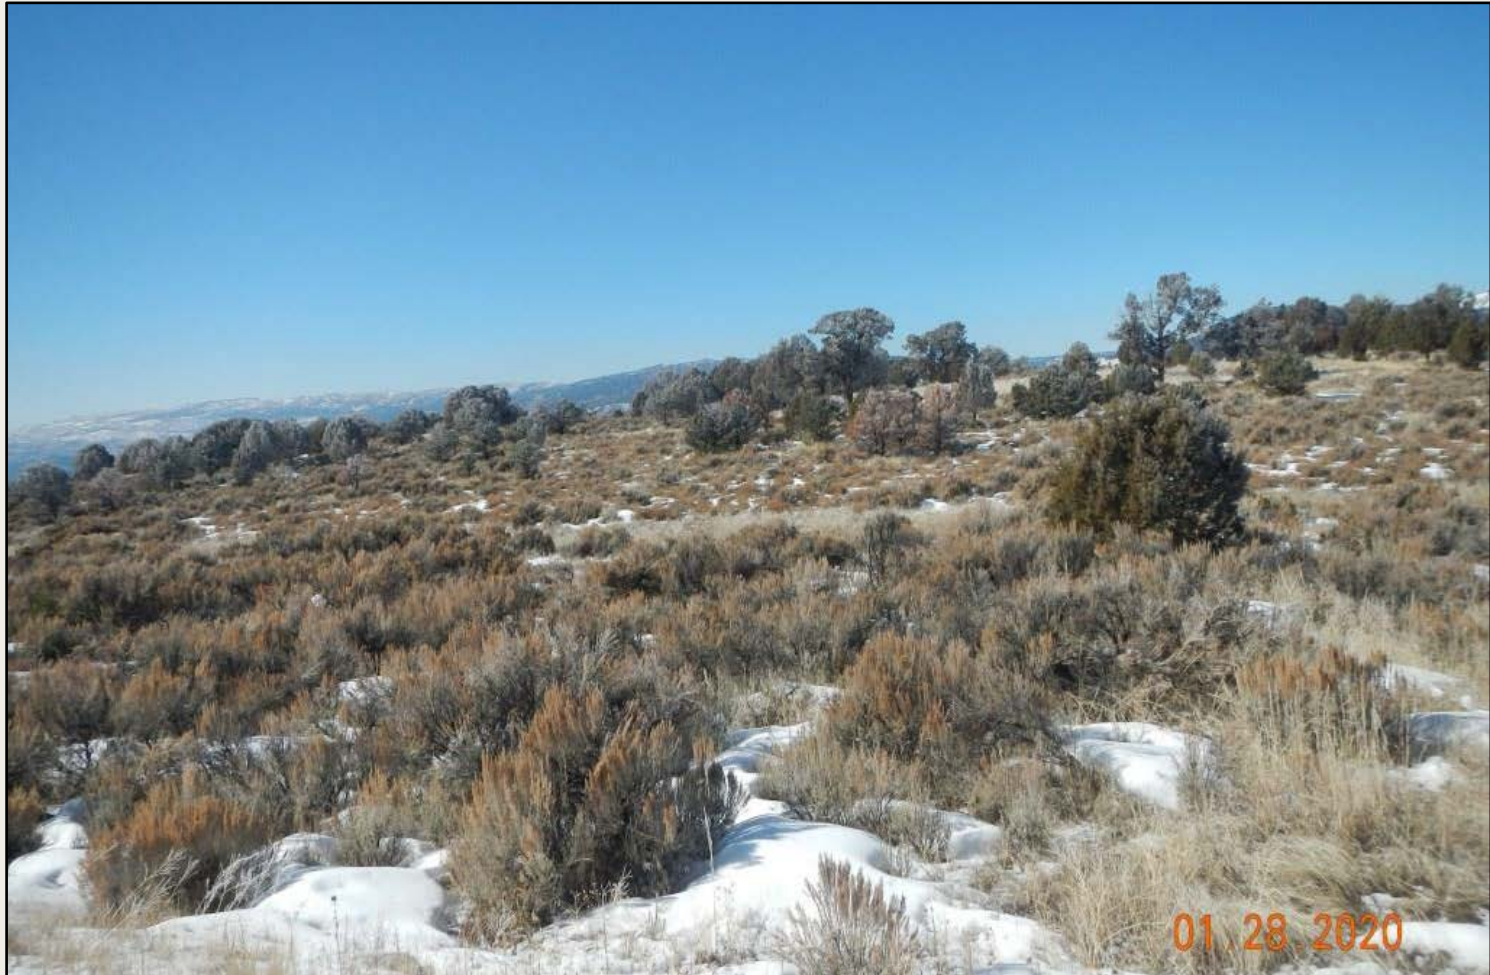
Photo 5. View of the reference area comprised of mixed sagebrush shrubland and pinyon and juniper woodland.
