**RE:** Request to Remove Equipment from Location  
Shields Marie 2 6 2 Gas Well (API# 0506707929)

Inspection Date: <u>12/18/2019</u> Submitted Date: <u>12/19/2019</u> Document Number: <u>693901235</u>																
<b>FIELD INSPECTION FORM</b>																			
Loc ID <u>326370</u> Inspector Name: <u>ROY, CATHERINE</u> On-Site Inspection <input type="checkbox"/> 2A Doc Num: _____		<b>Status Summary:</b> <input type="checkbox"/> THIS IS A FOLLOW UP INSPECTION <input checked="" type="checkbox"/> FOLLOW UP INSPECTION REQUIRED <input type="checkbox"/> NO FOLLOW UP INSPECTION REQUIRED																	
<b>Operator Information:</b> OGCC Operator Number: <u>10133</u> Name of Operator: <u>HILCORP ENERGY COMPANY</u> Address: <u>P O BOX 61229</u> City: <u>HOUSTON</u> State: <u>TX</u> Zip: <u>77208</u>		<b>Findings:</b> <u>7</u> Number of Comments <u>2</u> Number of Corrective Actions <input checked="" type="checkbox"/> Corrective Action Response Requested

**Inspection Photos**  
**Operator: Hilcorp Energy**  
**Location/API #: 067-07929**  
**Date: 12-18-2019**

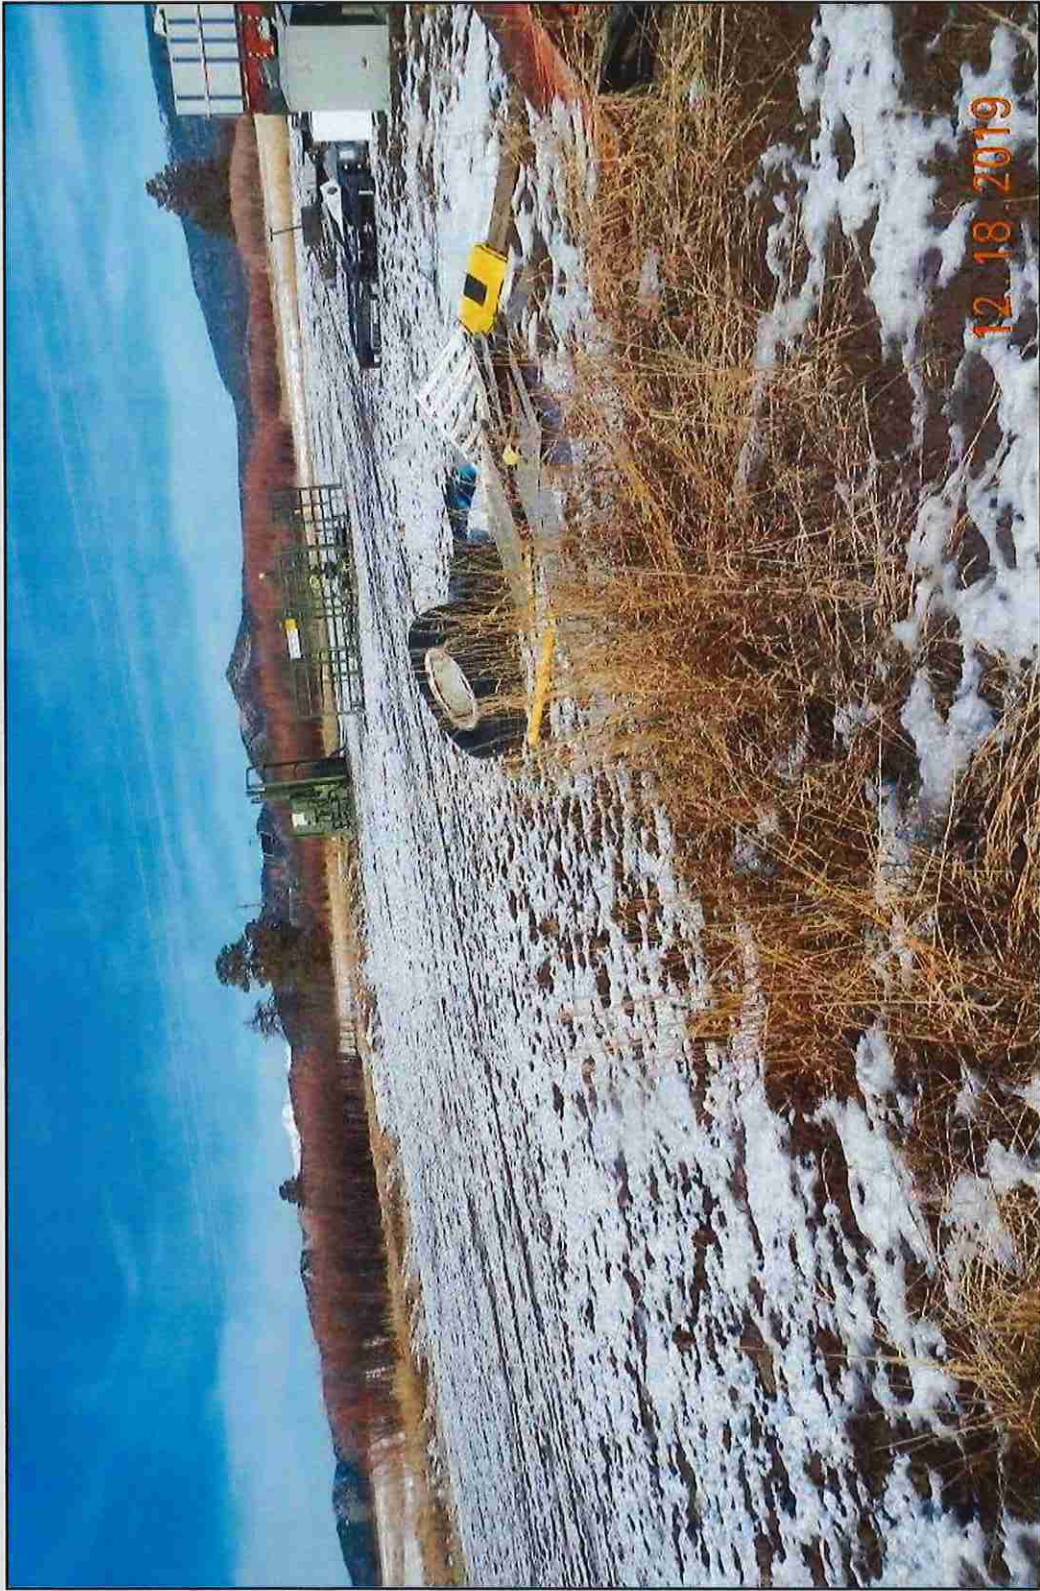
Photo 1. View of the project area from the southeastern corner facing center.

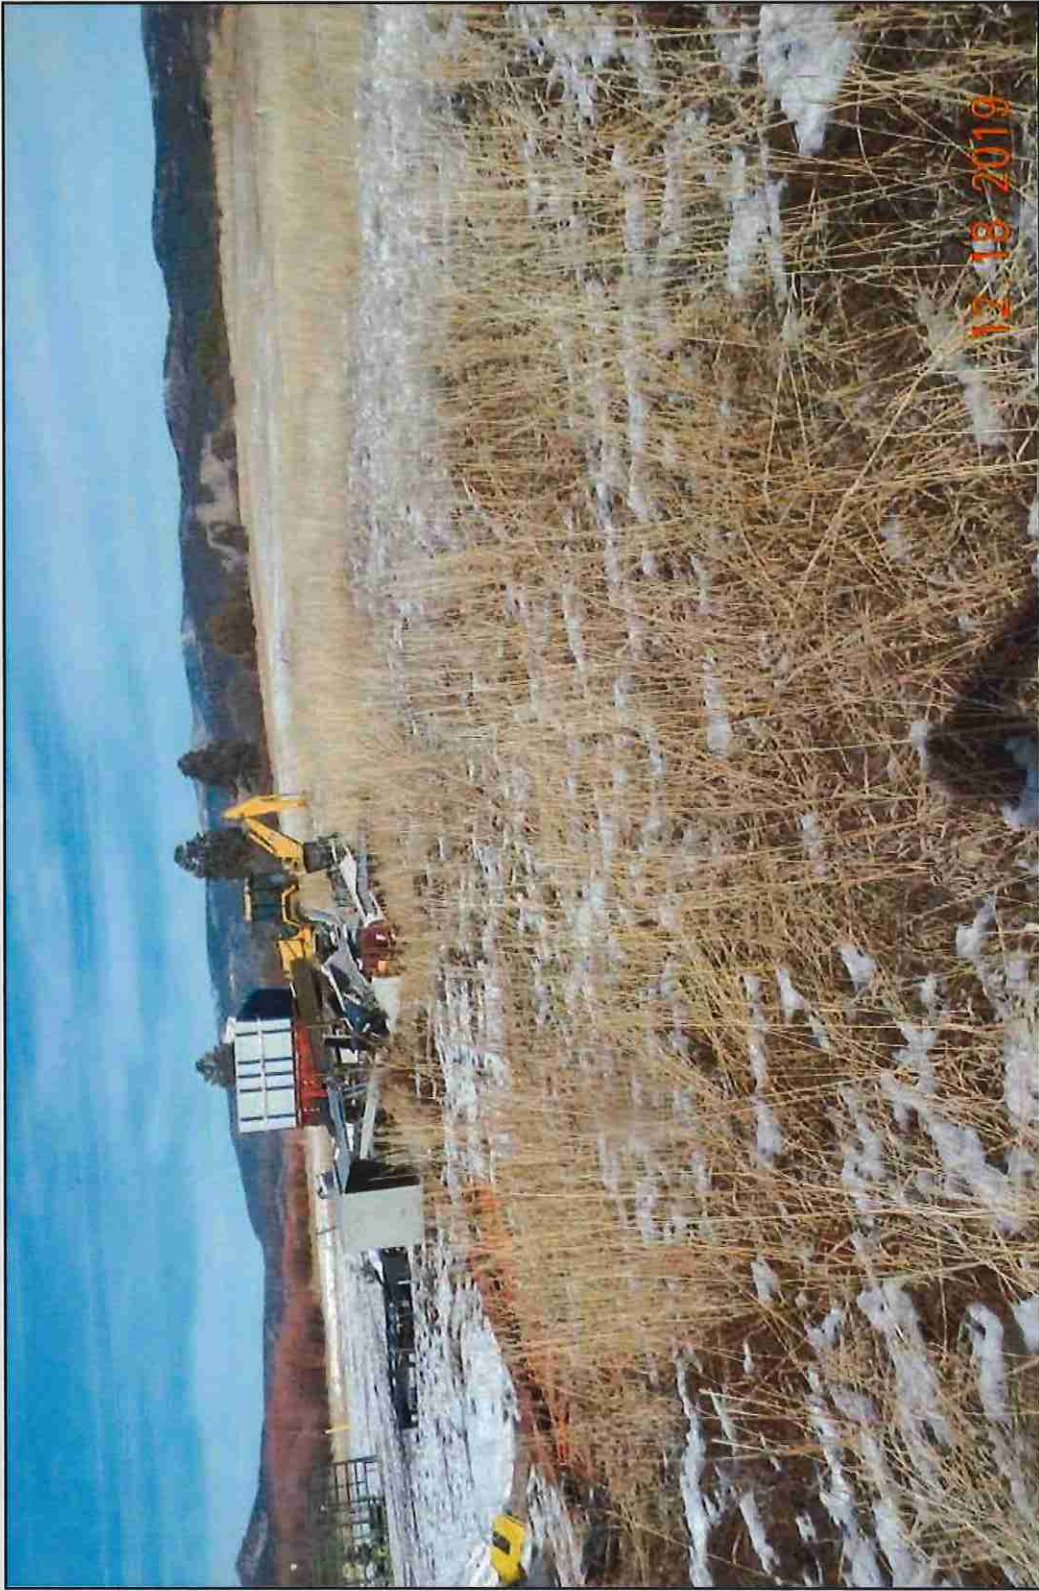
1003a. Waste and Debris removed? FailComment Waste and debris observed within the eastern project area.Corrective Action Remove and properly dispose of waste nad debris.Date 01/31/2020Unused or unneeded equipment onsite? FailComment Unused equipment observed within the project area.Corrective Action Remove and properly store unused equipment.Date 01/31/2020

Photo 2. View of the eastern fill slope from the southeastern corner facing northward. Location is partially snow covered at this time. Revegetation is in a dormant vegetative condition, and largely comprised of smooth brome, western wheatgrass, and sand dropseed. Junk, debris, and unused equipment stored within the eastern project area.

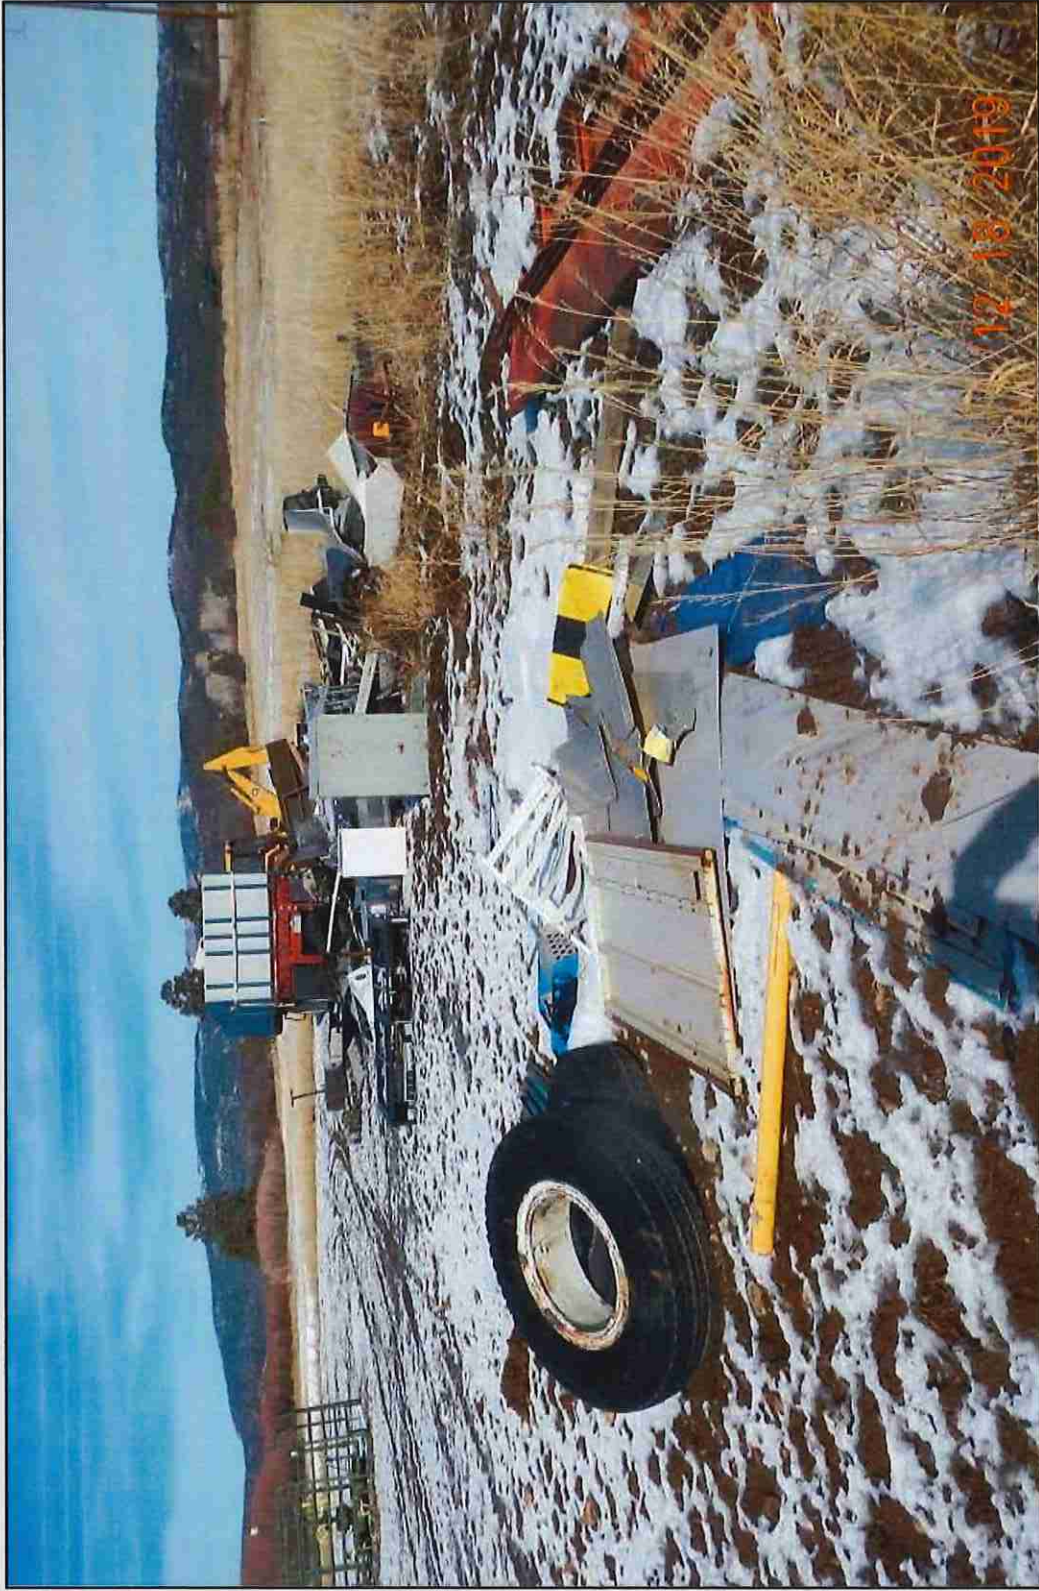
Photo 3. View of unused equipment, junk, and debris in the eastern project area, needs to be removed.

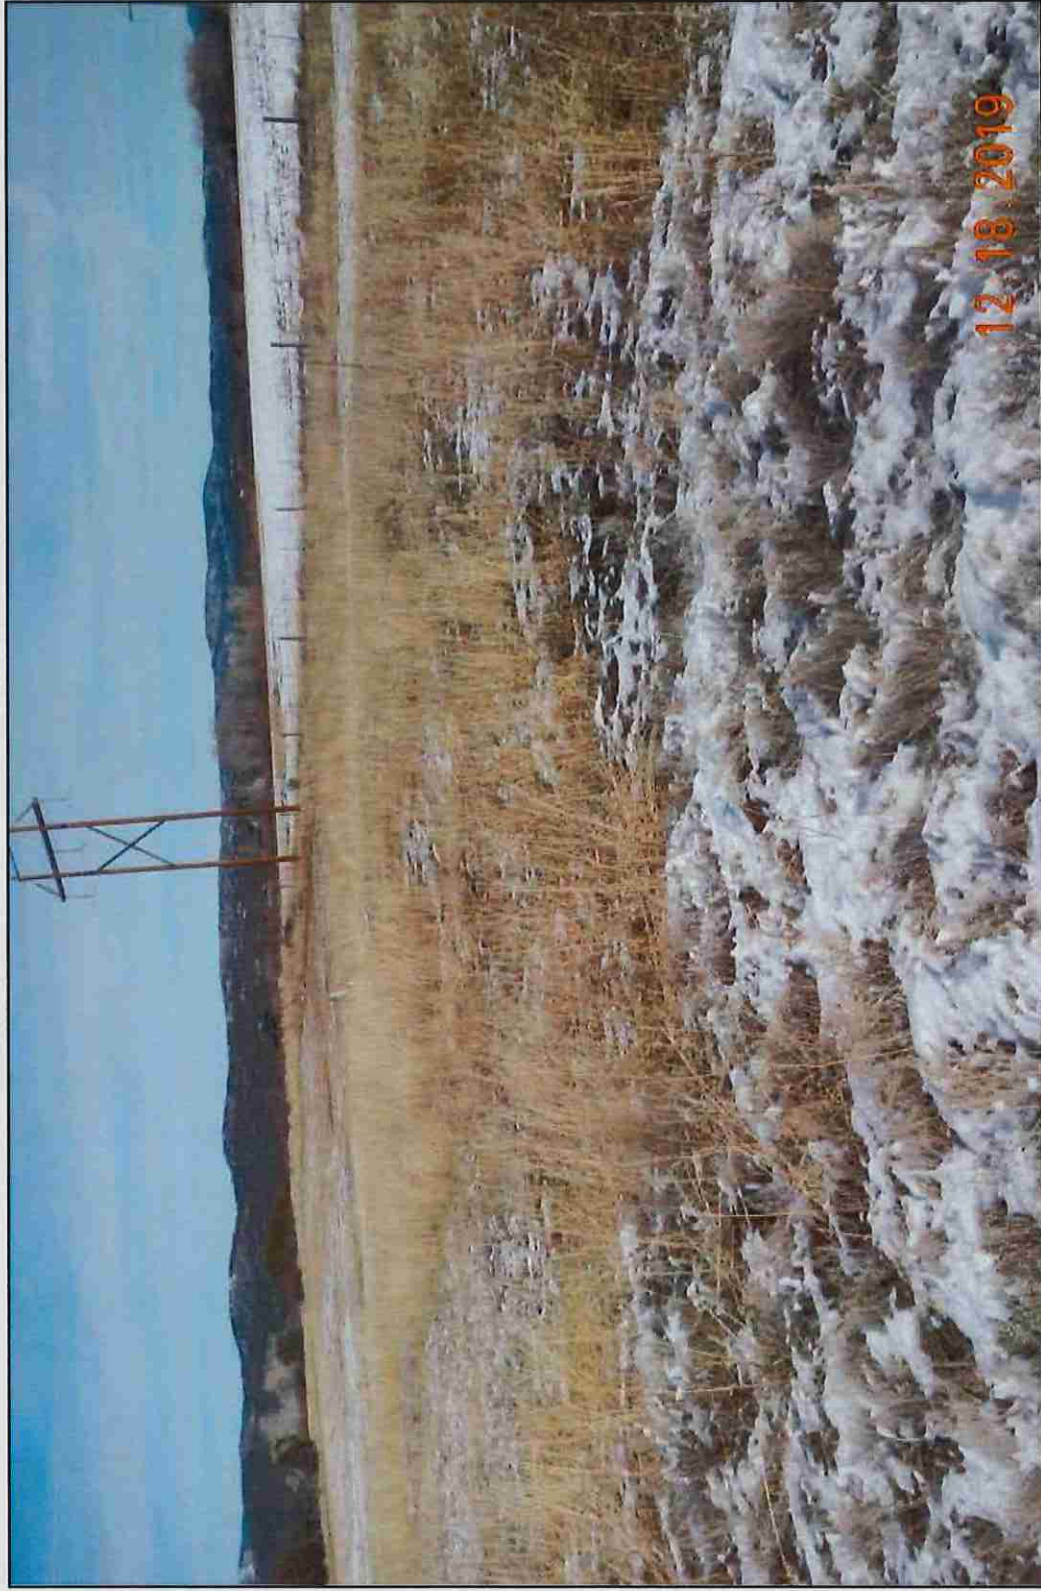
Photo 4. View of reference area comprised grass field, largely comprised of smooth brome in dormant vegetative condition.
