Inspection Photos
Location Name: Robertson 19-01 #2
API: 05-067-08778

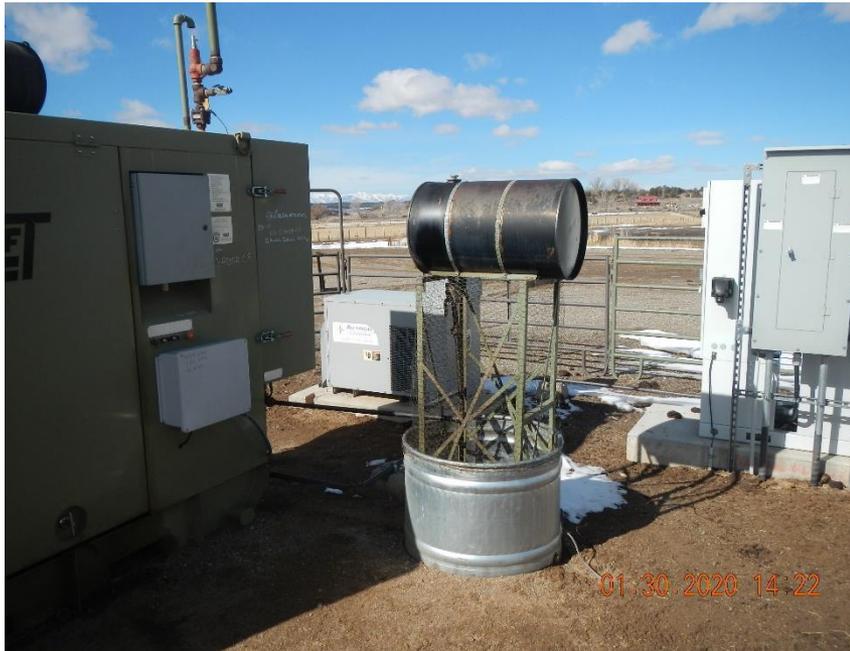
Lube oil container on secondary containment.

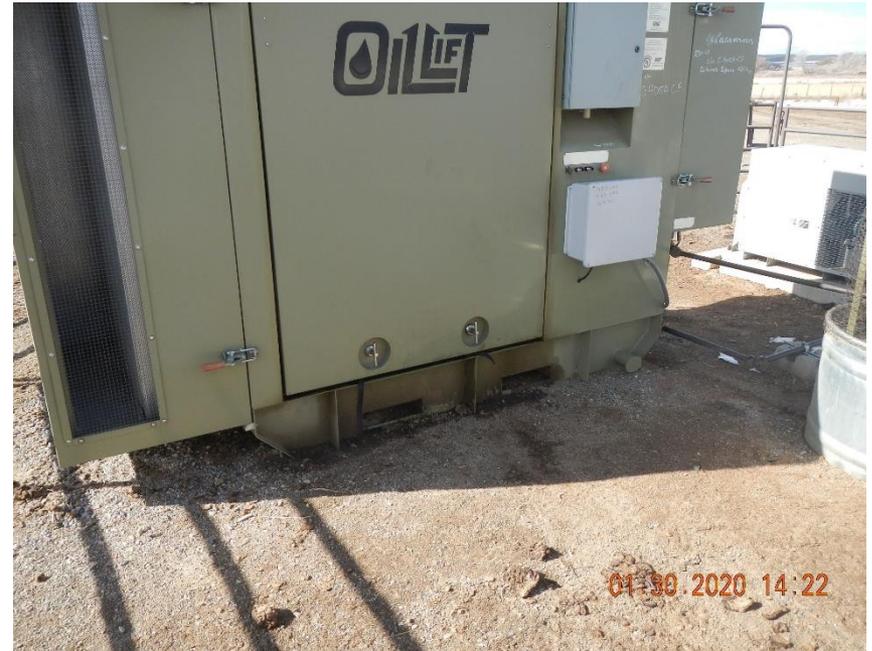
Lube oil staining on equipment and surrounding gravel.

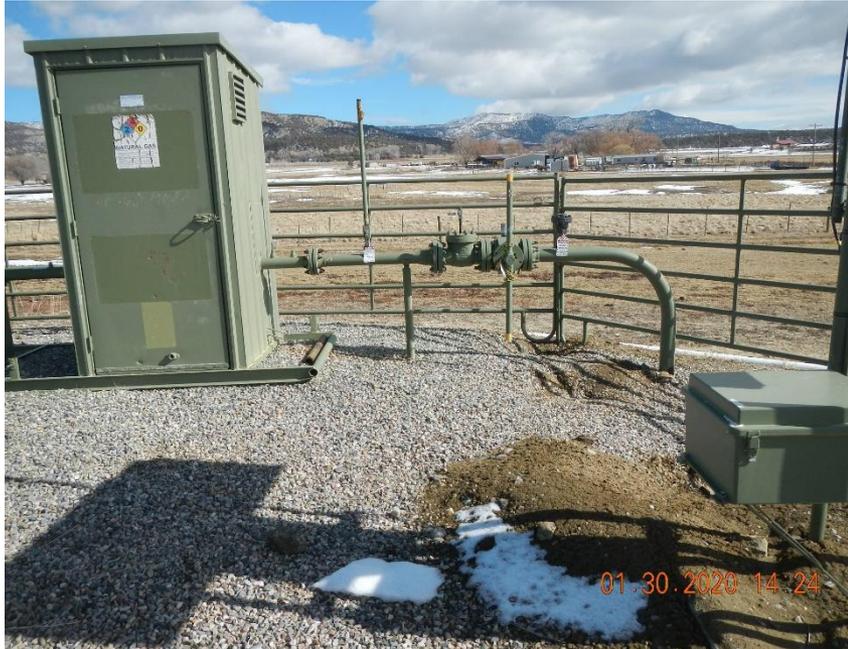
Production equipment is currently shut in while repairs are made to gathering system following Spill/Release Point ID #470891.

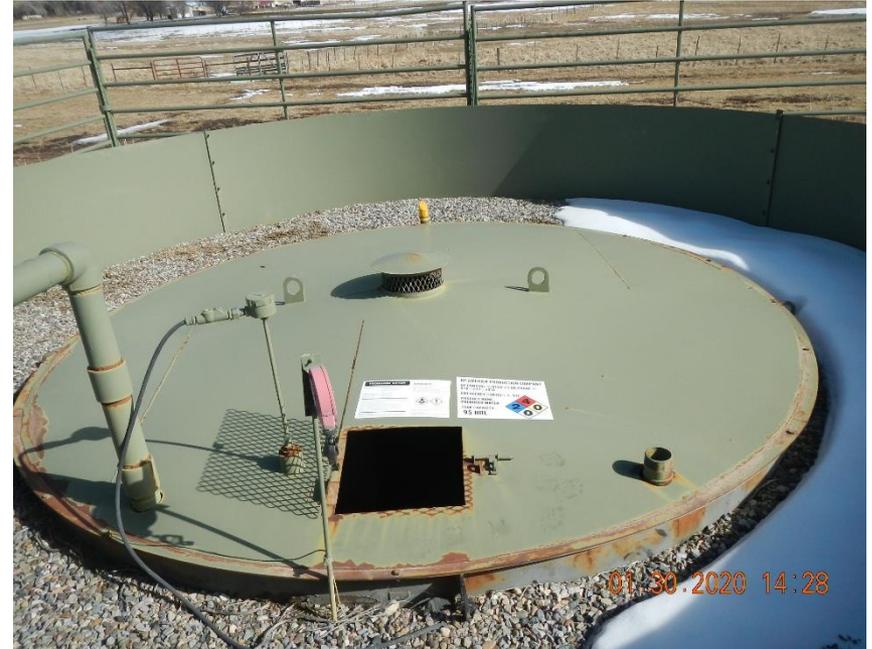
95 bbl. produced water PBV.
