Inspection Photos
Location Name: Johnson, Rolland A-1 & TB
Location ID: 332889

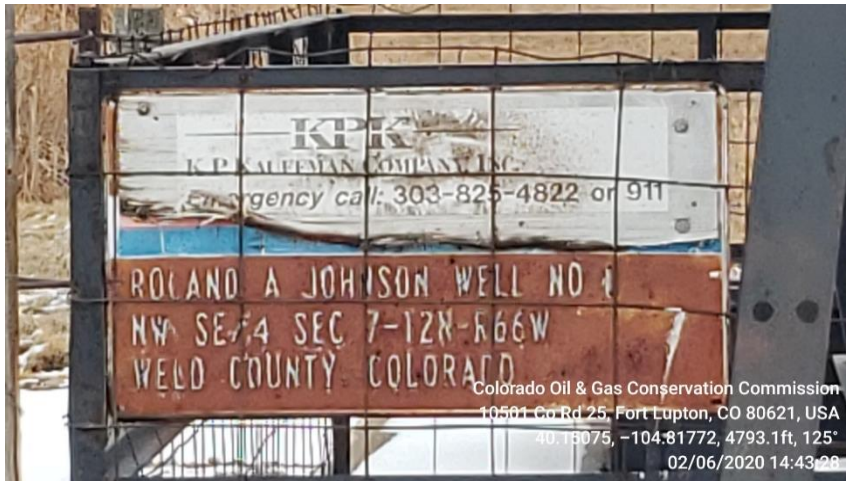
Photo 1 WH sign

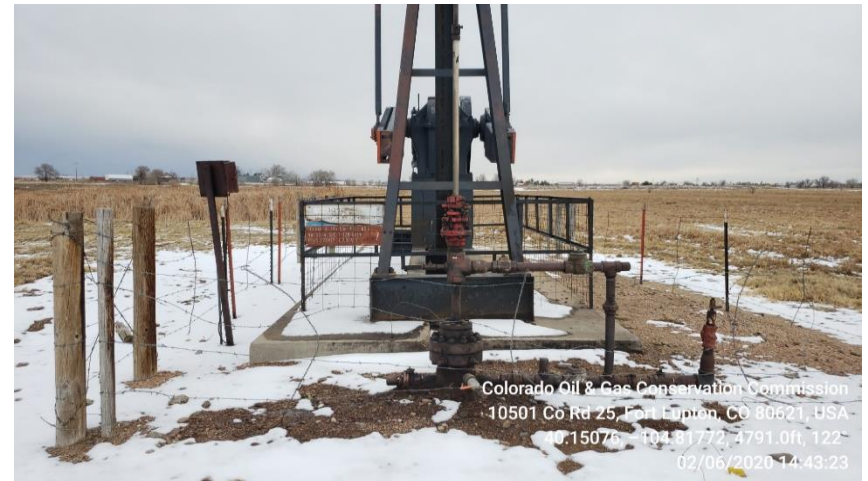
Photo 2 PU

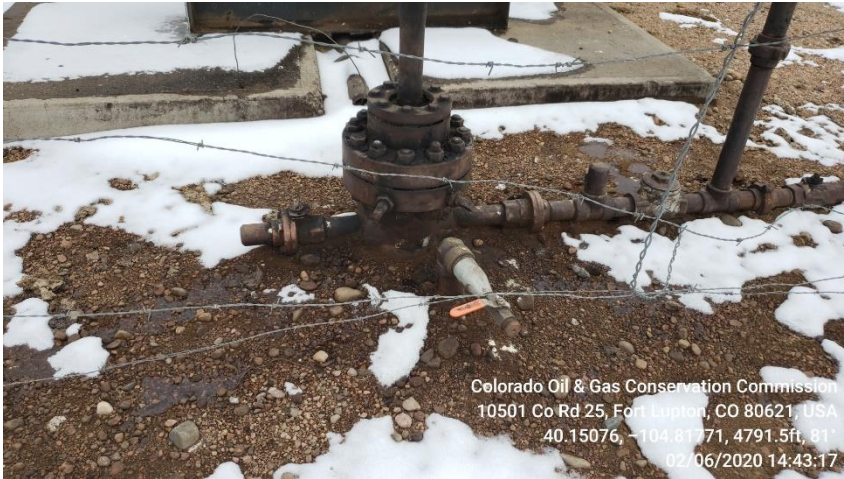
Photo 3 stained soil around WH

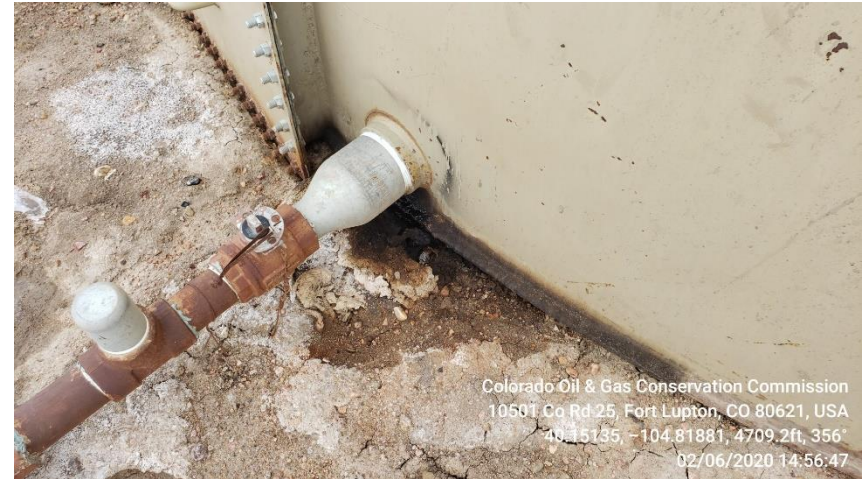
Photo 4 Stained soil possible leak under swedge on backside of crude oil tank

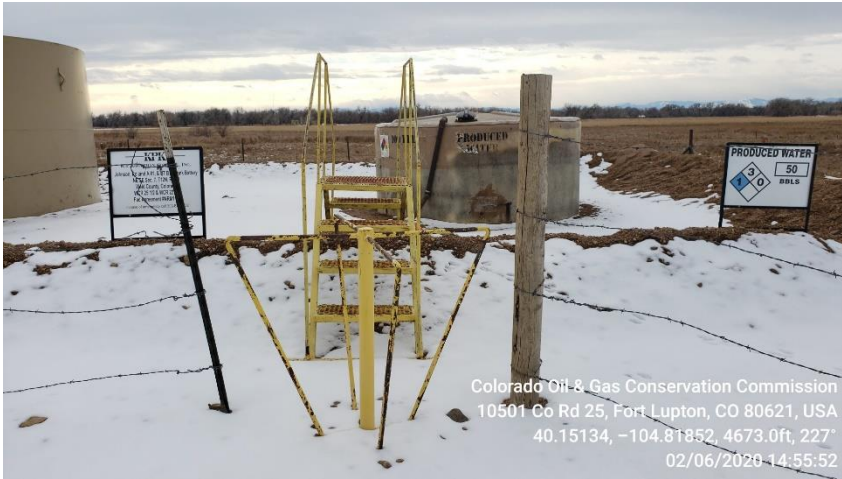
Photo 5 TB sign PW tank sign shows 50 bbl

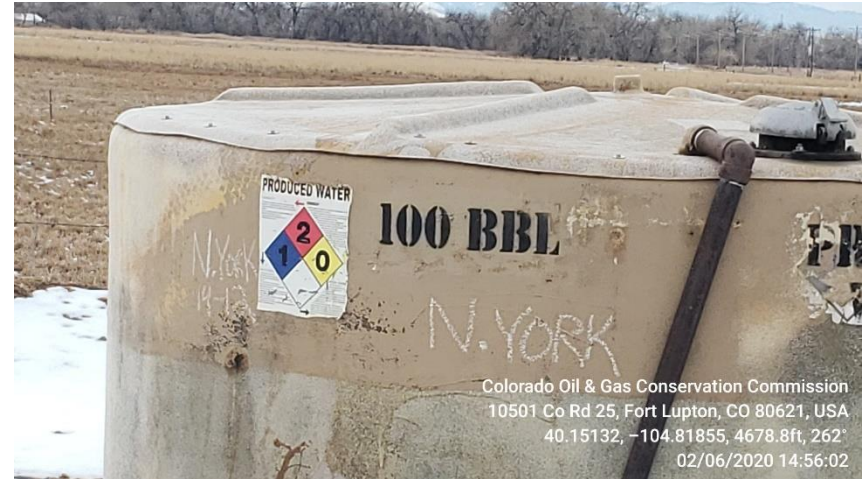
Photo 6 PW tank shows 100 bbl

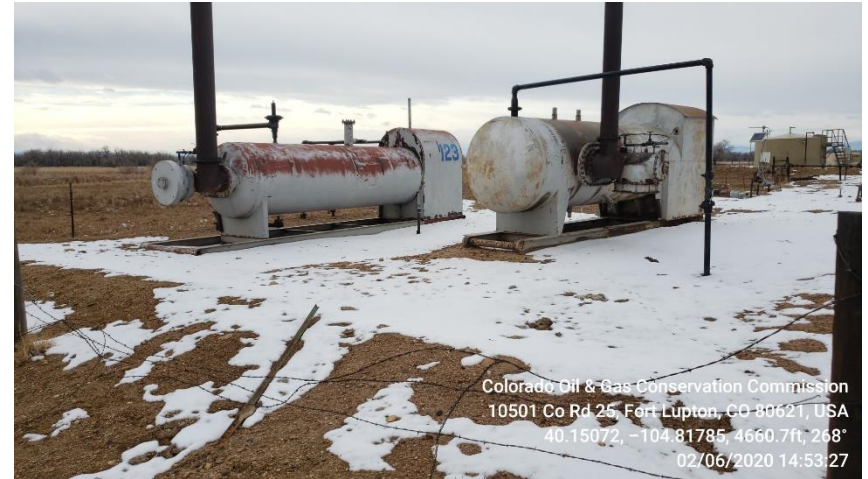
Photo 8 Horizontal heated Separators berm is not properly maintained

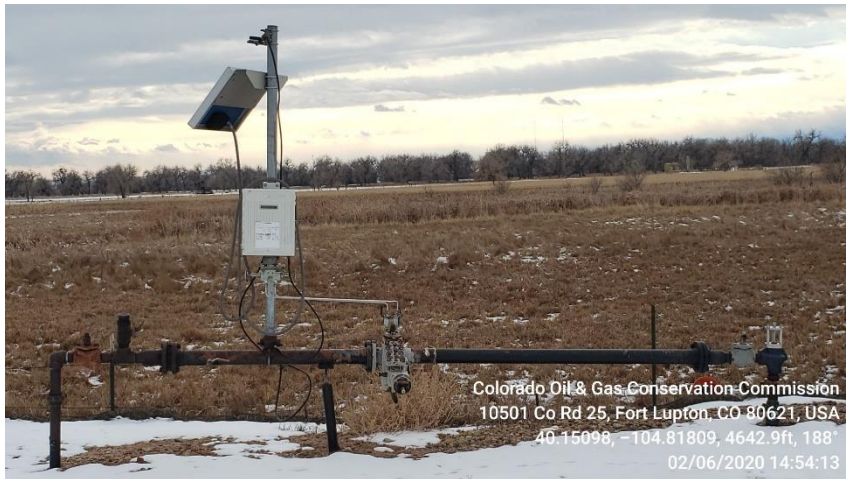
Photo 9 Gas meter run

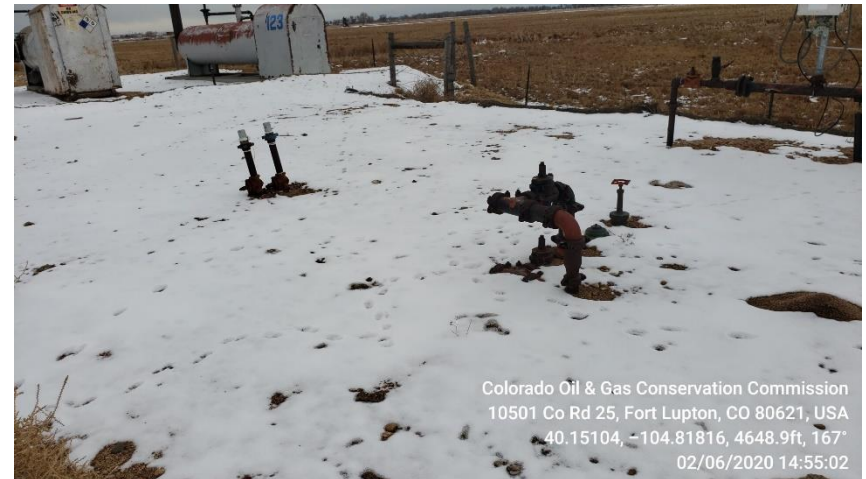
Photo 10 flow lines & valves bull plugged no LOTO

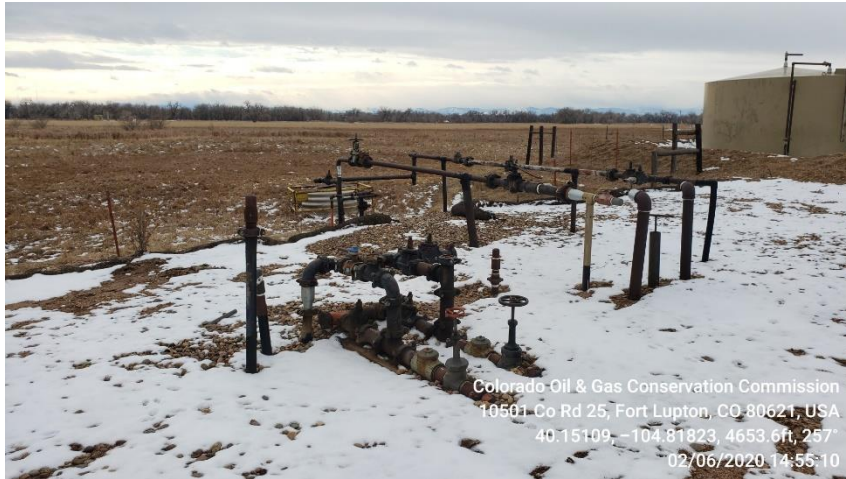
Photo 11 Manifold and flow lines bull plugged no LOTO
