Well Name: Jaquez 6F API # 05-067-07692  
Well Name: Jaquez 10 API # 05-067-10018  
Well Name: Jaquez 11 API # 05-067-10019  
Well Name: Jaquez 12 API # 05-067-10020

Inspection Number: 693901104  
Inspection Number: 693901367

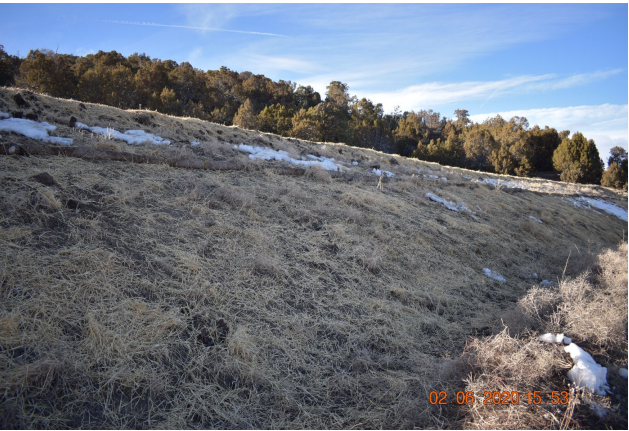
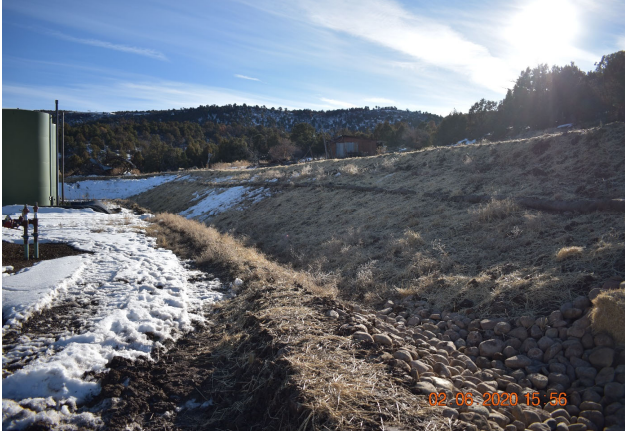
Corrective Action: Conduct revegetation throughout the interim reclamation areas. Weeds need to be controlled. Corrective action date is the date of this inspection as revegetation should be progressing at this time and needs to be conducted immediately.

Action Completed: Removed and disposed of weed debris, reseeded and applied straw mulch on bare cut slope, Will seed and mulch remaining slope when snow melts.

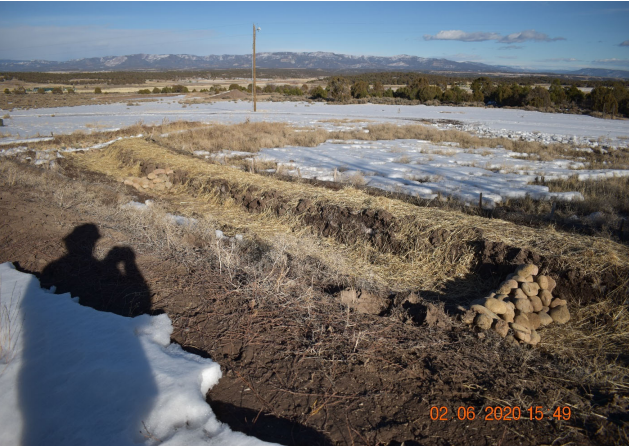
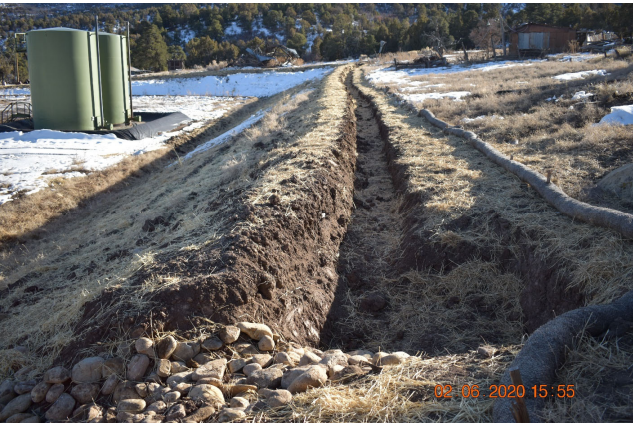
Corrective Action: Stormwater controls (ie BMPs) and erosion controls (ie mulching/blankets etc.) are needed to stabilize soils within the project area. Stormwater controls need to be selected, sized, installed, and maintained in accordance with good engineering practices such as those described by CDOT in their erosion control manuals

Action Taken: Installed drainage ditch at the top of the cut slope with rock catch basins at the outlets for storm water and erosion control  
Installed straw mulch on bare slope.
