Interim Reclamation and Stormwater Inspection

January 21, 2020

Operator: Noble Energy (Operator #100322)

Location ID: 329964

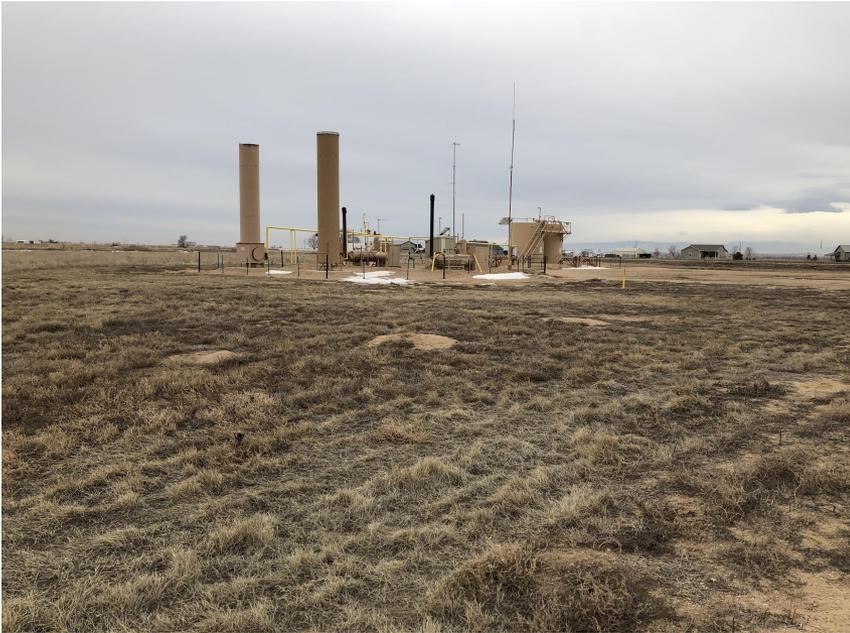
Photo 1. Photo taken from the Northern perimeter of the location on January 21, 2020, facing Southeast. Photo illustrates the completion of intermediate reclamation; however, Operator did not reinstall ditch and berm BMP at the time of this inspection. Germination in interim area was high but will require a follow up to due to high amounts of mowed weedy debris.

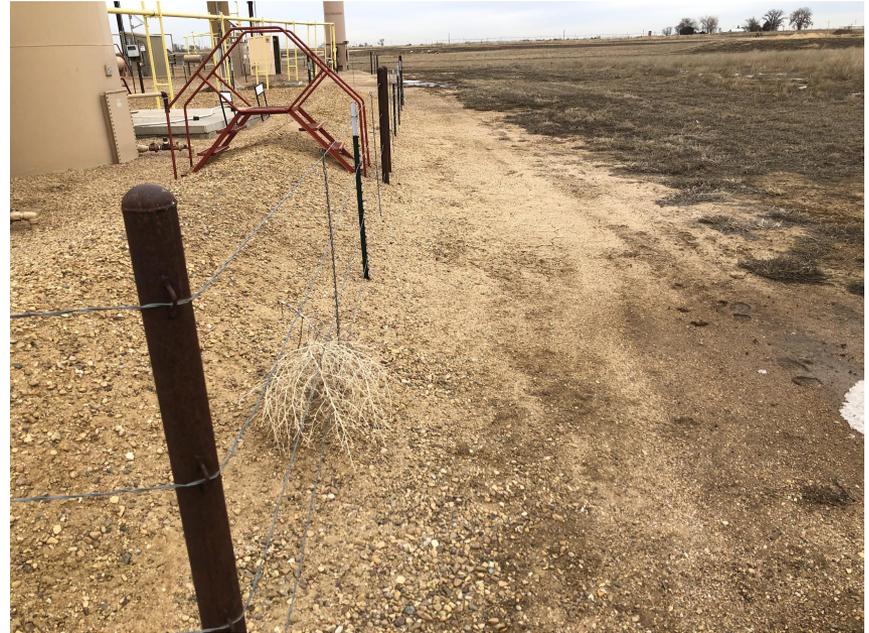
Photo 2. Photo taken from the Southwestern corner of location on January 21, 2020, facing East. Photo illustrates no ditch and berm BMP installed after intermediate reclamation.

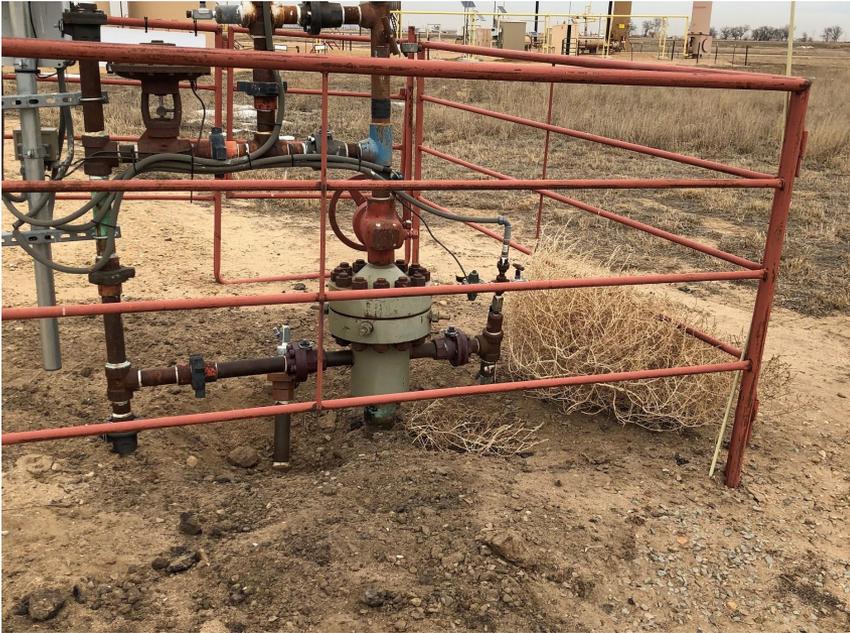
Photo 3. Photo taken from the southern wellhead location on January 21, 2020, facing Northeast. Weed debris present on well pad; it appeared this debris moved in from off site.

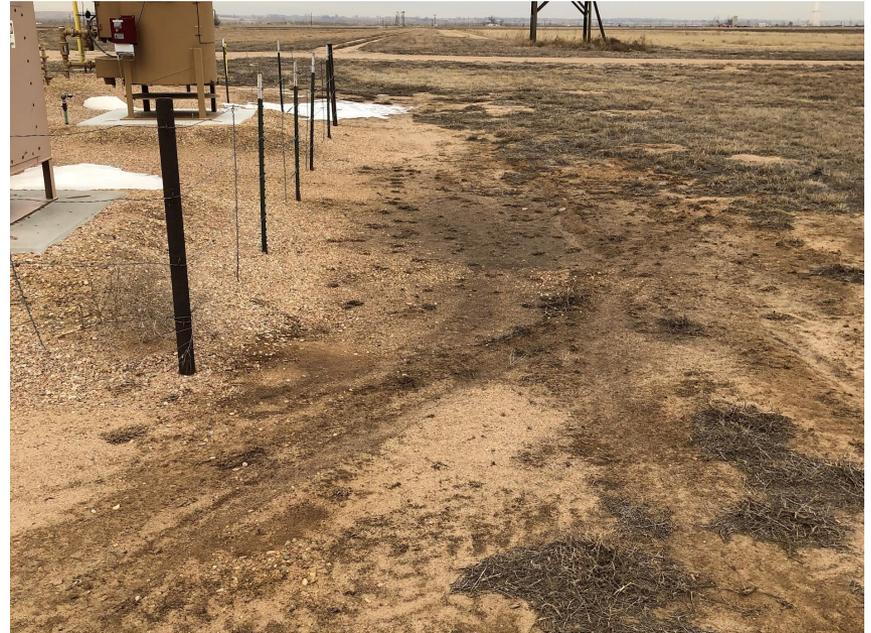
Photo 4. Photo taken from the eastern perimeter of location on January 10, 2020, facing North. Photo depicts no ditch and berm BMPs installed throughout site; interim reclamation germination will require a follow up visit.
