# Interim and Stormwater Inspection

Operator: SRC Energy (Operator 10311)

Location ID: 433828

Weld County, CO

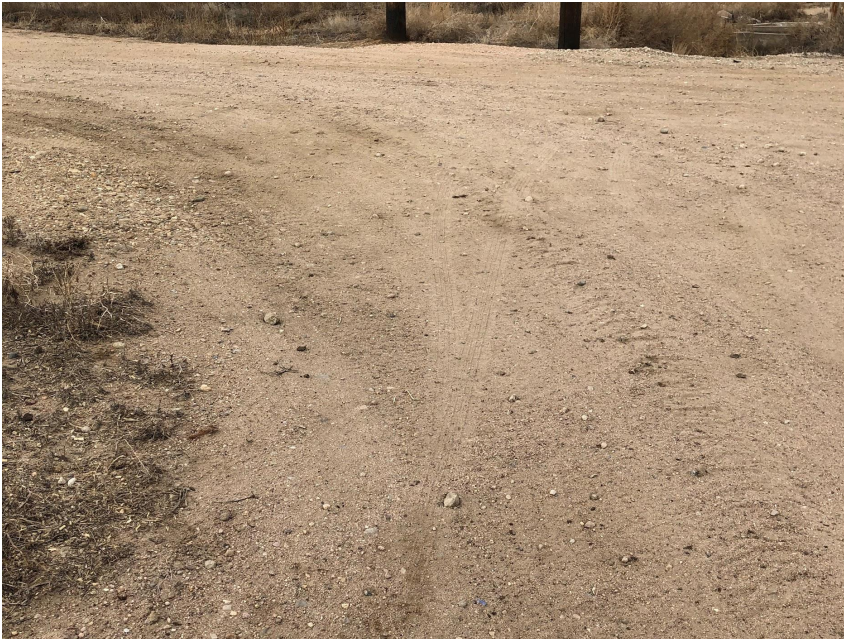
**Photo 1.** Photo taken from the entrance of the location on January 21, 2020, facing Southeast. Photo illustrates no current track out BMPs installed. However, no track out issues were present during the time of the inspection.

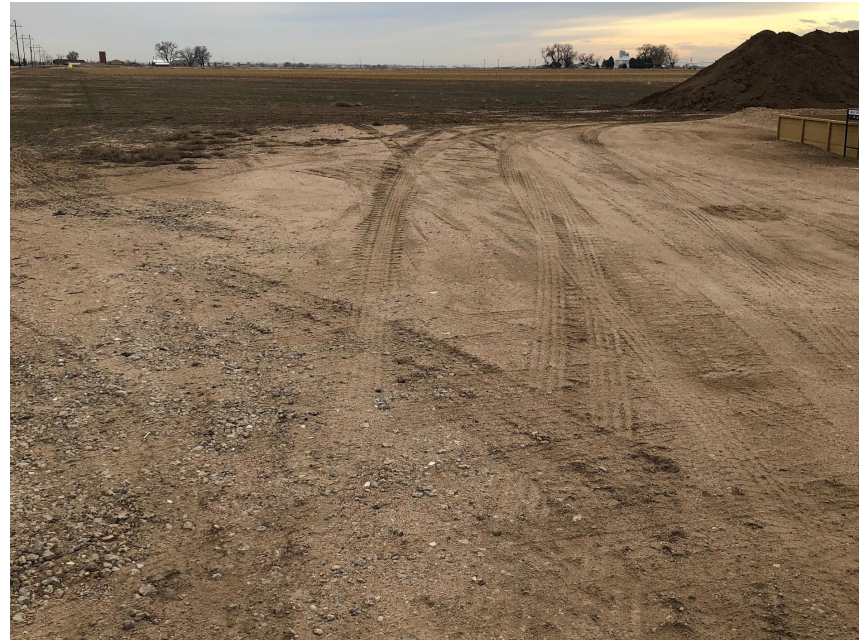
**Photo 2.** Photo taken from the Northwestern corner of location on January 21, 2020, facing South. Photo illustrates no ditch and berm BMP installed after interim reclamation. No current runoff issues existed at time of inspection.

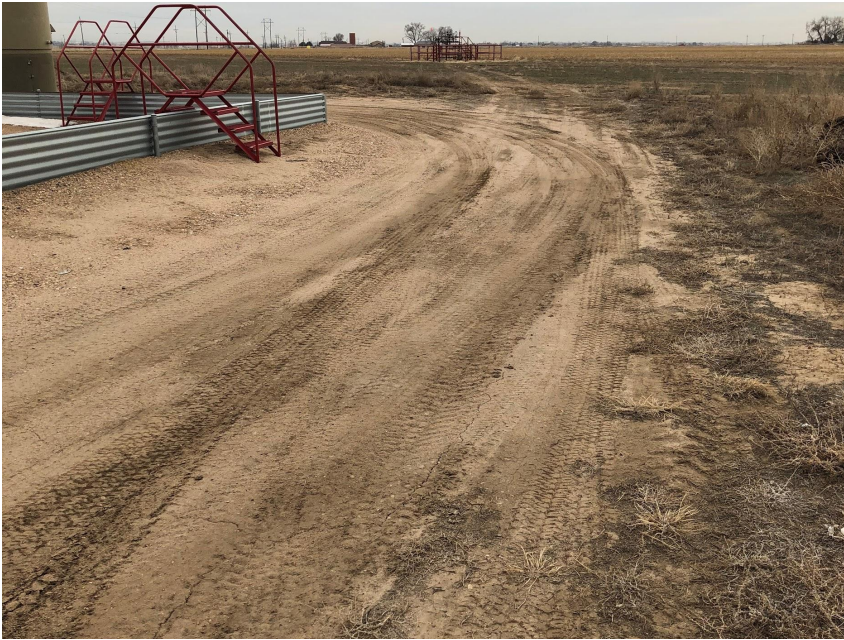
**Photo 3.** Photo taken from the Southwestern corner of location on January 21, 2020, facing east. No ditch and berm present at time of inspection.

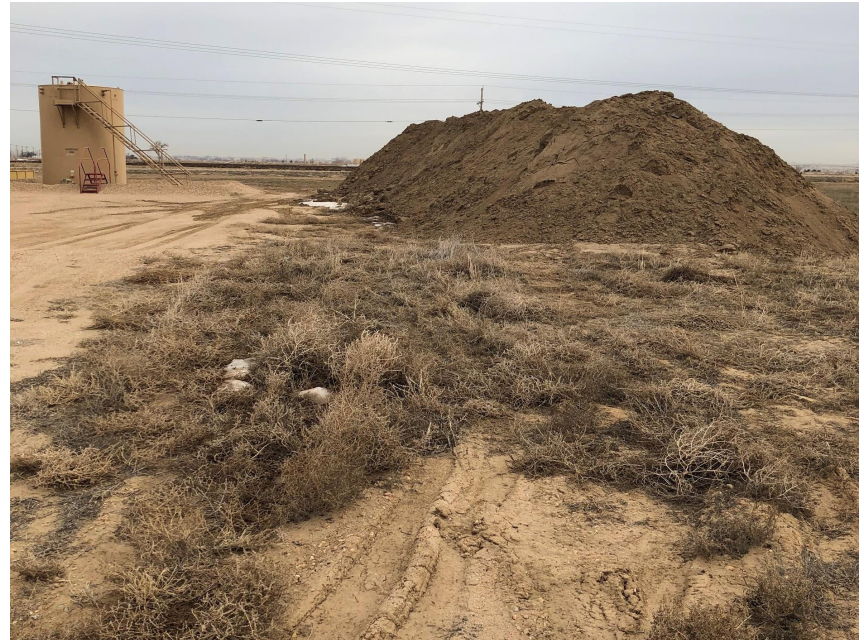
**Photo 4.** Photo taken from the eastern perimeter of location on January 10, 2020, facing West.. Photo depicts no ditch and berm BMPs installed throughout site; Tank battery in background. Unconsolidated soil pile on pad site may be apart of adjacent agricultural field.

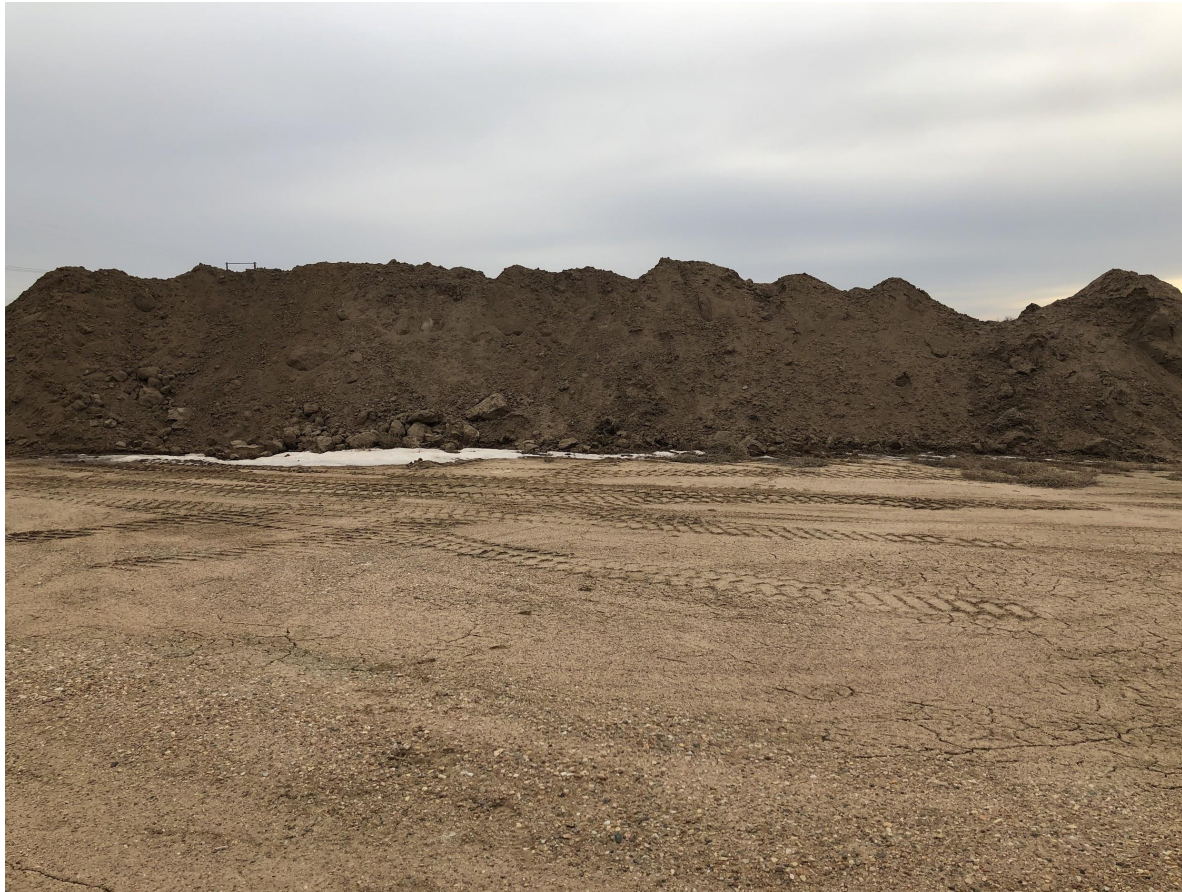
**Photo 7.** Photo taken from the Northern perimeter of location on January 21, 2020. Large Unconsolidated soil pile stored on the edge of the pad site. This soil may be in use for agricultural field adjacent to pad site.
